Second Five-Year Review Report

Atlantic Fleet Weapons Training Area – Vieques Vieques, Puerto Rico

December 2023

Prepared for NAVFAC Atlantic by CH2M HILL, Inc. Virginia Beach, Virginia Contract N62470-21-D-0007 CTO N6247021F4140

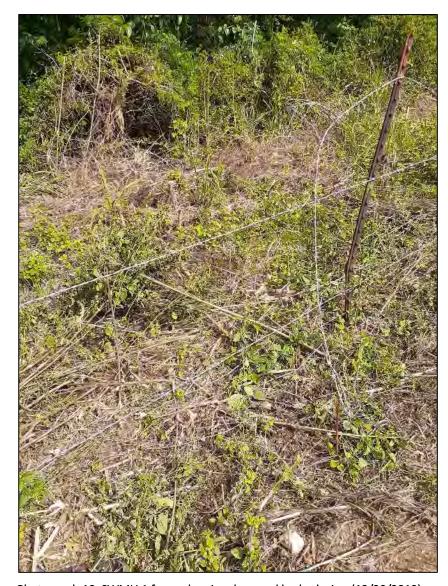
Photograph 10. SWMU 1 fence showing damaged barbed wire. (12/30/2019)

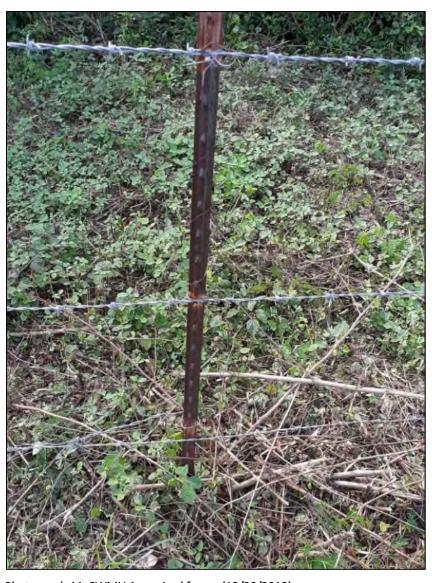
Photograph 11. SWMU 1 repaired fence. (12/30/2019)

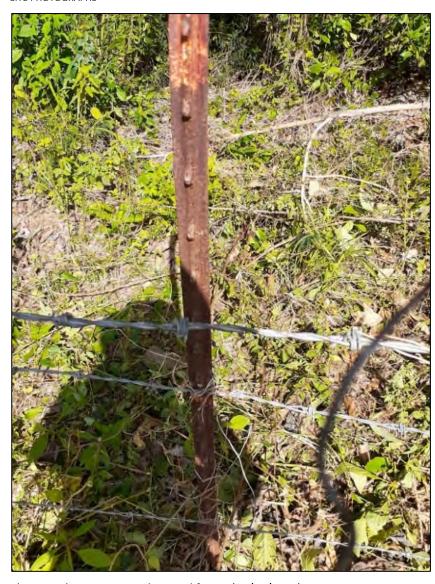
Photograph 12. SWMU 1 damaged fence. (12/30/2019)

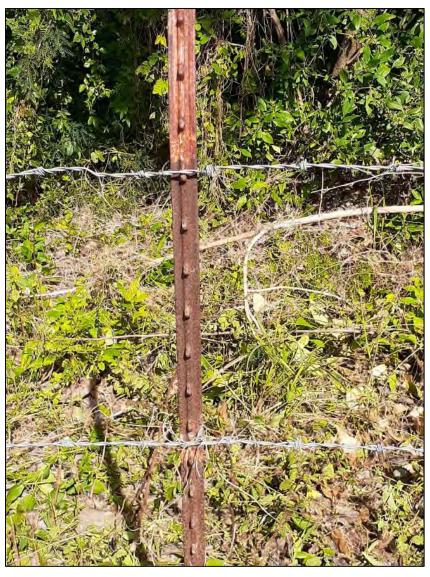
Photograph 13. SWMU 1 barbed wire damage was repaired prior to inspection. (12/30/2019)

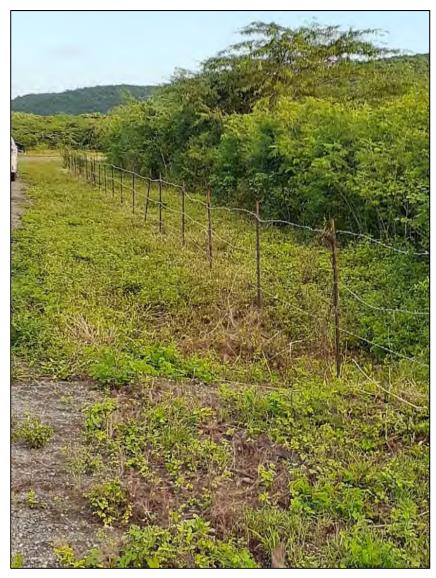
Photograph 14. SWMU 1 fence facing west with broken wire. Damage was repaired prior to inspection. (12/30/2019)

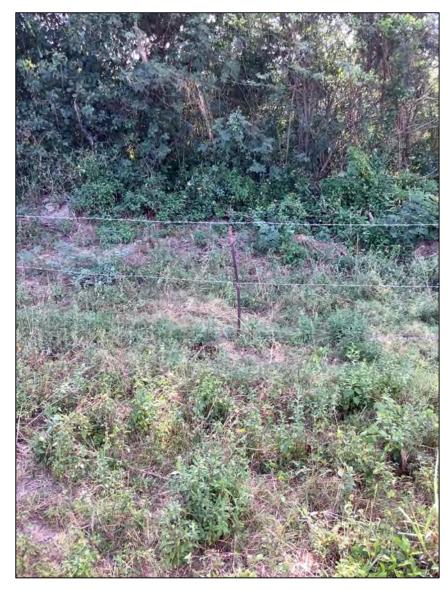
Photograph 20. SWMU 1 damaged fence post #1. Photograph taken on January 28, 2021.

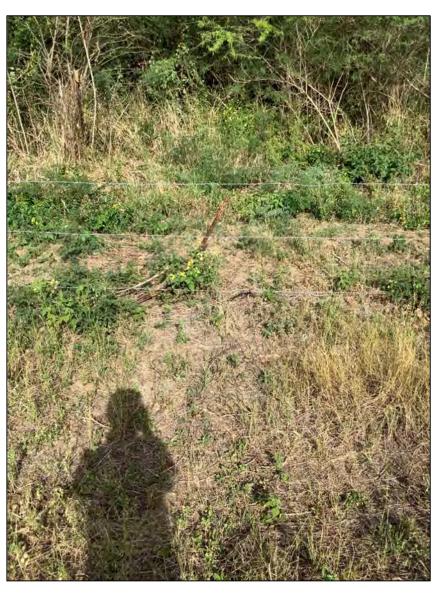
Photograph 21. SWMU 1 damaged fence post #2. Photograph taken on January 28, 2021.

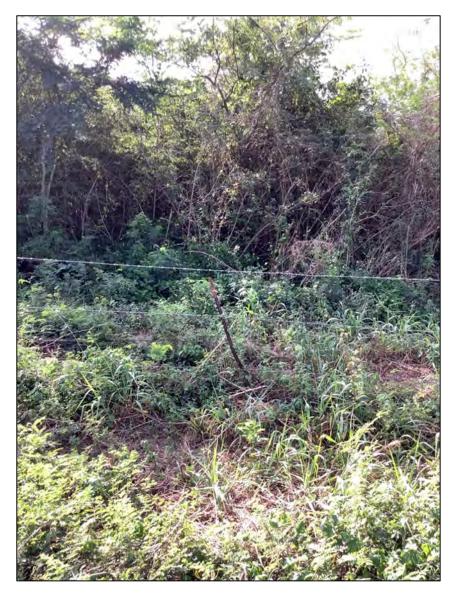
Photograph 22. SWMU 1 damaged fence post #3. Photograph taken on January 28, 2021.

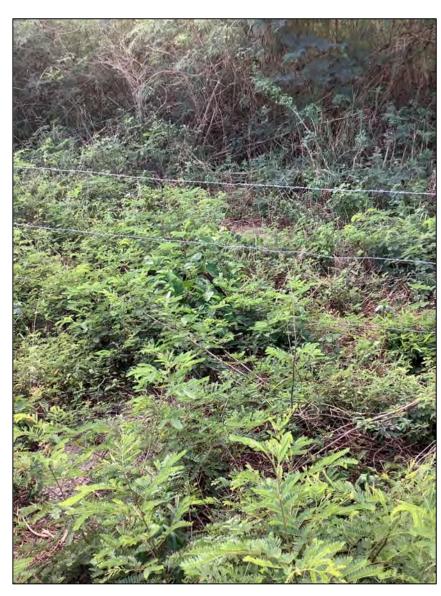
Photograph 23. SWMU 1 missing fence post #1. Photograph taken on January 28, 2021.

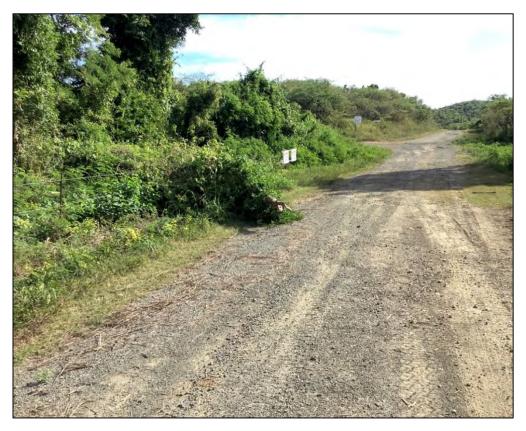
Photograph 29. Small tree down along north side of access road with dense overgrowth, facing east. Photograph taken on January 28, 2021.

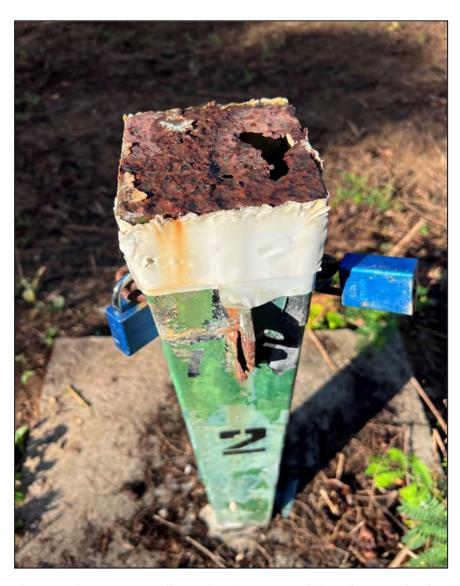
Photograph 2. MW-02 well top of casing rust condition. Photograph taken on January 20, 2022.

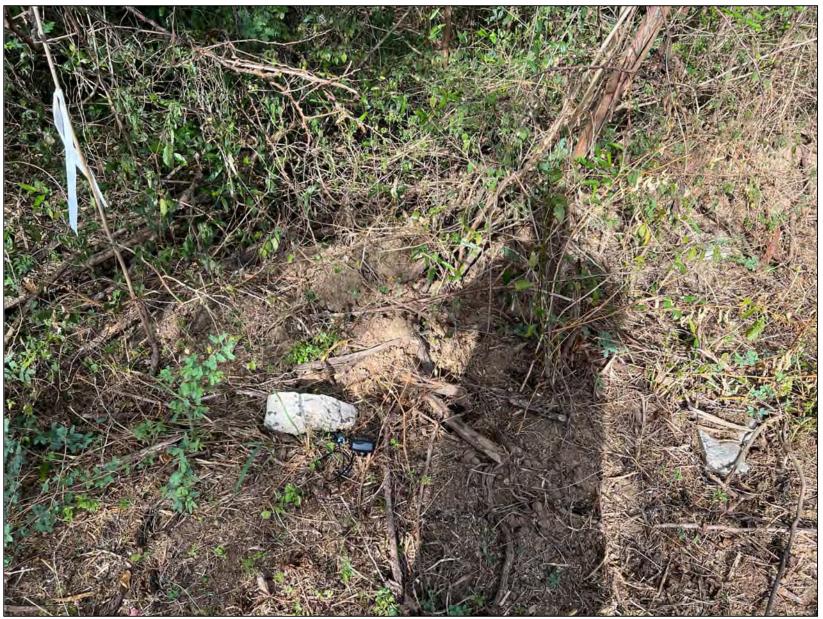
Photograph 5. Exposed broken concrete fragments 30 feet north and 50 feet south of MW-03. Photograph taken on January 20, 2022.

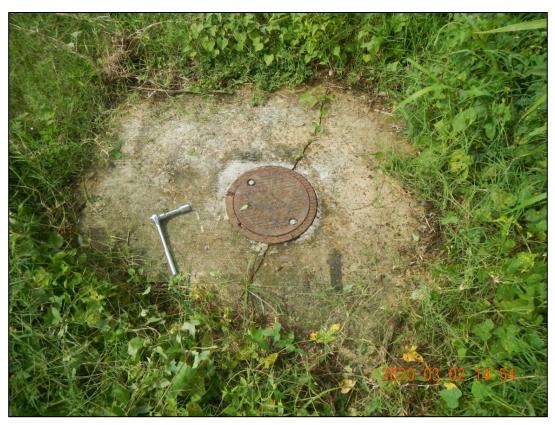
Figure 17. MW-01 pad and well cover condition; minor pad cracking observed.

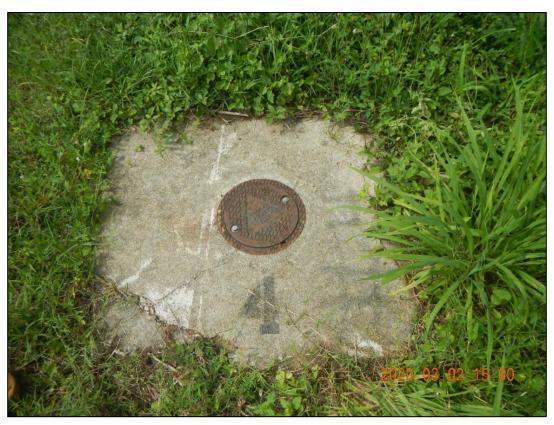
Figure 23. MW-04 pad and well cover condition; minor pad cracking observed.

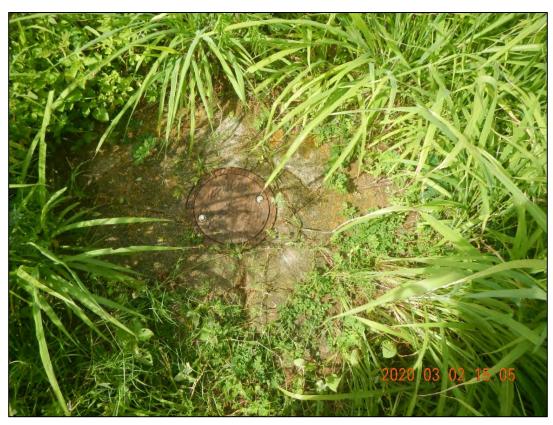
Figure 25. MW-05 well pad and cover condition; minor pad cracking observed.

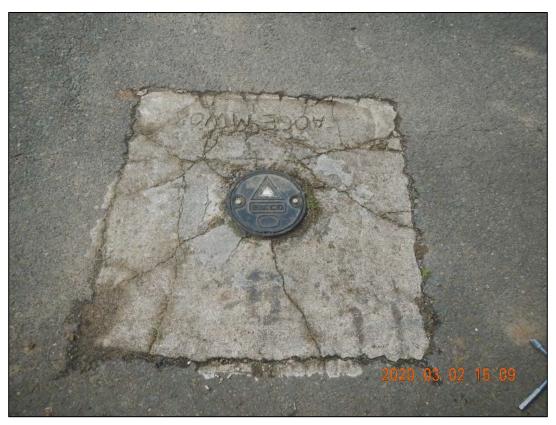
Figure 29. MW-08 well cover and pad condition; minor pad cracking observed.

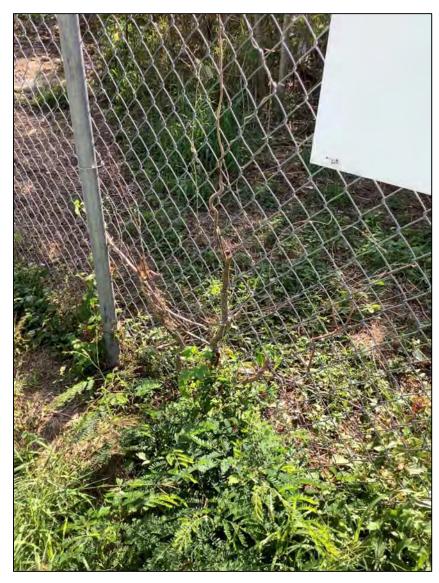
Photograph 7. Small tree growing along west fence line facing west on 2/1/2021.

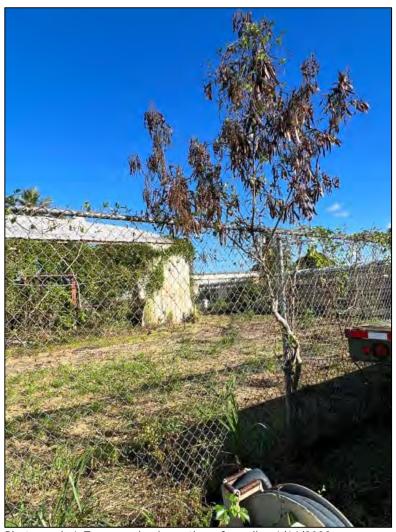
Photograph 4. Tree growing in southern fence line 1/14/2022.

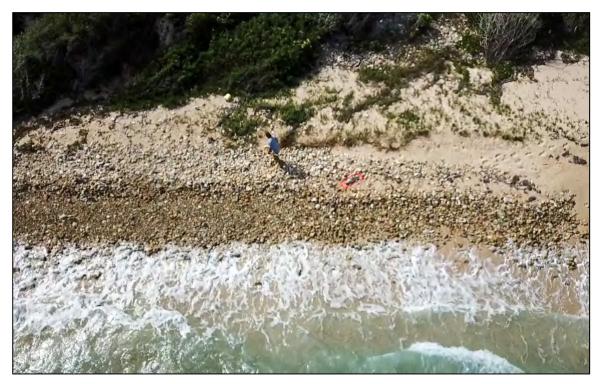
Aerial photo of Playa Blanca showing location of sonar buoy piece found on southern portion of beach near the beach trail entrance. Orange spray paint was used to mark the item prior to removal.

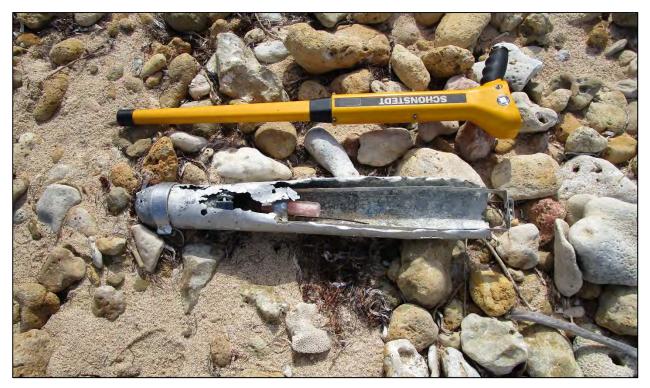
Sonar buoy piece encountered on Playa Blanca. A Schonstedt is shown above the sonar buoy for scale.
