Naval Facilities Engineering Command Northwest

Safety Lessons Learned Accident Abstract

Accident Type: Worker crushed by Front end loader.

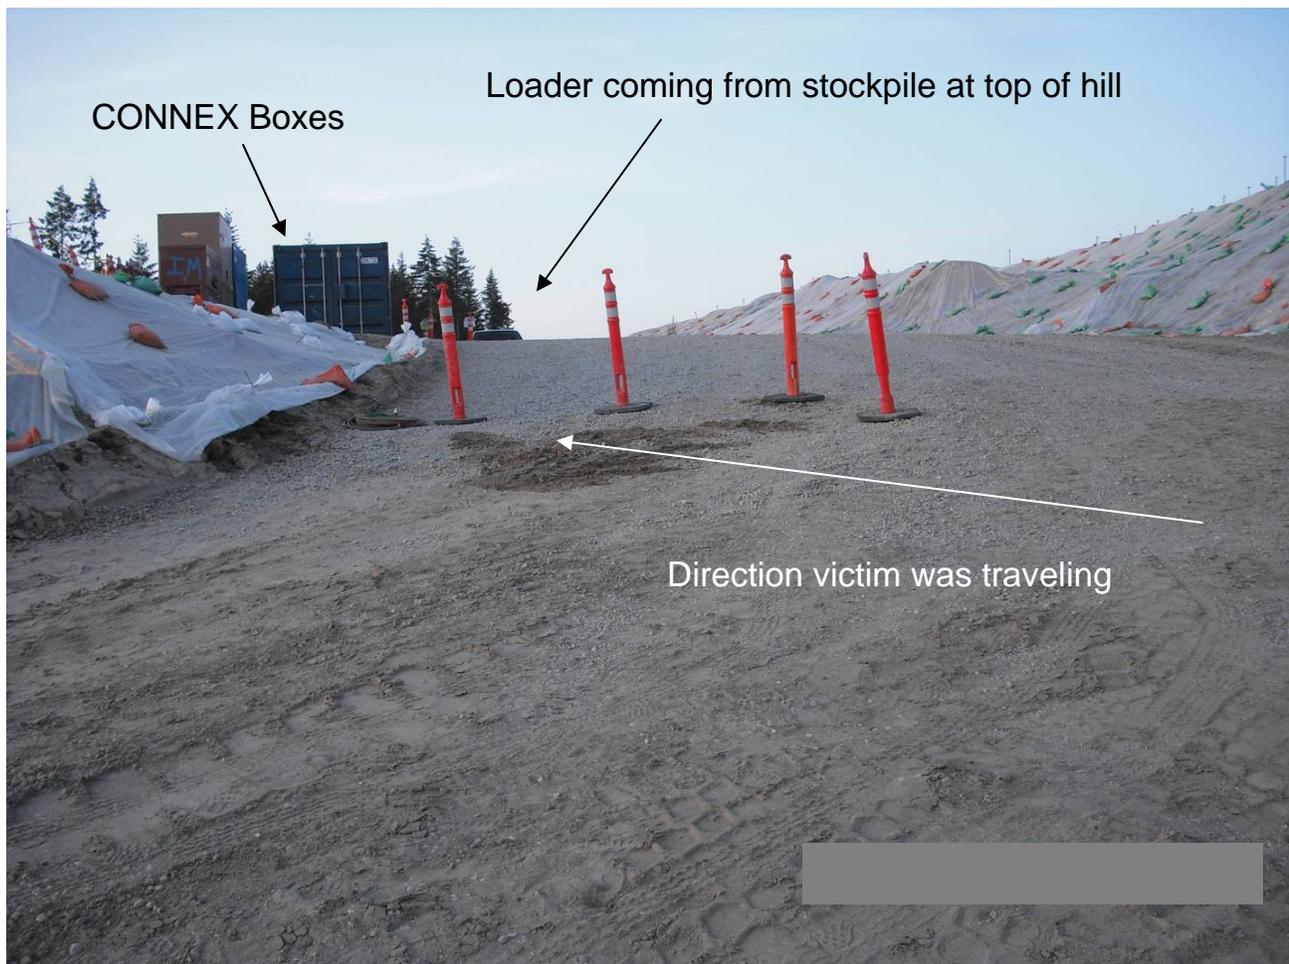
A 47 Year old subcontract 3 year sheet metal apprentice worker on-site for a month was crushed under the right front and rear wheels of a Catepillar Model 966 articulating front end loader. Loader operator was hauling 3/4minus rock down a 10%-12% grade to a soil build-up area. The apprentice was walking upgrade from his job site to one of two conex boxes located midway up the incline on a flat grade that separated the incline. He was carrying oxy/acteylene welding hose on his right shoulder and a regulator in his right hand. The loader and the apprentice met at mid grade of the first incline (see picture below).

- ◆ Inattention to detail. From all accounts, the victim and the FEL operator were both unaware of the impending collision.
- ◆ Failure to employ basic traffic management. The requirements of the EM385 for an Access/Haul Road Plan address these controls.
- ◆ Failure of any contractor employee (prime or sub) to act on what was recognized as a hazardous situation.

- ◆ Equipment blind spots.
- ◆ Centralizing the Intermech conex boxes thus requiring pedestrian traffic to transit an active haul road from multiple, uncontrolled entry points.

- ◆ Human error is the root cause of this accident. On the part of the operator for failing to identify the victim in his path of travel; on the part of the victim for failing to avoid the FEL or use generally known precautions around heavy equipment (inexperience with this type of operation was a likely contributor); and on the part of the contractor employees, supervisors, foreman, and SSHO for failing to recognize the high hazard/risk associated with the activities and site layout or to properly act on the hazard/risk if they did.

- ◆ Define the threshold for an NOV for safety deficiencies, communicate it, and stick to it.
- ◆ Execute an approved Access/haul Road Plan. This is a specific requirement of the contract.

- ◆ Require spotters/flag persons in congested work areas with traffic hazards. Required per EM385-1-1, 16.B.02.
- ◆ Reschedule heavy equipment operations around other activities to reduce interference. This mitigation measure could result in zero risk.
