Contractor Fatality

Tipped Elevated Manlift

Activity: Aircraft Hangar Capital Improvements (CI) Milcon project - steel erection.

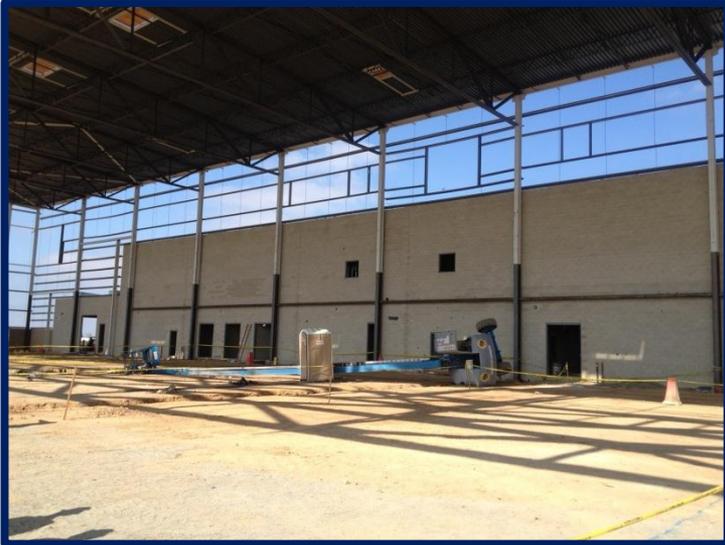
Two contractor employees working for a third tier subcontractor installing overhead steel were injured one fatal and one seriously when the articulating boom platform (man lift) they were operating within the interior foot print of a hanger with earth floor tipped over. The boom was elevated to approximately 35'. When repositioning the lift which was straddling a 2' deep trench, a wheel rolled into the trench, causing the lift to topple. The men fell with the lift bucket an equivalent of 3 stories.

Potential Contributing Causes:

Equipment travel over uneven surfaces (trench).

Man lift traveling in elevated position.

Failure or bypass of controls limiting elevated platform travel.

Conflicting work scheduling (trenching / overhead steel work).

Ineffective trench barricades /demarcation.

Communication Points:

KNOW operational tolerances /restrictions of equipment in areas of uneven surfaces and stay clear of trenches (trenches) .

KNOW travel limitations/restrictions in elevated position.
