# Dropped Steel Beam Fatality

- August 2009 Working after normal business hours
- An 8A IDIQ Contractor
- Performing ATFP Improvements
- Subcontractor Employee
- Steel erection - setting canopy beams with a material handling rough terrain forklift. Nylon rigging strap overloaded and broke causing beam to fall on worker (employee under suspended load) pinning him under the beam.
- Process changed when contractor lifted one 70+ foot long section versus two approximately 35+ feet long sections as planned.
- Operator not licensed.

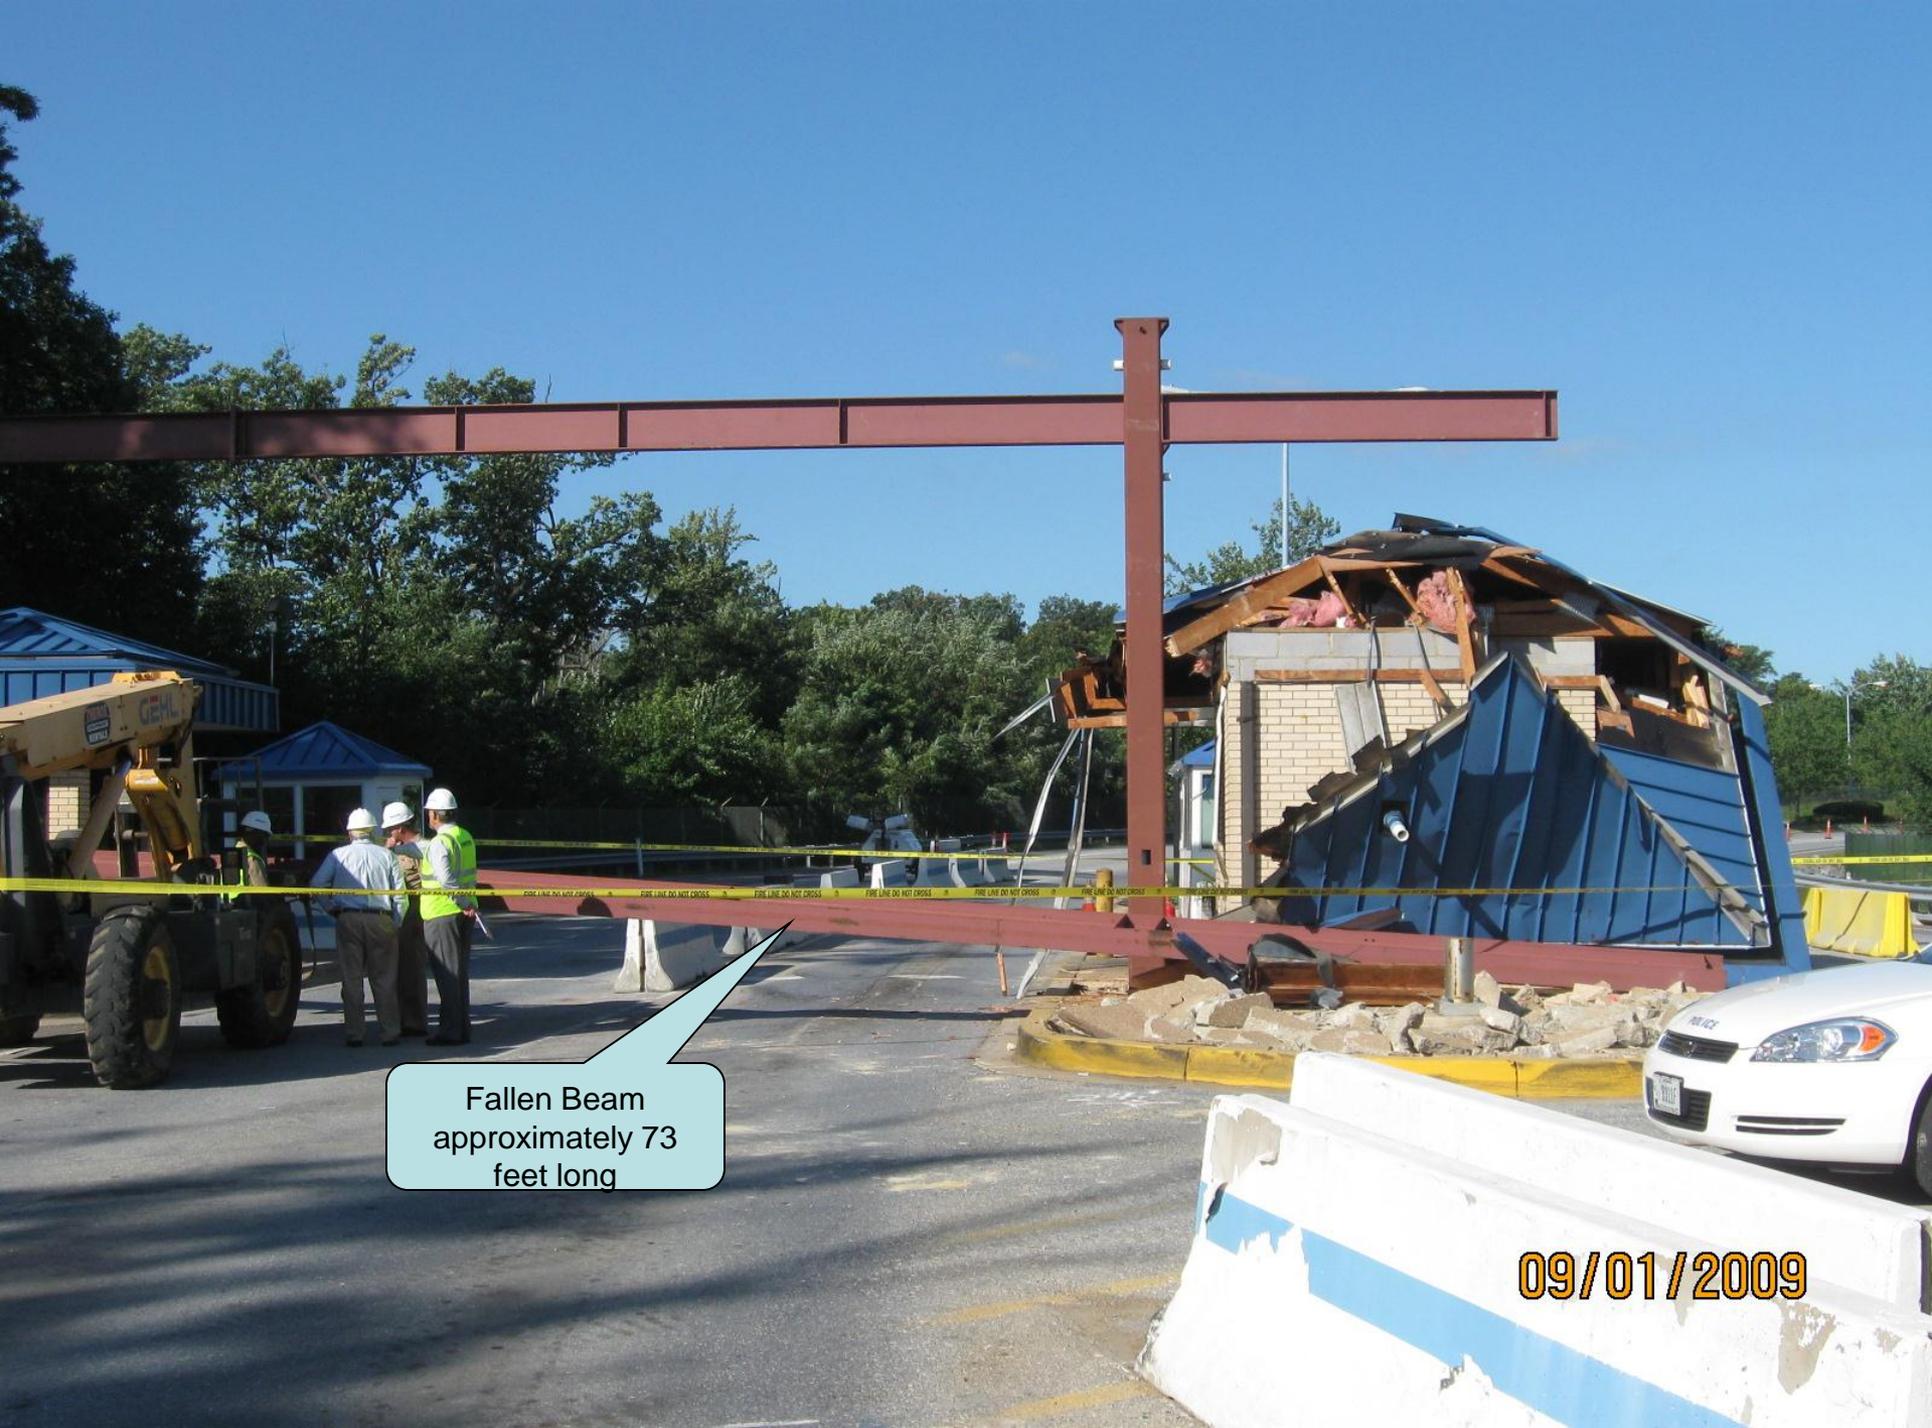
Fallen Beam  
approximately 73  
feet long

Vertical column  
(pedestal) location of  
intended final beam  
resting point

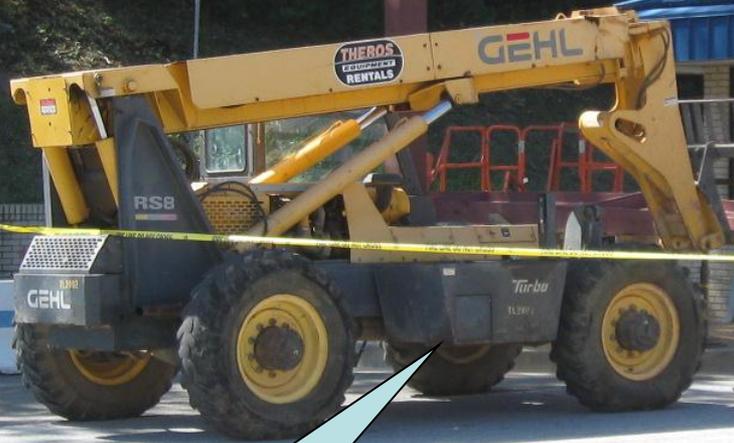
Rough terrain  
material handling  
forklift

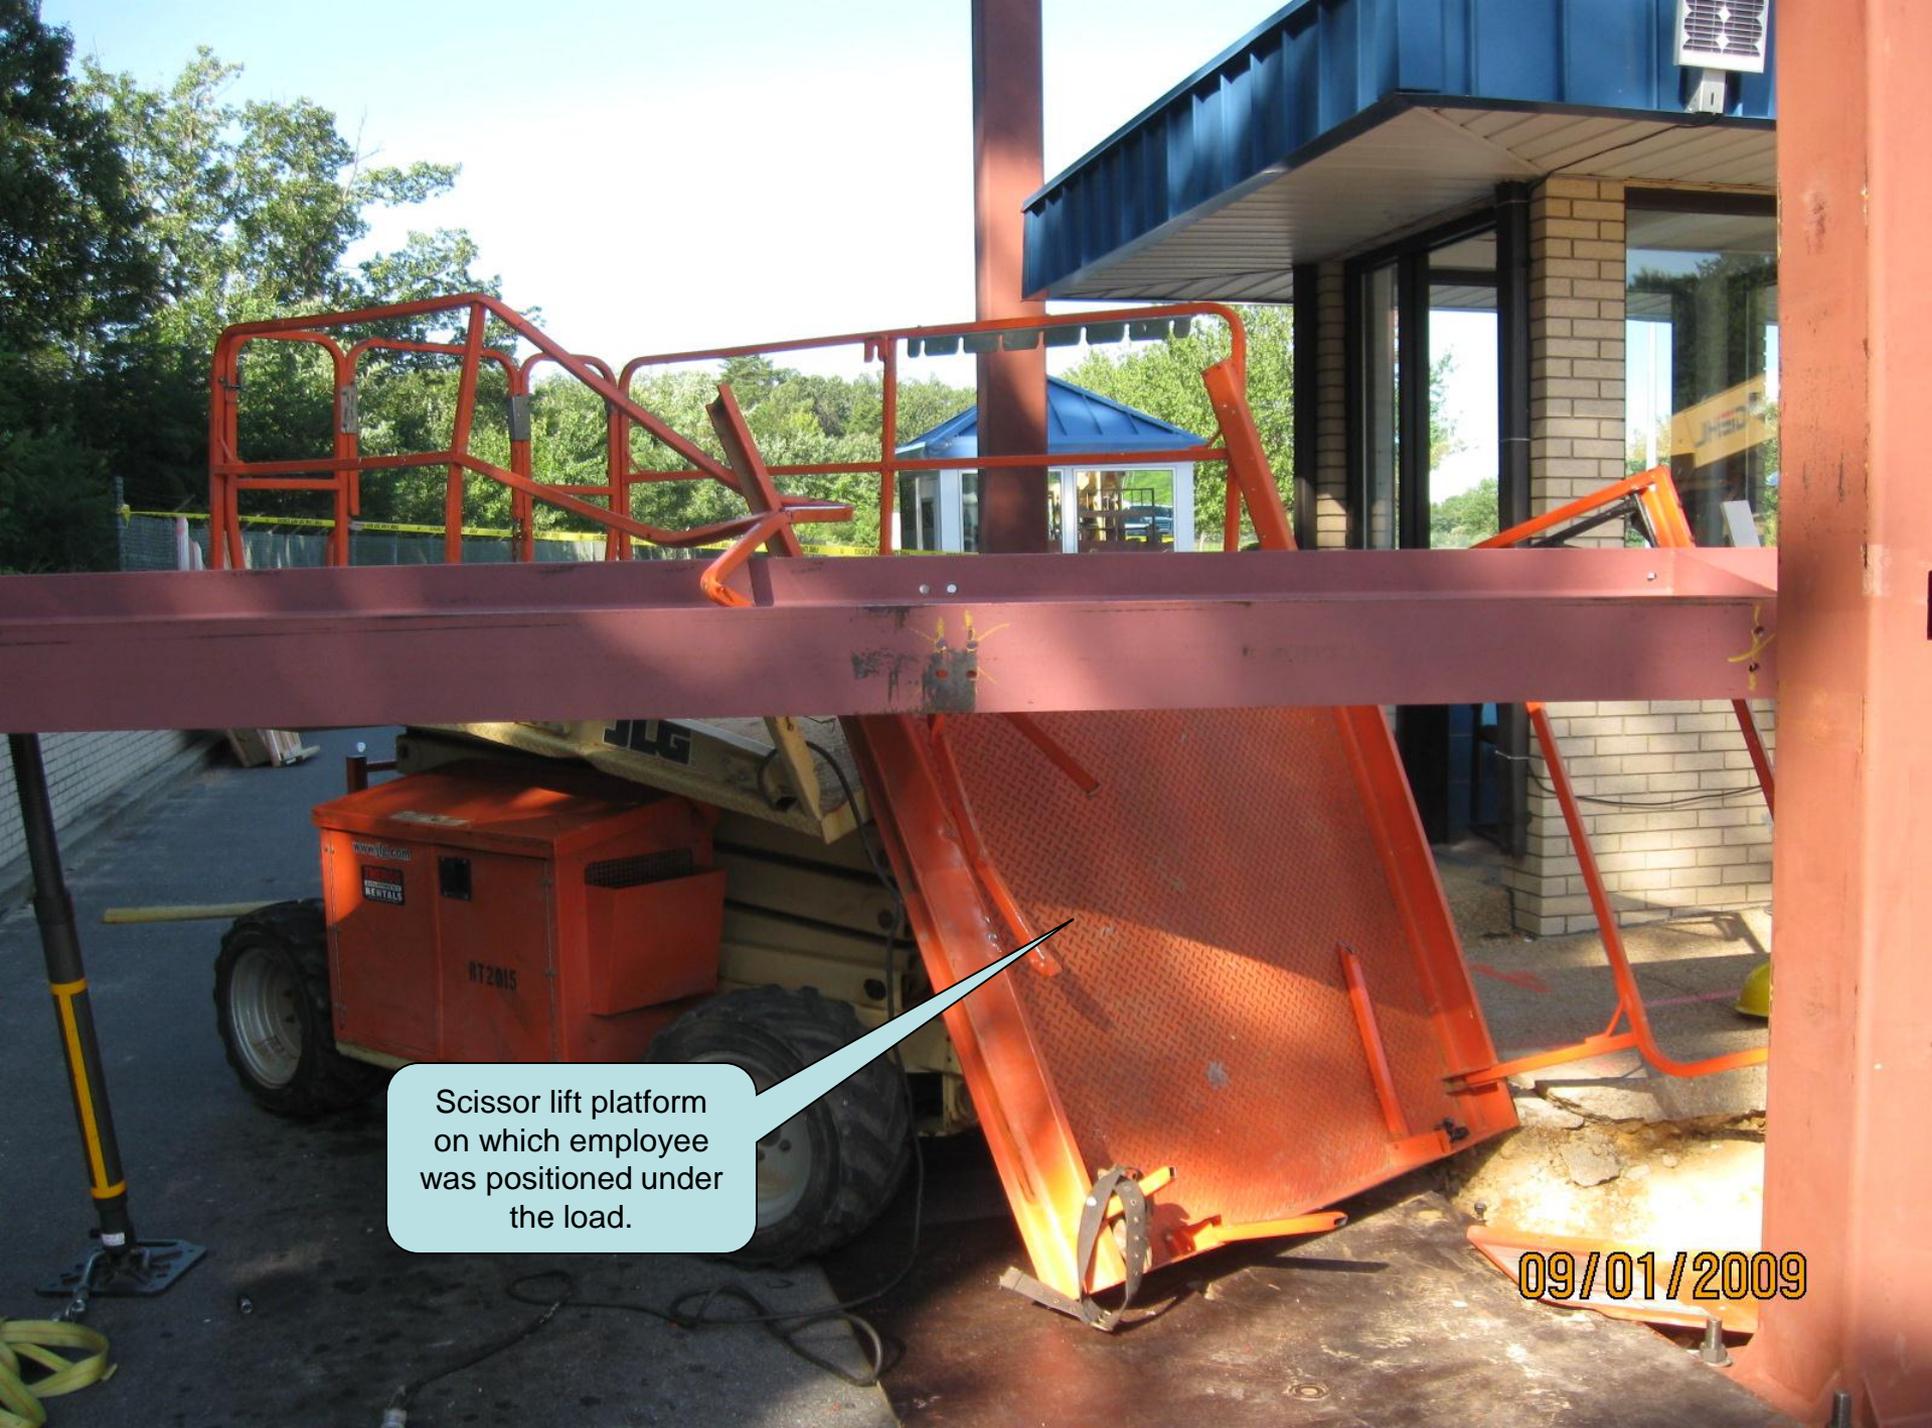
Scissor lift platform  
on which employee  
was positioned under  
the load.

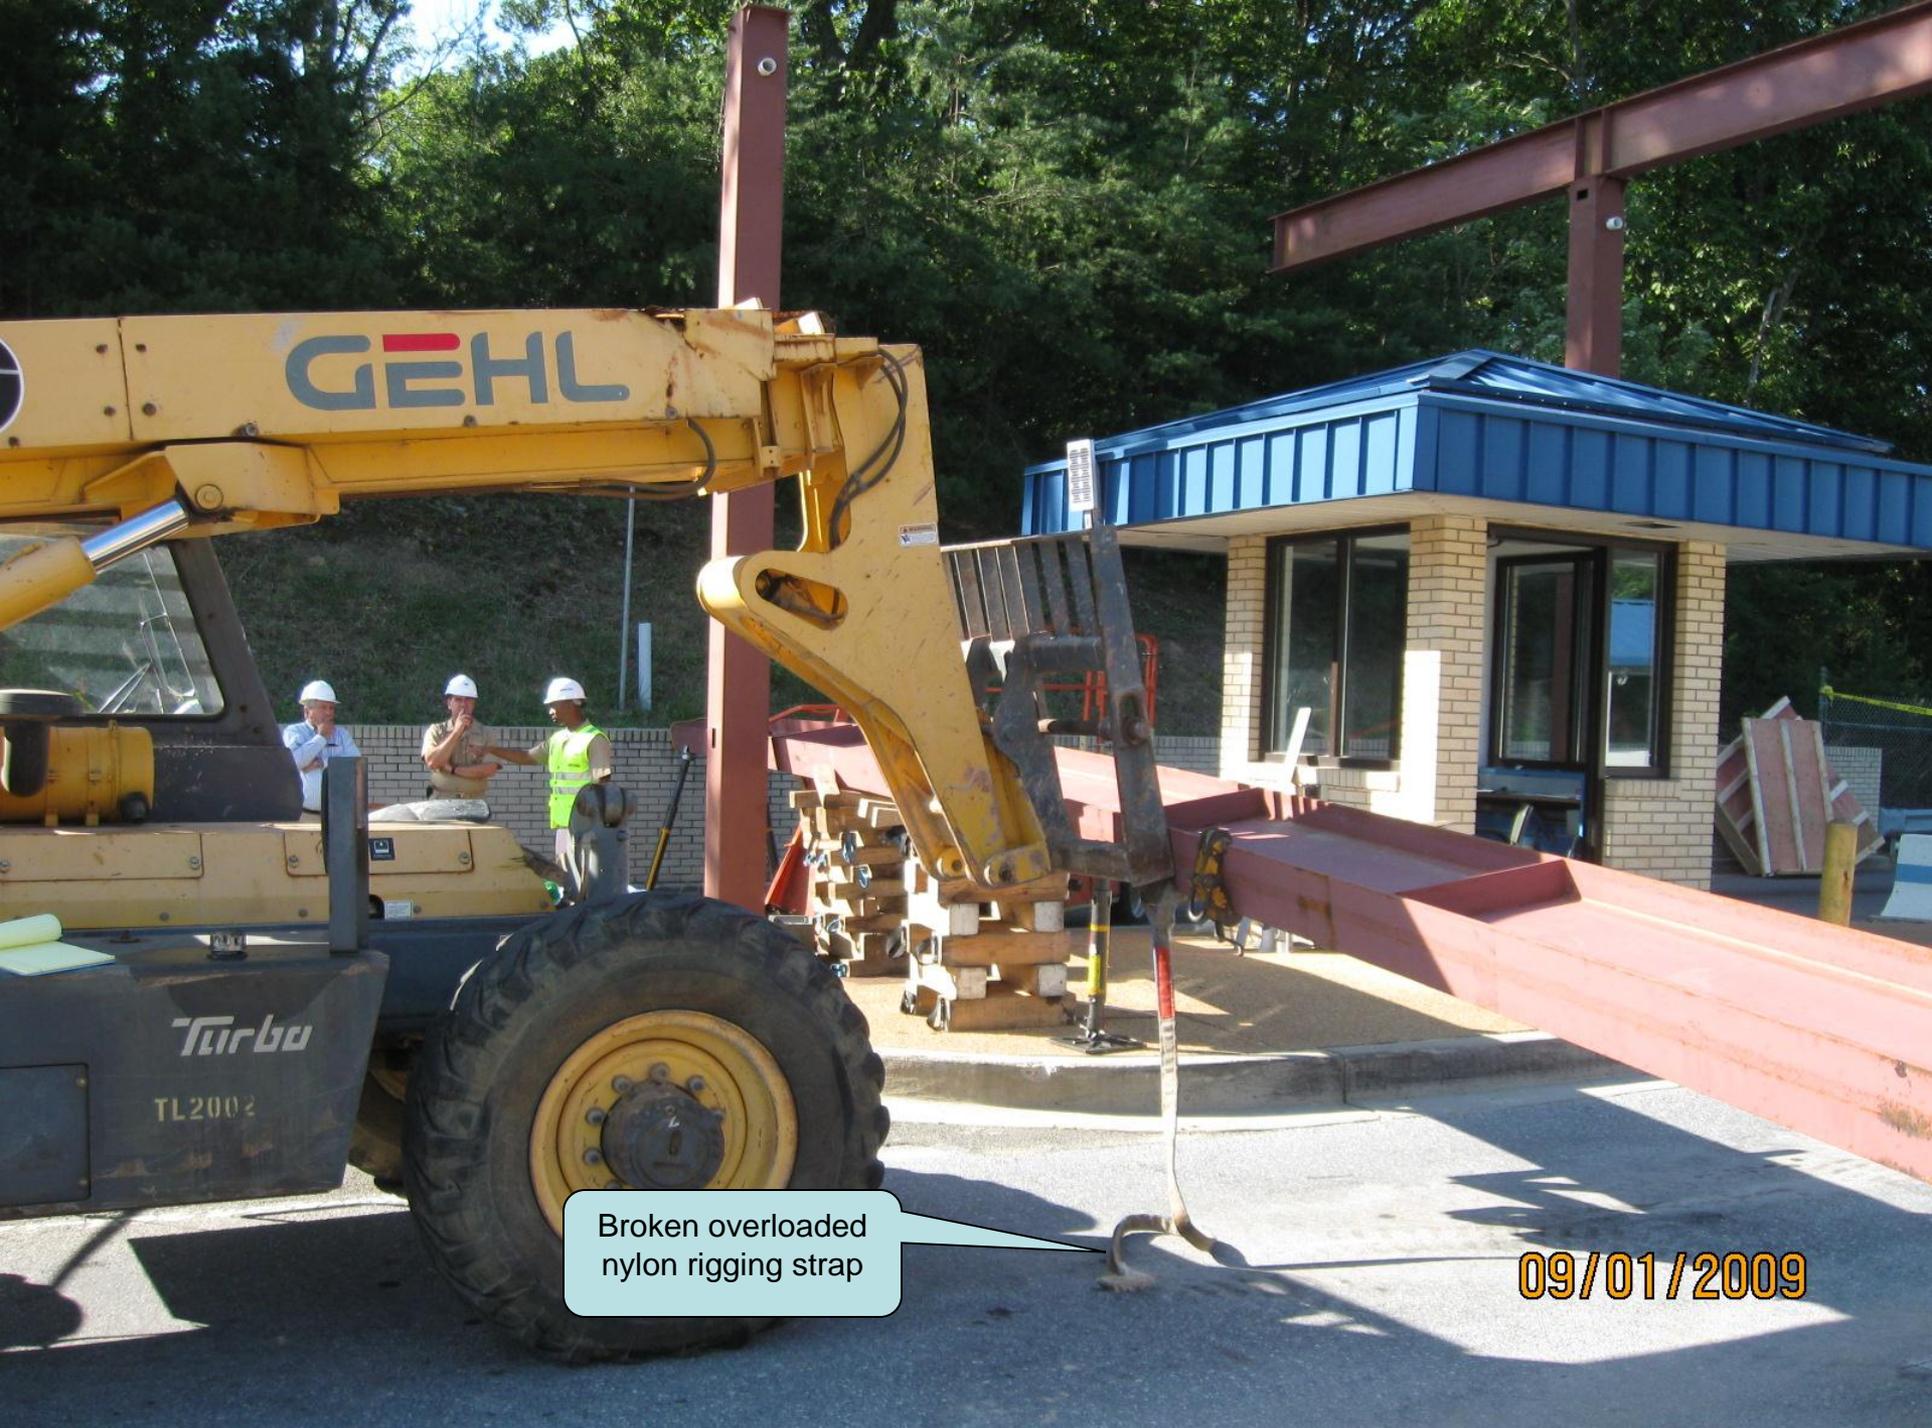
Broken overloaded  
nylon rigging strap

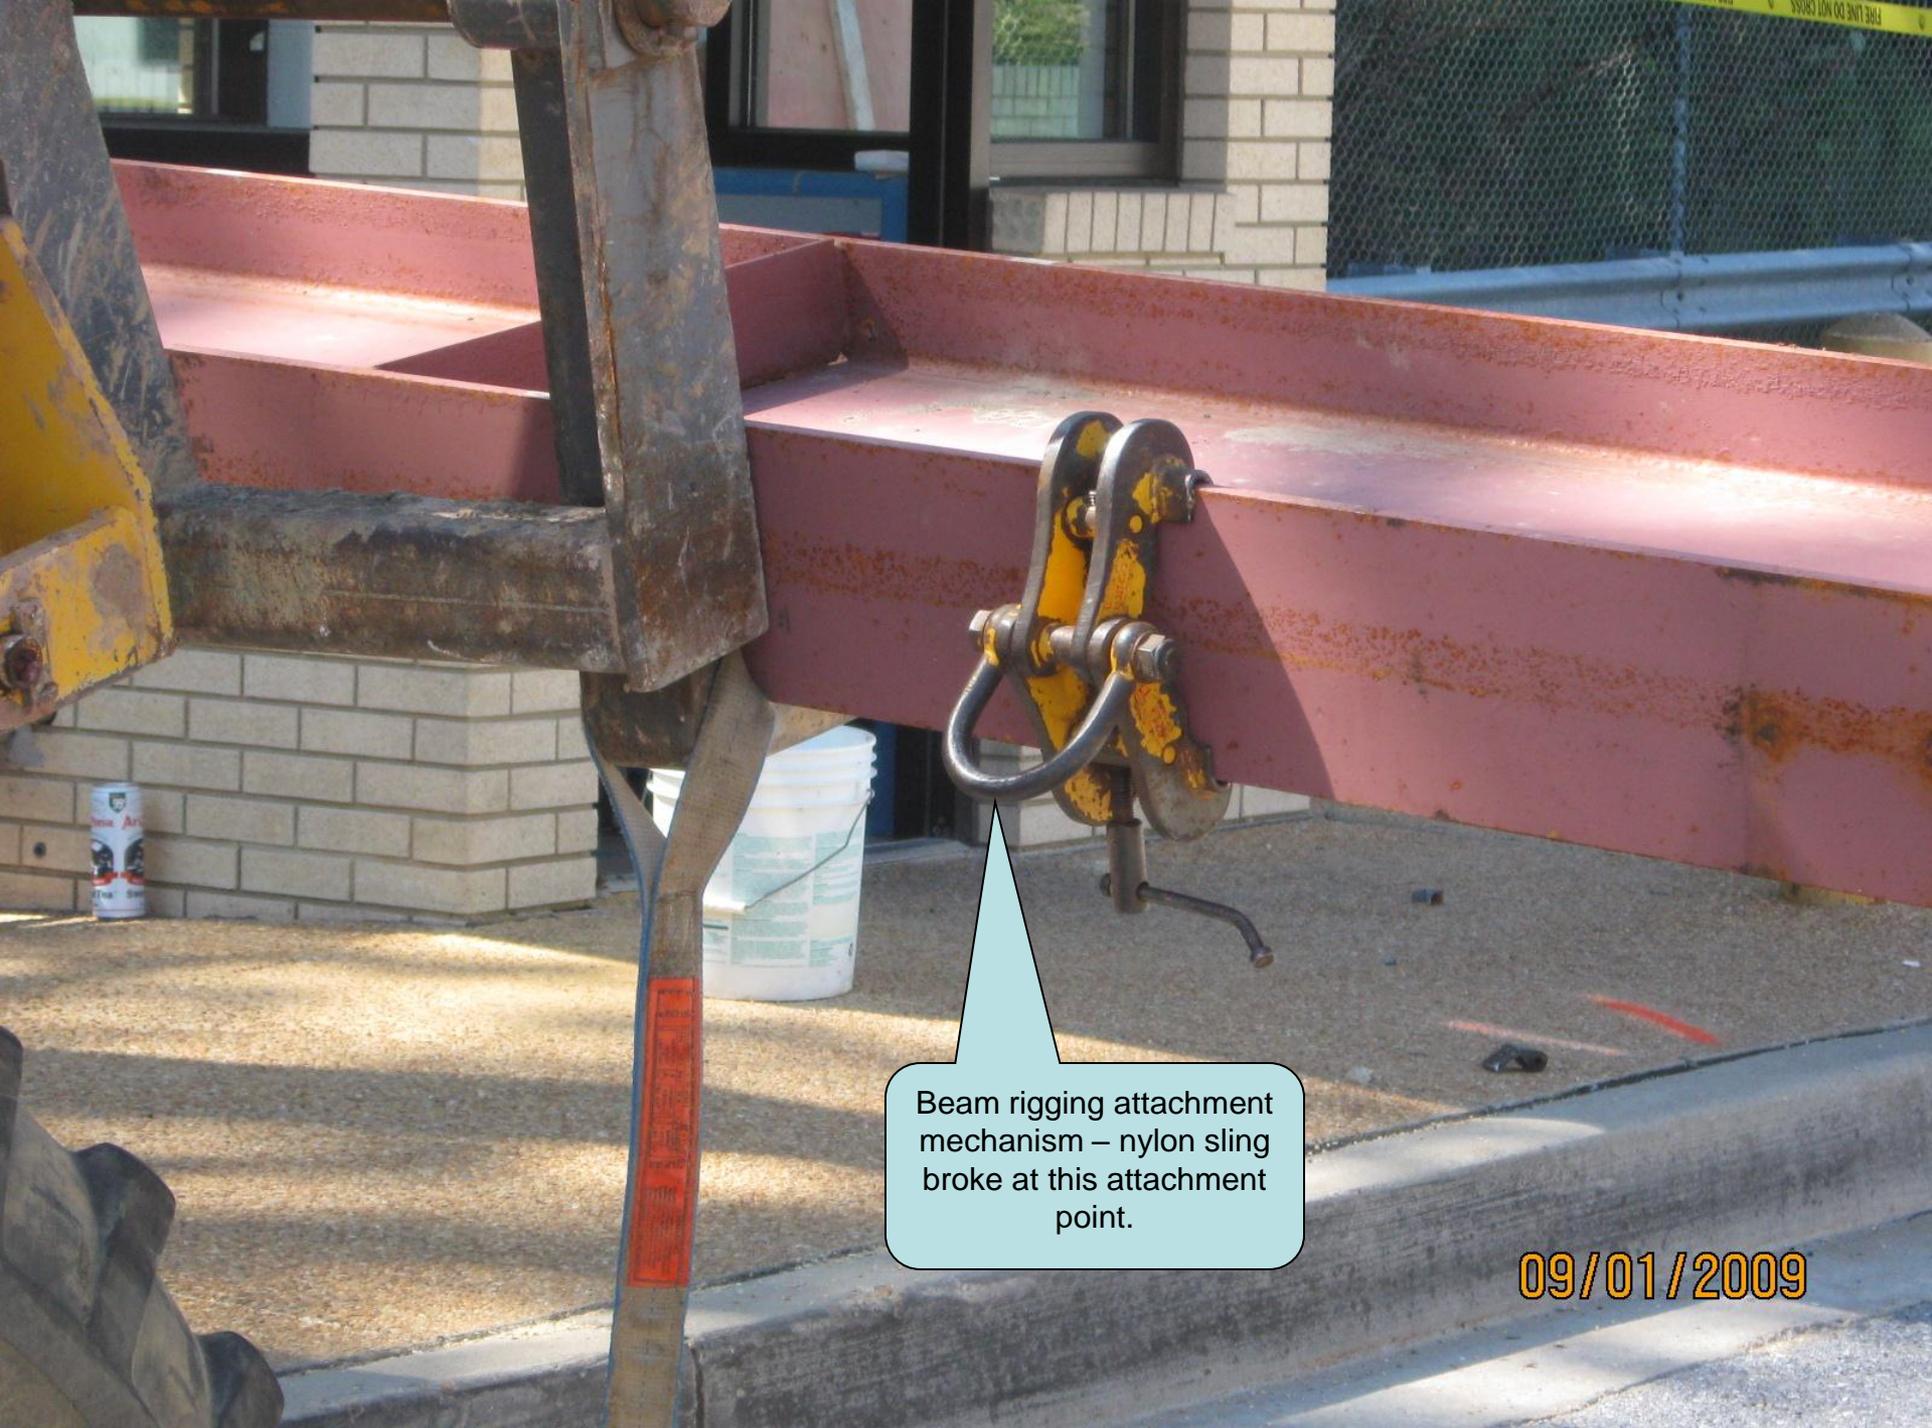
Beam rigging attachment mechanism – nylon sling broke at this attachment point.

Sling used in choker configuration – 5000 lbs max. capacity. Critical lift required for 75% of capacity.

Beam = 4960 lbs  
Rigging = 450 lbs
