Naval Facilities Engineering Command, Mid-Atlantic

SAFETY ALERT

Incident Types: Failure to follow use PPE
Damage: Laceration to forearm/ 5 stitches
Type of Work: Renovation
Equipment: N/A

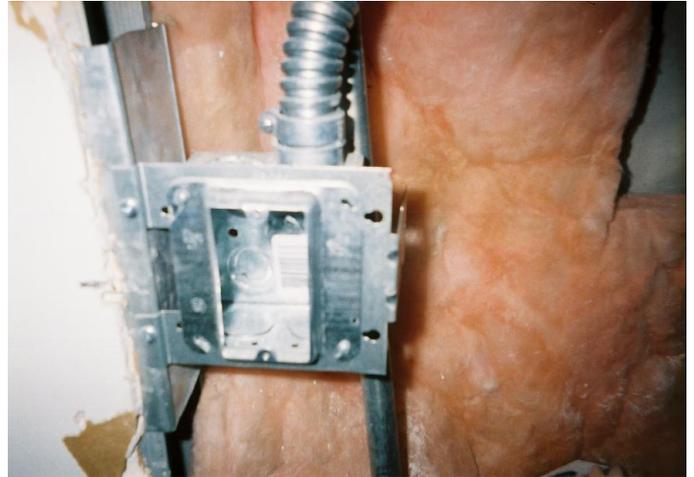
DESCRIPTION OF THE INCIDENT: Contractor was installing metal framing in an existing wall that needed to be patched with drywall. A one foot square piece of drywall was removed from this area to install an electrical box as part of the renovation. As employee was installing the metal stud he had his arm in the wall cavity to support the metal stud. After installing the stud he pulled his arm out of the wall cavity and his forearm caught the corner of the electrical box and cut his forearm requiring 5 stitches.

DIRECT CAUSE: Lack of using engineering controls to eliminate the hazard before performing the operation. Work area of wall was not opened sufficiently to allow work. Work area was too tight and required awkward work position to work

INDIRECT CAUSE: Improper work techniques to install metal stud. AHA did not define possible hazard of sharp edges nor were control measures implemented to eliminate or reduce the hazard to an acceptable level of risk considered.

ACTIONS REQUIRED: Safety stand down was held with jobsite personnel to review the proper procedures to perform the task safely. Provide a larger opening for patch so more space is available. Cut the existing drywall to an existing stud eliminating the need for additional studs in wall.
