ATLANTIC DIVISION, NAVAL FACILITIES ENGINEERING COMMAND

ACCIDENT ABSTRACT

Accident Type: _____ Crushed by
Injury: Fatality
Type of Work: Masonry
Equipment: Self-Supported Scaffolding

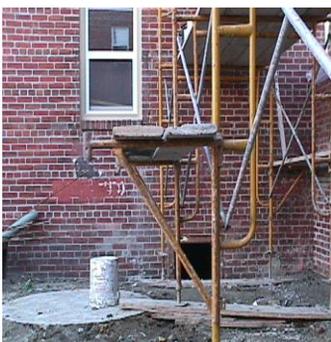
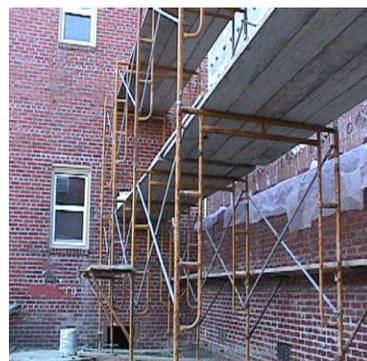
During a self supported scaffold dismantling operation a stack of approximately 20 scaffold 2" X 10" X 16 feet scaffold planks were temporarily loaded on an outrigger bracket scaffold accessory located on the outboard side of the system. The stack of planks overloaded the system causing the scaffold to tip over. The planks, which were located on the third level of the scaffold system landed on top of a mason who was working at the facility finished floor level, approximately 20 feet away.

The scaffold outrigger bracket platform was overloaded. No provisions had been made for additional support necessary to offset the overturning moment caused by the scaffold plank loading.

- 1) The employees involved in the dismantling operation had not been adequately trained to recognize the over loading hazard.
- 2) The use of a forklift to lower the planks made it necessary for the employees to find a method for loading the forklift outside the scaffold platform due to the length of the planks.

The outrigger bracket accessory was not used in accordance with manufacturers printed instructions and USACE EM 385-1-1 14.B.05, 22.B.09, and 22.B.11. The accessory is designed for workers and light tools and not for material loading. Because the outrigger platform accessory has the potential to be misused to support material, and the fact that the extended platform makes installation of required fall protection guard rail system more difficult on the outboard side of the scaffold system their use should be terminated.

Individuals designated as competent persons and involved in erection or dismantling of scaffold systems shall have documented training in accordance with USACE EM 385-1-1 and 29 CFR 1926.454.
