# Steel Erection Contractor Fatality

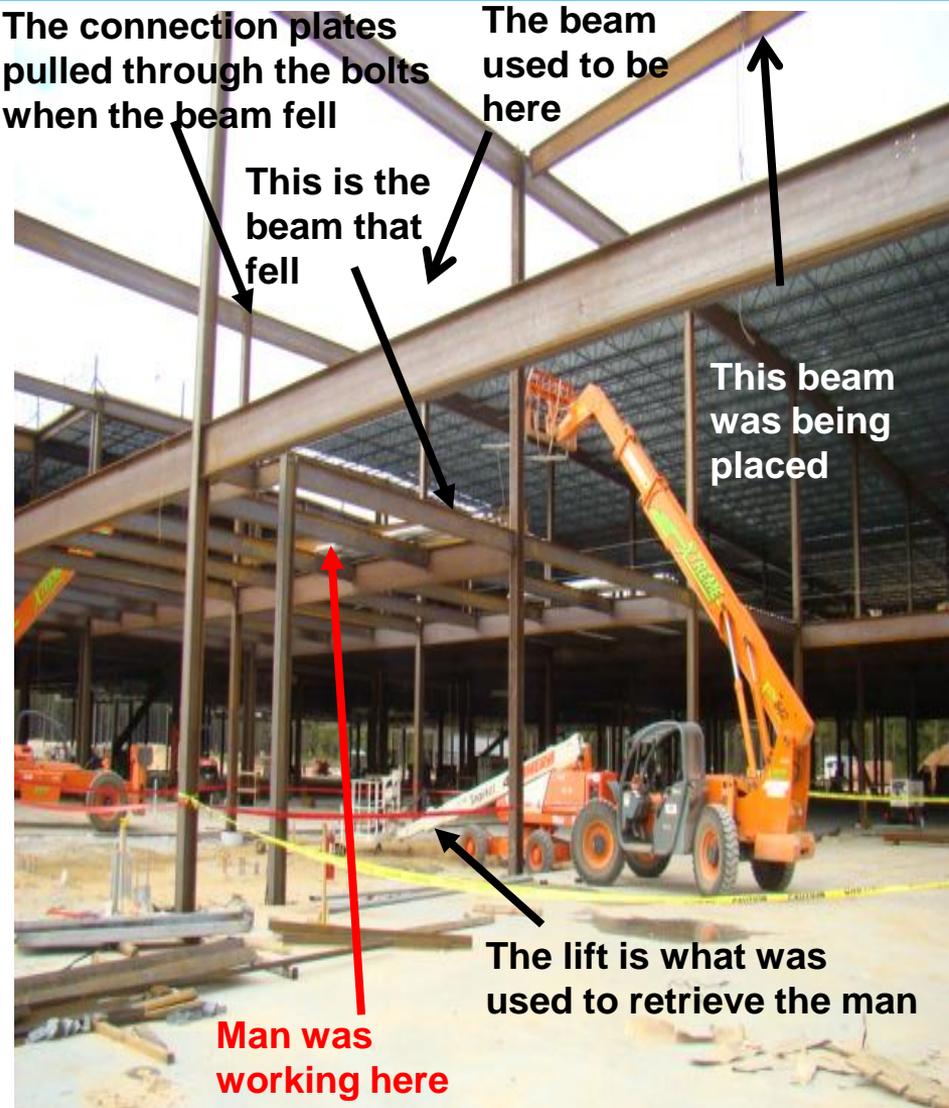
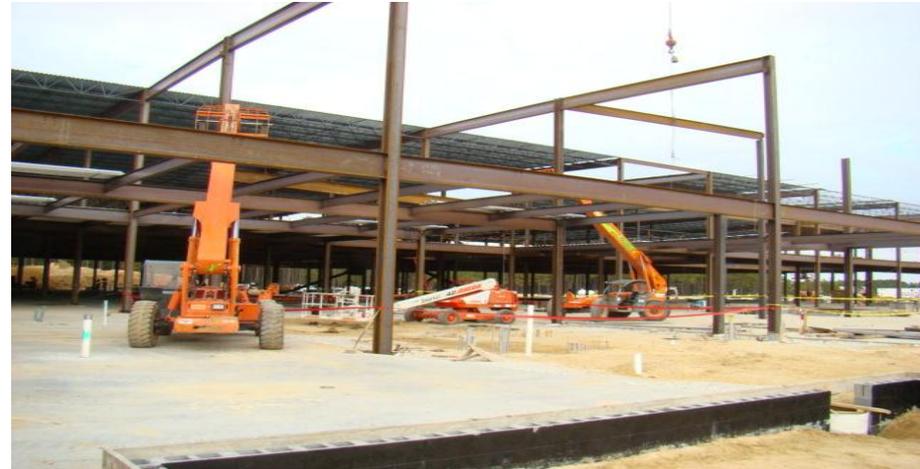
- 38 year old Iron Worker
- Second Tier Sub
- Cause: Unsecured load above
- Root Cause(s): Beam released from material handling equipment without being fastened, bolted, or without seat support during double connection process.
- Initial Lessons Learned:
  - Ensure there is a fastened bolt or seat for double connections during erection.
  - Ensure no one is under a live load.
