# ***Controlling Risks of Double Connections in Steel Erection***

# Double Connection High Hazard Recognition

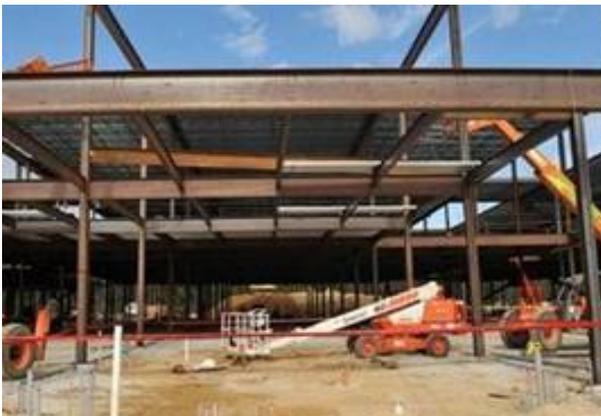
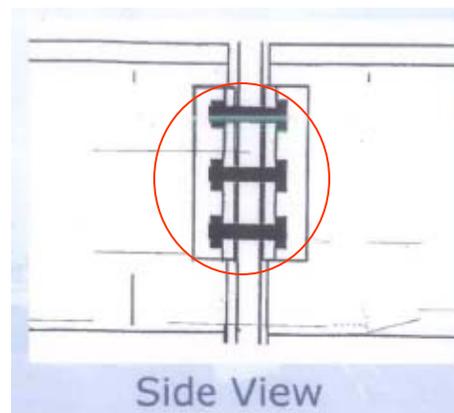
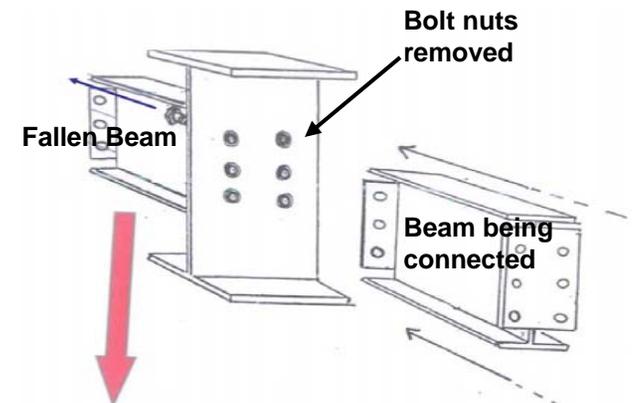
- **Summary:**
  - A contractor employee was crushed when a steel I-beam in the process of being connected directly above fell.
  - The beam had recently been secured between two columns. Two other steel erectors were attaching a second beam above to the other side of the column shared by the fallen beam (see sequence diagram on next slide).
  - The attachment (DOUBLE CONNECTION) required the beam in the process of being installed to be secured to the column using the same two bolts that held the beam which fell.
- **Direct Cause:**
  - Crushed under a beam falling after removal of both nuts from the bolts that secured the beam to the column in order to attached a second beam.

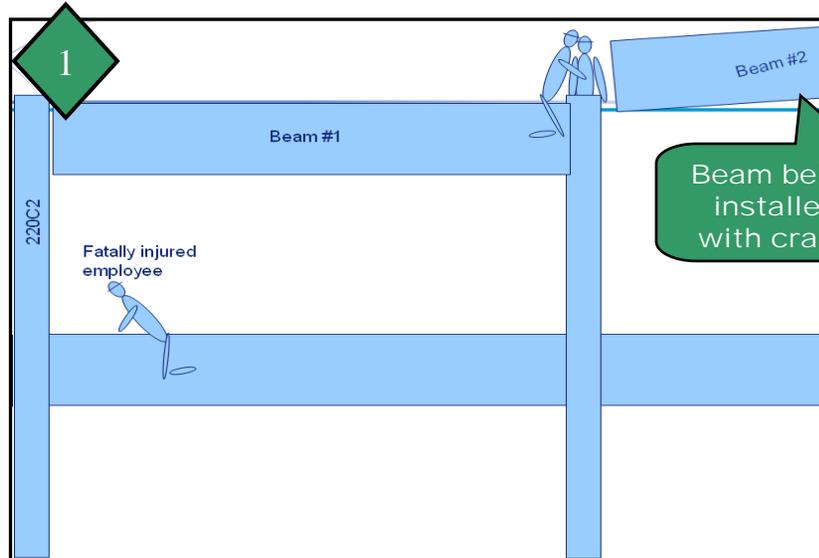
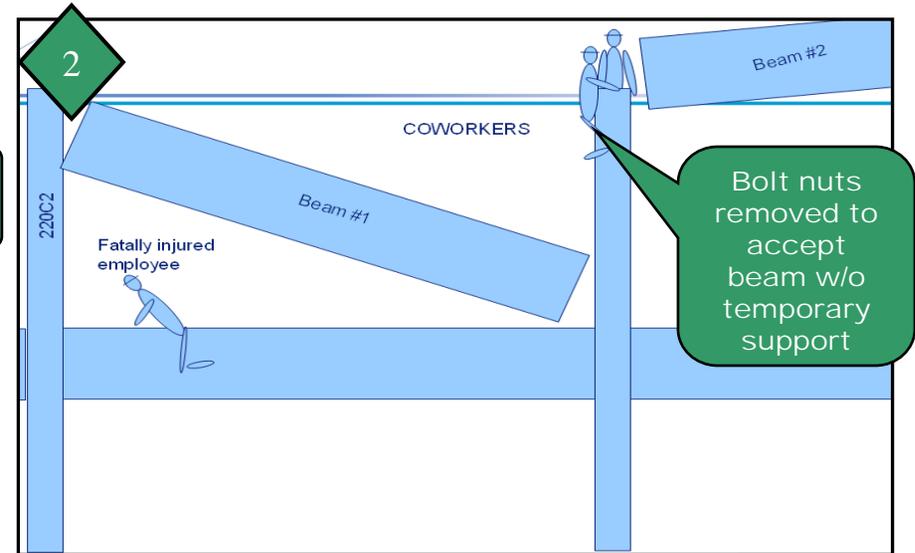
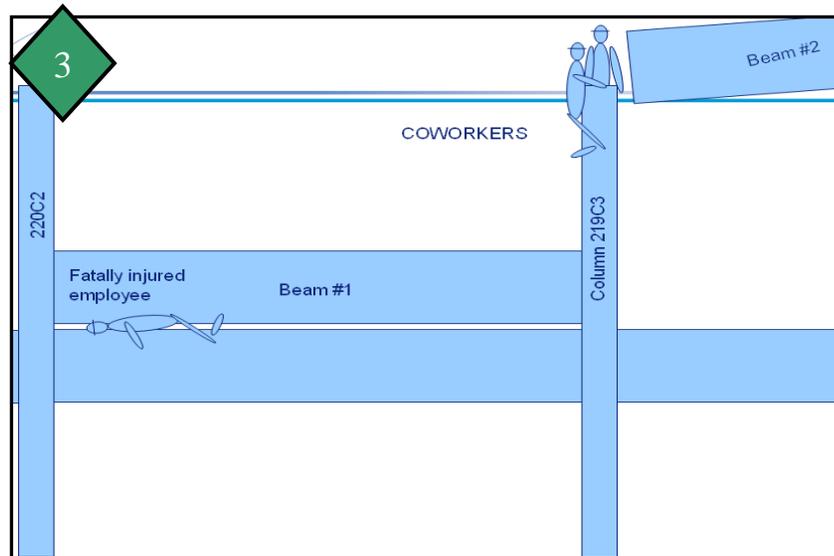
# Operation Sequence

- Installers training/qualifications.
- Improper procedure to support beam.
- Failure to follow work plan (AHA).
- Adequacy of prime oversight.
- Connections not addressed in Steel Erection Plan.

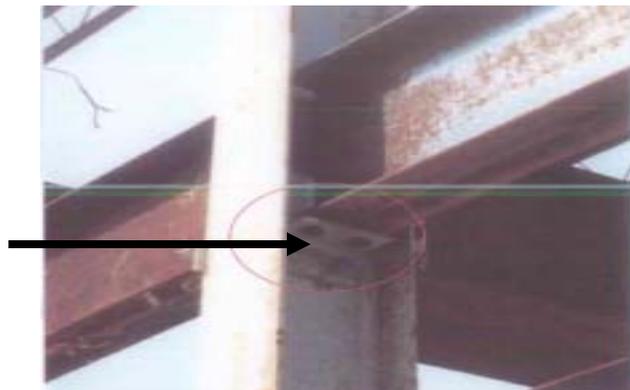
TEMPORARY  
ERECTION SEAT SUPPORT

- Failure to install a required “seat” under beams. Regulations are vague on who is responsible for seat identification but EM 385-1-1 specifically requires a separate steel erection plan to be submitted by the steel erector to address “connections”.
- OSHA and US Army Corps of Engineers (USACE) have established strict requirements on correct attachment procedures for double connections.
- USACE EM-385-1-1 (2003) regulation 27.E.22 and OSHA 29 CFR 1926.756(c) specifically state that where there is not at least one bolt that can remain connected the connection shall include a “seat” installed under the beam specifically to prevent it from falling during the connection process.
- If the required seat had been installed under the beam, the mishap would not have occurred.
- Sequence work to prevent employee positions under operations.
