Naval Facilities Engineering Command, Atlantic

Safety Lessons Learned Accident Abstract

Accident Type: Pre-manufactured wood truss collapse
Injury: Four military sentry personnel - contusions
Damage: Two military personnel POVs
Type of Work: Construction of main gate entrance canopy (70'X40') with steel frame support structure and pre-manufactured wood truss roof system.
Equipment: N/A

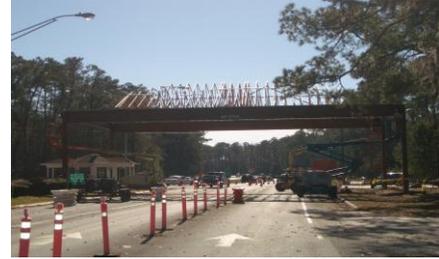
Construction of a main gate canopy was performed after normal working hours on weekends with traffic lanes rerouted to avoid interruption to station access during normal hours. When work activity stopped the gate entrance lanes were reopened for traffic. Four days after the in process work stopped the partially installed wood truss system collapsed **injuring four active duty military security personnel and damaging two active duty military personal vehicles.**

- ◆ **Failure to provide adequate temporary bracing** in accordance with Truss Plate Institute (TPI) & Wood truss Council of America (WTCA) specifications (See below). The TPI & WTCA specification was not reviewed, followed, or on site.

- ◆ The contractor **did not assure that the trusses were plumb** and only toe nailed rather than using the permanent steel uplift connectors at the truss ends into the bearing plate so that they could be repositioned when the sheathing was installed. TPI recommends that trusses be installed in a plumb position without the need for any adjustment prior to final placement or sheathing installation.

- ◆ Work in military and civilian public areas requires strict adherence to quality control and safety oversight. The work site was visited on the weekend by three ROICC personnel. When a concern is raised that may involve safety especially public safety take measures to carefully review contract documents.
- ◆ Use the Activity Hazard Analysis. A more thorough AHA would have prevented the accident by helping to identify the significance of temporary bracing.
- ◆ The contract was a task order based on a seed project with contract drawings and no contract specifications for the project. Several notes were on the drawing in particular the requirement to follow the TPI specification which may not always be included. Designers should ensure that projects involving wood truss include this note. (<http://www.tpinst.org/>) & (<http://www.woodtruss.com/index.php>)
