FINAL RESOURCE CONSERVATION AND RECOVERY ACT PARTIAL CLOSURE REPORT
FOR BUILDING 28 OXYGEN SHOP NAS BRUNSWICK ME
3/1/2010
TETRA TECH NUS

**RCRA PARTIAL CLOSURE REPORT
for
BUILDING 28 – OXYGEN SHOP
NAVAL AIR STATION BRUNSWICK, MAINE
USEPA IDENTIFICATION NUMBER ME8170022018
MARCH 2010**

**BUILDING INSPECTION FORM
RCRA PARTIAL CLOSURE PROGRAM
NAS BRUNSWICK
BRUNSWICK, MAINE
CTO WE22**

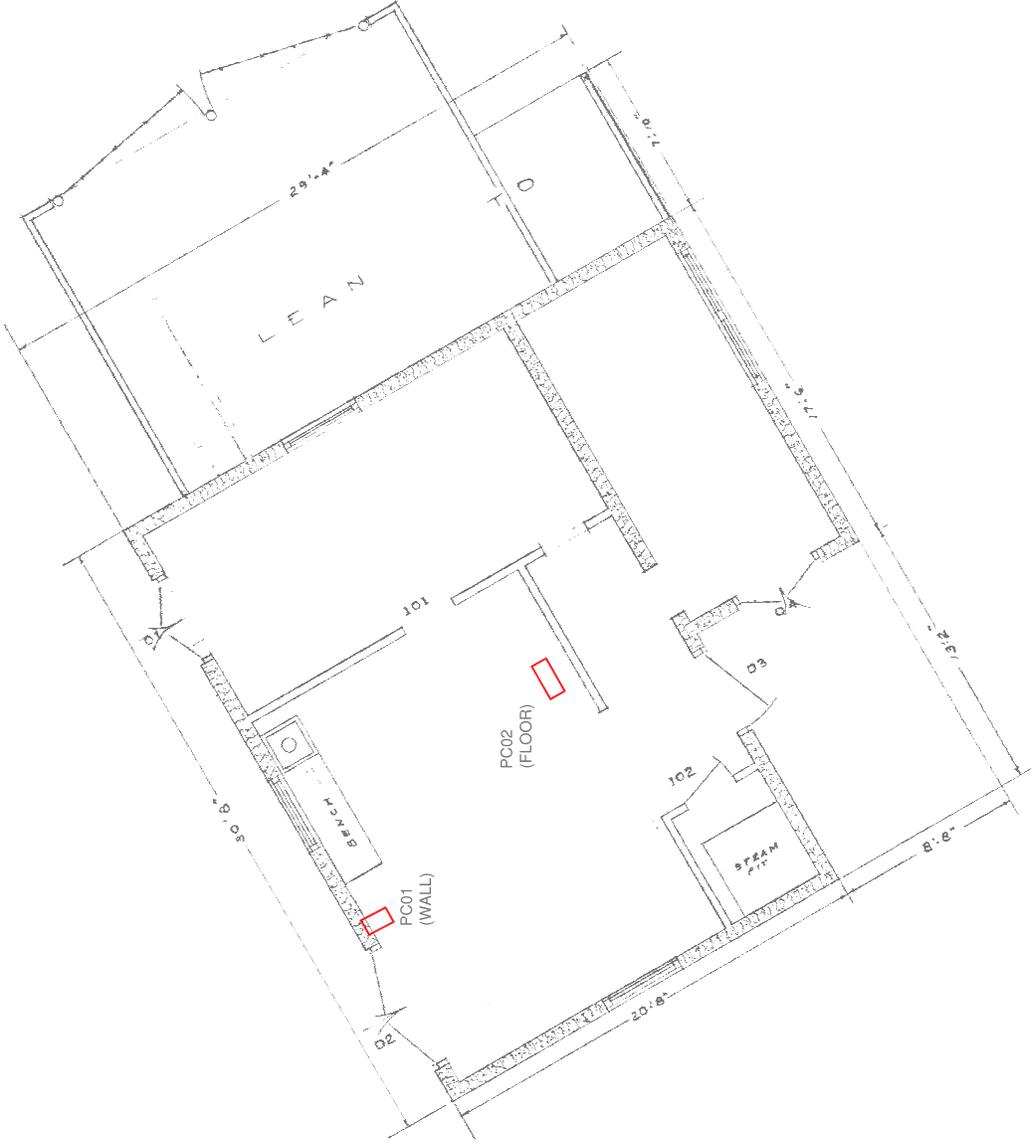
FIGURE NUMBER
 3

Total RCRA 8 metals analysis was performed on Building 28 paint-chip samples as a screening tool in lieu of TCLP. On October 7, 2009, TtNUS collected two paint chip samples from Building 28 for RCRA 8 metals analysis by its subcontractor analytical laboratory (Analytics Environmental Laboratory, Portsmouth, New Hampshire). Sample NASB-B28-PC01 was collected from the wall of the main room of the Oxygen Shop, and sample NASB-B28-PC02 from the floor of the main room, adjacent to the tank rack (Figure 3). Sample analytical data underwent limited data

As presented in Table 1, in paint chip sample NASB-B28-PC01 concentrations of chromium (330 mg/kg), lead (1,500 mg/kg), and mercury (14 mg/kg) exceed 20 times the respective TCLP regulatory limit. In sample NASB-B28-PC02, concentrations of lead (550 mg/kg) and mercury (6.4 mg/kg) exceed 20 times the TCLP standard. Since the total levels of lead and other RCRA metals exceed 20 times the TCLP limits, a TCLP test should be completed for the Building 28 paint-chip waste to determine the applicable waste handling and disposal requirements.

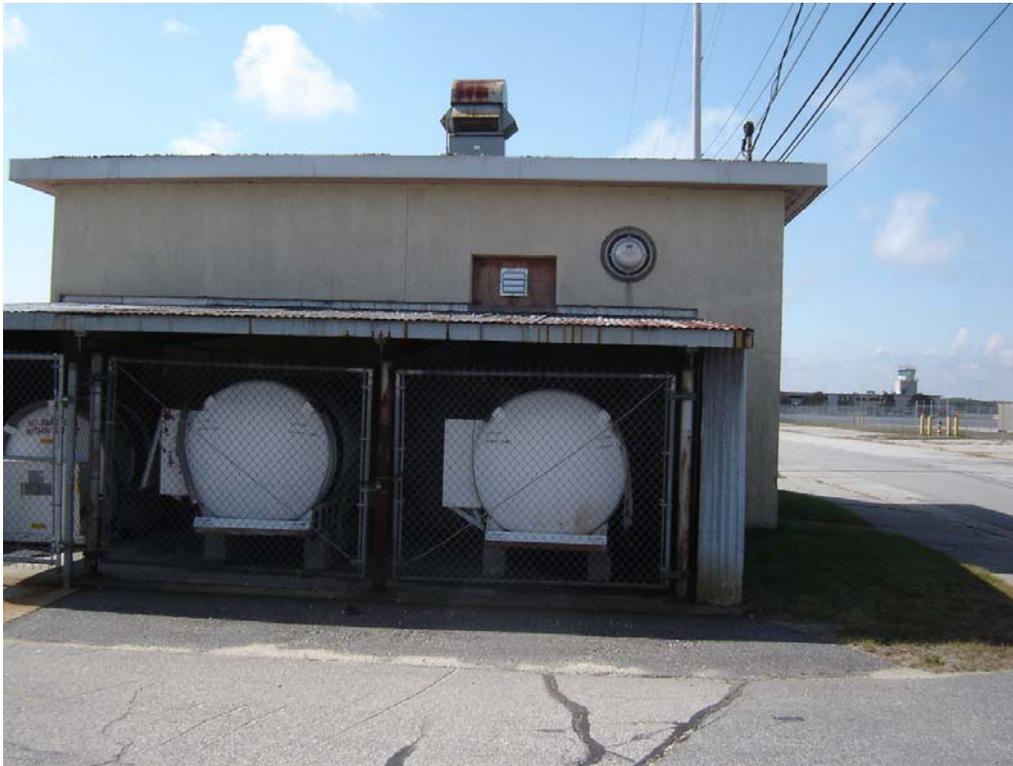
No. 1 Building 28 – NAS Brunswick June 30, 2009
Liquid nitrogen and oxygen tanks in lean to area of Building 28 – Oxygen Shop.

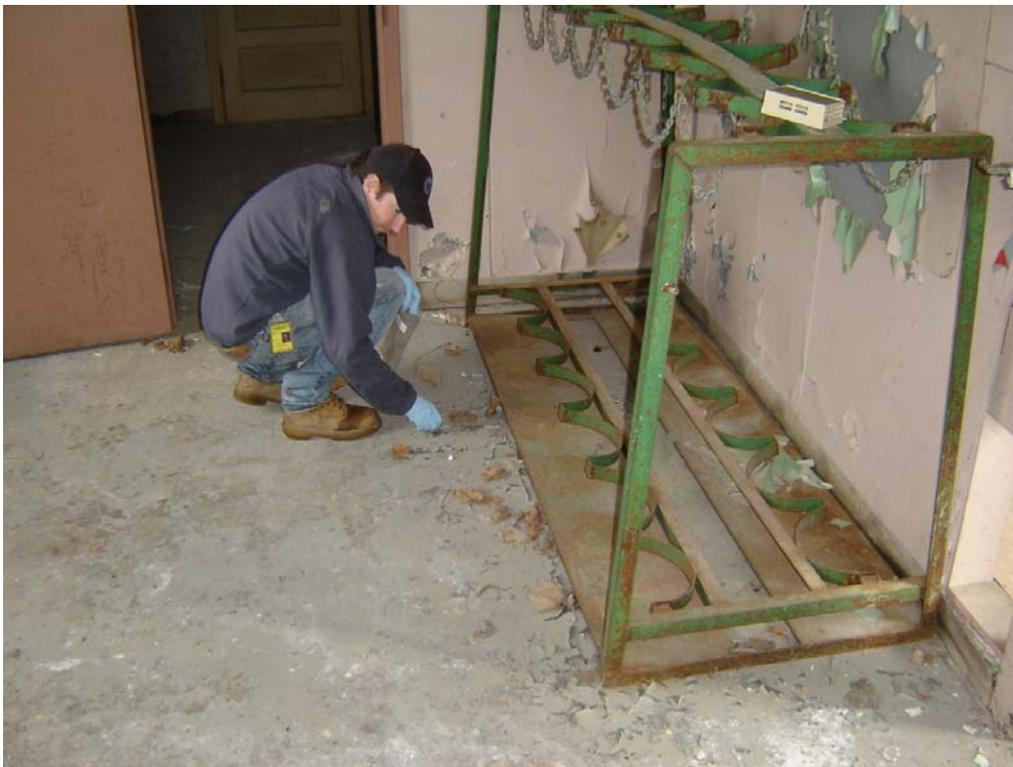
- The paint coating of the main room wall is deteriorating (peeling), resulting in the accumulation of paint-chip waste material on the floor. (Disposal of the paint-chip waste material may be subject to RCRA requirements, as discussed in Section 6 below.)

No. 2 Building 28 – NAS Brunswick October 7, 2009
Sampling paint chips in Building 28 – Oxygen Shop
