FINAL RESOURCE CONSERVATION AND RECOVERY ACT PARTIAL CLOSURE REPORT
FOR BUILDING 32 PETROLEUM, OIL AND LUBRICANTS OFFICE NAS BRUNSWICK ME
3/1/2010
TETRA TECH NUS

RCRA PARTIAL CLOSURE REPORT
for
BUILDING 32–POL OFFICE
NAVAL AIR STATION BRUNSWICK, MAINE
USEPA IDENTIFICATION NUMBER ME8170022018
MARCH 2010

**BUILDING INSPECTION FORM
RCRA PARTIAL CLOSURE PROGRAM
NAS BRUNSWICK
BRUNSWICK, MAINE
CTO WE22**

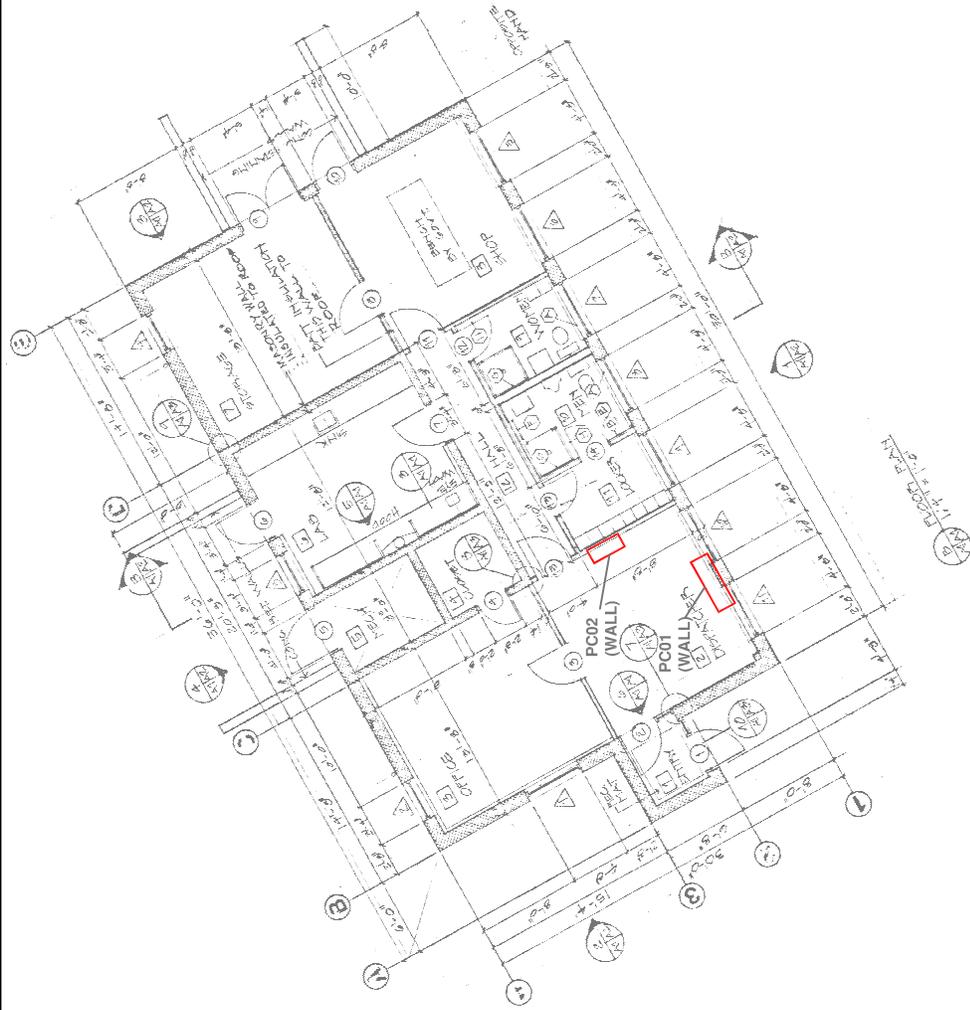
FIGURE NUMBER
 3

As presented in Table 1, concentrations of lead in the Building 32 paint chip samples are lower than 20 times the TCLP limit for lead (100 mg/kg). However, concentrations of barium in sample NASB-B32-PC01 (2,900 mg/kg) and in sample NASB-B32-PC02 (2,400 mg/kg) exceed 20 times the TCLP limit for barium (2,000 mg/kg). If the Building 32 interior wall paint peels, flakes, or is removed, a TCLP test should be completed for the paint-chip waste to determine the applicable waste handling and disposal requirements.

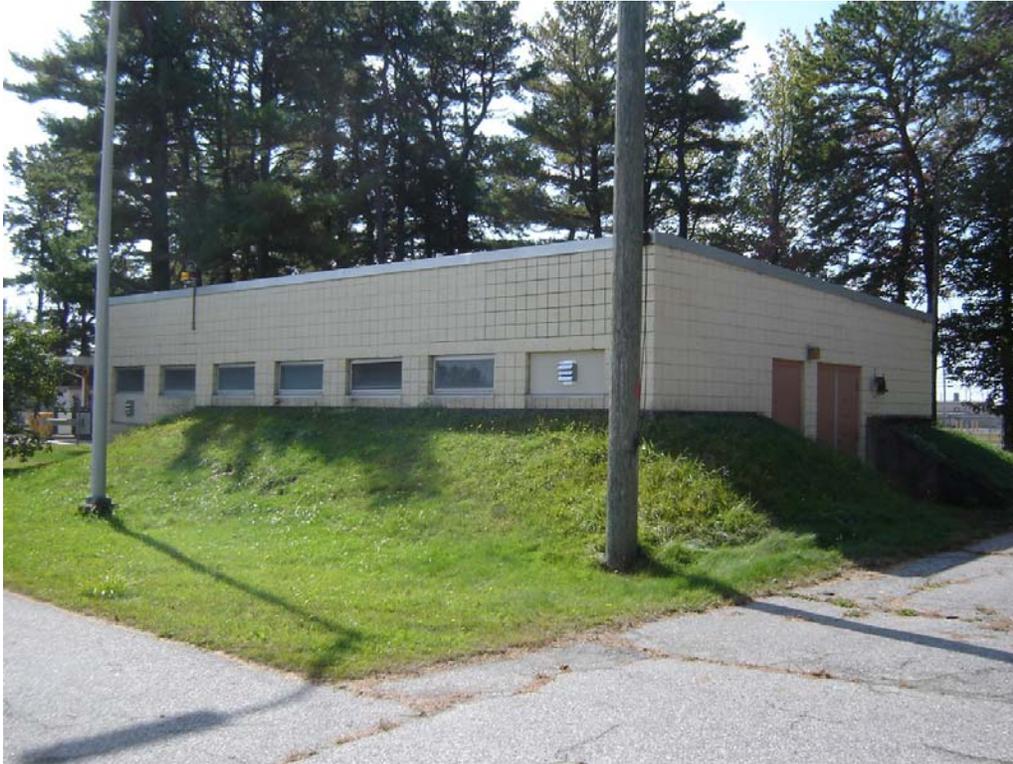
No. 1 Building 32 – NAS Brunswick
Exterior of Building 32 – Fuel Farm POL Office

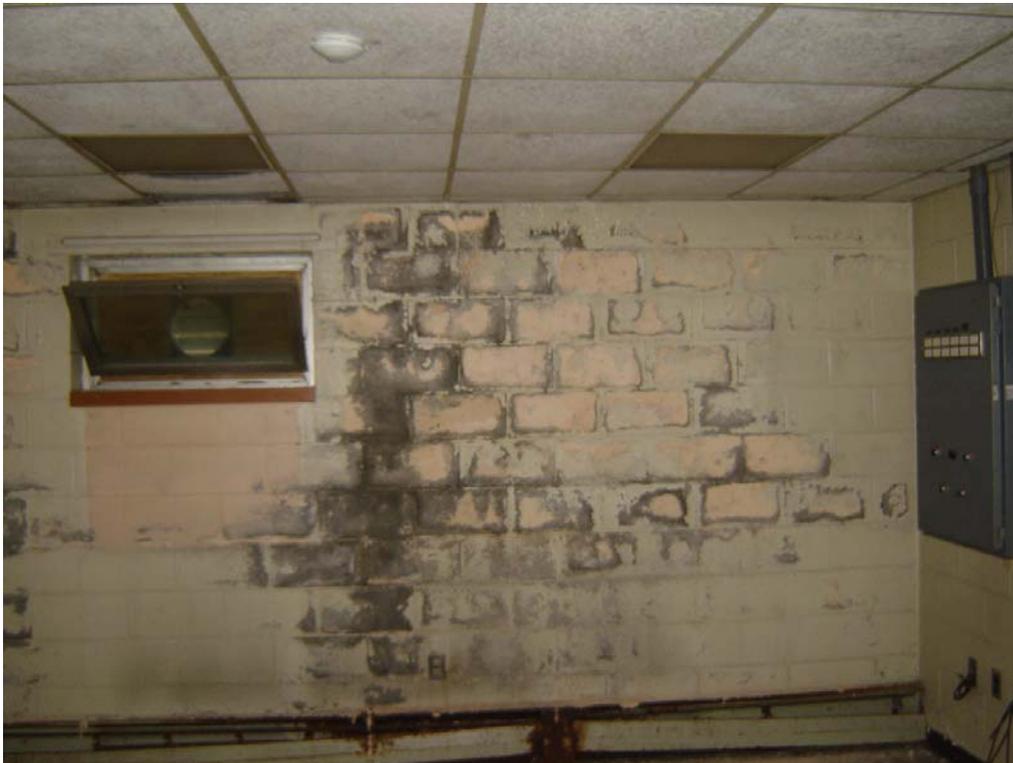
No. 2 Building 32 – NAS Brunswick
Interior wall in dispatcher room of Building 32 – Fuel Farm POL Office
