FINAL RESOURCE CONSERVATION AND RECOVERY ACT PARTIAL CLOSURE REPORT
FOR BUILDING 516 NITEFLITE NAS BRUNSWICK ME
3/1/2010
TETRA TECH NUS

**RCRA PARTIAL CLOSURE REPORT
for
BUILDING 516 – NITEFLITE
NAVAL AIR STATION BRUNSWICK, MAINE
USEPA IDENTIFICATION NUMBER ME8170022018
MARCH 2010**

**BUILDING INSPECTION FORM
RCRA PARTIAL CLOSURE PROGRAM
NAS BRUNSWICK
BRUNSWICK, MAINE
CTO WE22**

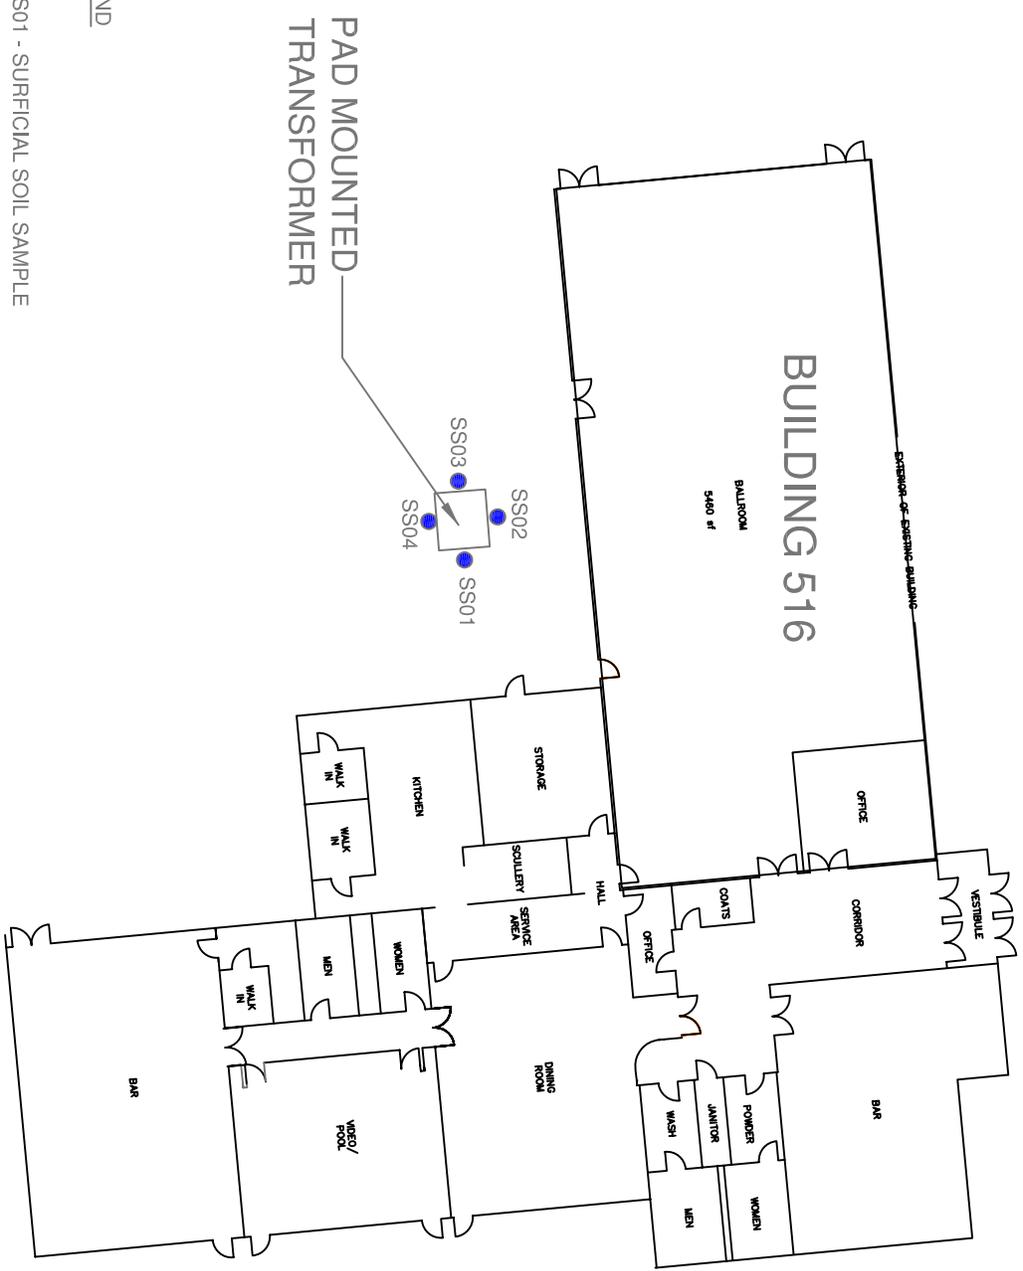
FIGURE NUMBER 3

The pad-mounted transformer location on the southwestern side of the building could potentially be a historical source of PCB soil contamination in the event of a transformer leak. On October 7, 2009, TtNUS collected eight surface soil samples around the transformer pad at Building 516. A hand auger was used for the collection of four samples from 0 to 6 inches below ground surface (bgs) [NASB-B516-SS01-0006 through NASB-B516-SS04-0006] and four samples from 6 to 24 inches bgs (NASB-B516-SS01-0624 through NASB-B516-SS04-0624). Sample locations are presented on Figure 3.

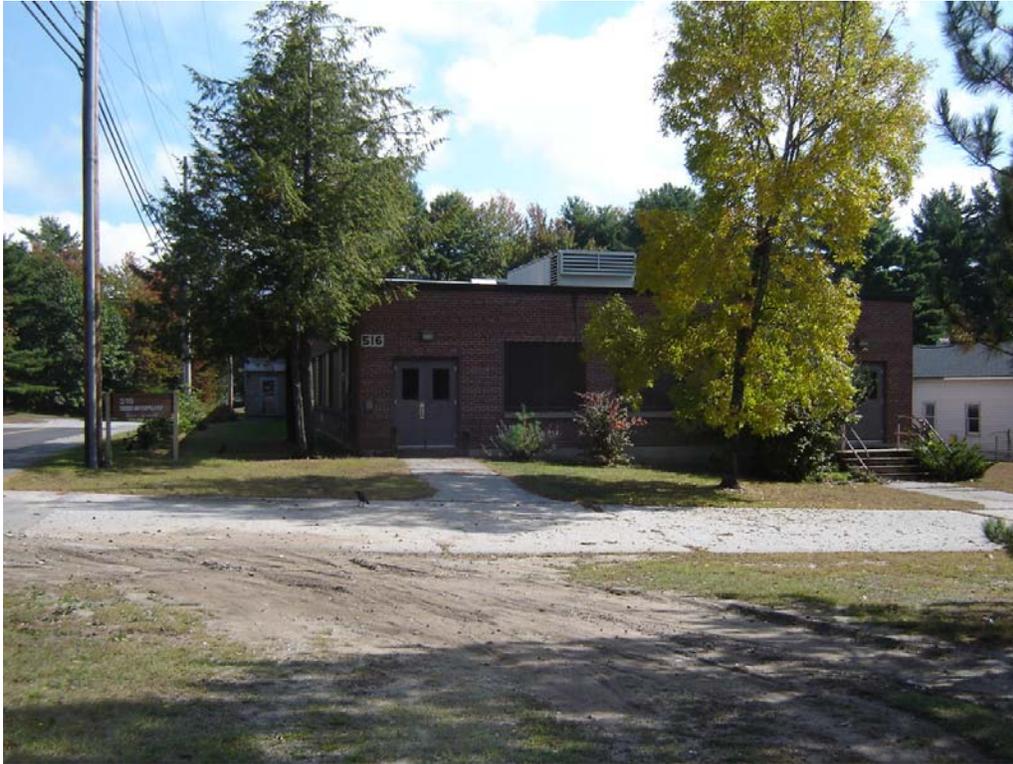
The building was not occupied at the time of the site visit and appeared in fair condition. Water damage was noted throughout from roof leaks and a dry powder chemical release occurred in the kitchen area.

No. 1 Building 516 – NAS Brunswick June 30, 2009
Exterior of Building 516 - Niteflite

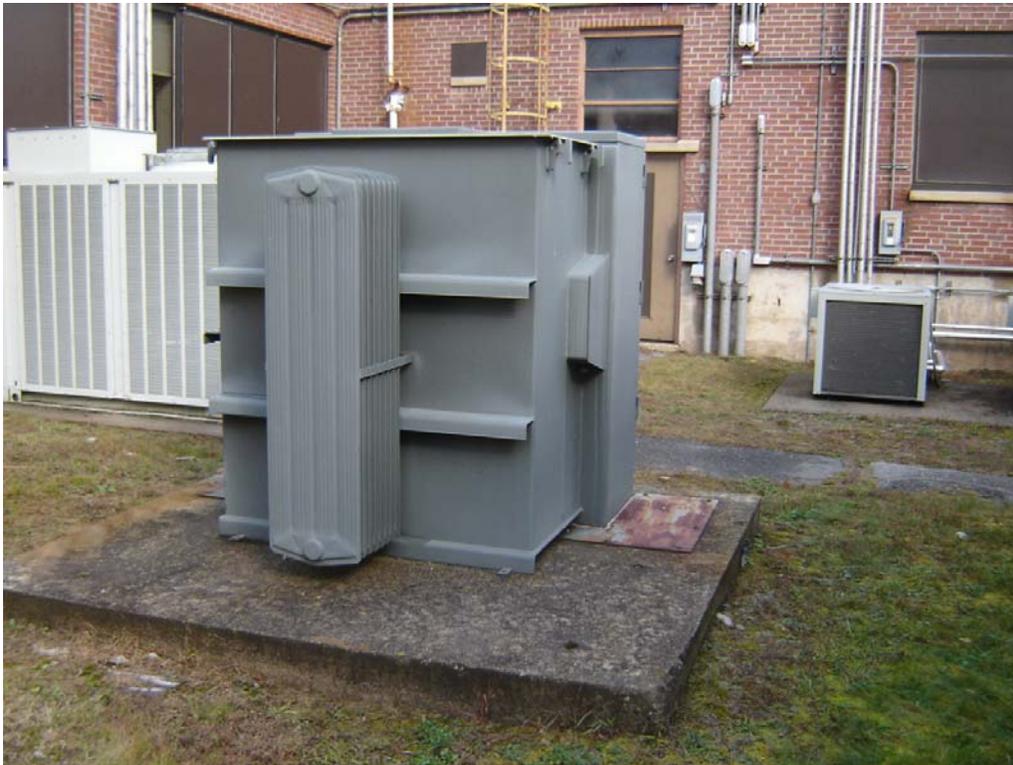
A transformer that could be a potential source of polychlorinated biphenyls (PCBs) contamination in the event of a leak was observed on the southwestern side of the building.

A pad mounted transformer was present on the southwest side of Building 516. According to the removed transformer database, a non-PCB containing 150 kva transformer, 516.0 (Serial No. RTE 896003343), was moved to Building 53.

No. 2 Building 516 – NAS Brunswick June 30, 2009
Pad-mounted transformer at Building 516 – Niteflite

Based on the findings of the records research and site visit observations, it was determined that sampling for PCBs around the transformer pad at the Building 516 parcel was required to complete the MEDEP hazardous waste closure requirements.
