FINAL RESOURCE CONSERVATION AND RECOVERY ACT PARTIAL CLOSURE REPORT  
FOR BUILDING 103 WITH TRANSMITTAL LETTER NAS BRUNSWICK ME  
6/7/2010  
NAS BRUNSWICK

**RCRA PARTIAL CLOSURE REPORT**  
**for**  
**BUILDING 103 – SECURITY-DOG KENNEL PARCEL**  
**NAVAL AIR STATION BRUNSWICK, MAINE**  
**USEPA IDENTIFICATION NUMBER ME8170022018**  
**JUNE 2010**

**BUILDING INSPECTION FORM  
RCRA PARTIAL CLOSURE PROGRAM  
NAS BRUNSWICK  
BRUNSWICK, MAINE  
CTO WE22**

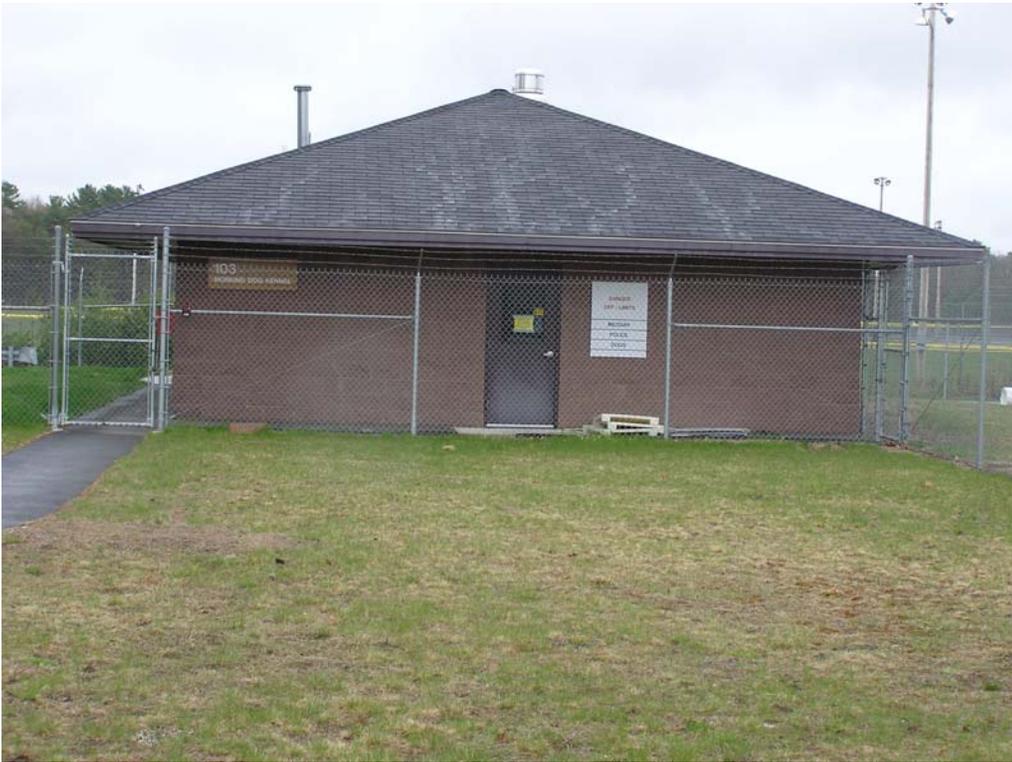
No. 1 Building 103 – NAS Brunswick April 27, 2010  
Building 103 – Military Working Dog Kennel Building exterior southwest elevation showing main entrance.

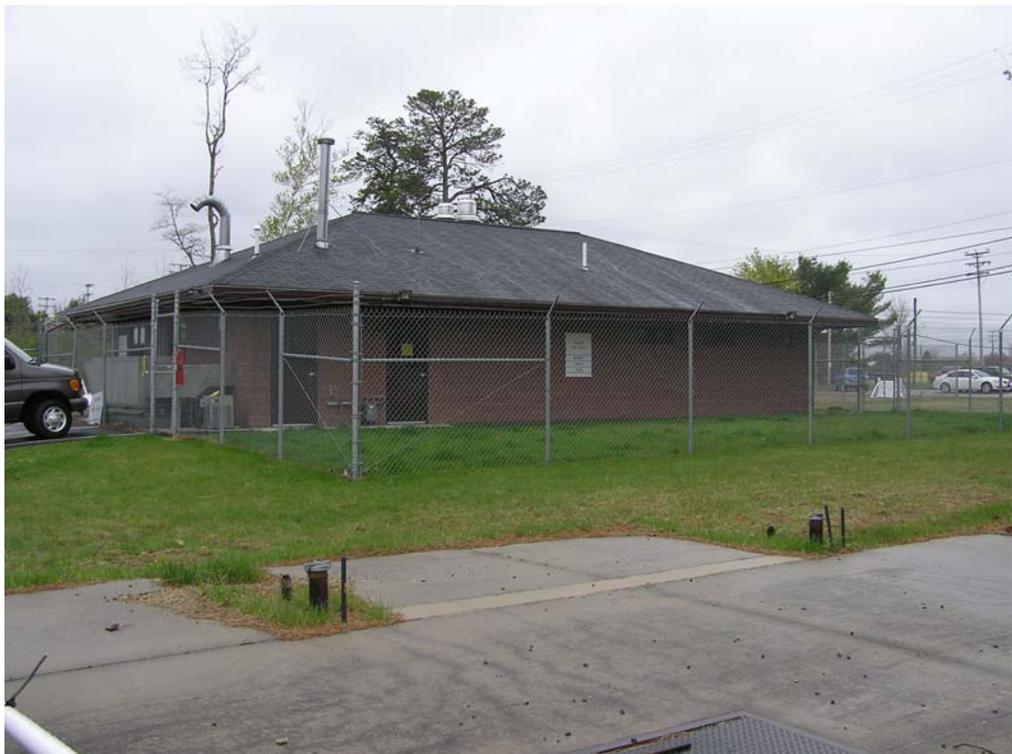
No. 2 Building 103 – NAS Brunswick April 27, 2010  
Building 103- Military Working Dog Kennel Building exterior northeast elevation showing filling station pad in the foreground and monitoring wells in the foreground.

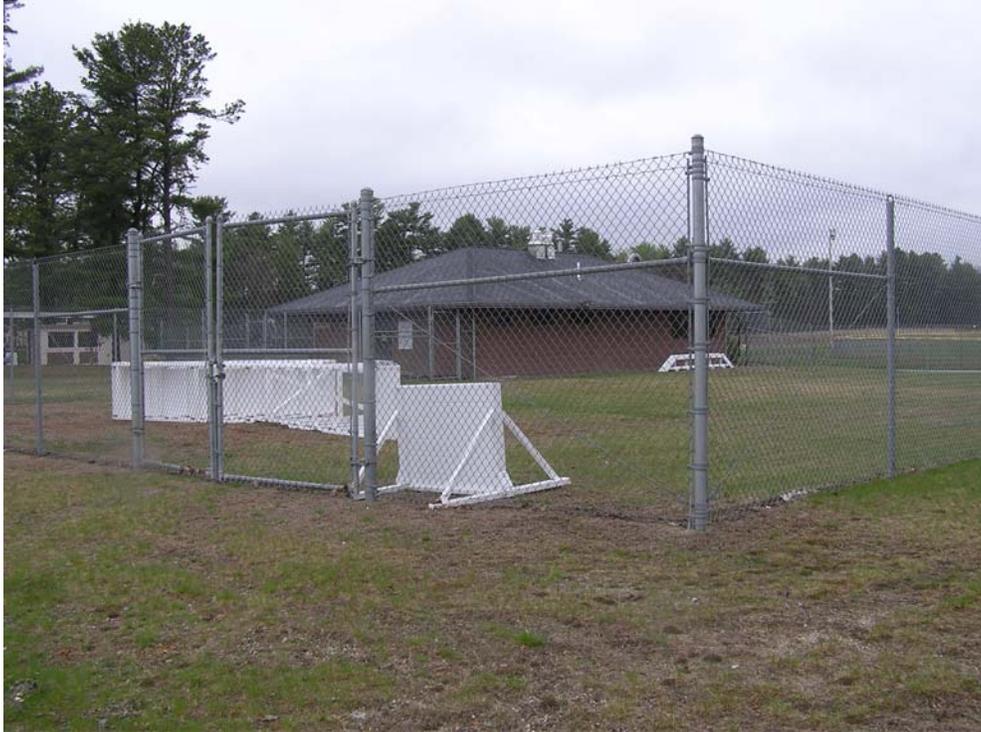
No. 3 Building 103 – NAS Brunswick April 27, 2010  
Building 103- Military Working Dog Kennel Building exterior southwest elevation showing dog training area in the foreground.

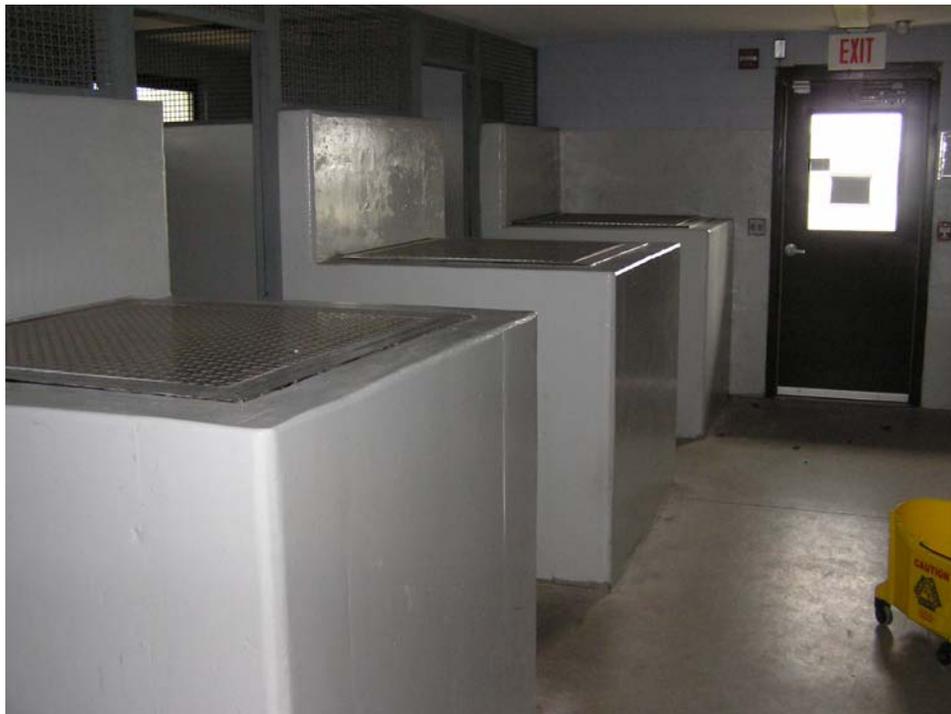
No. 4 Building 103 – NAS Brunswick April 27, 2010  
Building 103- Military Working Dog Kennel Building interior in western part of the building showing dog kennels.
