FINAL RESOURCE CONSERVATION AND RECOVERY ACT PARTIAL CLOSURE REPORT
FOR BUILDINGS 228 AND 516 WITH TRANSMITTAL LETTER NAS BRUNSWICK ME
8/24/2010
NAS BRUNSWICK

Subj: Final RCRA Partial Closure Report for Buildings 228 and 516

RCRA PARTIAL CLOSURE REPORT
for
BUILDING 228 – SENTRY HOUSE (CPRW 5)
NAVAL AIR STATION BRUNSWICK, MAINE
USEPA IDENTIFICATION NUMBER ME8170022018
AUGUST 2010

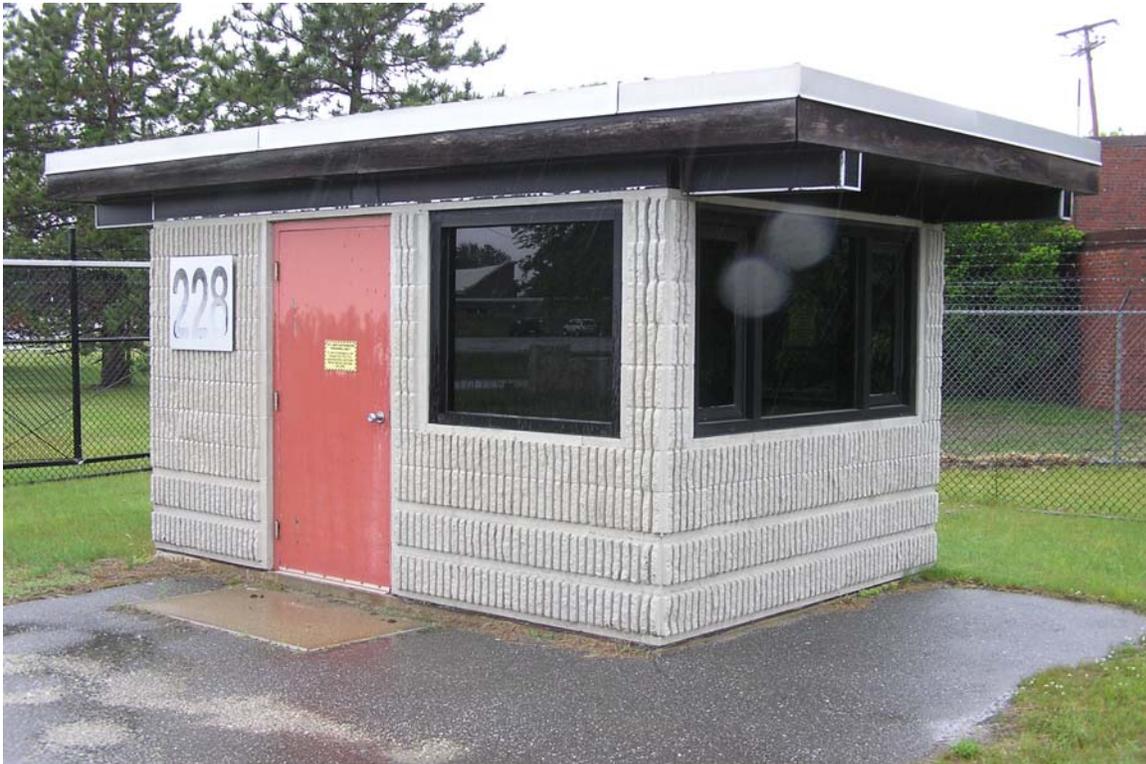
No. 1
Southeast elevation

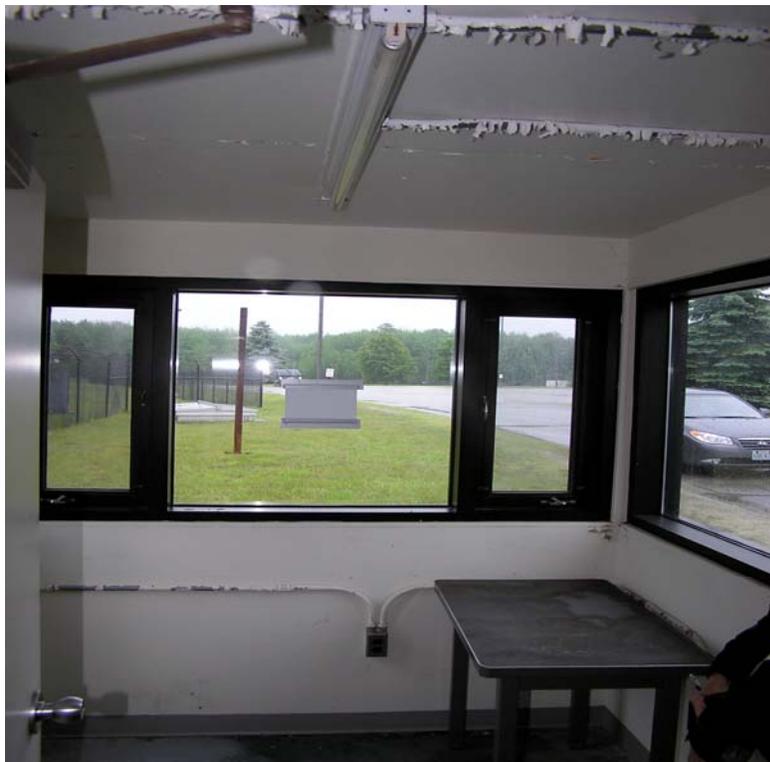
Total RCRA 8 metals analysis was performed on a sample of the loose-paint material observed on the Building 228 piping as a screening tool in lieu of TCLP. The paint chip sample was collected on June 16, 2010 for RCRA 8 metals analysis by Tetra Tech's subcontractor analytical laboratory (Analytics Environmental Laboratory, Portsmouth, New Hampshire). Sample analytical data underwent limited data validation, consisting of field duplicate evaluation, blank contamination evaluation and completeness evaluation.

shown that paint-chip waste with a lead level as measured in the above sample would not be characterized as hazardous waste based on the TCLP test.

Due to the localized presence of peeling paint on piping in the interior of the building, paint chip sampling was recommended.

No. 2
Interior view looking east – localized peeling paint on pipes along the wall and ceiling

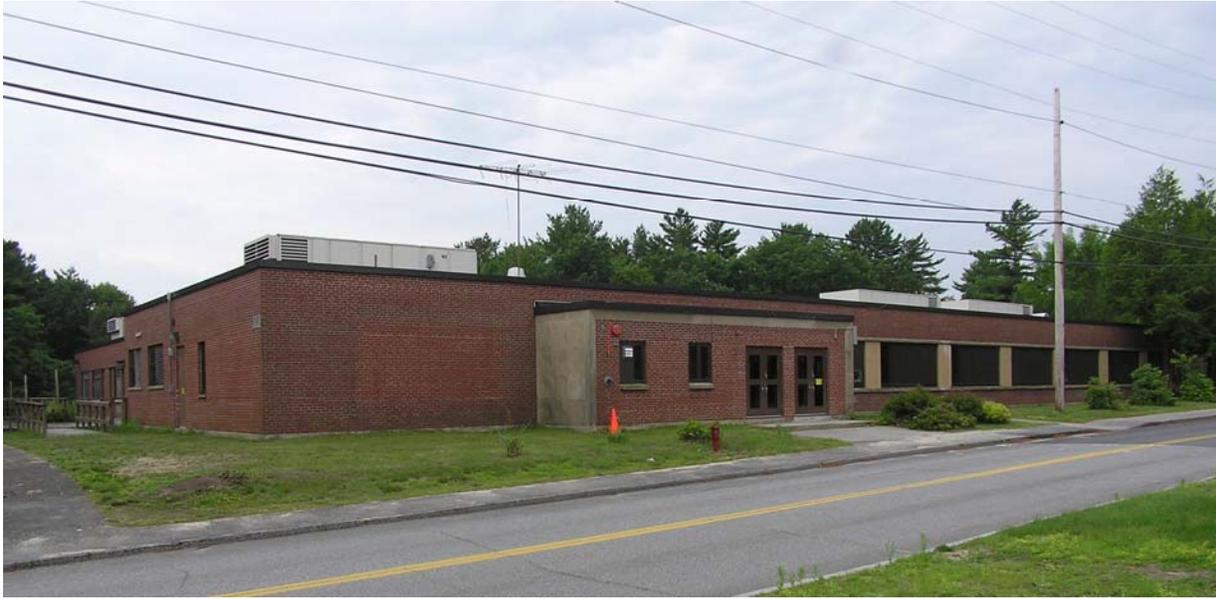
No. 1 Building 516 Parcel – NAS Brunswick July 24, 2010
Building 516 - Niteflite north elevation

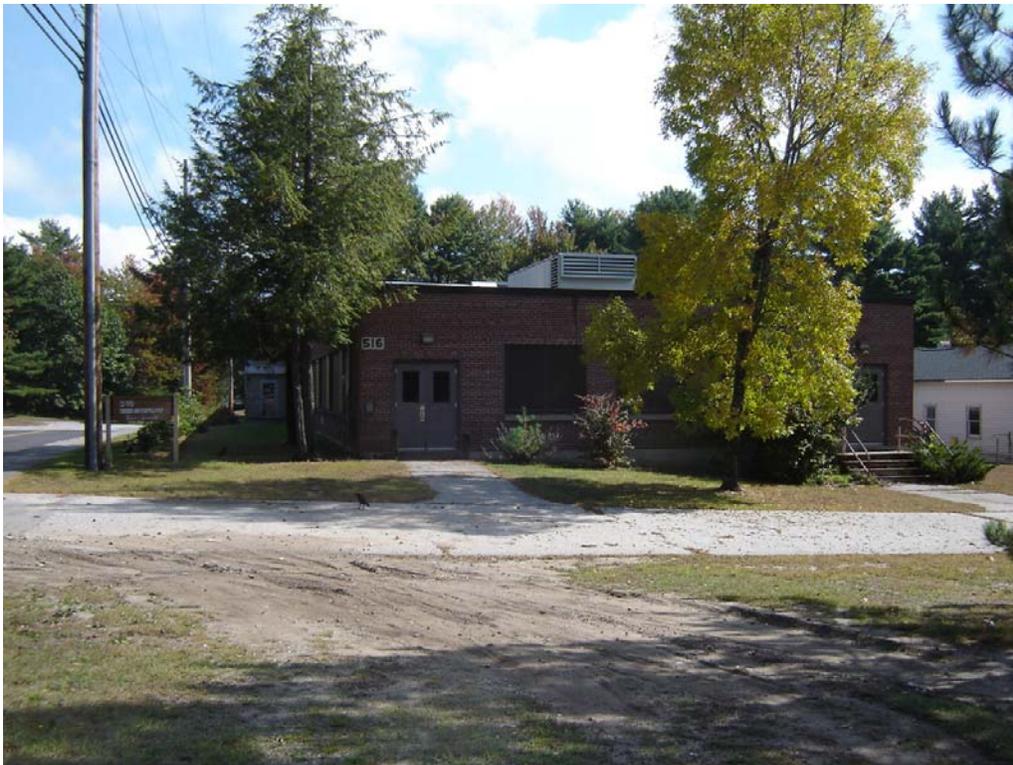
No. 2 Building 516 Parcel – NAS Brunswick June 30, 2009
Building 516 - Niteflite west elevation

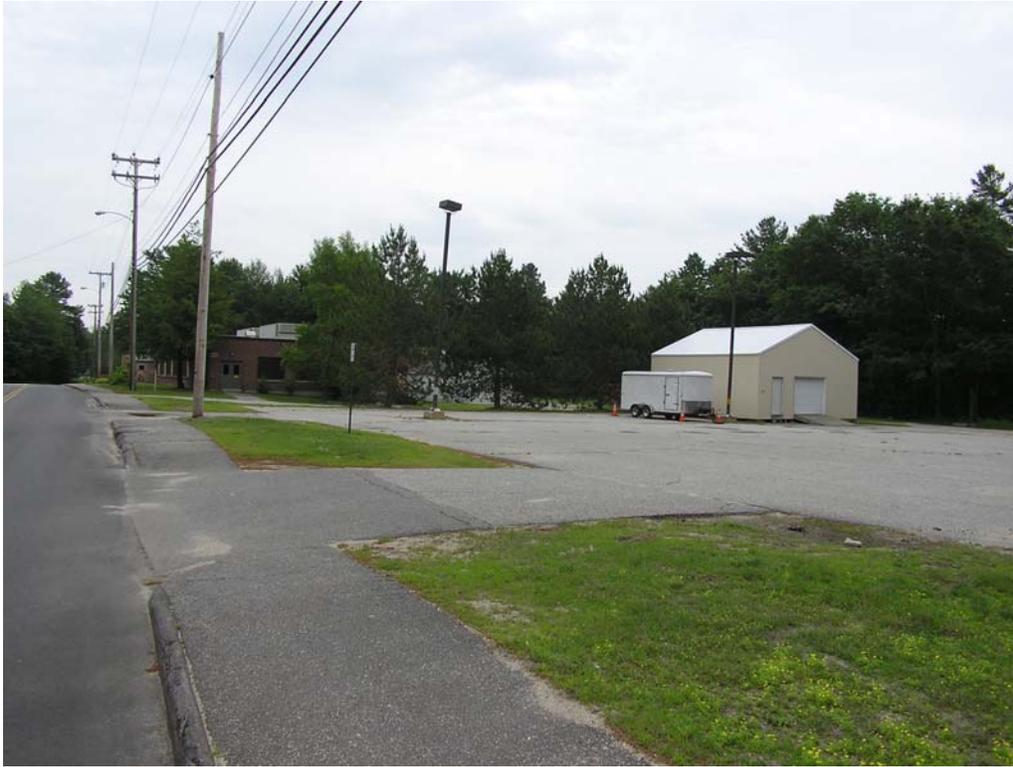
No. 3 Building 516 Parcel – NAS Brunswick July 24, 2010
Building 516 Parcel, view from west - parking area and Buildings; Building 516 in the background

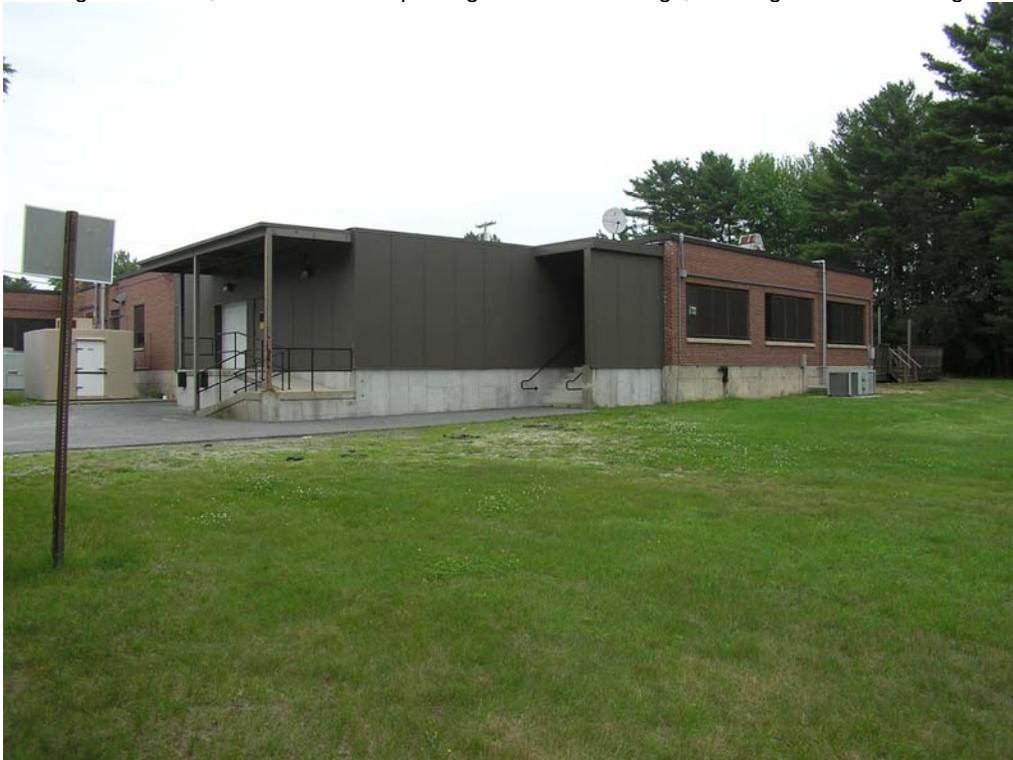
No. 4 Building 516 Parcel – NAS Brunswick July 24, 2010
Building 516 - Niteflite south elevation

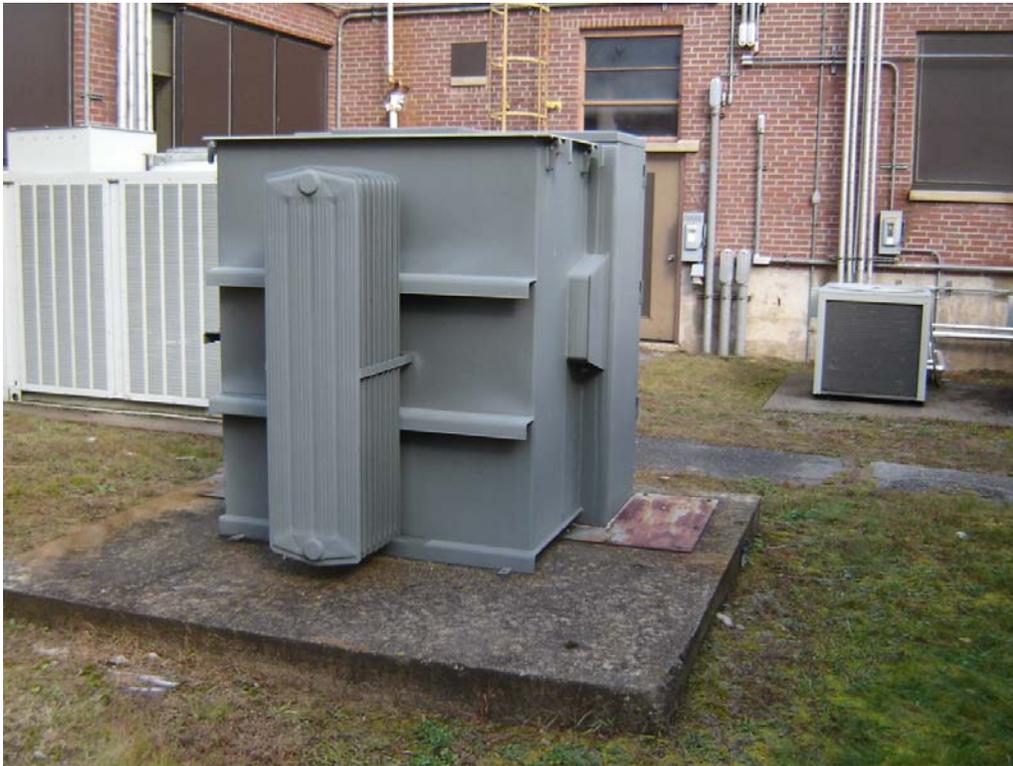
A transformer that could be a potential source of polychlorinated biphenyls (PCBs) contamination in the event of a leak was observed on the southwestern side of the building.

No. 5 Building 516 Parcel – NAS Brunswick June 30, 2009
Pad-mounted transformer (No. 516.2), located immediately south of Building 516

Based on the findings of the records research and site visit observations, it was determined that sampling for PCB around the transformer pad at the Building 516 parcel was required to complete the MEDEP hazardous waste closure requirements.

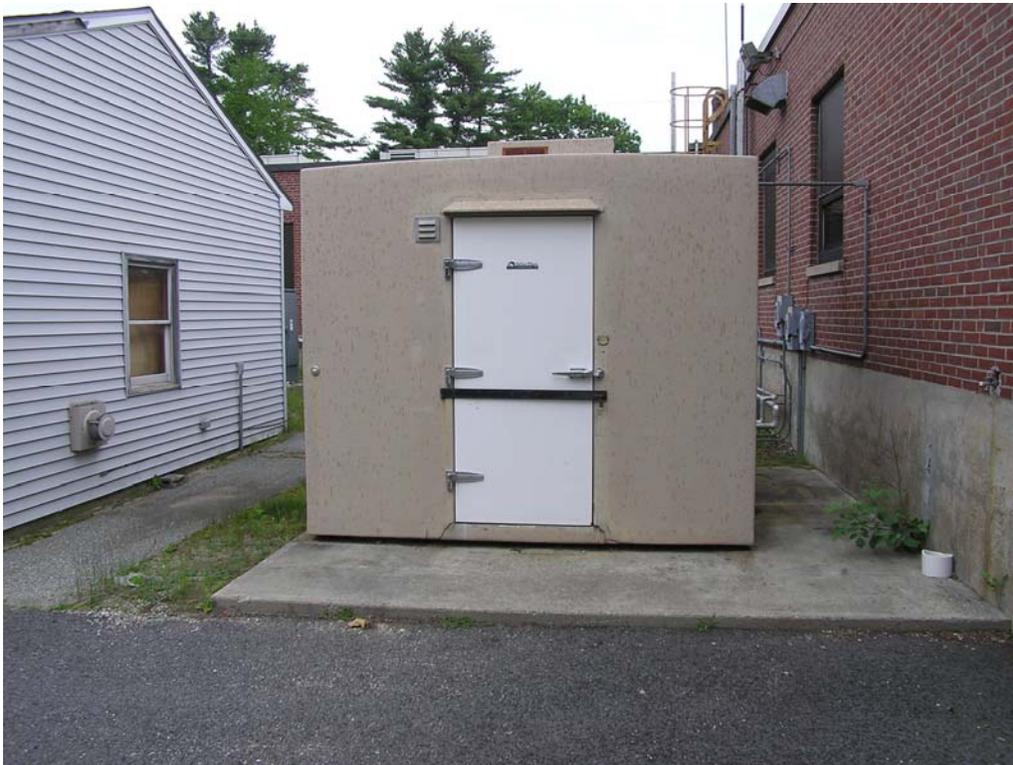
No. 6 Building 516 Parcel – NAS Brunswick July 24, 2010
Building 516 Parcel, inactive, empty walk-in refrigeration unit located between Buildings 460 and 516

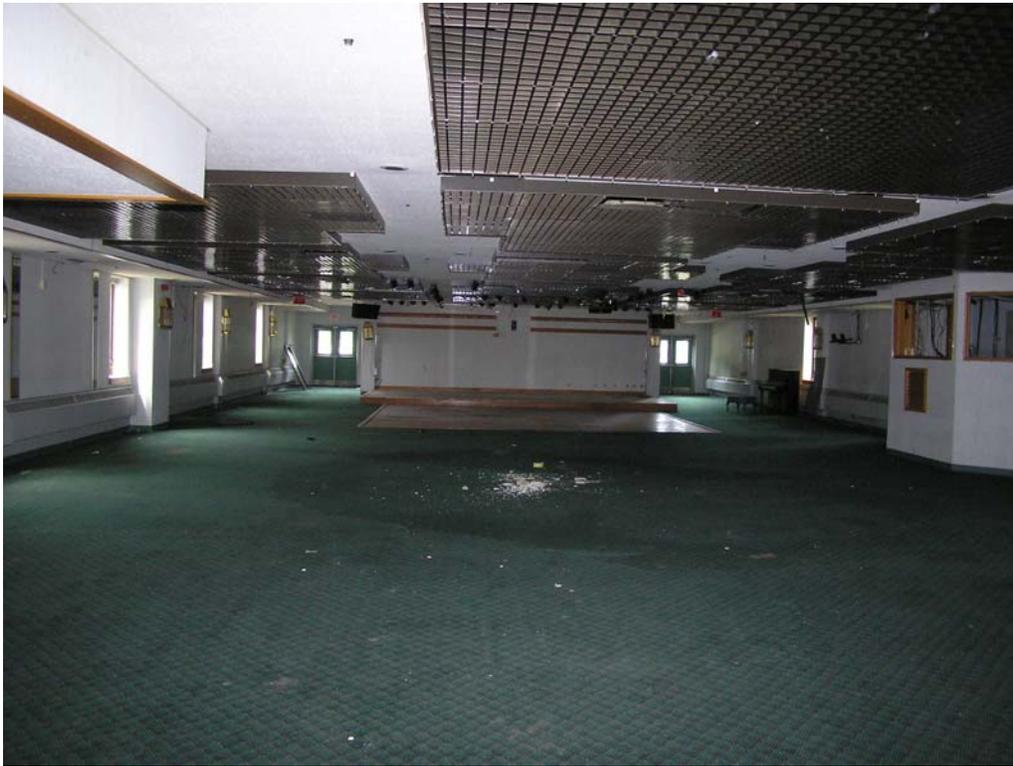
- At the time of inspections, Building 516 was unoccupied and in fair condition. Water damage from roof leaks and condensation from fluctuations of humidity within the building have supported significant growth of mold within the facility. Mold was observed on the floors and walls of the facility in numerous rooms, particularly on carpeted floors.

No. 7 Building 516 Parcel – NAS Brunswick July 24, 2010
Building 516 ballroom with water stains and ceiling materials on the carpet

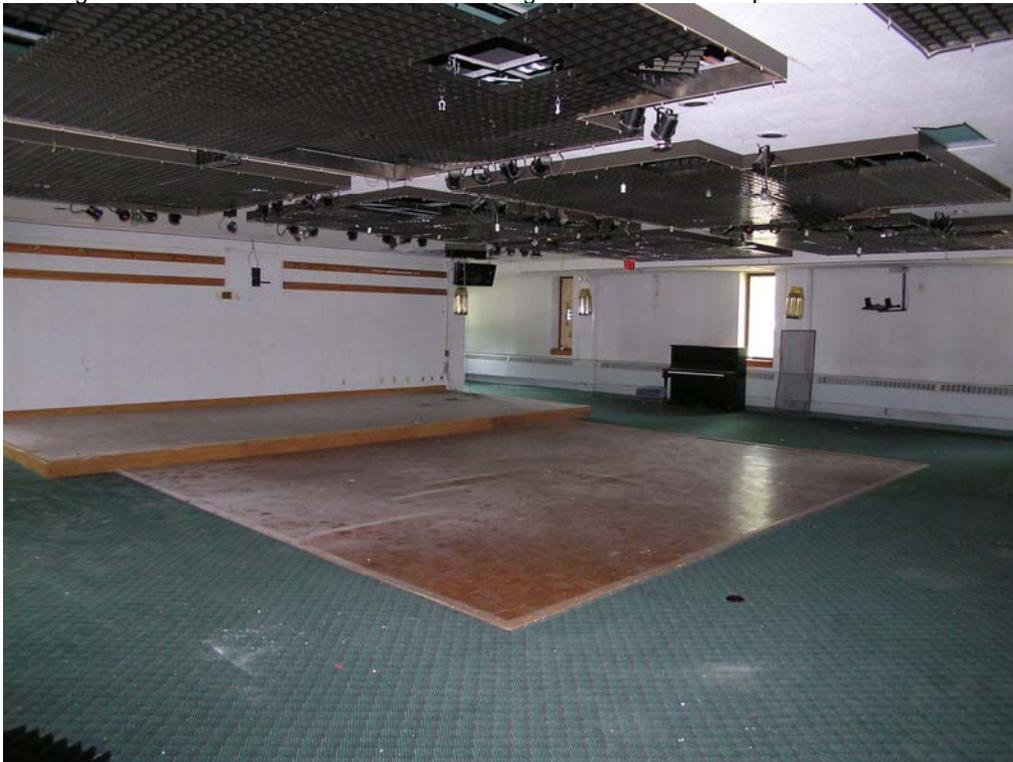
No. 8 Building 516 Parcel – NAS Brunswick July 24, 2010
Building 516 ballroom dance floor

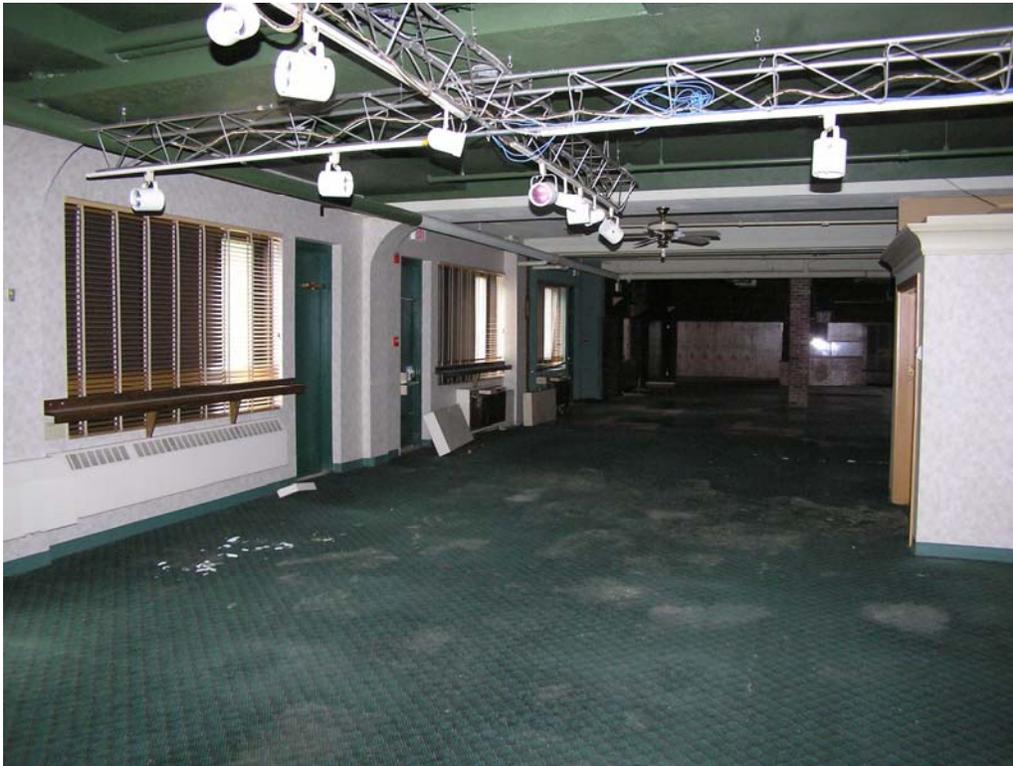
No. 9
Building 516 dining room

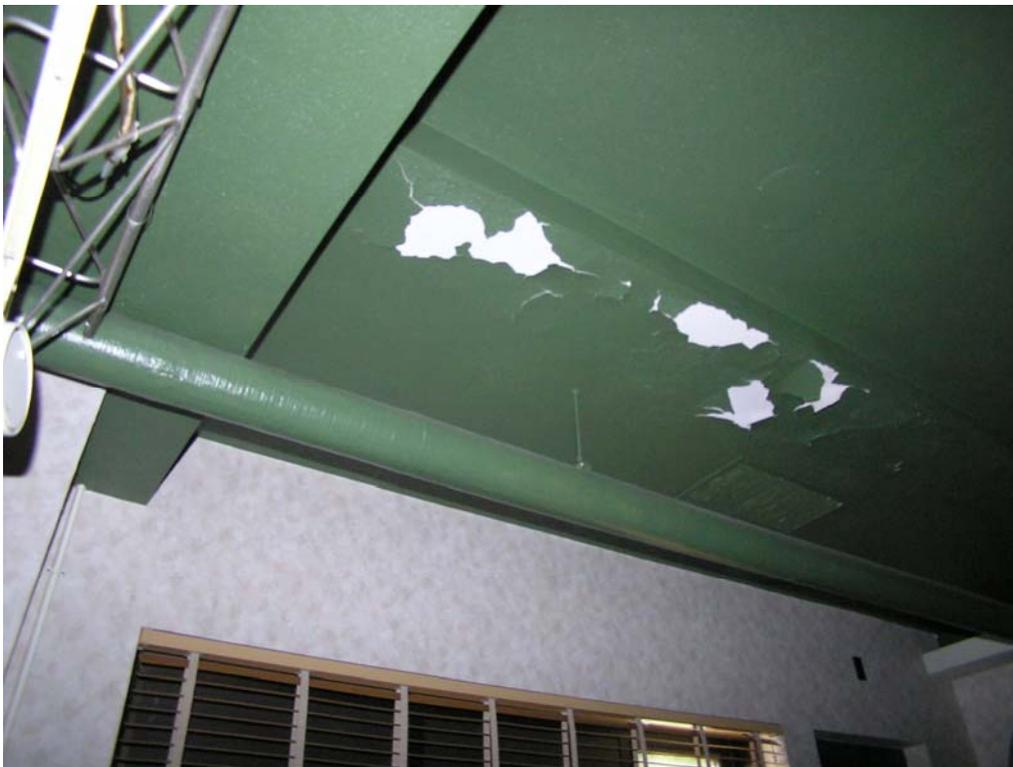
- Localized areas of paint peeling from the ceiling were noted in Building 516.
- The grease trap in Building 516 boiler/electric room appears to be full.

No. 10
Building 516 dining room ceiling – localized paint deterioration area

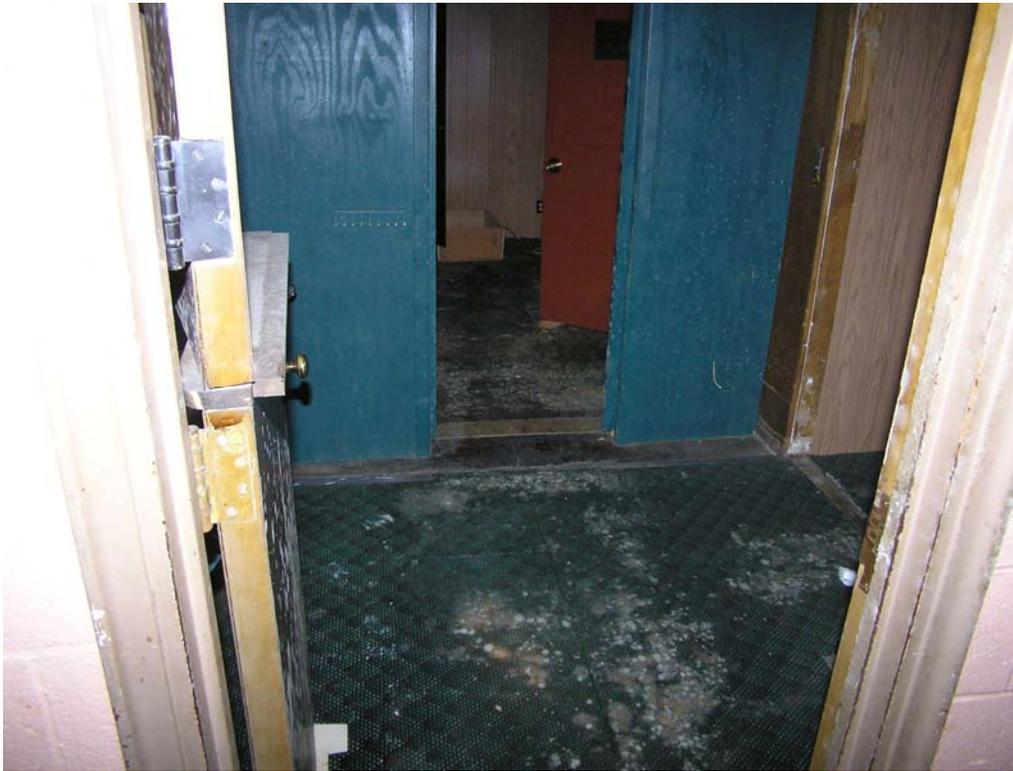
No. 11 Building 516 Parcel – NAS Brunswick July 24, 2010
Building 516 hallway area outside of kitchen

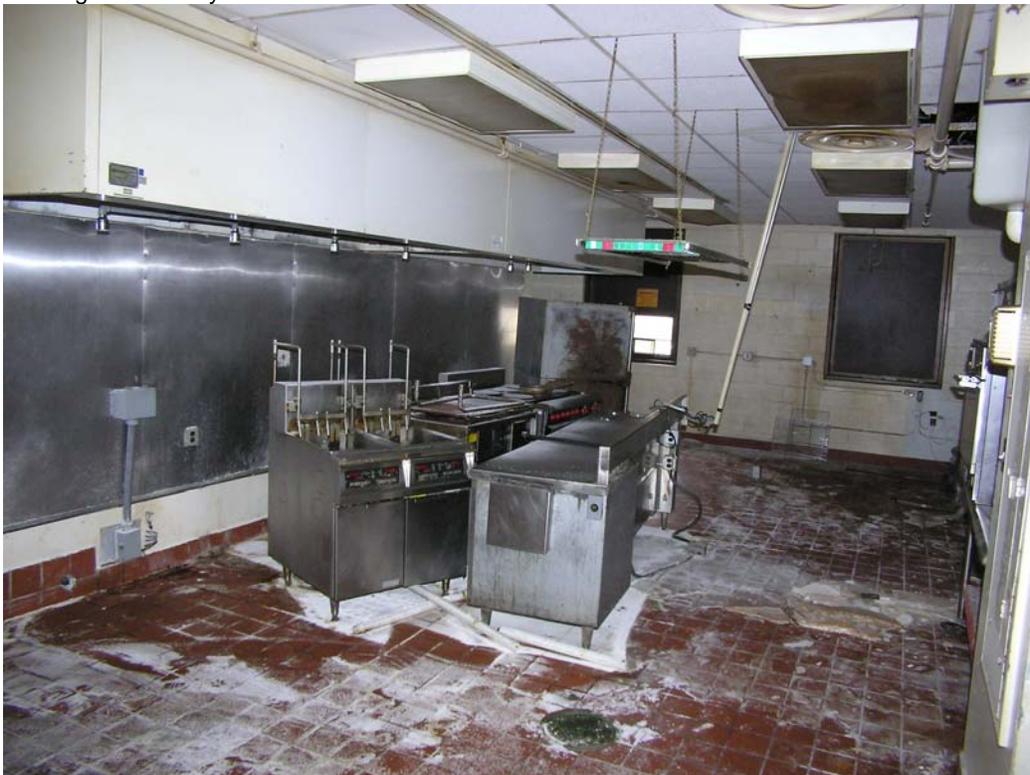
- A dry, powdery substance was observed on the kitchen area floor and other horizontal surfaces due to a past activation of the fire suppression system.

No. 12 Building 516 Parcel – NAS Brunswick July 24, 2010
Building 516 kitchen area - fire suppression material (white substance) on floor

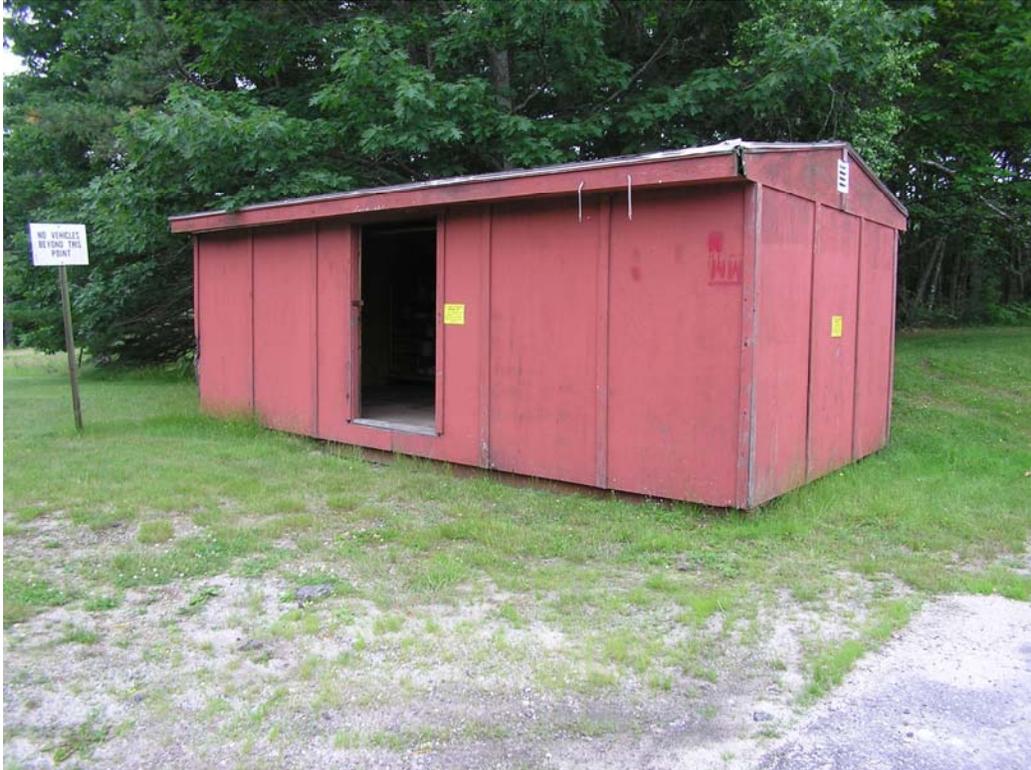
No. 13 Building 516 Parcel – NAS Brunswick July 24, 2010
Storage shed (Structure WW) northeast elevation

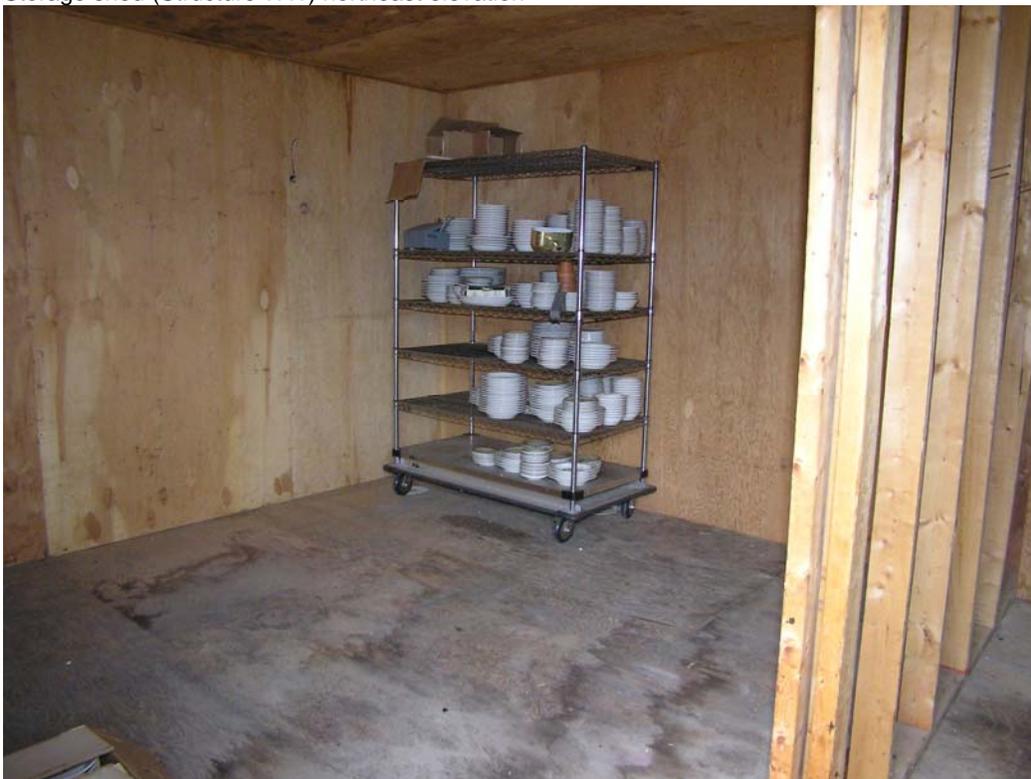
A small wooden storage shelter (Building WW) was observed to the south of Building 460. This building was empty and previously been used to store kitchen supplies. No hazardous material or evidence of hazardous material generation was observed in Building WW.

No. 14 Building 516 Parcel – NAS Brunswick July 24, 2010
Storage shed (Structure WW) interior

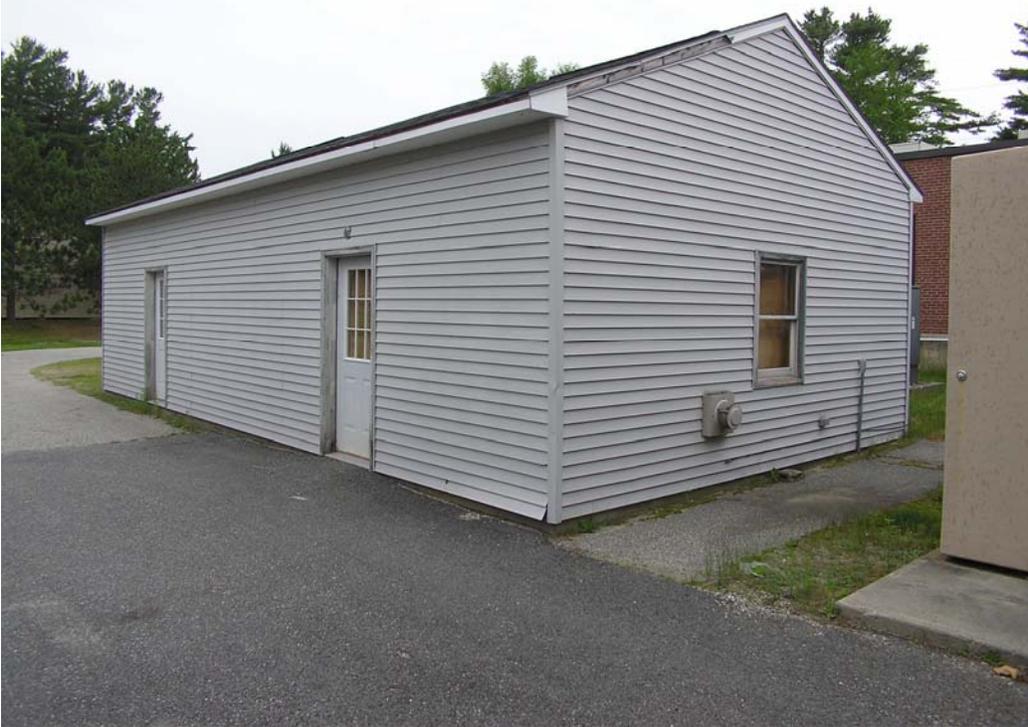
No. 15 Building 516 Parcel – NAS Brunswick July 24, 2010
Building 460 - Niteflite Storage southeast elevation

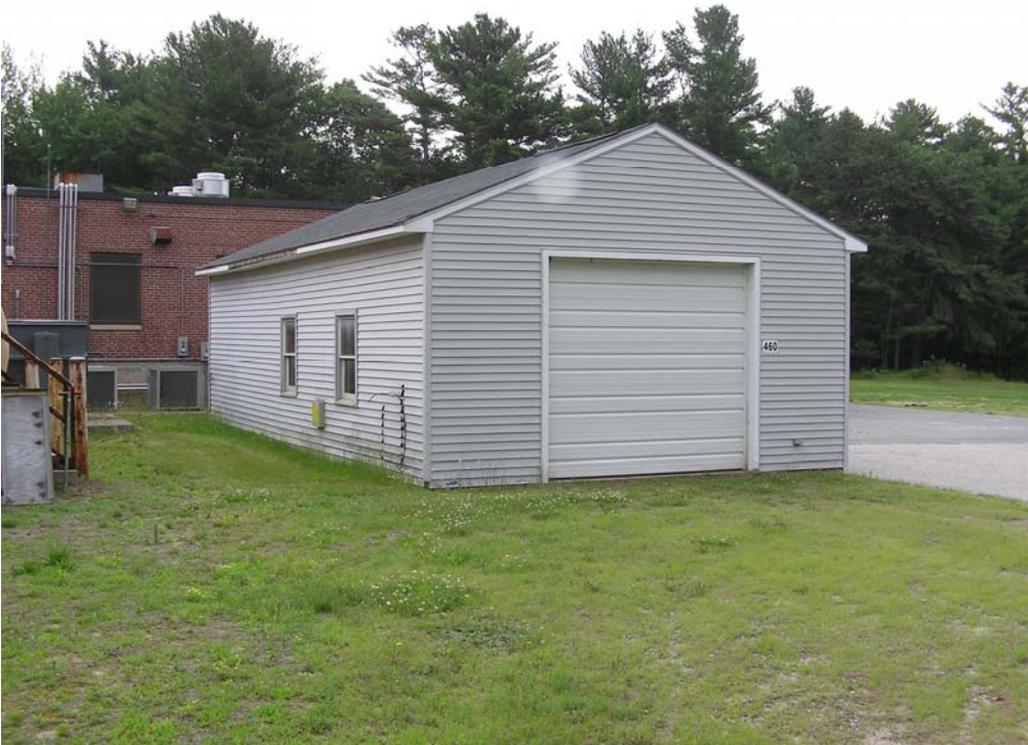
No. 16 Building 516 Parcel – NAS Brunswick July 24, 2010
Building 460 - Niteflite Storage northwest elevation

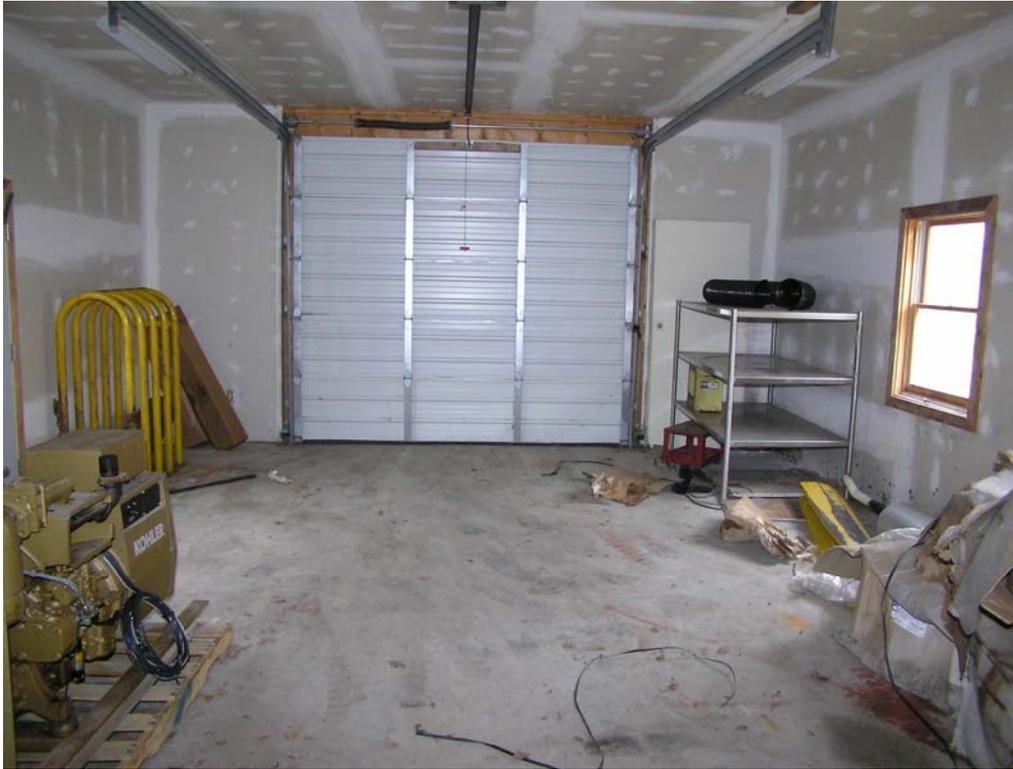
Two minor areas of mold were observed in Building 460, indicating previous water intrusion.

No. 17 Building 516 Parcel – NAS Brunswick July 24, 2010
Building 460 - Niteflite Storage interior

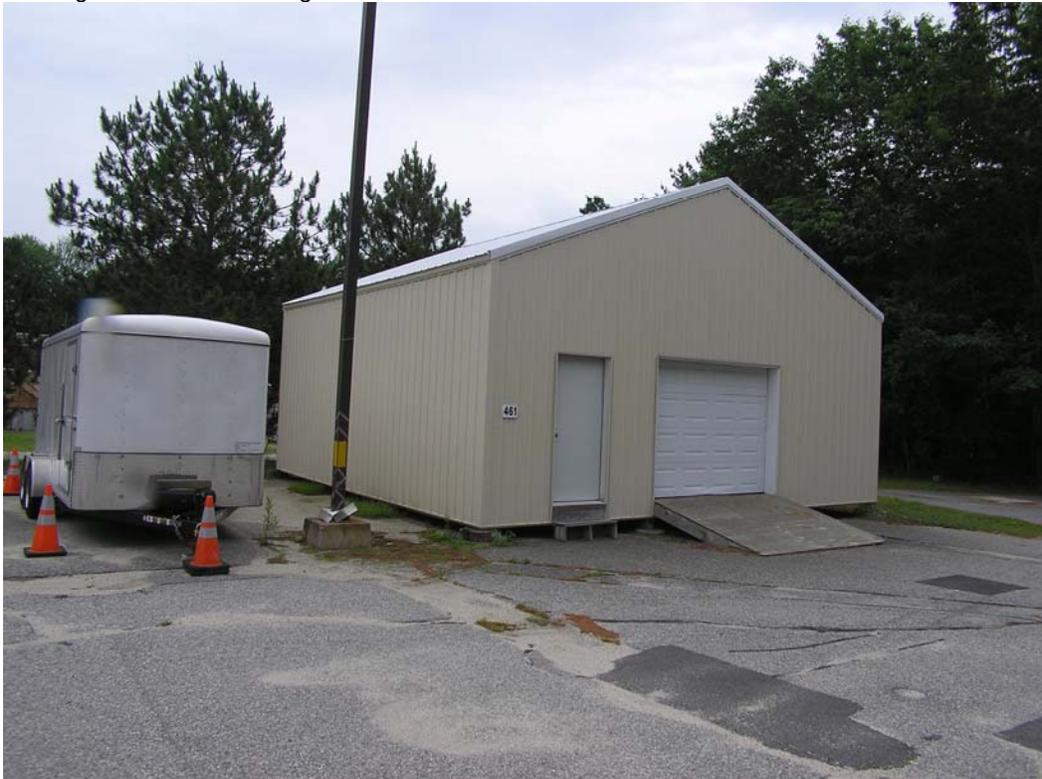
No. 18 Building 516 Parcel – NAS Brunswick July 24, 2010
Building 461 - Niteflite Storage northwest elevation

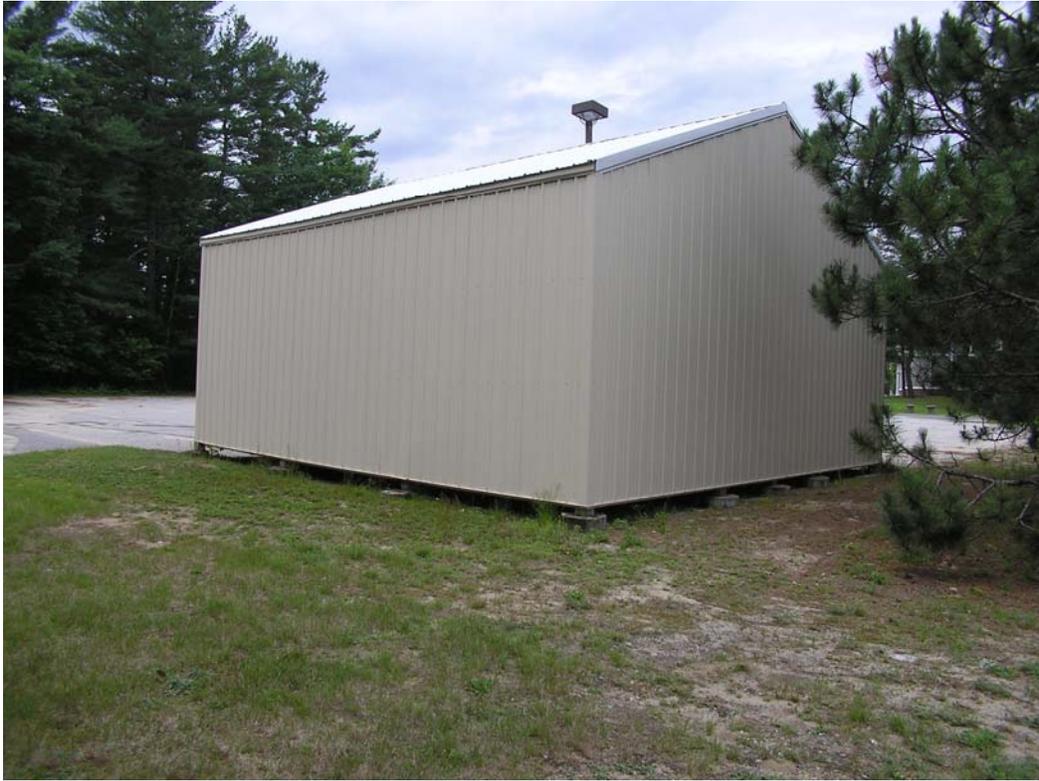
No. 19 Building 516 Parcel – NAS Brunswick July 24, 2010
Building 461 Niteflite Storage southeast elevation

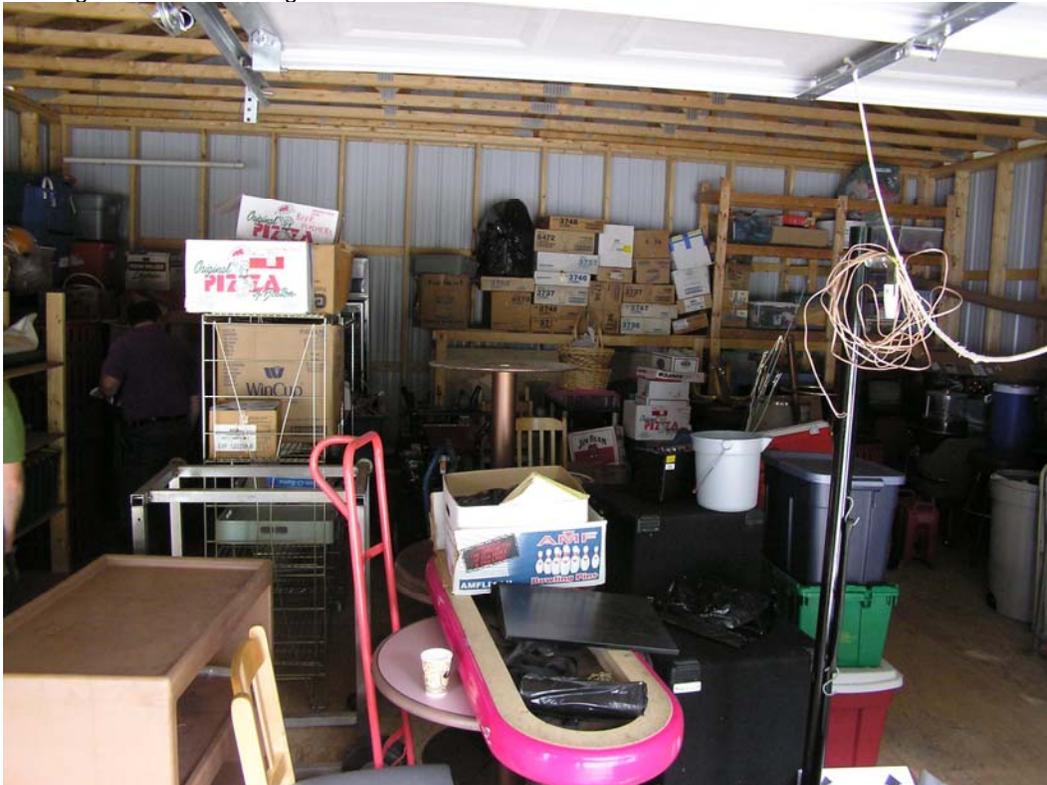
No. 20 Building 516 Parcel – NAS Brunswick July 24, 2010
Building 461 - Niteflite Storage interior
