FINAL RESOURCE CONSERVATION AND RECOVERY ACT PARTIAL CLOSURE REPORT
FOR RUNWAYS AREA AND AIRFIELD PARKING APRON AREA WITH TRANSMITTAL
LETTER NAS BRUNSWICK ME
8/24/2010
NAS BRUNSWICK

Subj: Final RCRA Partial Closure Report for Runways Area and Airfield Parking Apron Area

RCRA PARTIAL CLOSURE REPORT
for
RUNWAYS AREA AND AIRFIELD PARKING APRON AREA
NAVAL AIR STATION BRUNSWICK, MAINE
USEPA IDENTIFICATION NUMBER ME8170022018
AUGUST 2010

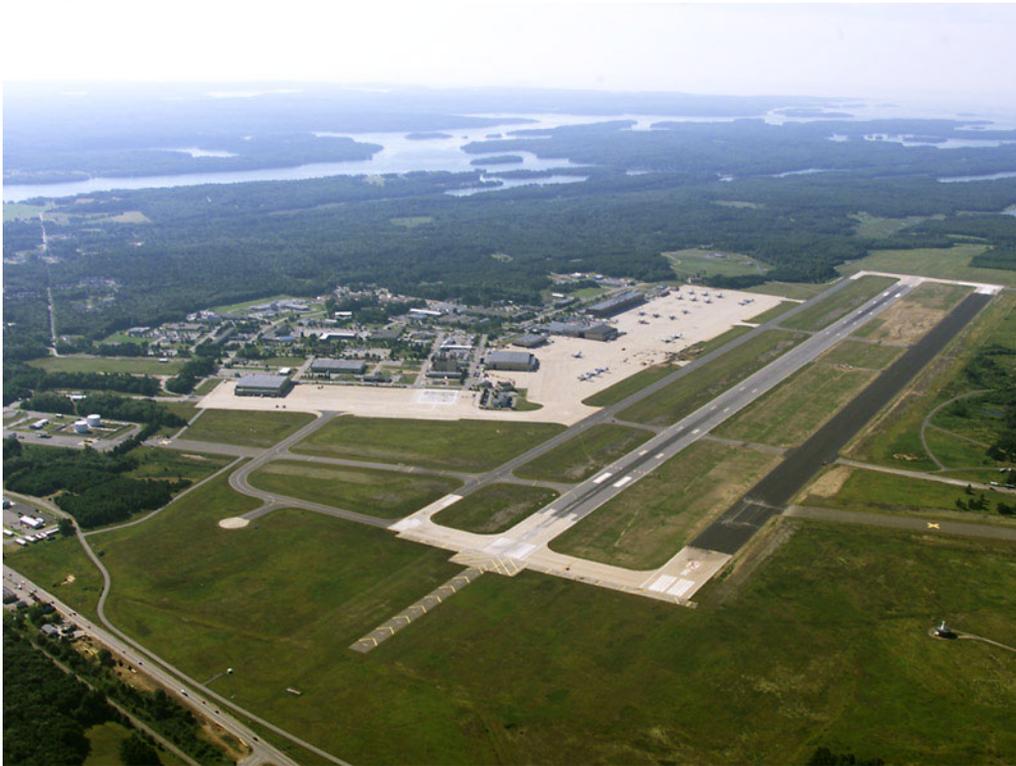
No. 1 Runways Area – NAS Brunswick 2004
Historical (2004) aerial photograph of runways area from northwest (Note: Photograph date is prior to Hangar 1 and 3 demolition and Hangar 6 construction.)

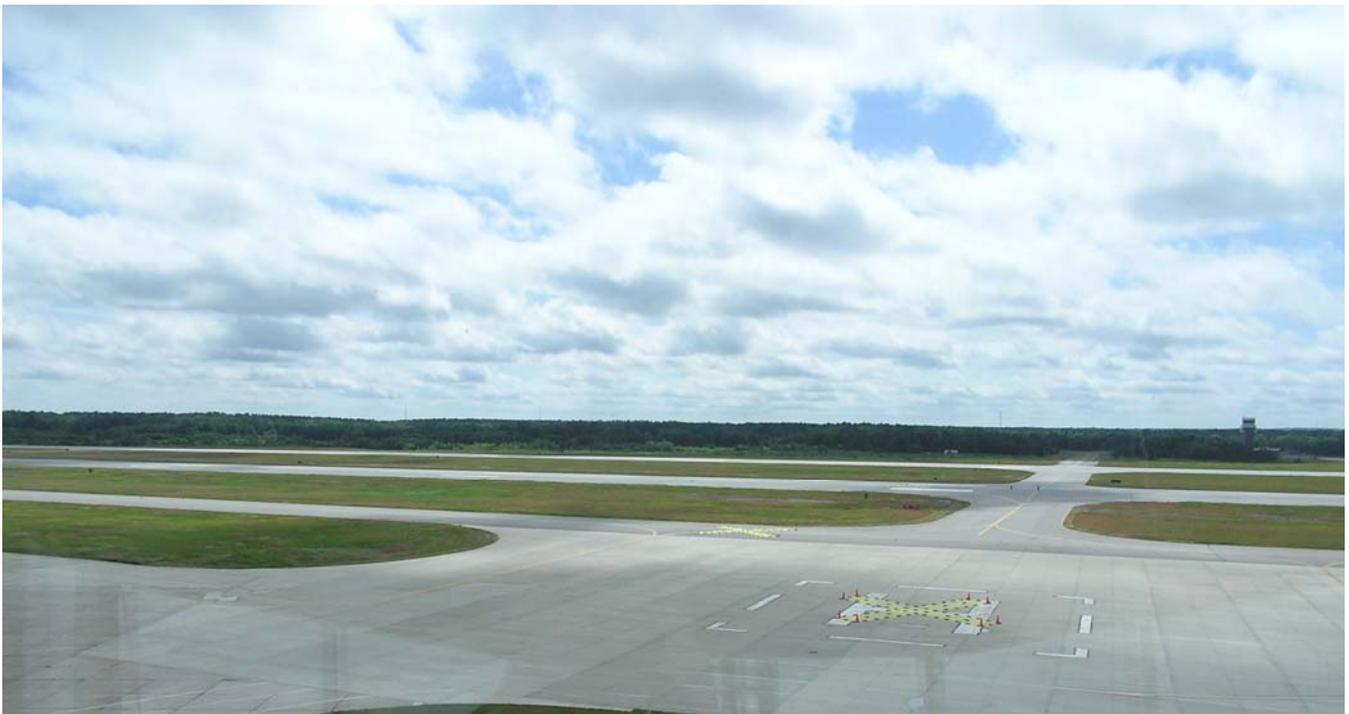
No. 2 Runways Area – NAS Brunswick June 23, 2010
North central runways area opposite former air control tower with former helipad in foreground

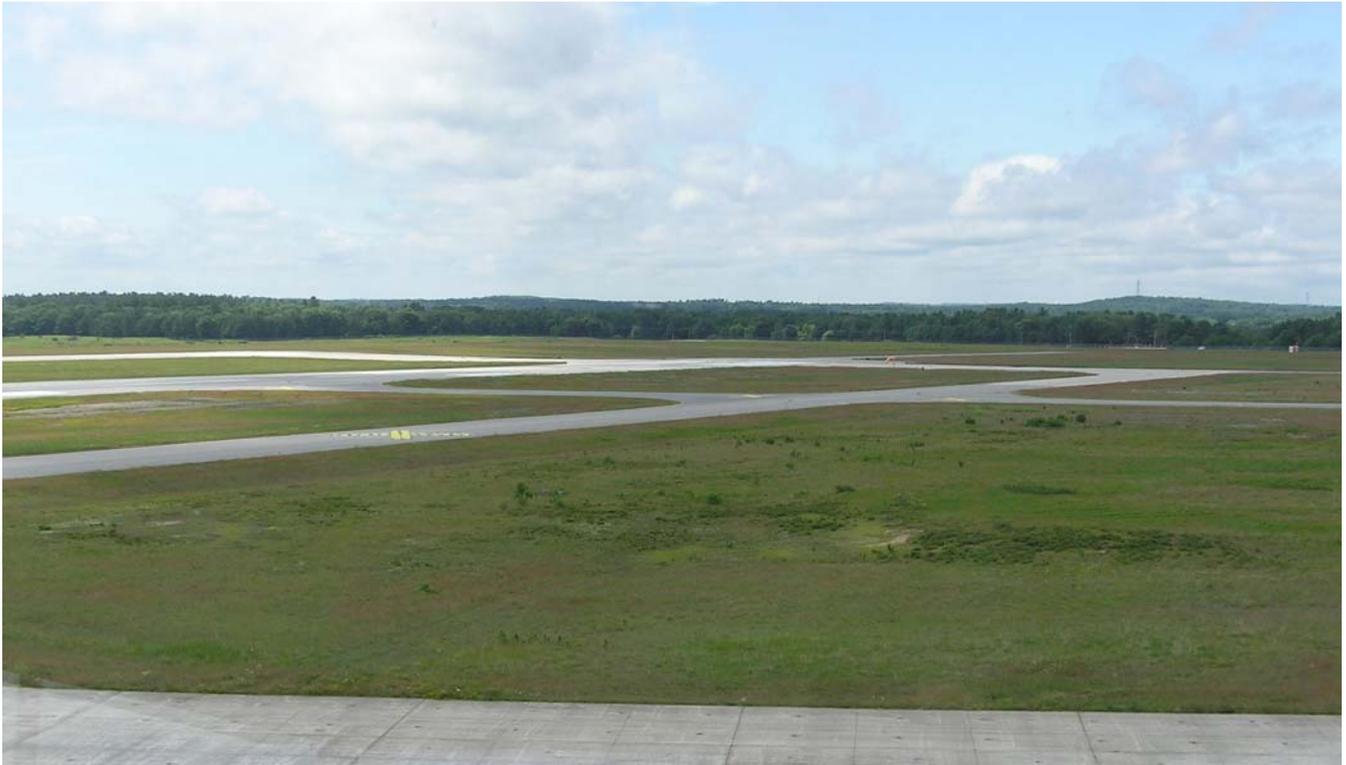
No. 3 Runways Area – NAS Brunswick
Central runways area from northeast

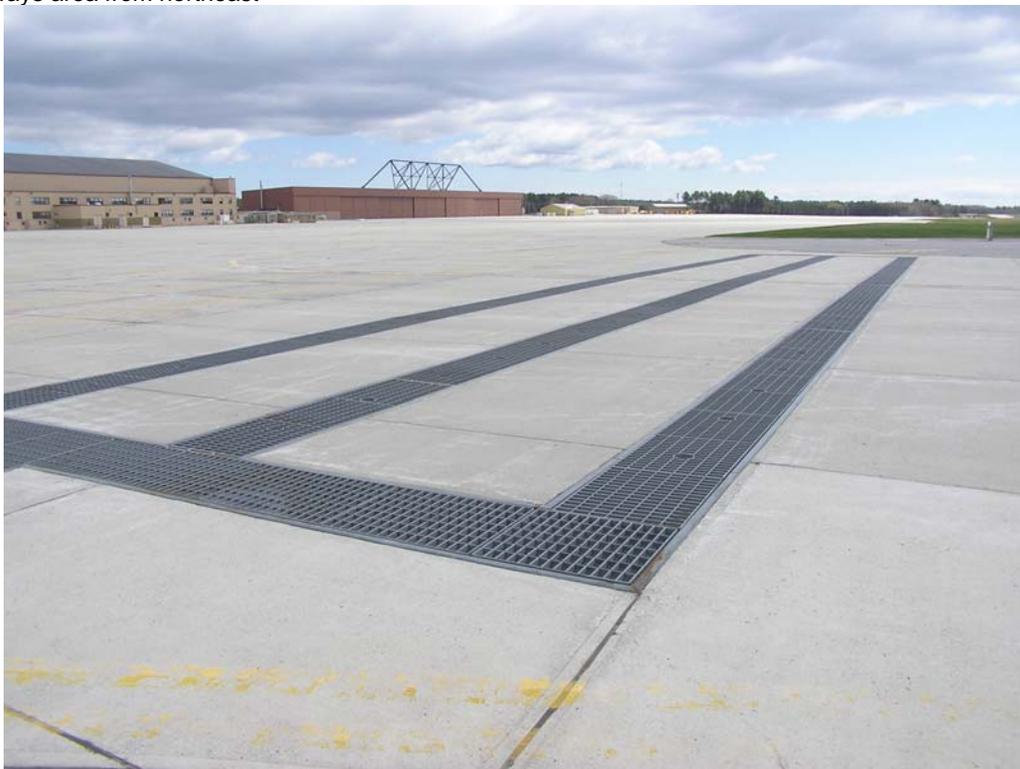
No. 4 Runways Area – NAS Brunswick
Taxiway G wash rack – airfield parking apron area, Hangar 4 (left) and Hangar 5 (center) in background

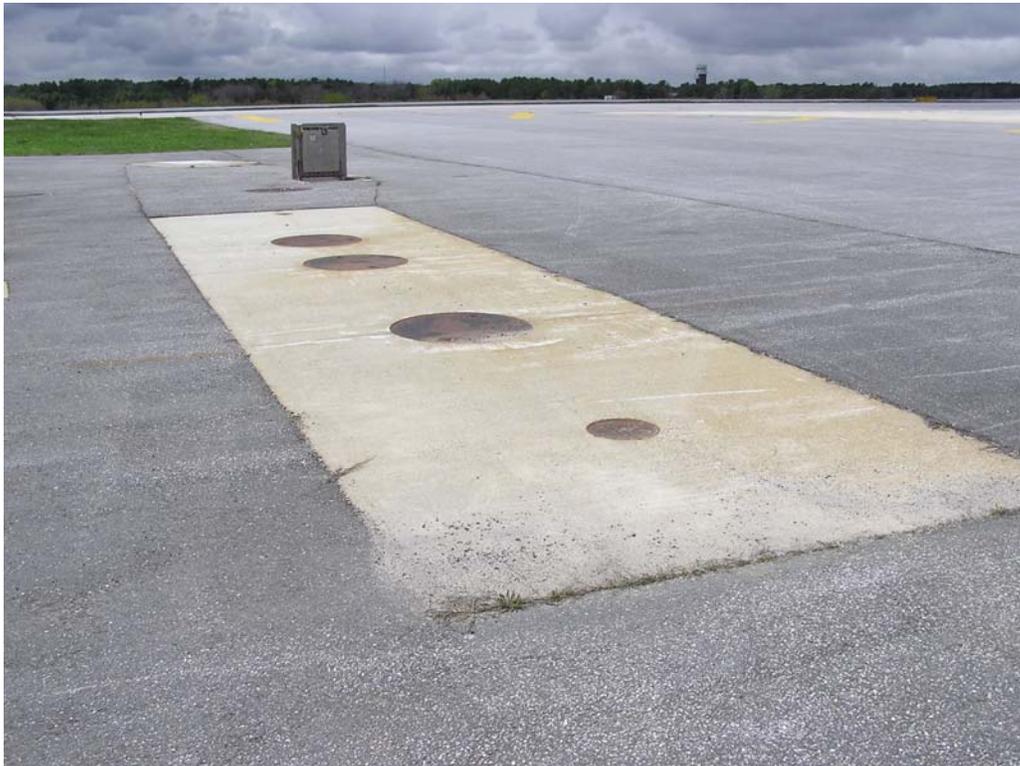
No. 5 Runways Area – NAS Brunswick April 28, 2010
Oil/water separator at Taxiway G wash rack

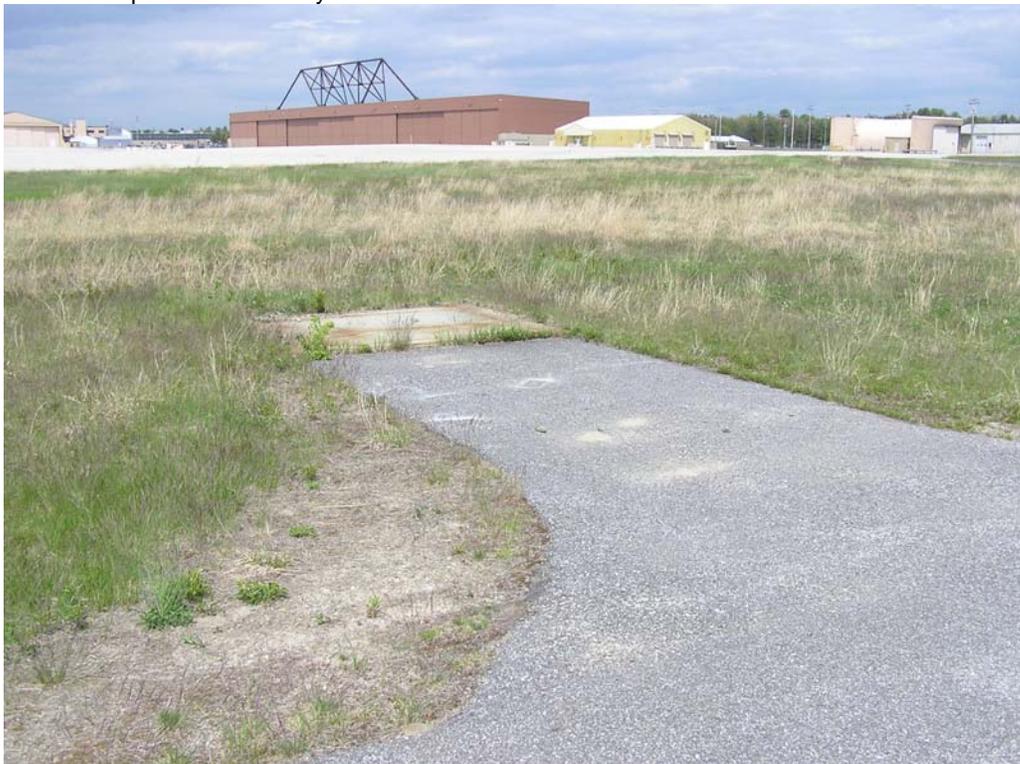
- At the time of the inspection, the runways and taxiways within the Runways Area were closed and in good condition.
- At the Ready Storage Area, no secure-storage buildings were present; only concrete pads where the buildings were previously situated were present on the north and south of the Abandoned Road. (The secure-storage lockers were previously removed as part of the Weapons Department decommissioning.)

No. 6 Runways Area – NAS Brunswick April 28, 2010
One of the secure-storage buildings locations at the former ready storage area – airfield parking apron area and Hangar 5 in background

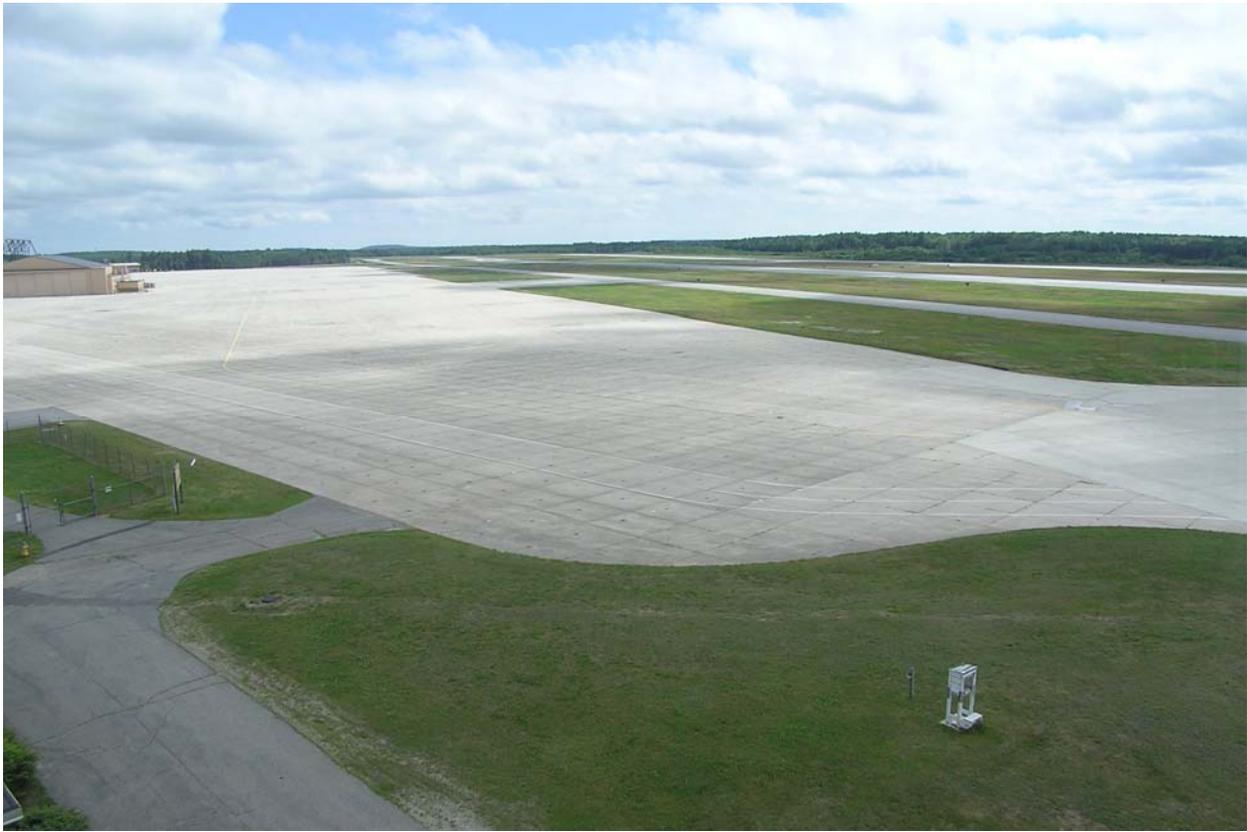
No. 1 Airfield Parking Apron Area – NAS Brunswick June 23, 2010
Parking Apron Area from north – in background Hangar 4 (left) and runways area

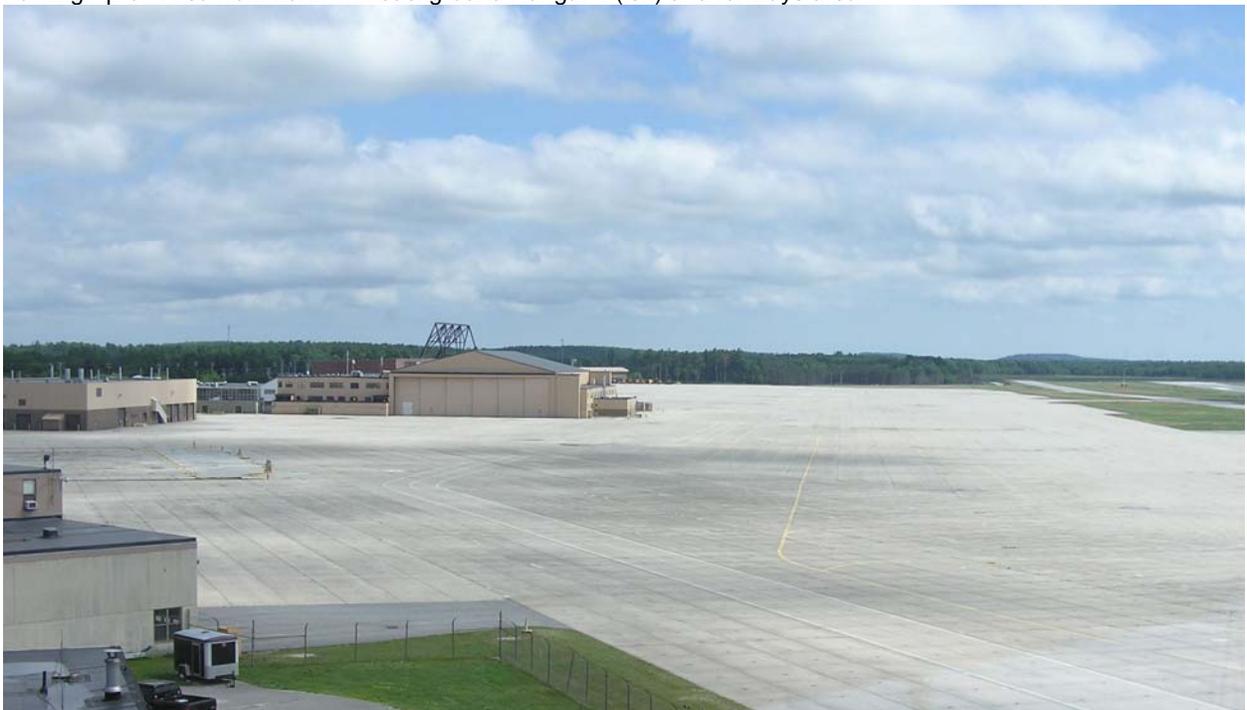
No. 2 Airfield Parking Apron Area – NAS Brunswick June 23, 2010
Parking Apron Area from north – in background Building 86 (left), Building 250/Hangar 4 (center) and runways area (right)

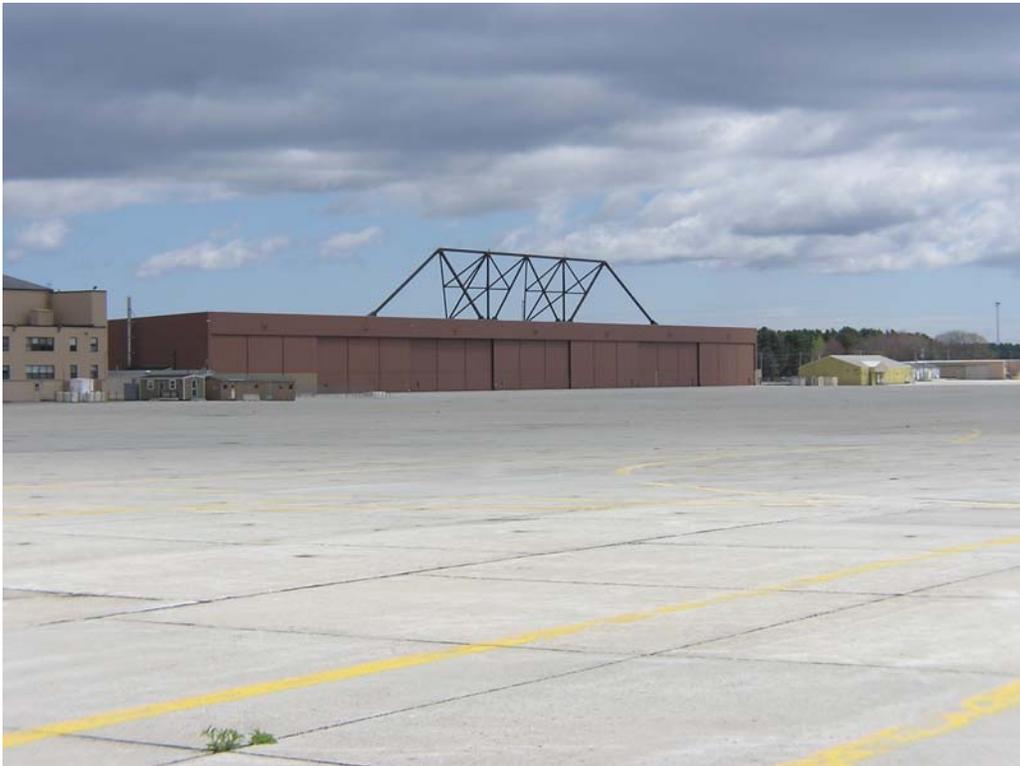
No. 3 Airfield Parking Apron Area – NAS Brunswick April 28, 2010
Central section of Aircraft Parking Apron Area – in background Hangar 4 (left) and Hangar 5 (center)
