FINAL RESOURCE CONSERVATION AND RECOVERY ACT PARTIAL CLOSURE REPORT
FOR BUILDING 150 WITH TRANSMITTAL LETTER NAS BRUNSWICK ME
9/13/2010
NAS BRUNSWICK

RCRA PARTIAL CLOSURE REPORT
for
BUILDING 150 – MULTI-TENANTS
NAVAL AIR STATION BRUNSWICK, MAINE
USEPA IDENTIFICATION NUMBER ME8170022018
AUGUST 2010

**HWSA INSPECTION FORM
HAZARDOUS WASTE STORAGE AREAS CLOSURE
NAS BRUNSWICK
BRUNSWICK, MAINE
CTO WE22**

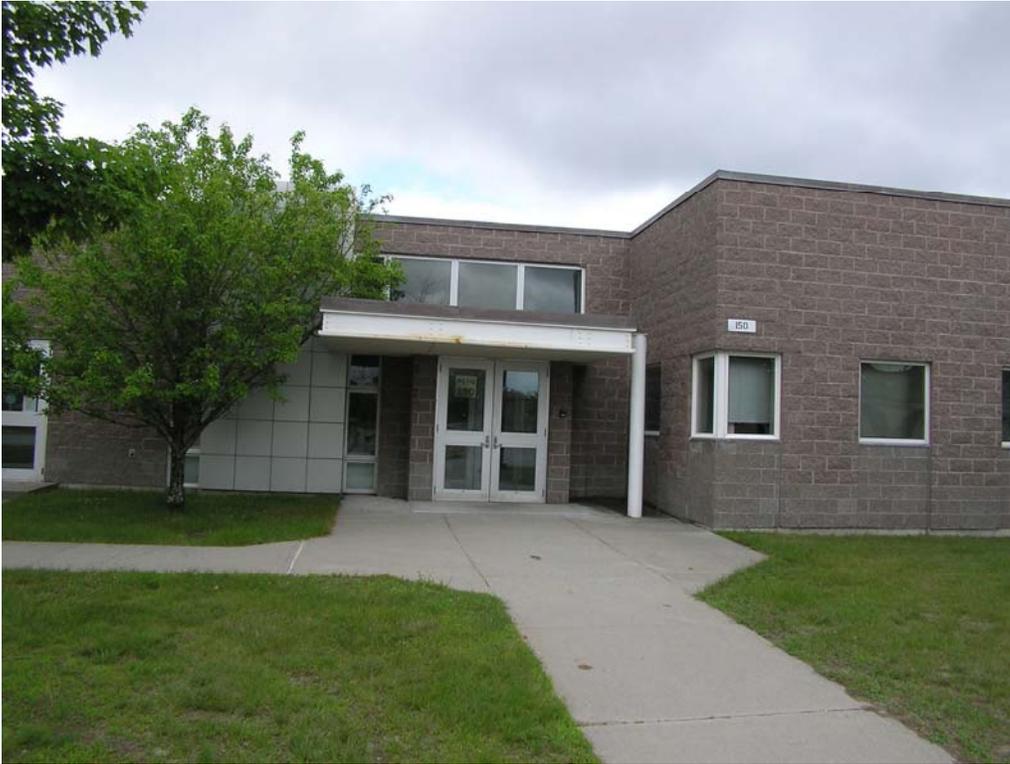
No. 1 Building 150 Multi-Tenants Parcel – NAS Brunswick
West elevation main entrance

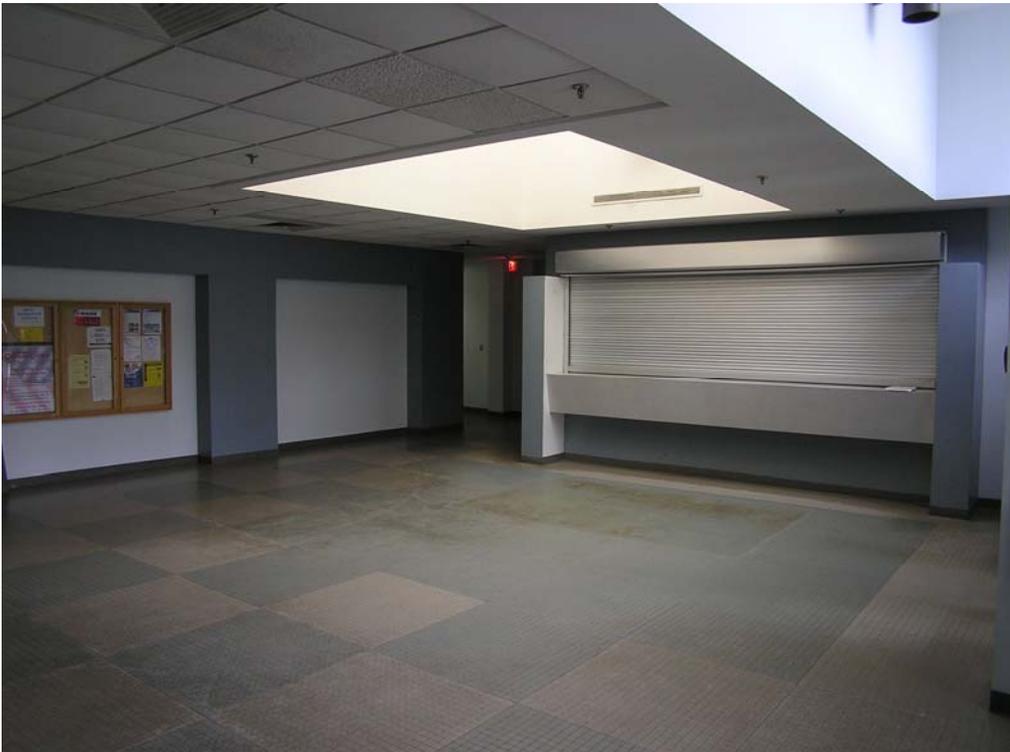
No. 2 Building 150 Multi-Tenants Parcel – NAS Brunswick
Front lobby area accessed through main entrance

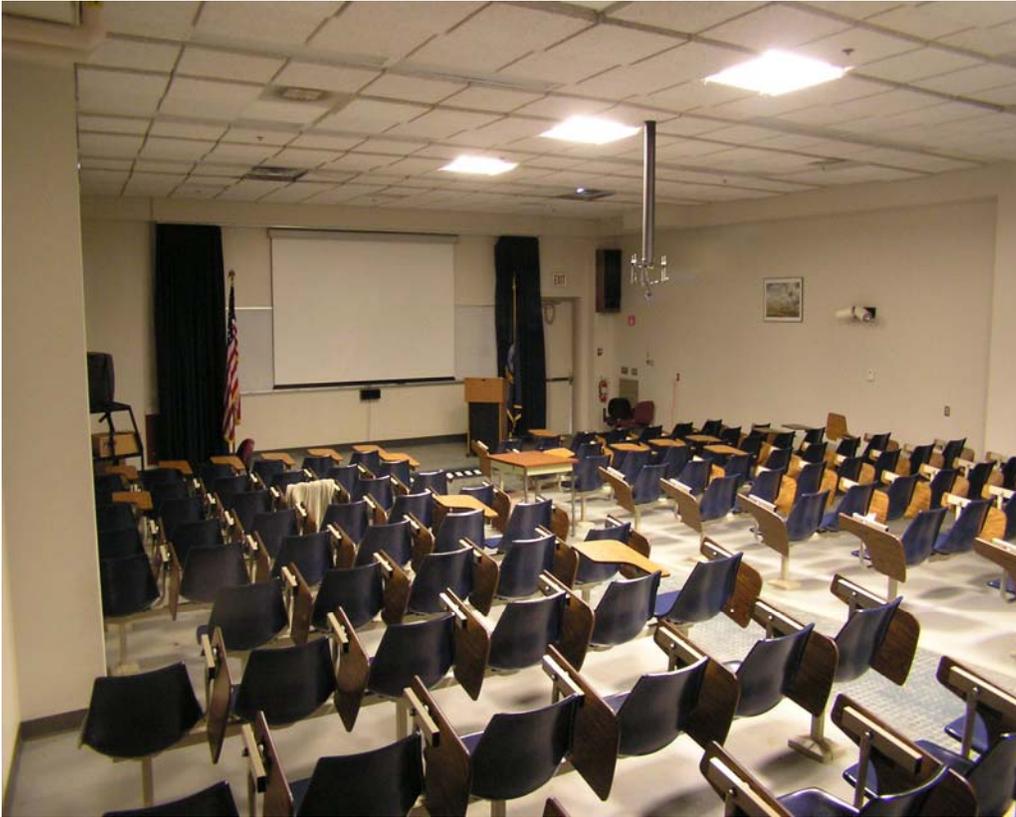
No. 3 Building 150 Multi-Tenants Parcel – NAS Brunswick June 23, 2010
Presentation room (location of former hypobaric chamber room)

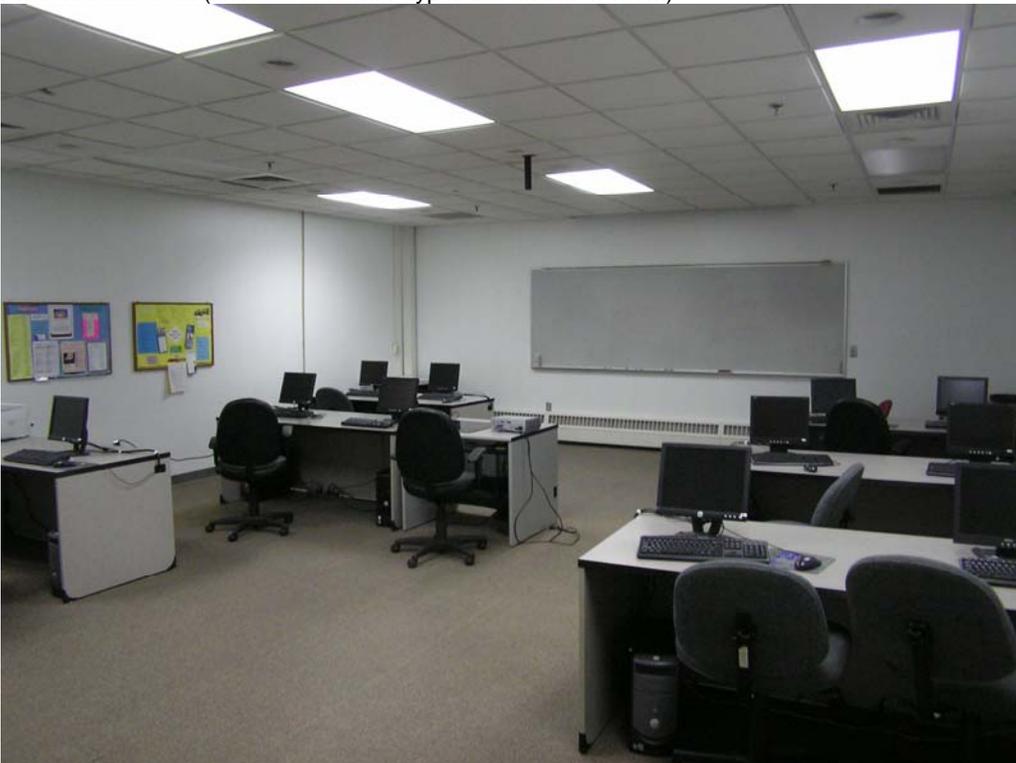
No. 4 Building 150 Multi-Tenants Parcel – NAS Brunswick June 23, 2010
Small classroom

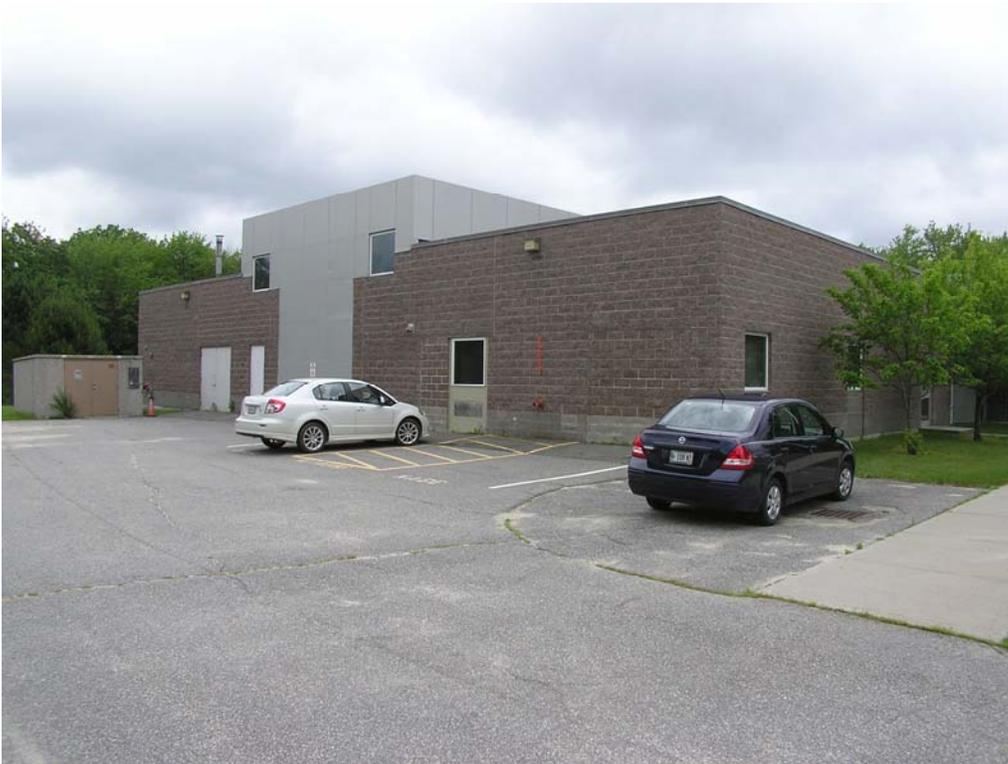
No. 5 Building 150 Multi-Tenants Parcel – NAS Brunswick June 23, 2010
North elevation; Structure D4 (hazardous material storage shed) shown in left background

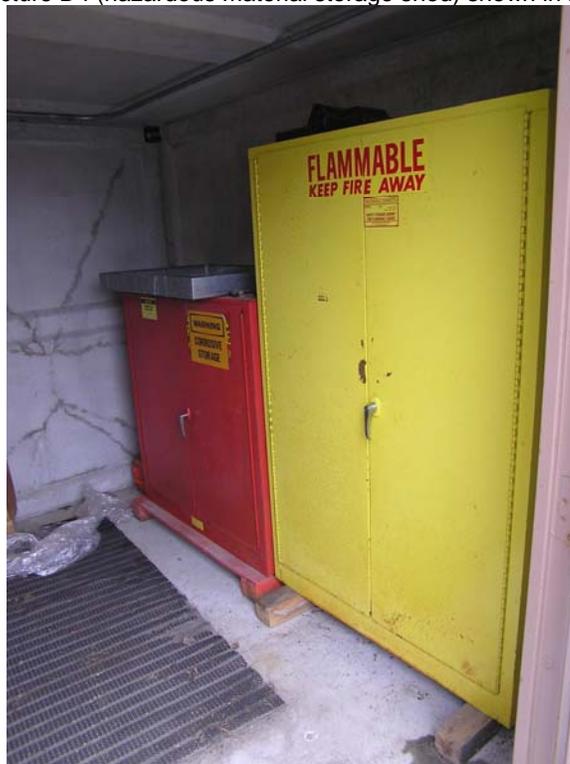
Corrosive and flammable materials were stored in an approximate 100 square-foot pre-cast concrete structure located northeast of Building 150 known as Building D4. The structure was empty at the time of inspection. Paint wastes and universal waste were generated during the operations in Building 150 according to NASB personnel.

No. 6 Building 150 Multi-Tenants Parcel – NAS Brunswick June 23, 2010
Structure D4 (hazardous materials storage shed) interior

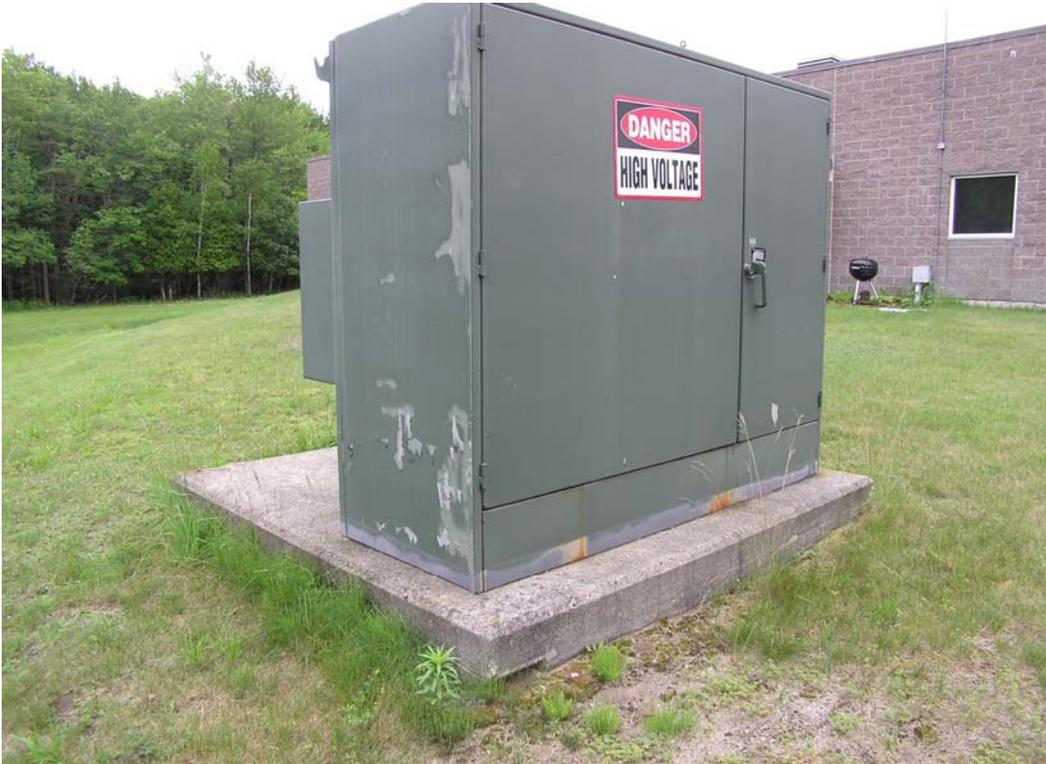
One transformer that could be a potential source of polychlorinated biphenyls (PCBs) contamination in the event of a leak was observed in the northeast corner of Building 150.

225 KVA Pad-Mounted – Cooper Serial No. 91600517 – Non-PCB containing

No. 7 Building 150 Multi-Tenants Parcel – NAS Brunswick June 23, 2010
Non-PCB containing pad-mounted transformer located on east side of Building 150

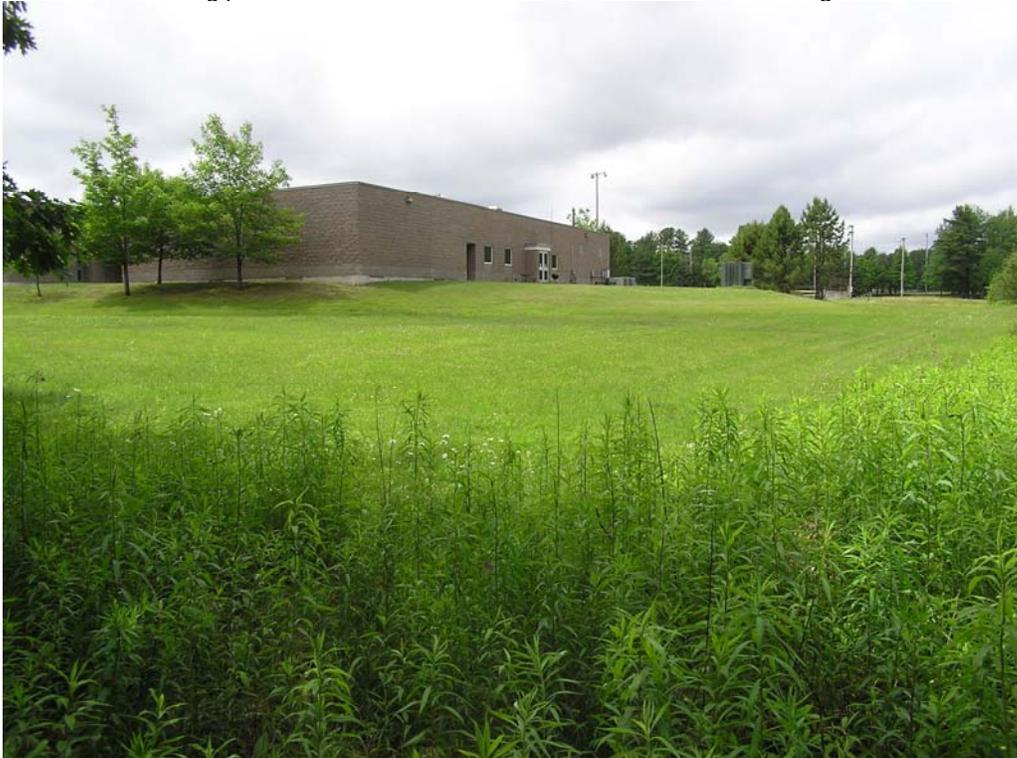
No. 8 Building 150 Multi-Tenants Parcel – NAS Brunswick June 23, 2010
South elevation

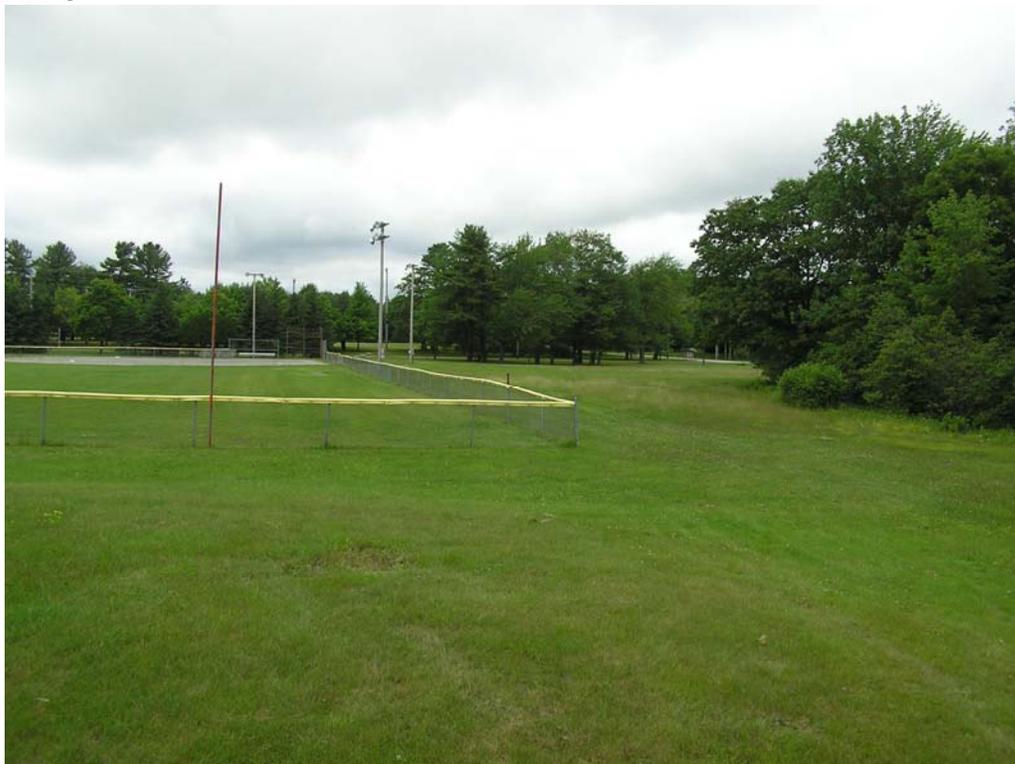
No. 9 Building 150 Multi-Tenants Parcel – NAS Brunswick June 23, 2010
Northeast area of parcel (ball field)
