FINAL RESOURCE CONSERVATION AND RECOVERY ACT PARTIAL CLOSURE REPORT
FOR BUILDING 64 WITH TRANSMITTAL LETTER NAS BRUNSWICK ME
12/1/2010
NAS BRUNSWICK

Subj: Final RCRA Partial Closure Report for Building 64

RCRA PARTIAL CLOSURE REPORT
for
BUILDING 64 – WEST BUNKER
NAVAL AIR STATION BRUNSWICK, MAINE
USEPA IDENTIFICATION NUMBER ME8170022018
NOVEMBER 2010

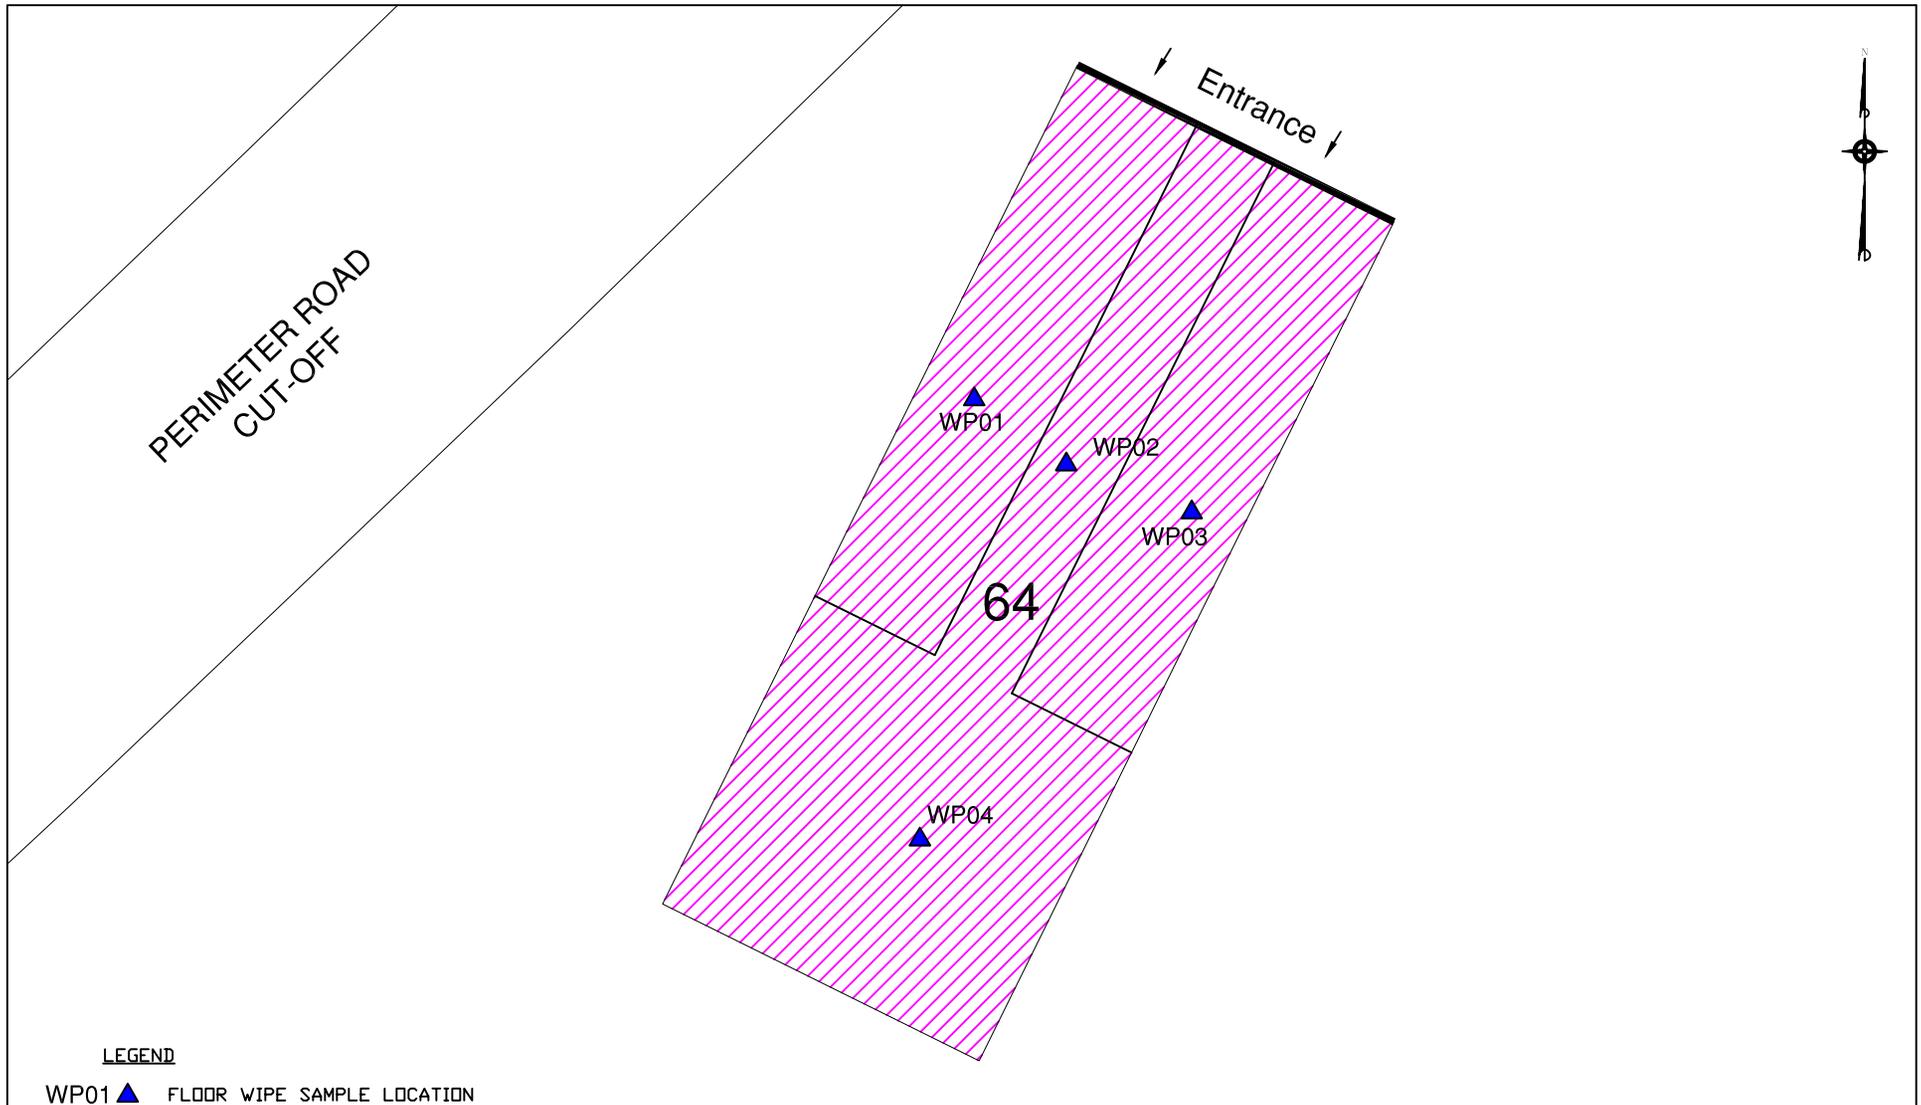
Due to the age of Building 64 and its use as a weapons magazine, on October 7, 2009, four wipe samples were collected, one from the floor of each of the four rooms, for analysis of semi-volatile organic compounds (SVOCs) and RCRA metals (sample locations are shown on Figure 3). Analytical results are presented in Table 1.

Lead levels in floor wipe samples were found to exceed the MEDEP criterion ($40 \mu\text{g}/\text{ft}^2$) in all four rooms, with concentrations ranging from 632 to $2,323 \mu\text{g}/\text{ft}^2$. In addition, screening criteria for arsenic, cadmium, and chromium were exceeded.

Based on the investigation results, closure remedial actions were undertaken at Building 64 to remove waste residues as required to achieve MEDEP hazardous waste closure requirements. Remedial actions consisted of the cleaning of floors in all four interior rooms.

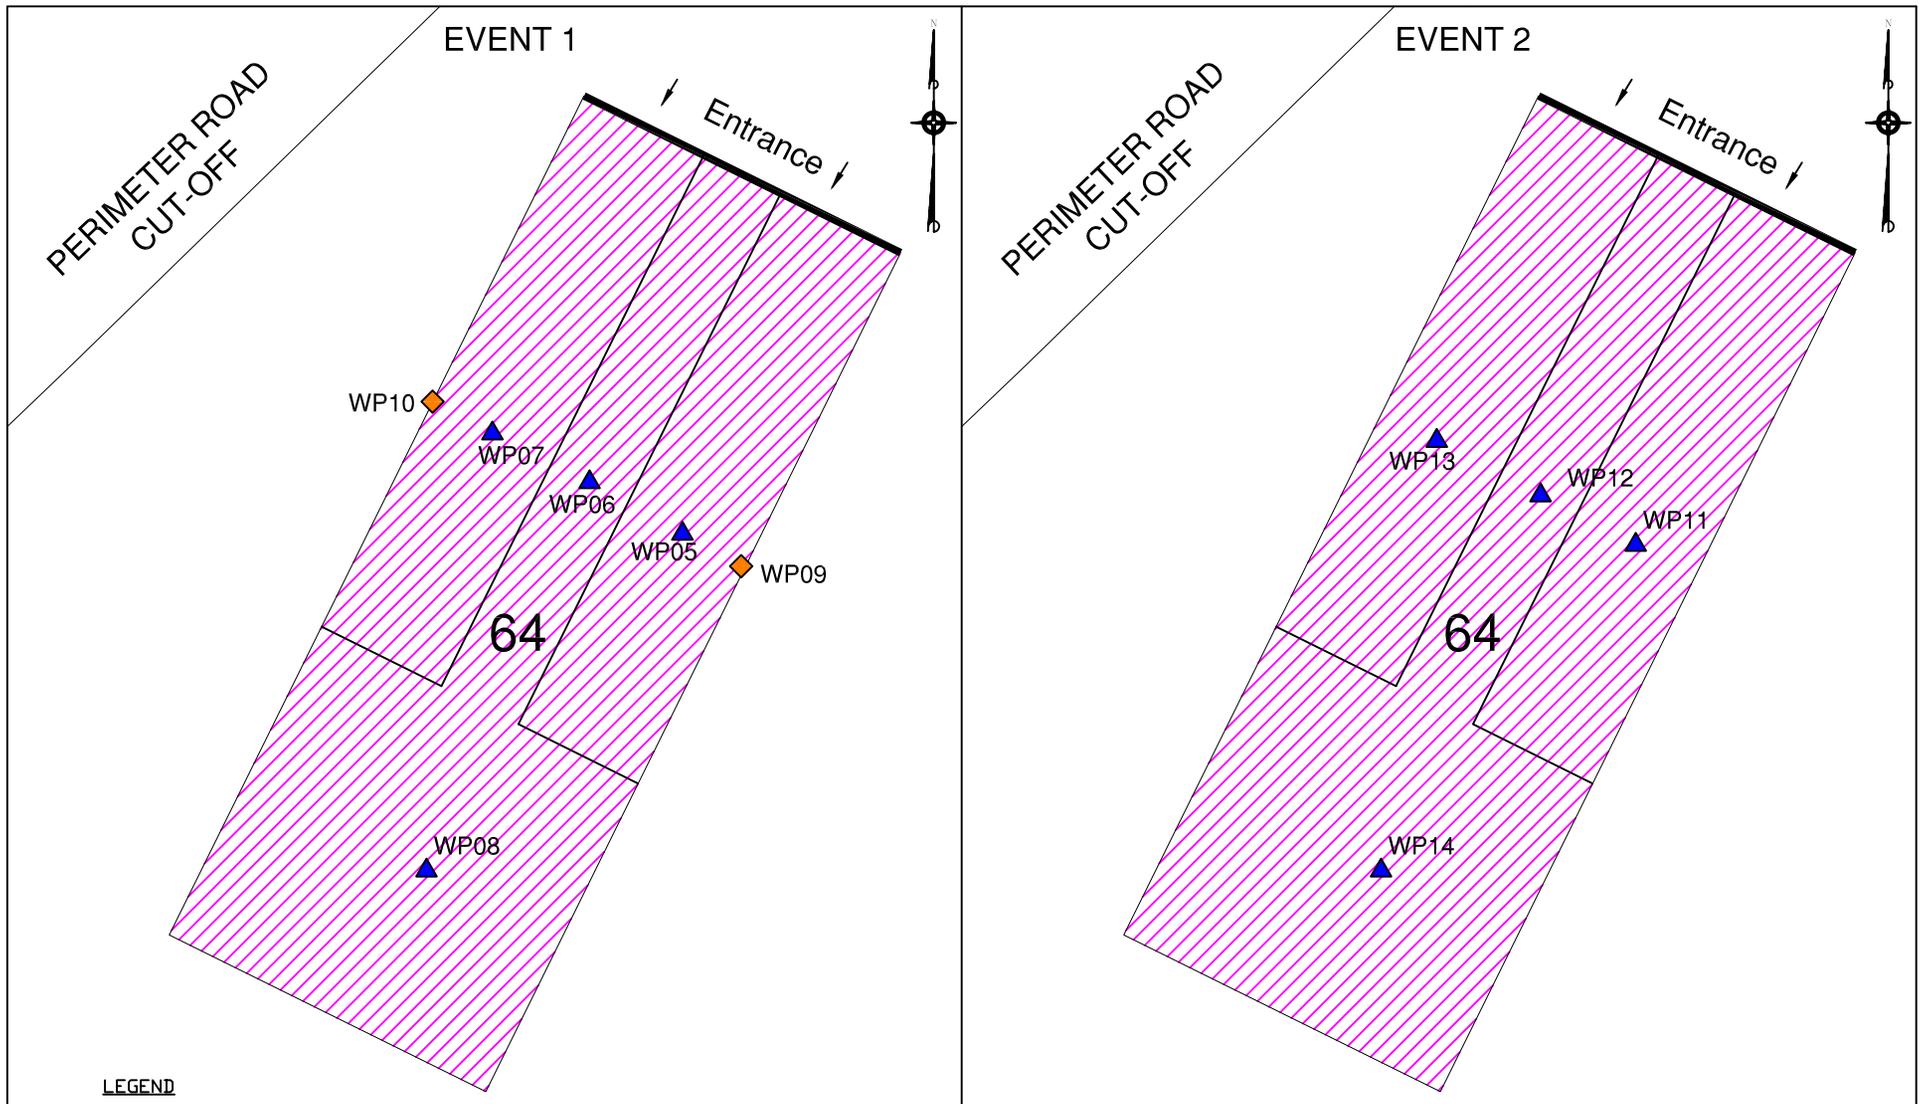
After the work areas were allowed to dry, post-cleaning confirmatory sampling was conducted. Four wipe samples were collected from the floor and two from the walls (Figure 4). As shown in Table 2, analytical results indicated that lead exceeded the applicable MEDEP criterion of $40 \mu\text{g}/\text{ft}^2$ in the majority of the post-cleaning confirmation wipe samples. Lead levels in wall-location confirmatory samples did not exceed the associated MEDEP criterion for lead-contaminated, settled dust on walls, up to a height of 8 feet ($250 \mu\text{g}/\text{ft}^2$).

On September 27, 2010, Tetra Tech's cleaning subcontractor, Global Remediation Services (Global), performed floor-cleaning activities in Building 64, as well as the cleaning of walls up to a height of 8 feet. The floor was then manually swept and then vacuumed with a high-efficiency particulate air (HEPA) vacuum. After sweeping and vacuuming, floors and walls were sprayed and scrubbed with a 2-percent, lead-specific detergent solution. Floors and walls were then pressure-washed using a 5,000-pounds-per-square-inch (psi) steam-cleaner. All cleaning wastewater was containerized using a wet-vacuum, placed in 55-gallon drums, and transferred to the NAS Brunswick hazardous waste department for disposal. Upon completion, the Tetra Tech field representative performed a visual inspection of the cleaned area.

A second decontamination of the Building 64 floors was performed on October 20, 2010, using the procedures described above. After the work areas were allowed to dry, four post-cleaning confirmatory wipe samples were collected from the floor for lead analysis (Figure 5). Following this second decontamination event, wipe sample analytical results indicated that lead was not detected at concentrations exceeding $40 \mu\text{g}/\text{ft}^2$ at any of these post-cleaning sample locations (Table 3).

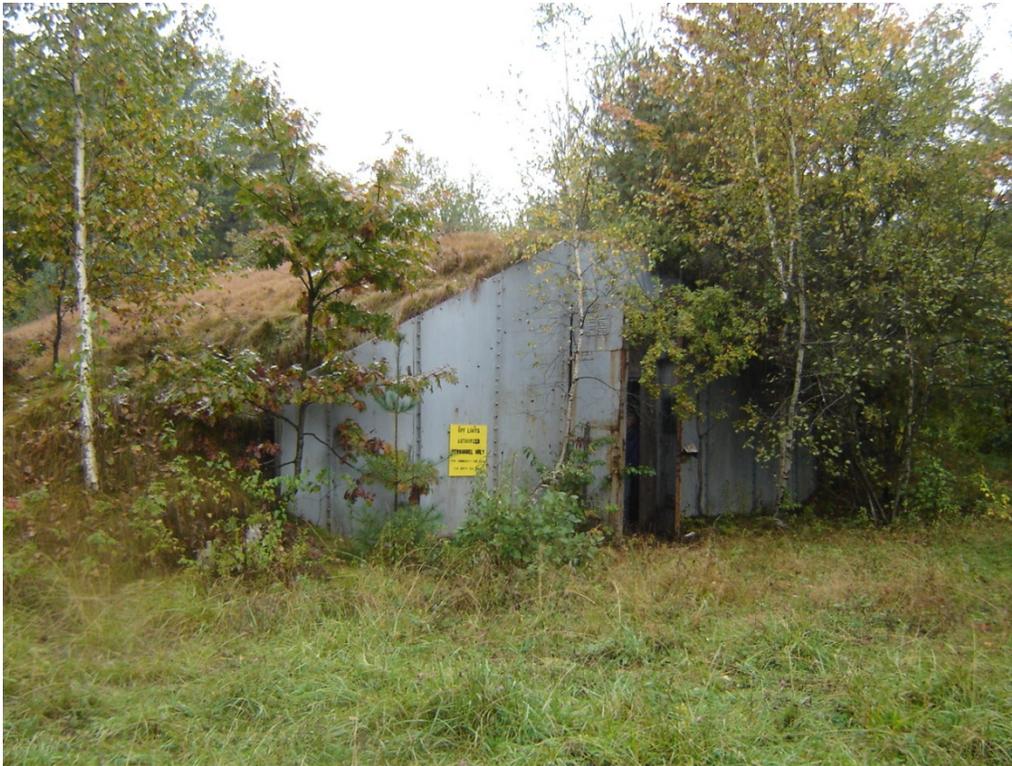
No. 1 Building 64 – NAS Brunswick
West Bunker (Building 64) eastern elevation

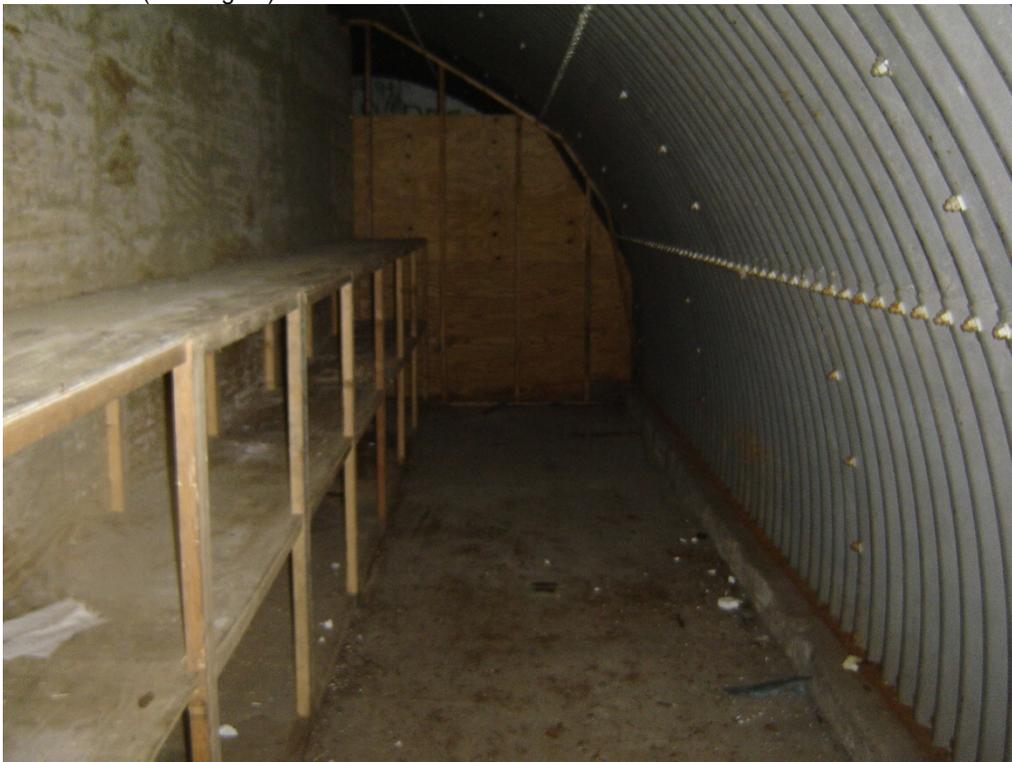
No. 2 Building 64 – NAS Brunswick
West Bunker (Building 64) west storage area

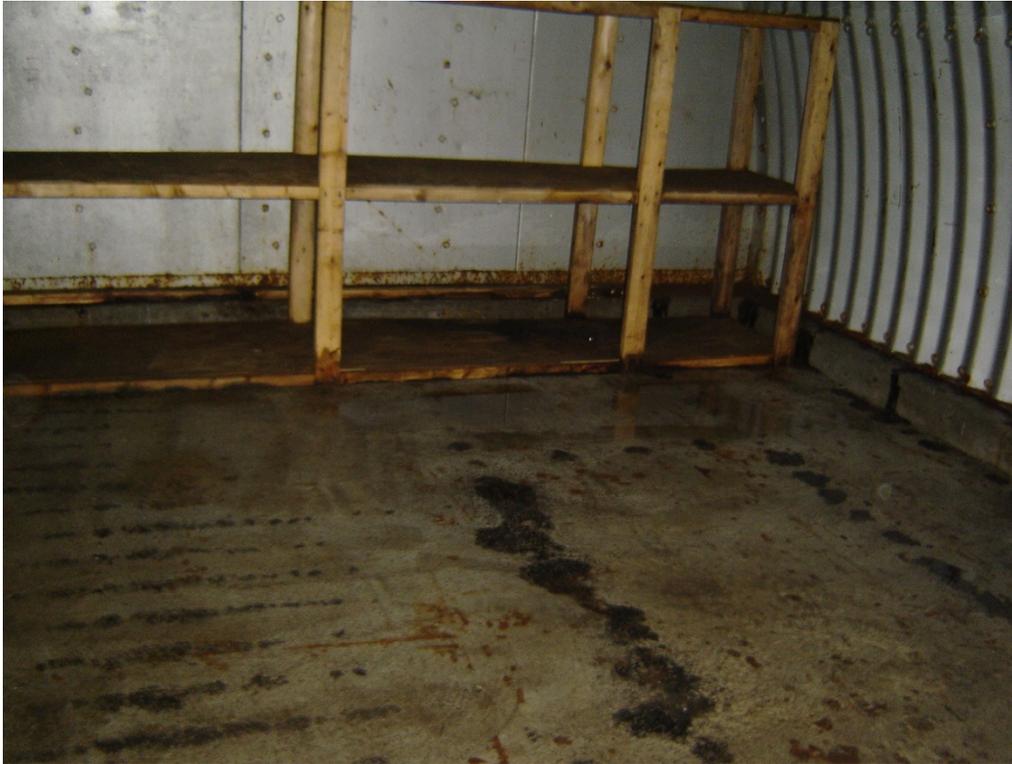
No. 3 Building 64 – NAS Brunswick October 1, 2010
West Bunker (Building 64) south storage area post-decontamination (Event 1)

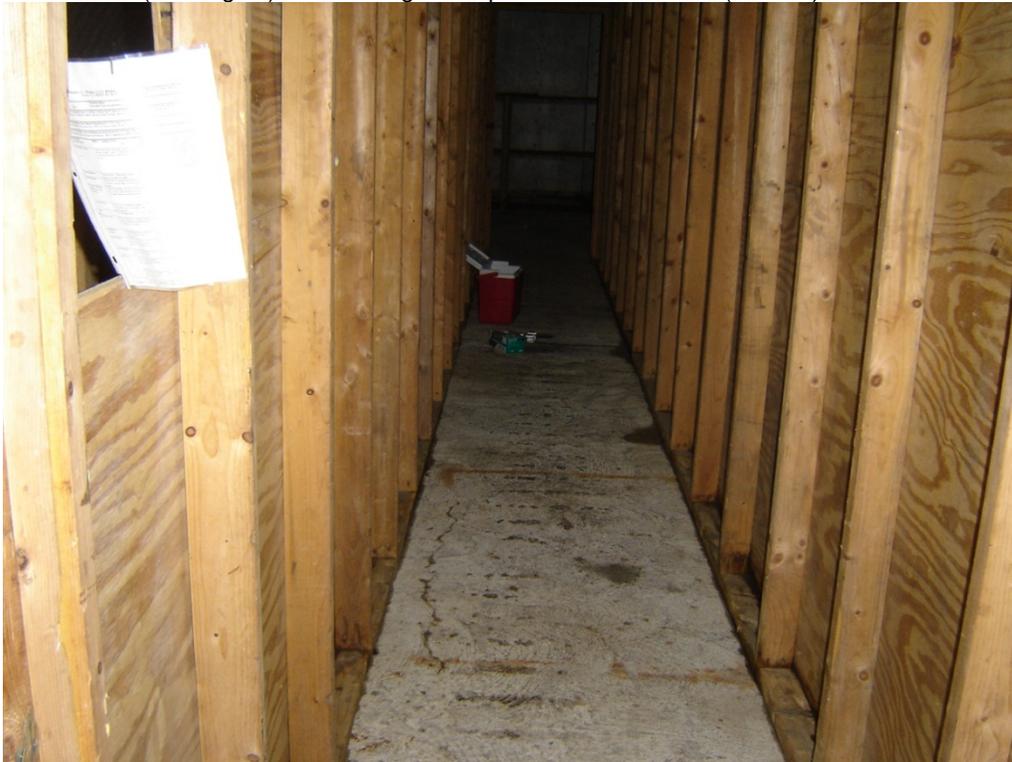
No. 4 Building 64 – NAS Brunswick October 21, 2010
West Bunker (Building 64) central corridor post-decontamination (Event 2)
