FINAL RESOURCE CONSERVATION AND RECOVERY ACT PARTIAL CLOSURE REPORT  
FOR BUILDING 81 WITH TRANSMITTAL LETTER NAS BRUNSWICK ME  
12/1/2010  
NAS BRUNSWICK

Subj: Final RCRA Partial Closure Report for Building 81

**RCRA PARTIAL CLOSURE REPORT**  
for  
**BUILDING 81 – CHRIMP FACILITY PARCEL**  
**NAVAL AIR STATION BRUNSWICK, MAINE**  
**USEPA IDENTIFICATION NUMBER ME8170022018**  
**NOVEMBER 2010**

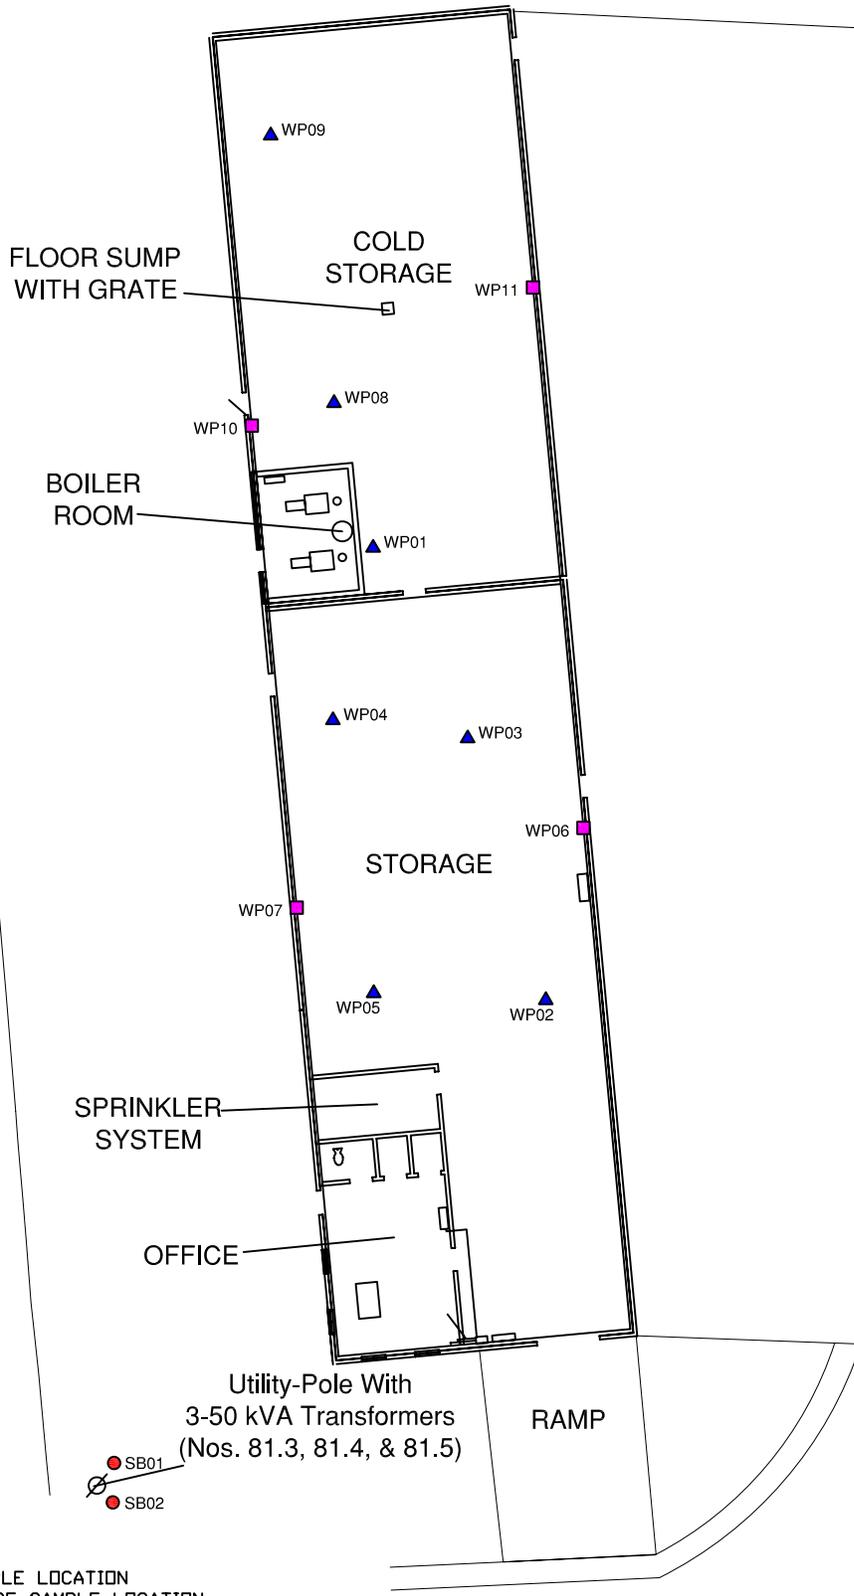
On September 2 and October 14, 2010, Tetra Tech collected wipe samples from eleven locations within the heated-storage (south) and cold-storage (north) areas of Building 81 (Figure 3). One floor wipe sample (WP01) was collected from the “white-discolored” area. Six additional wipe samples were collected from the storage area floors, and four wipe samples were collected from the storage area walls.

In several floor-wipe samples, lead was detected at levels ranging from 40 to 94  $\mu\text{g}/\text{ft}^2$ , exceeding the MEDEP lead criterion for floors (40  $\mu\text{g}/\text{ft}^2$ ). In sample B81-WP01, collected from the area of the lead-based-battery release, lead was detected at 15  $\mu\text{g}/\text{ft}^2$ , less than the MEDEP lead criterion, indicating no significant residual impacts from the battery release. As shown in Table 2, all levels of other detected metals are below the screening values. Based on the analytical results, cleaning of the floor in the Building 81 storage areas was required to remove lead-contaminated residue exceeding the associated MEDEP criterion for dust on floors.

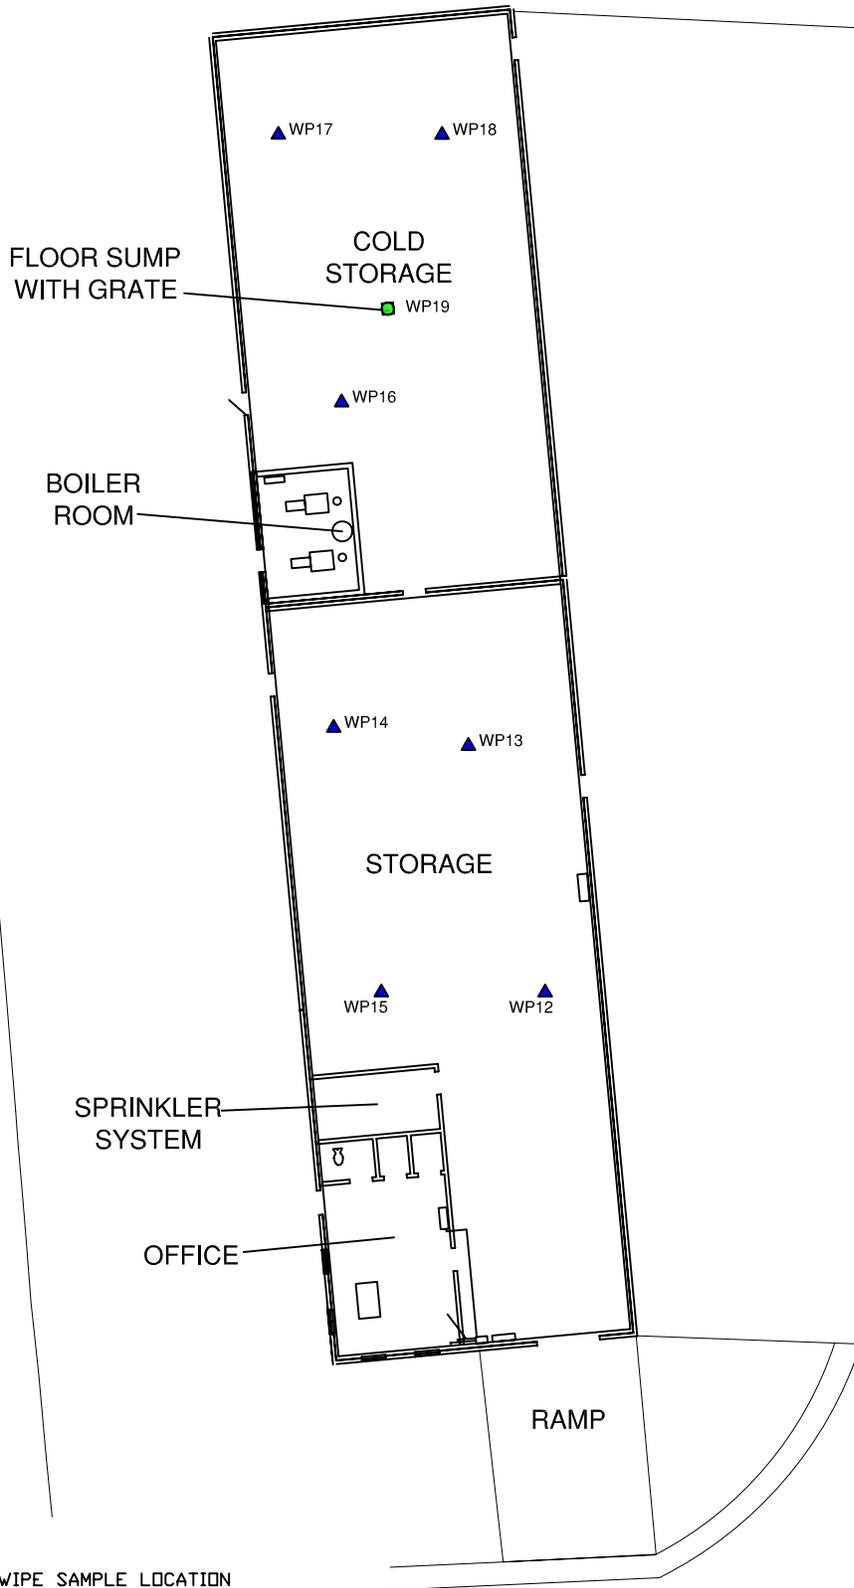
Following the cleaning activities, on October 28, 2010, seven confirmatory wipe samples were collected from the dried floor for lead analysis by Analytics (Figure 4). As presented in Table 4, lead levels in all seven samples were less than the MEDEP floor lead criterion (40  $\mu\text{g}/\text{ft}^2$ ).

The sump walls and bottom were cleaned to a visibly clean condition. One confirmatory wipe sample was collected from the sump wall for RCRA metals analysis by Analytics (Figure 4). As this location is not readily accessible by workers, the sump wipe sample lead level was compared against the MEDEP wall criterion (250  $\mu\text{g}/\text{ft}^2$ ) for informational purposes. As shown in Table 4, the lead level did not exceed the MEDEP wall lead criterion, and levels of six other metals did not exceed the available WTC screening values.

Tetra Tech's cleaning subcontractor (Global Remediation Services [Global]) performed floor and sump cleaning activities at Building 81 on October 26 and 27, 2010. The floor and sump was first manually swept and then vacuumed with a high-efficiency particulate air (HEPA) vacuum. After sweeping and vacuuming, floors and sump were sprayed with a 2-percent, lead-specific detergent solution, scrubbed, and pressure-washed, using a 5,000-pounds-per-square-inch (psi) steam-cleaner. All cleaning wastewater was containerized using a wet-vacuum, placed in three 55-gallon drums, and transferred to the NAS Brunswick hazardous waste department for storage pending disposal. Upon completion, the Tetra Tech field representative performed a visual inspection of the cleaned area.

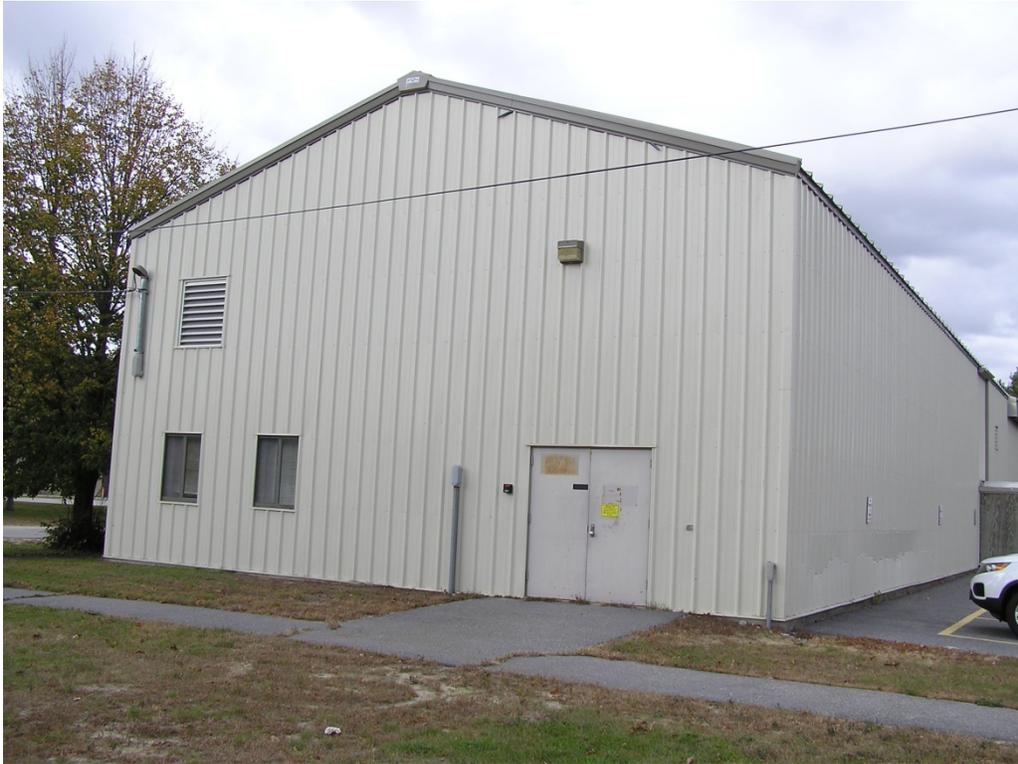
No. 1 Buildings 81 Parcel – NAS Brunswick  
CHRIMP Facility south elevation, main entrance

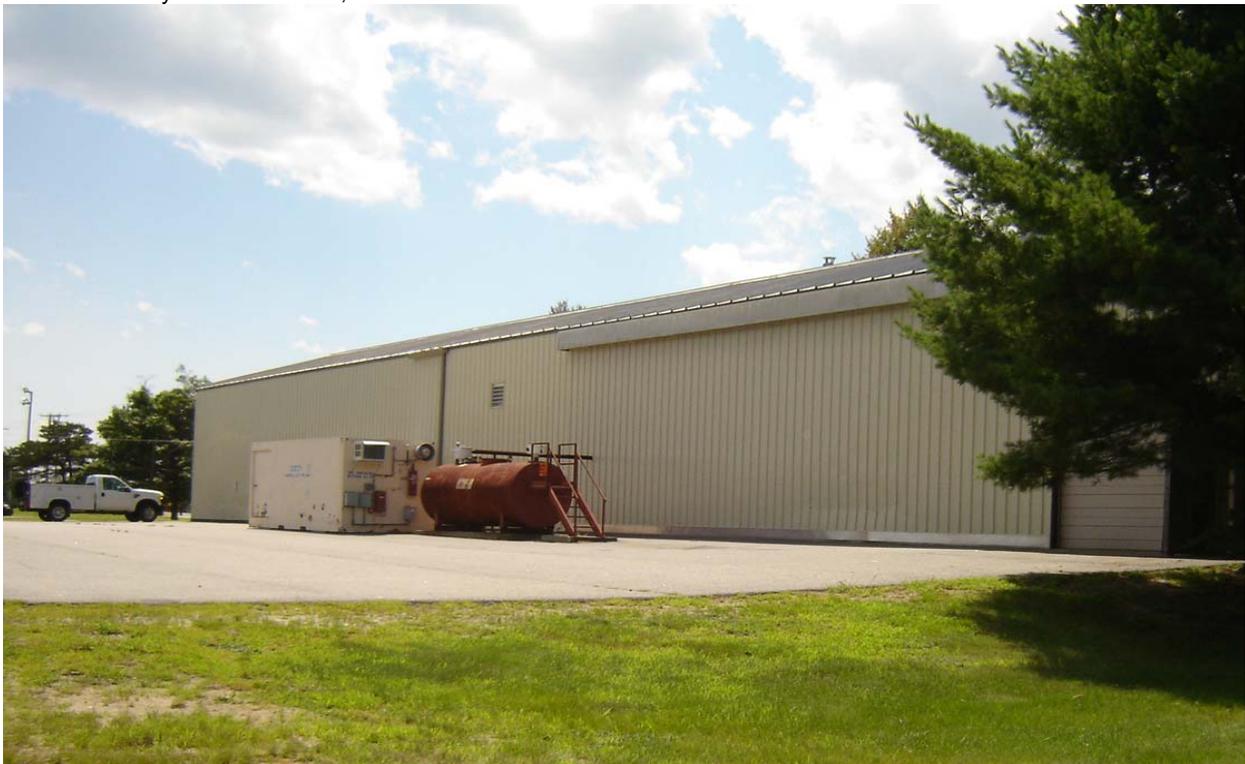
No. 2 Buildings 81 Parcel – NAS Brunswick  
CHRIMP Facility south elevation, with an unmarked flammable locker and a closed AST in the foreground

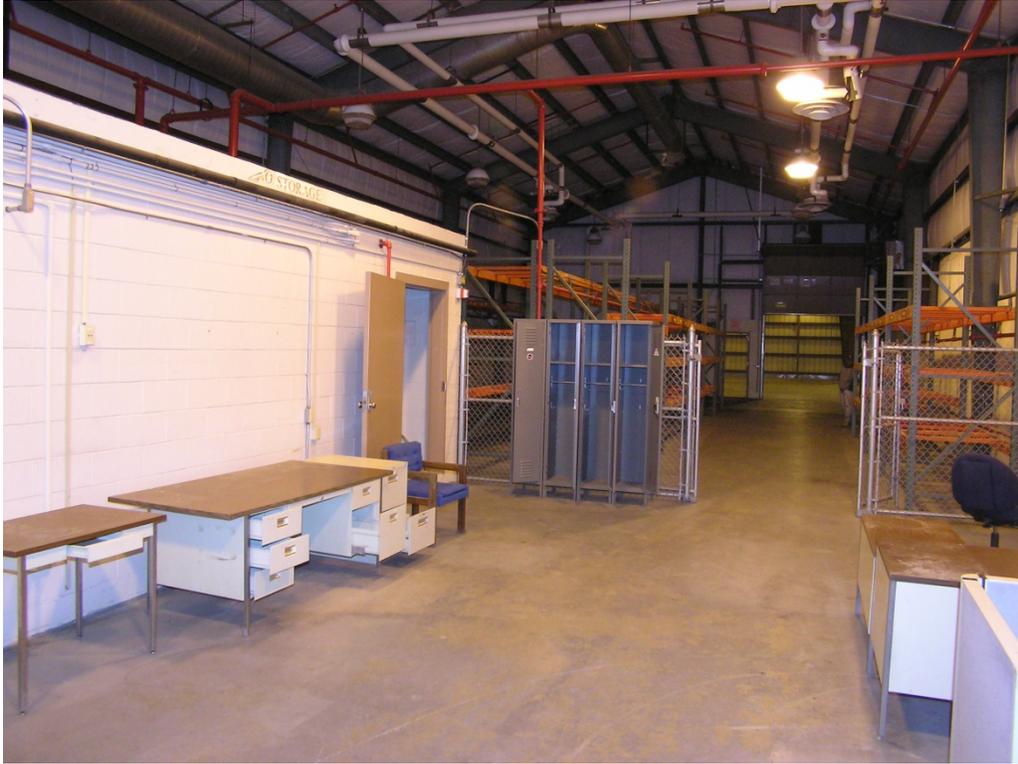
No. 3 Buildings 81 Parcel – NAS Brunswick October 14, 2010  
CHRIMP Facility interior, office in southwest corner of the building at right

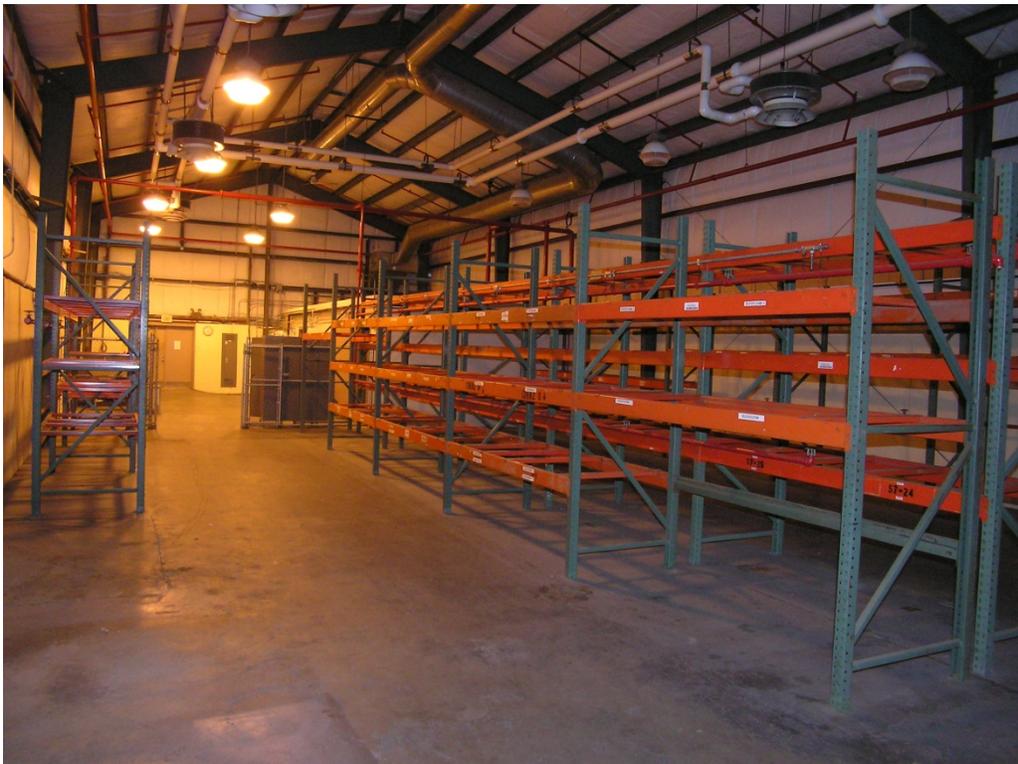
No. 4 Buildings 81 Parcel – NAS Brunswick October 14, 2010  
CHRIMP Facility interior, view south of southern storage area, with main entrance in background

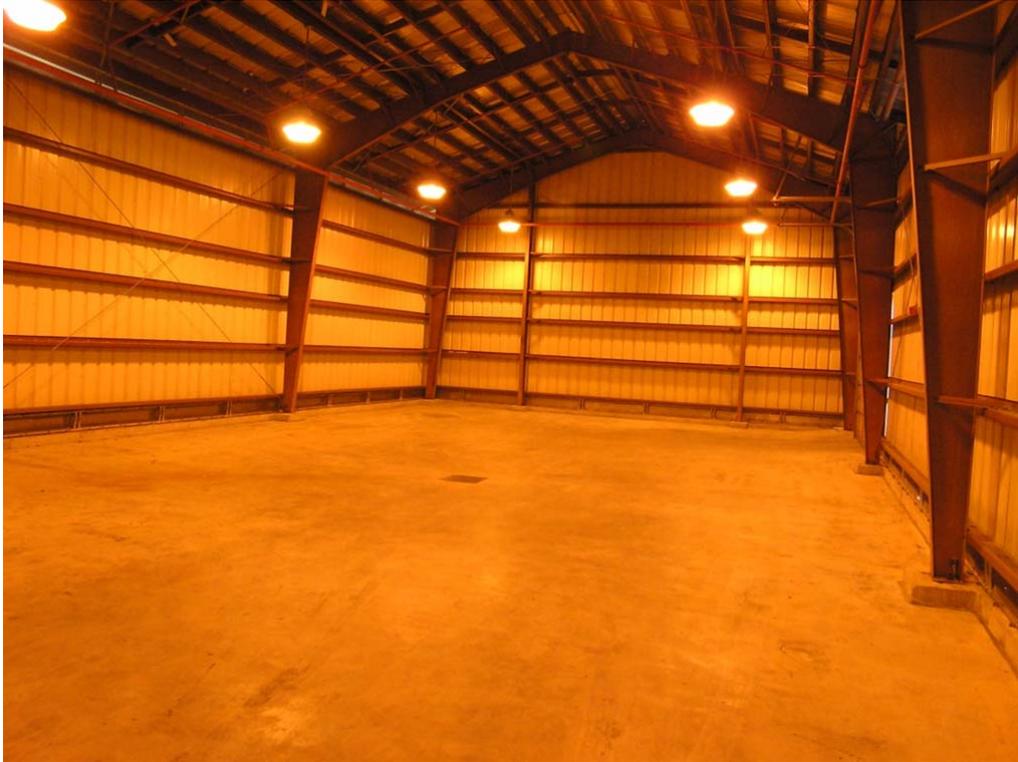
A floor sump was observed within the northern storage area. Review of Building 81 construction plans, and discussed with navy personnel, indicates that this sump is sealed off from the subsurface and was only to be used as a sump to collect releases from within the building.

No. 5 Buildings 81 Parcel – NAS Brunswick October 14, 2010  
CHRIMP Facility interior, northern storage area (from south) sump at center of floor area

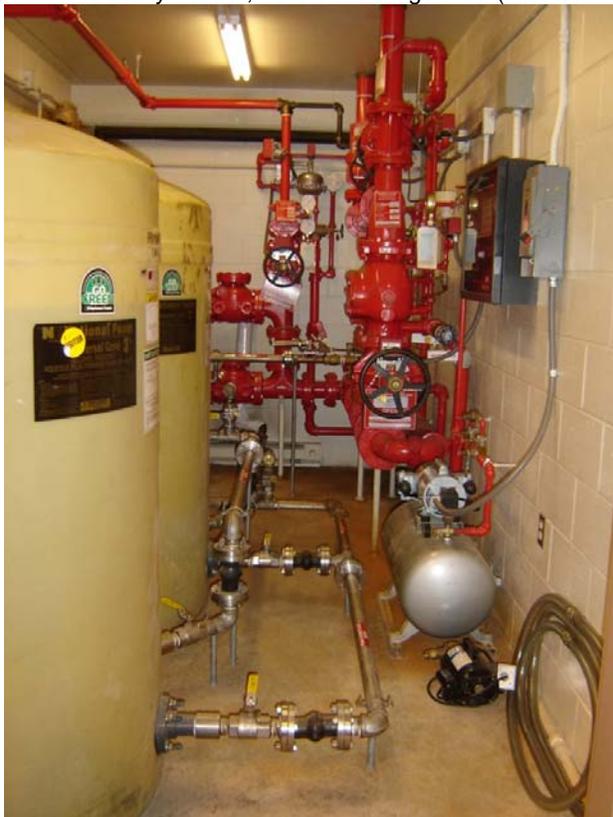
- No hazardous waste storage was observed.
- The AFFF system appeared to be in good condition with no observed leaks or stains.
- Three utility-pole-mounted transformers were identified at the southwest corner of the Building 81 parcel, adjacent to Orion Street. No evidence of a past leak from these transformers was observed.

No. 6 Buildings 81 Parcel – NAS Brunswick July 29, 2010  
CHRIMP Facility interior, fire protection mechanical room; AFFF storage tanks at left of frame

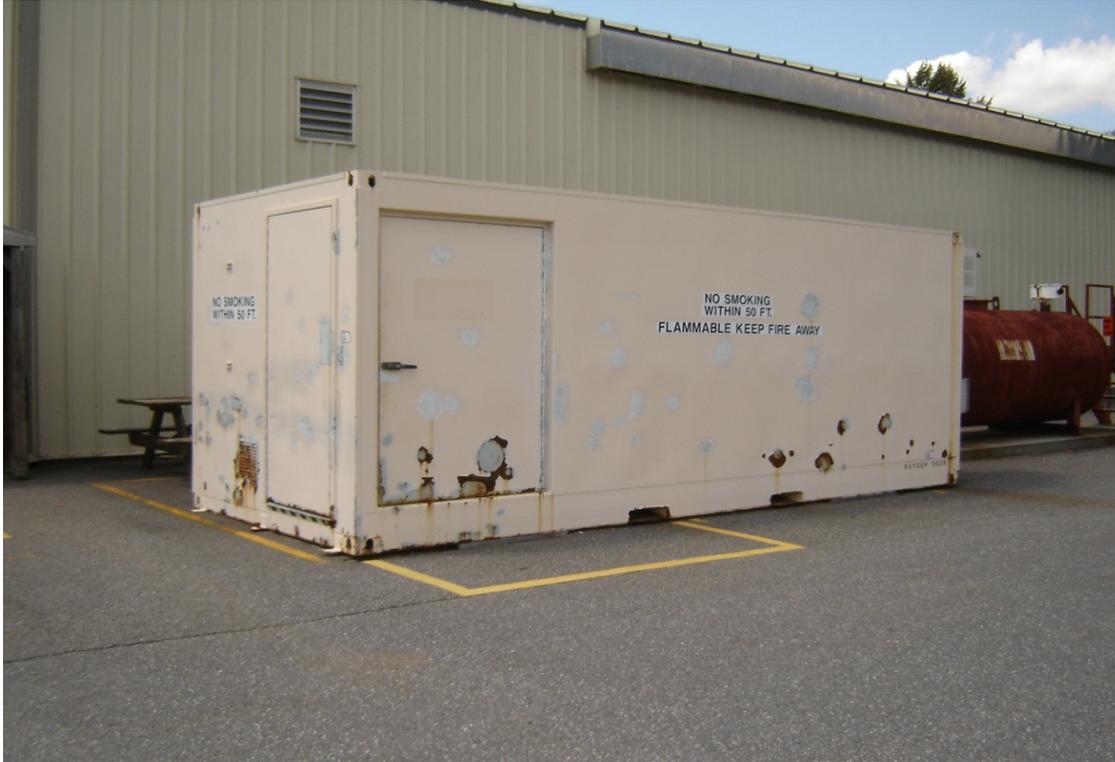
No. 7 Buildings 81 Parcel – NAS Brunswick July 29, 2010  
Unmarked Flammable Locker at the CHRIMP Facility, southeast elevations, with AST in background

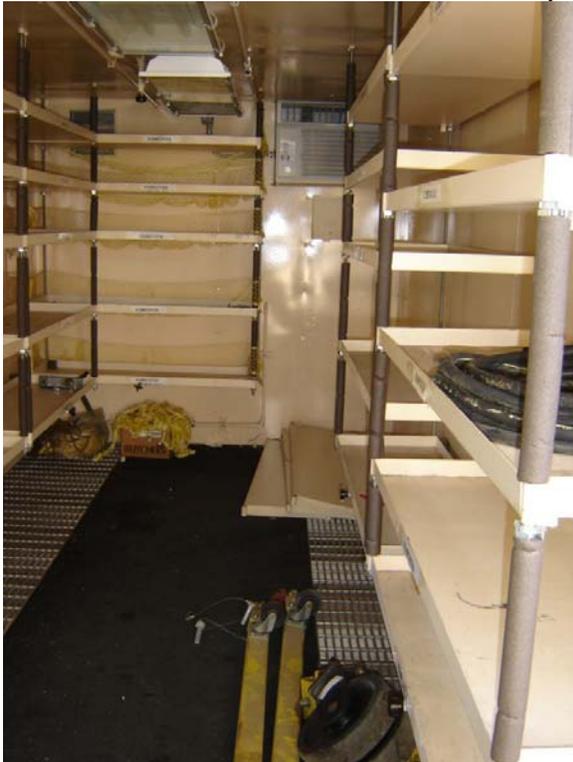
No. 8 Buildings 81 Parcel – NAS Brunswick September 16, 2010  
Unmarked Flammable Locker at the CHRIMP Facility, interior view from entrance

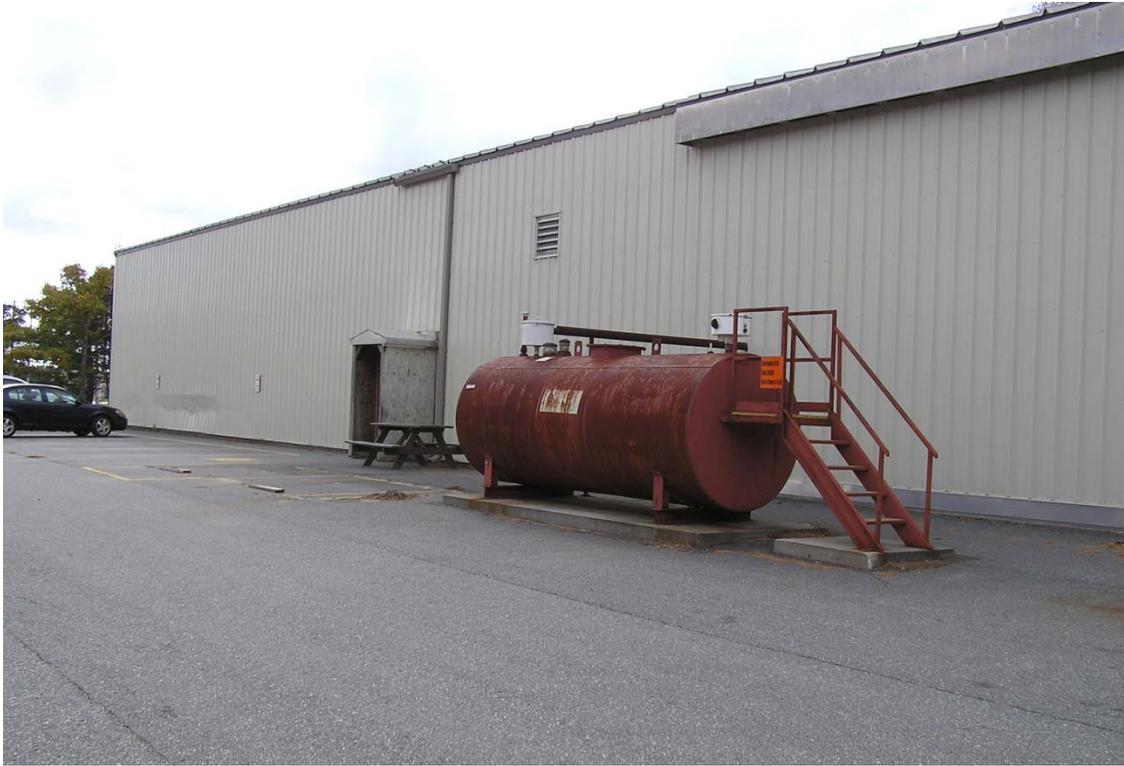
- One closed 2,500-gallon AST (No. A81.0) was identified on the east side of Building 81, immediately north of the flammable locker. The tank appeared to be in good condition and no evidence of a past leak from this AST was observed.

No. 9                      Buildings 81 Parcel – NAS Brunswick                      October 14, 2010  
Closed 2,500 Gallon AST, located on east side of Building 81; after removal of flammable locker
