FINAL RESOURCE CONSERVATION AND RECOVERY ACT PARTIAL CLOSURE REPORT
FOR BUILDINGS 60 AND 71 WITH TRANSMITTAL LETTER NAS BRUNSWICK ME
2/11/2011
NAS BRUNSWICK

Subj: Final RCRA Partial Closure Report for Buildings 60 and 71

RCRA PARTIAL CLOSURE REPORT
for
BUILDING 60 – INERT ORDNANCE STORAGE
BUILDING 71 – AMMO MAGAZINE
NAVAL AIR STATION BRUNSWICK, MAINE
USEPA IDENTIFICATION NUMBER ME8170022018
JANUARY 2011

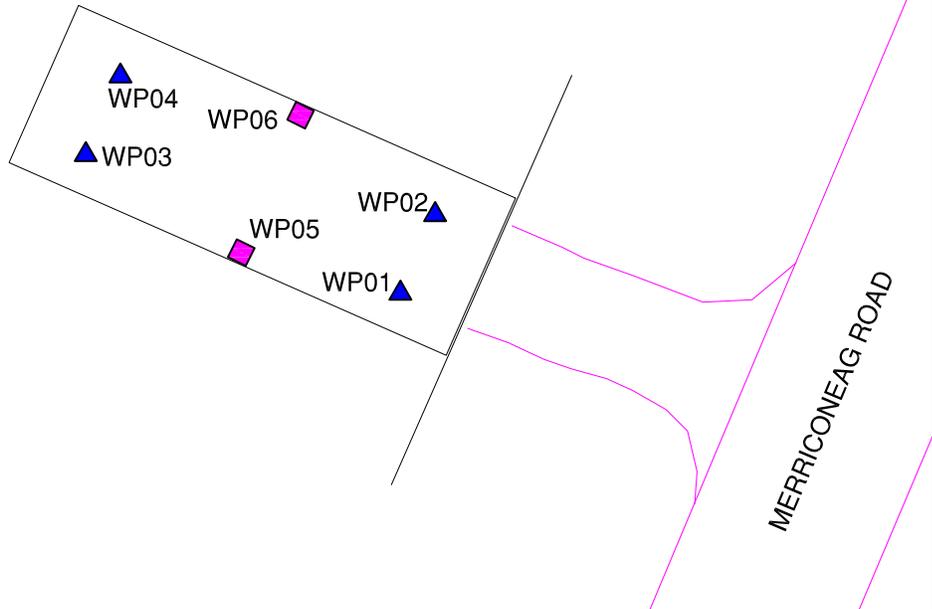
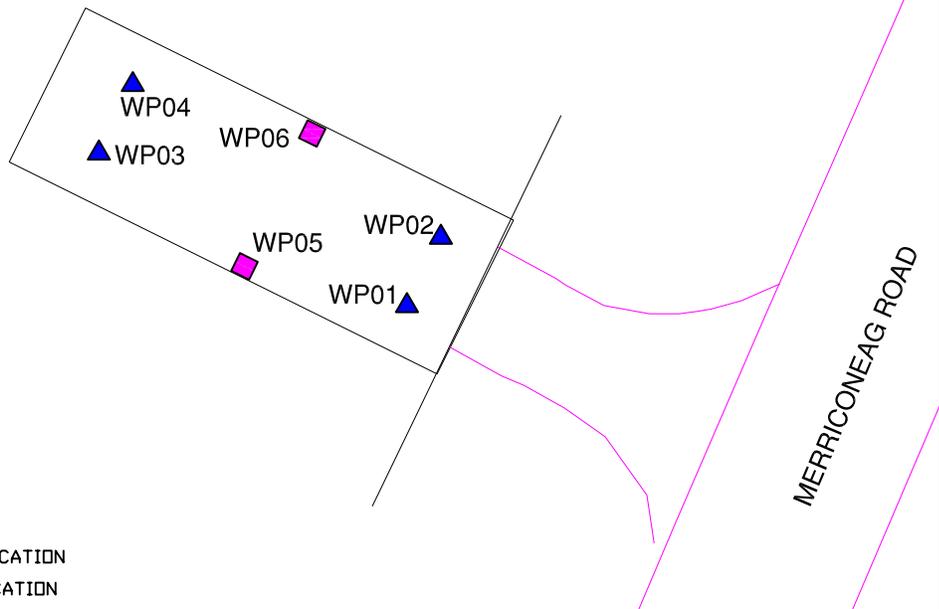
PRE-CLEANING SAMPLE LOCATIONS
BUILDING 60 - INERT ORDNANCE STORAGE
AND BUILDING 71 - AMMO MAGAZINE
RCRA PARTIAL CLOSURE REPORT
NAVAL AIR STATION BRUNSWICK, MAINE

Lead levels in floor wipe samples were found to exceed the MEDEP criterion of 40 $\mu\text{g}/\text{ft}^2$ in all eight samples collected, four floor wipe samples from each of the two buildings. The lead levels in floor wipe samples ranged from 310 to 700 $\mu\text{g}/\text{ft}^2$ in Building 60, and from 310 to 620 $\mu\text{g}/\text{ft}^2$ in Building 71. In addition, the screening criterion for arsenic was exceeded at two of the four floor wipe sample locations in Building 60.

On January 26, 2011, Tetra Tech's cleaning subcontractor, TK&K Services, performed floor-cleaning activities in Buildings 60 and 71, as well as the cleaning of walls up to a height of 8 feet. The floor was then manually swept and then vacuumed with a high-efficiency particulate air (HEPA) vacuum. After sweeping and vacuuming, floors and walls were sprayed and scrubbed with a 2-percent, lead-specific detergent solution. Floors and walls were then pressure-washed using a 5,000-pounds-per-square-inch (psi) steam-cleaner. All cleaning wastewater was containerized using a wet-vacuum, placed in 55-gallon drums, and transferred to the NAS Brunswick hazardous waste department for disposal. Upon completion, the Tetra Tech field representative performed a visual inspection of the cleaned area.

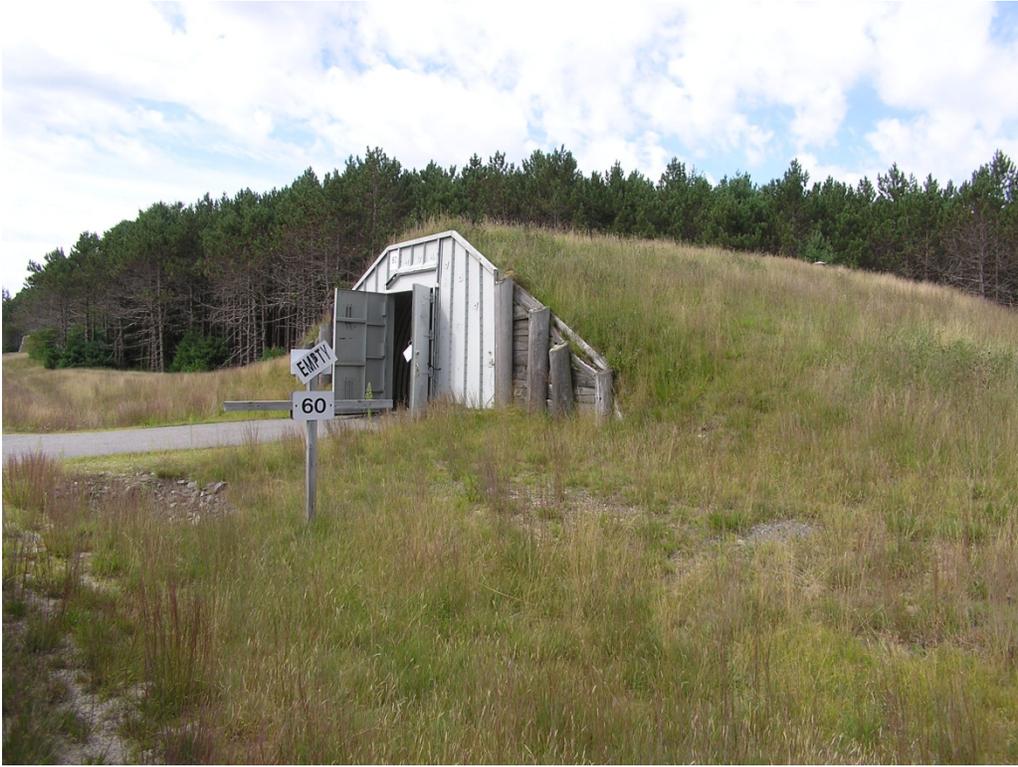
- At the time of inspection, Building 60 was unoccupied and in fair condition.
- No evidence of current or past hazardous waste generation was observed.
- No signs of a past release (staining, unusual odors, stressed vegetation, etc.) were observed.
- Gravity-drains in the floor were observed, as described above in Section 2.
- No modifications to the structure, which may conceal signs of a past release, were observed.
- No peeling or flaking paint was observed on the exterior or interior of the blast doors.

No. 1 Building 60 – Inert Ordnance Storage, NAS Brunswick August 12, 2010
Building 60 northeast elevation

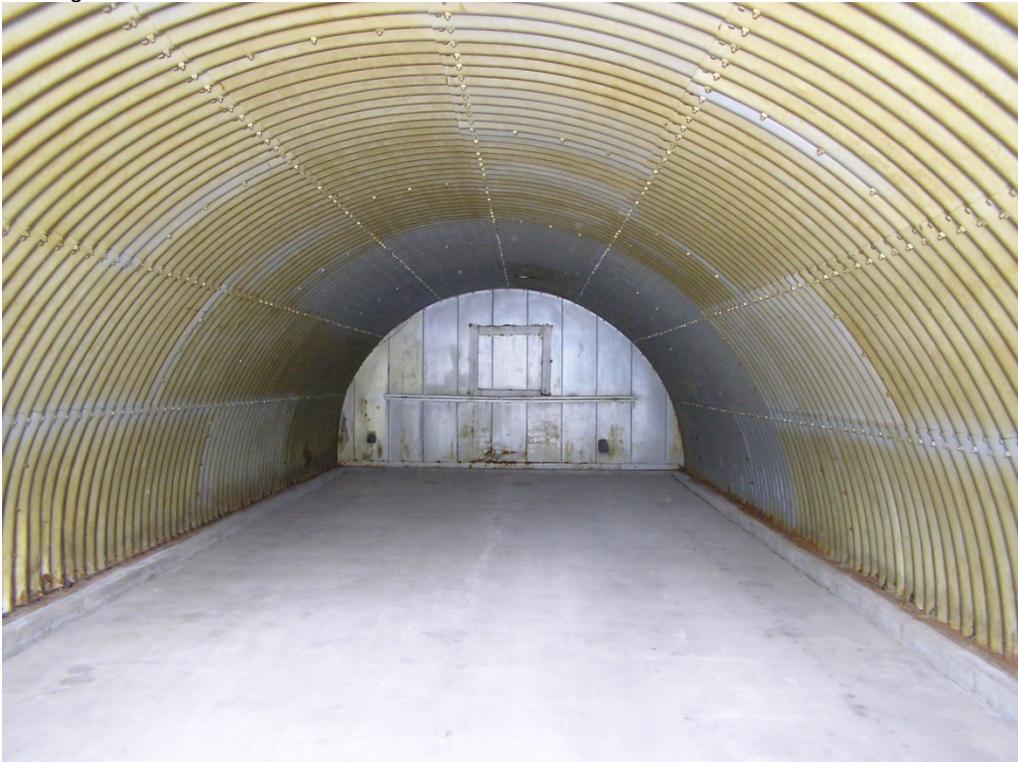
No. 2 Building 60 – Inert Ordnance Storage, NAS Brunswick August 12, 2010
Building 60 interior

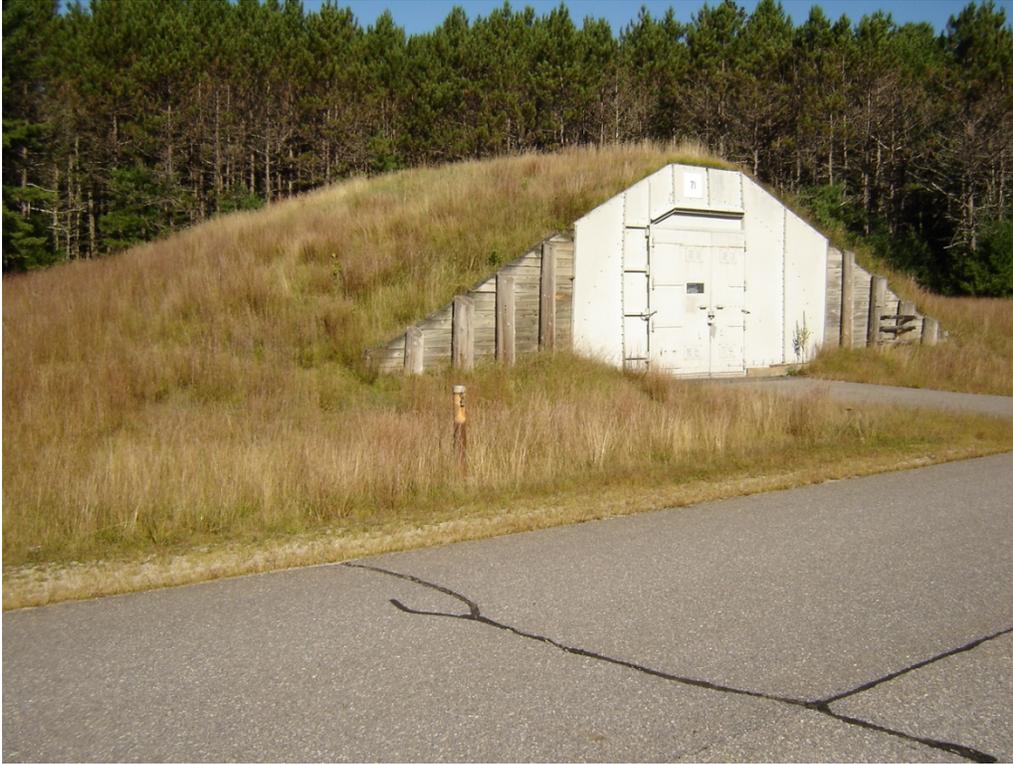
- At the time of inspection, Building 71 was unoccupied and in fair condition.
- No evidence of current or past hazardous waste generation was observed.
- No signs of a past release (staining, unusual odors, stressed vegetation, etc.) were observed.
- Gravity-drains in the floor were observed, as described above in Section 2.
- No modifications to the structure, which may conceal signs of a past release, were observed.
- No peeling or flaking paint was observed on the exterior or interior of the blast doors.

No. 3 Building 71 – Ammo Magazine, NAS Brunswick September 16, 2010
Building 71 southeast elevation

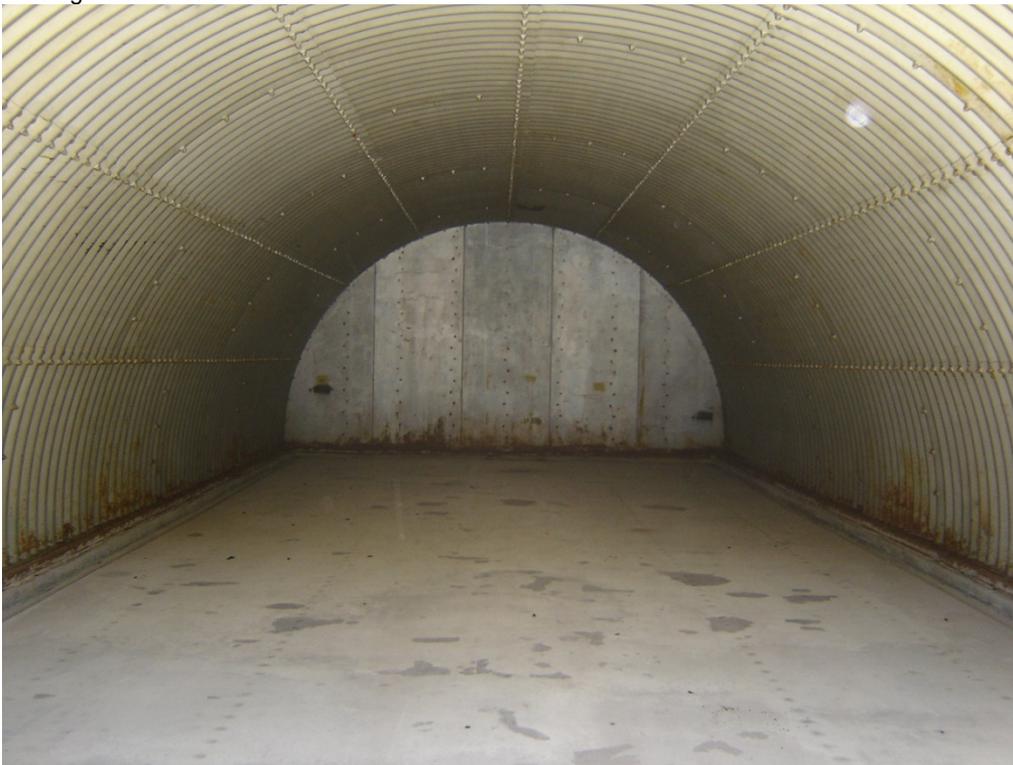
No. 3 Building 71 – Ammo Magazine, NAS Brunswick September 16, 2010
Building 71 interior
