FINAL RESOURCE CONSERVATION AND RECOVERY ACT PARTIAL CLOSURE REPORT  
FOR BUILDING 44 WITH TRANSMITTAL LETTER NAS BRUNSWICK ME  
3/14/2011  
NAS BRUNSWICK

**RCRA PARTIAL CLOSURE REPORT**  
**for**  
**BUILDING 44 – FITCH AVENUE MAGAZINE PARCEL**  
**NAVAL AIR STATION BRUNSWICK, MAINE**  
**USEPA IDENTIFICATION NUMBER ME8170022018**  
**MARCH 2011**

**HWSA INSPECTION REPORT  
HAZARDOUS WASTE STORAGE AREAS CLOSURE  
NAS BRUNSWICK  
BRUNSWICK, MAINE  
CTO WE22**

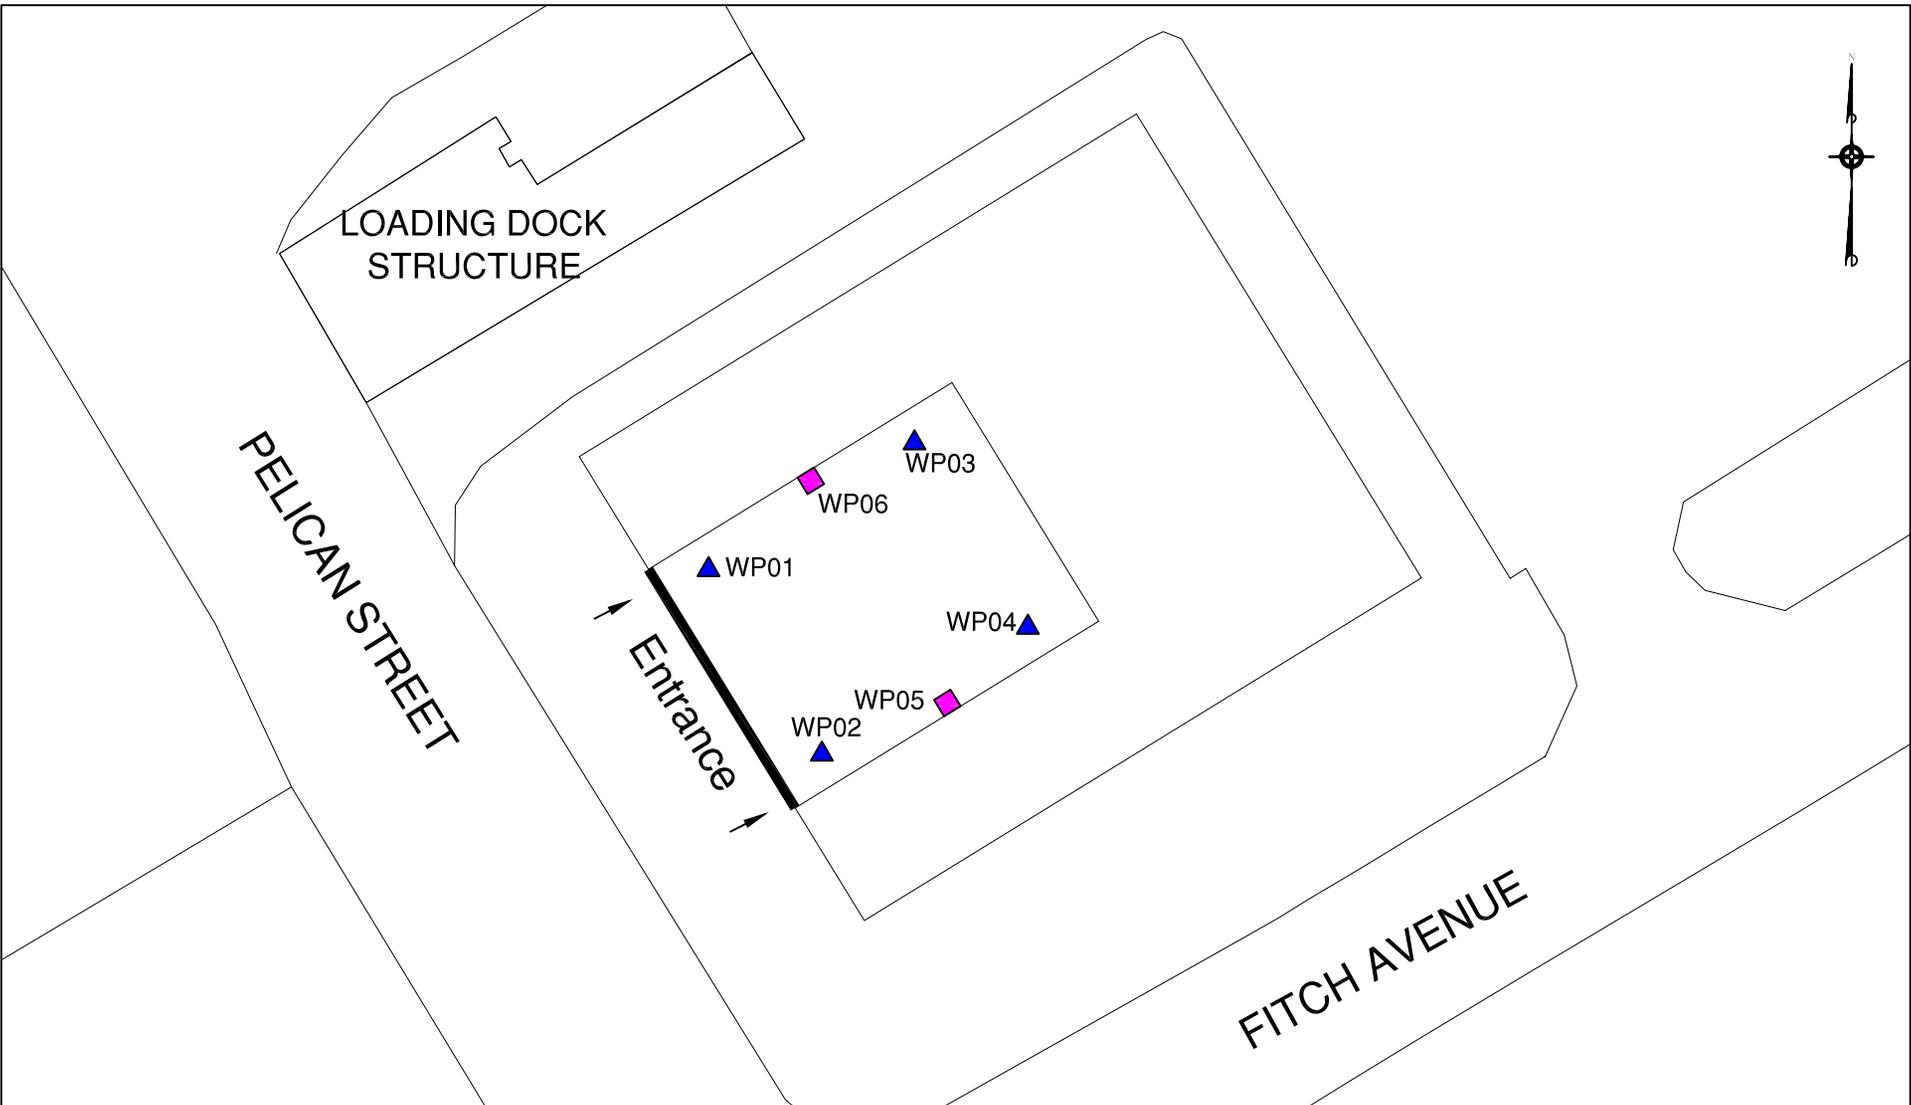
**PRE-CLEANING SAMPLE LOCATIONS**  
**BUILDING 44 - FITCH AVENUE MAGAZINE PARCEL**  
**RCRA PARTIAL CLOSURE REPORT**  
**NAVAL AIR STATION BRUNSWICK, MAINE**

Due to the age of Building 44 and its use as a weapons magazine, wipe sampling was conducted to evaluate potential hazardous waste residue in the building. On September 17, 2010, six wipe samples were collected, four from the floor, and one each from the north and south sidewalls

(Figure 3). The samples were collected for analysis of RCRA metals and semi-volatile organic compounds (SVOCs). Wipe samples were collected with cotton gauze saturated with dilute nitric acid (1:4 nitric acid to distilled water) for metals analysis, or with acetone for semi-volatile organic compound (SVOC) analysis. A 10-centimeter (cm) by 10-cm sampling area was wiped with the cotton gauze while applying moderate pressure. Wipe samples were submitted analysis, by Tetra Tech's subcontracted analytical laboratory, Analytics Environmental Laboratories (Analytics) of Portsmouth, New Hampshire. The resulting analytical data underwent limited data validation consisting of blank contamination evaluation and completeness evaluation. Analytical results are presented in Table 1.

In all four floor-wipe samples collected, lead levels exceeded the MEDEP criterion ( $40 \mu\text{g}/\text{ft}^2$ ), with levels ranging from 2,400 to 160,000  $\mu\text{g}/\text{ft}^2$ , as shown in Table 1. In addition, the screening criteria for three other metals were exceeded in floor-wipe samples, as follows: arsenic, in three samples; cadmium, in one sample; and chromium, in one sample. One SVOC, benzo(b)fluoranthene, was detected at a low level in one floor-wipe sample. In wall-wipe samples, only chromium exceeded the clearance value, in both samples.

Based on the analytical results, cleaning of Building 44 was required to remove metals-contaminated residue exceeding the screening criteria (metals-contaminated residue on floors, and chromium-contaminated residue on walls) as discussed in Section 6.

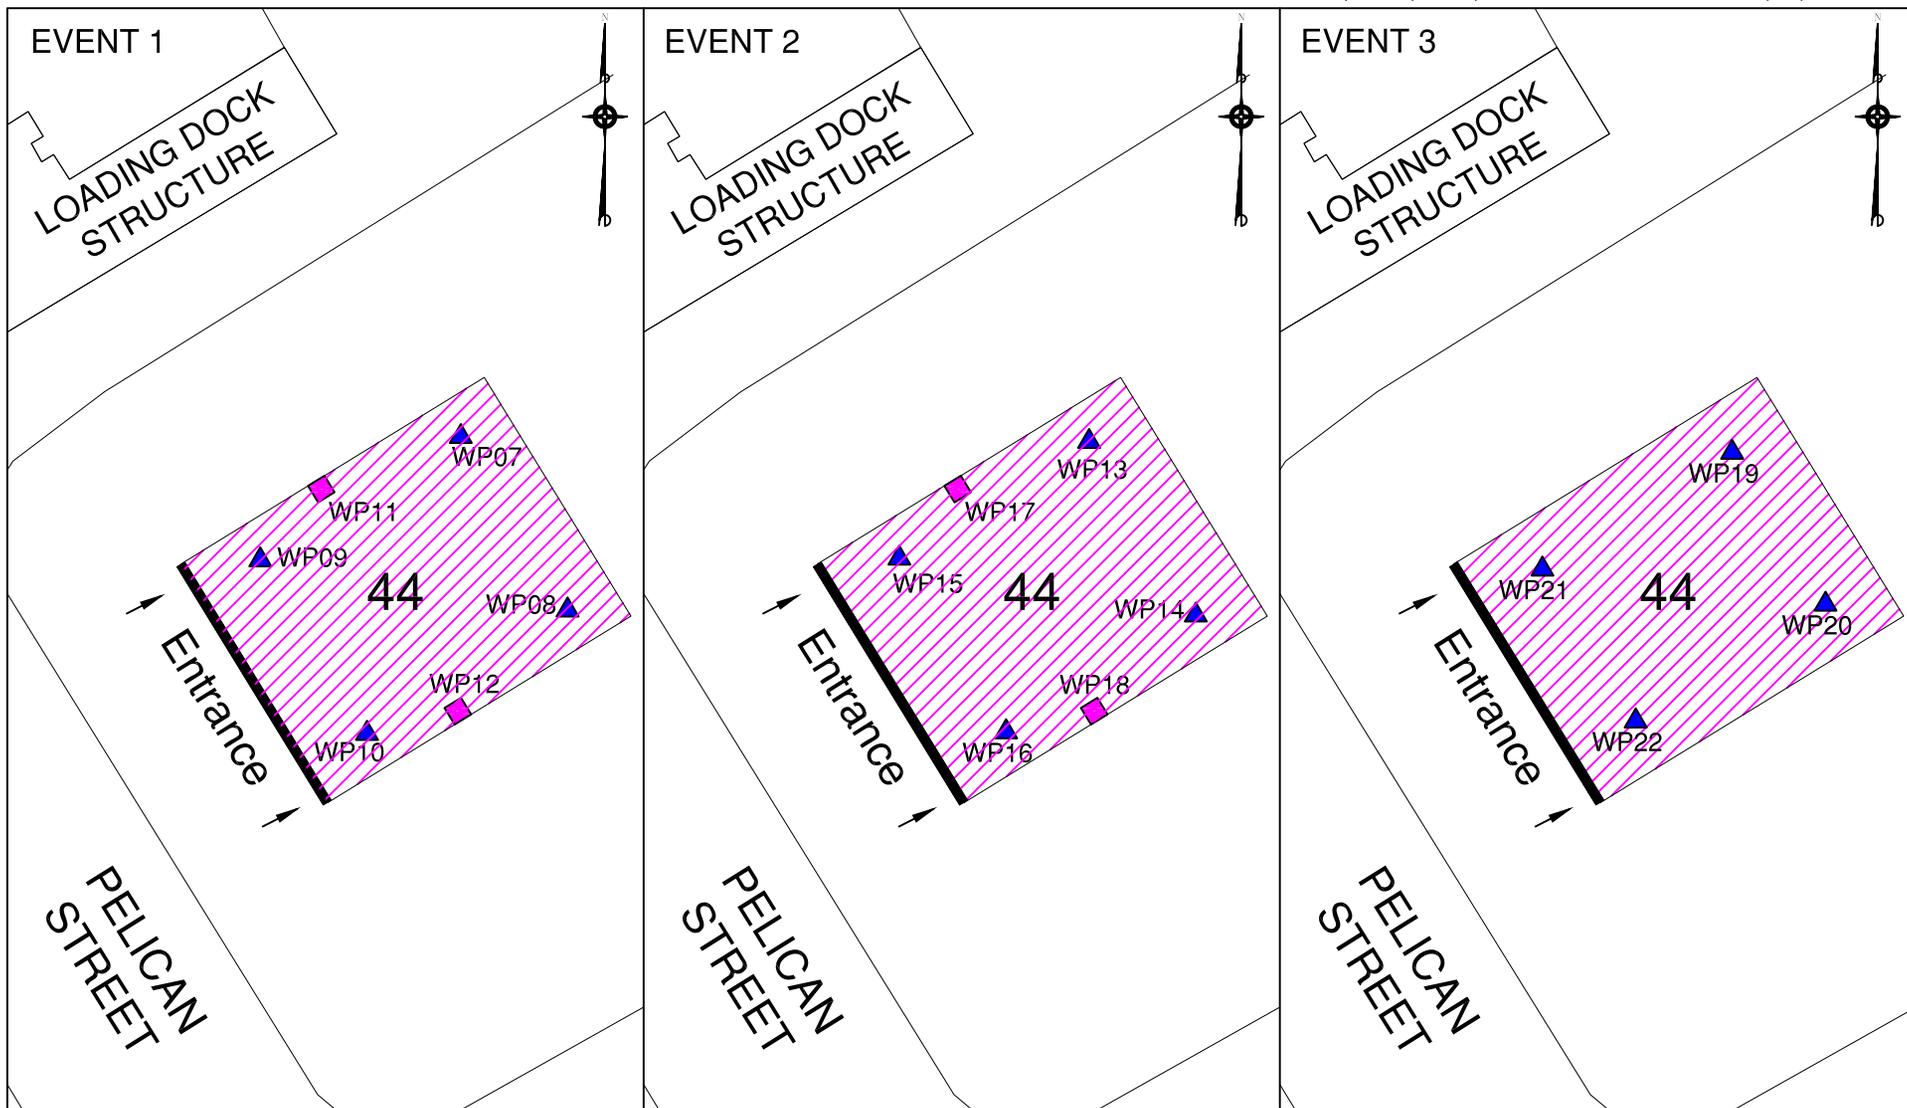
- WP09 ▲ FLOOR WIPE SAMPLE LOCATION
- WP11 ◆ WALL WIPE SAMPLE LOCATION
- DECONTAMINATION WORK AREA

After the work areas were allowed to dry, post-cleaning confirmatory sampling was conducted on January 18, 2011. Four wipe samples were collected from the floors and two from the walls, and were submitted for RCRA metals analysis by Tetra Tech's subcontracted analytical laboratory, Katahdin Analytical Services, Inc. (Katahdin) of Scarborough, Maine (Figure 4). The resulting analytical data underwent limited data validation, consisting of field duplicate evaluation, blank contamination evaluation, and completeness evaluation. As shown in Table 2, the associated analytical results indicated that lead levels at all four floor locations exceeded the applicable MEDEP criterion of 40  $\mu\text{g}/\text{ft}^2$ , with lead levels ranging from 59 to 290  $\mu\text{g}/\text{ft}^2$ . The chromium levels in one of two wall-location wipe samples and its duplicate, 460 and 980  $\mu\text{g}/\text{ft}^2$ , respectively, exceeded the associated WTC criterion for chromium-contaminated settled dust on walls (440  $\mu\text{g}/\text{ft}^2$ ).

A second decontamination event (Event 2) for the floors and walls of Building 44 was performed on February 1, 2011, using the procedures described above. All cleaning wastewater was containerized using a wet-vacuum, placed in one 55-gallon drum, and transferred to the NAS Brunswick hazardous waste department for disposal. After the work areas were allowed to dry, six post-cleaning confirmatory wipe samples were collected on February 1, 2011, four from the floors and two from the walls (Figure 4). Floor-wipe samples were analyzed for lead and wall-wipe samples were analyzed for RCRA 8 metals by Katahdin. The resulting analytical data underwent limited data validation. As shown in Table 3, following this second decontamination event, wipe sample analytical results indicated that lead levels at all four of the floor locations exceeded the applicable MEDEP criterion of 40  $\mu\text{g}/\text{ft}^2$ .

Based on Event 2 results, a third decontamination event (Event 3) was conducted at Building 44 on February 23, 2011, using the procedures described above. All cleaning wastewater was containerized using a wet-vacuum, placed in 55-gallon drums, and transferred to the NAS Brunswick hazardous waste department for disposal. Upon completion, the Tetra Tech field representative performed a visual inspection of the cleaned areas. After the work areas were allowed to dry, four floor-wipe samples were collected on February 25, 2011, for lead analysis by Katahdin (Figure 4). The resulting analytical data underwent limited data validation. Event 3 wipe sample results (Table 4) showed that lead levels in the post-cleaning confirmatory floor-wipe samples were well below the associated MEDEP floor criterion. Therefore, additional closure action is not warranted at Building 44.

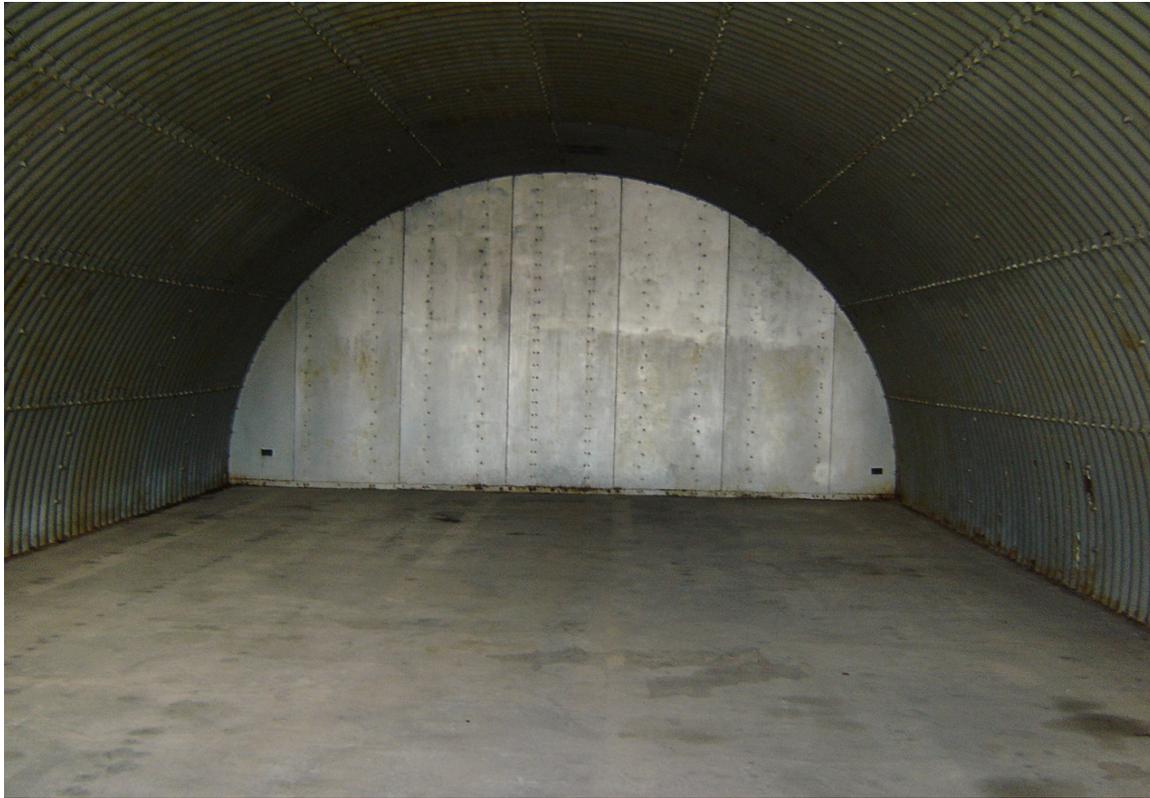
No. 3 Building 44 – Fitch Avenue Magazine, NAS Brunswick July 29, 2010  
Interior of Building 44, prior to cleaning

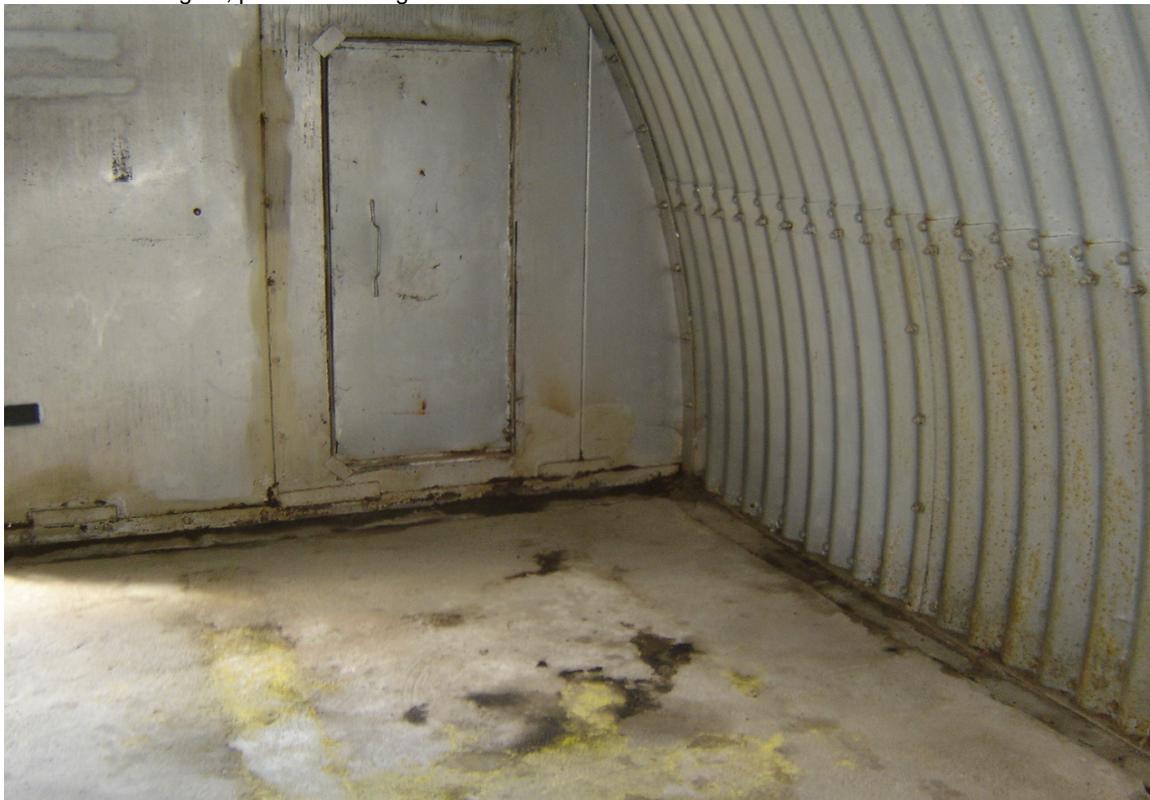
- No evidence of current or past hazardous waste generation was observed.
- No evidence of current or past hazardous materials use was observed.
- Minor staining of the interior floor of Building 44 was observed, including water stains and lubricant and oil staining attributable to fork-lift truck use within the building.

- In the interior northwest corner of Building 44, a minor amount of yellow paint overspray was observed, which was not peeling or flaking.
- No paint was observed on the exterior of Building 556.

There was some minor staining of the floor throughout the structure, including water stains, stains from dust/dirt, and lubricants and oils attributable to forklift trucks. Yellow and black colored stains were observed in the northwest corner of the structure.

No. 4 Buildings 44 – Fitch Avenue Magazine, NAS Brunswick July 29, 2010  
Building 44 floor stains and yellow paint, northwest corner of the facility prior to cleaning

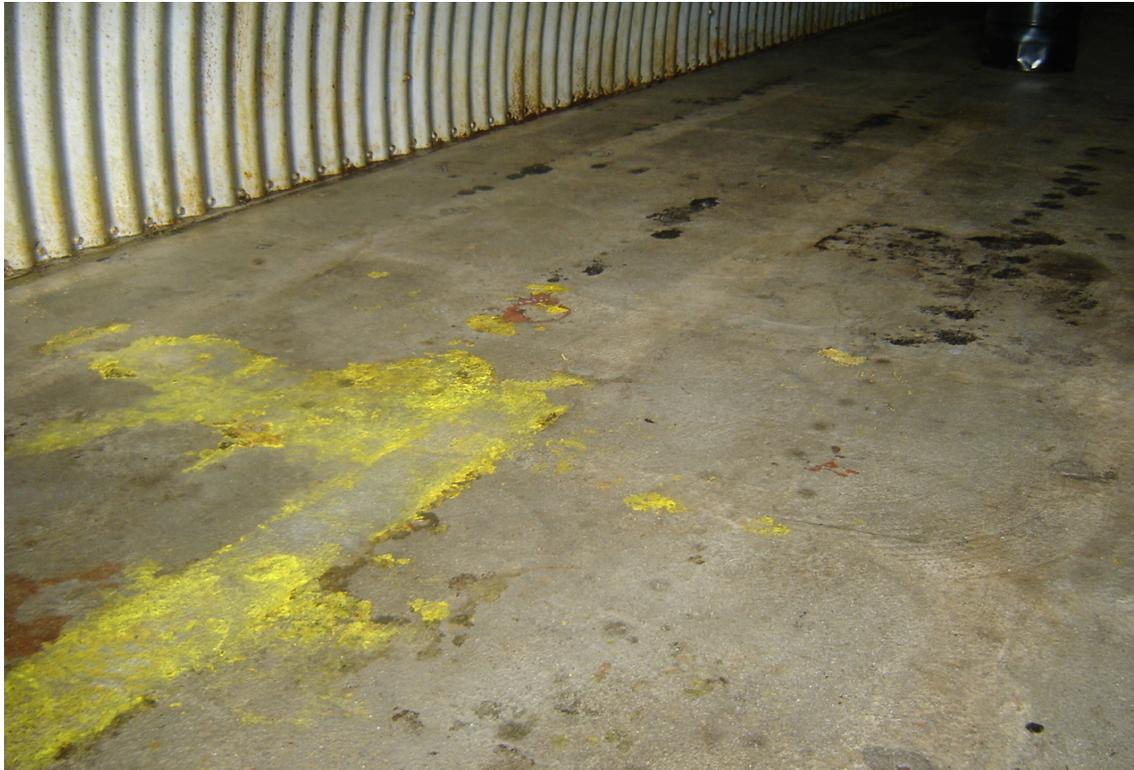
No. 5                      Building 44 – Fitch Avenue Magazine, NAS Brunswick                      January 14, 2011  
Building 44, view of northwest interior, with yellow paint overspray on floor, post-cleaning Event 1

On January 13 and 14, 2011, Tetra Tech's cleaning subcontractor, Global Remediation Services (Global), performed floor-cleaning activities in Building 44, as well as the cleaning of walls up to a height of 8 feet. The floor was manually swept and then vacuumed with a high-efficiency particulate air (HEPA) vacuum. After sweeping and vacuuming, floors and walls were sprayed and scrubbed with a 2-percent, lead-specific detergent solution. Floors and walls were then pressure-washed using a 5,000-pounds-per-square-inch (psi) steam-cleaner. All cleaning
