REVISED FINAL RESOURCE CONSERVATION AND RECOVERY ACT PARTIAL CLOSURE
REPORT FOR BUILDING 538 WITH TRANSMITTAL LETTER NAS BRUNSWICK ME
3/14/2011
NAS BRUNSWICK

Subj: Final RCRA Partial Closure Report for Building 538 (Revised)

**RCRA PARTIAL CLOSURE REPORT
for
BUILDING 538 – NEX SERVICE STATION PARCEL
BUILDING 605 – ENVIRONMENTAL SHED
NAVAL AIR STATION BRUNSWICK, MAINE
USEPA IDENTIFICATION NUMBER ME8170022018
FEBRUARY 2011**

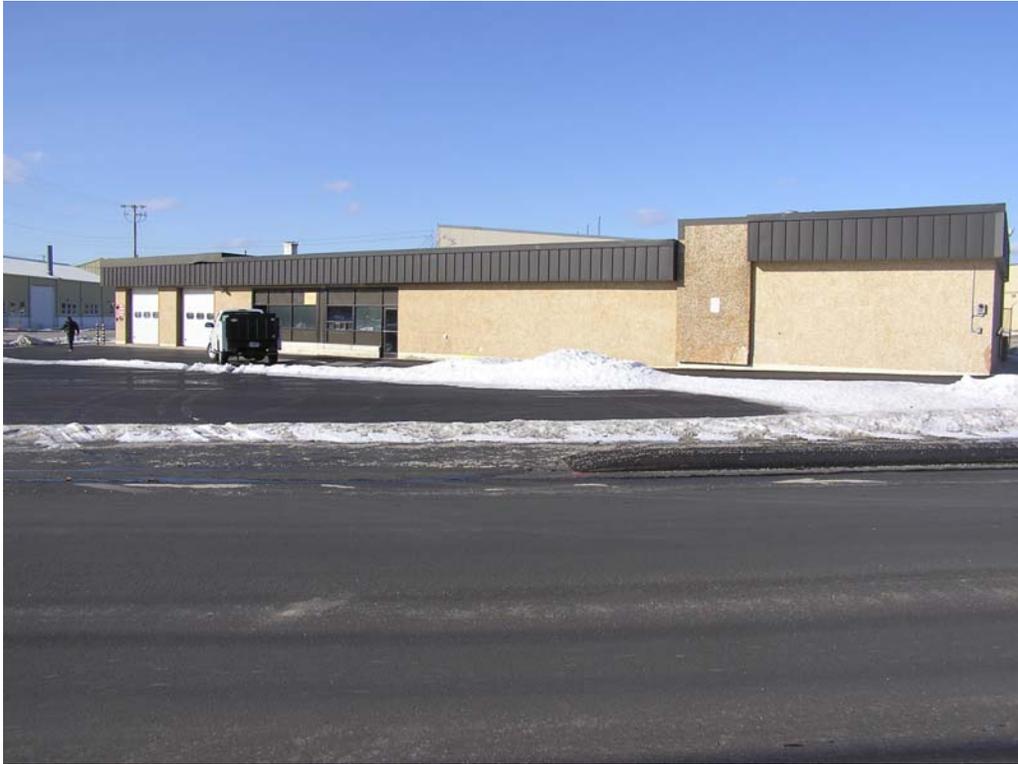
No. 1 Building 538 – NEX Service Station Parcel, NAS Brunswick February 2, 2010
NEX Service Station southeast elevation

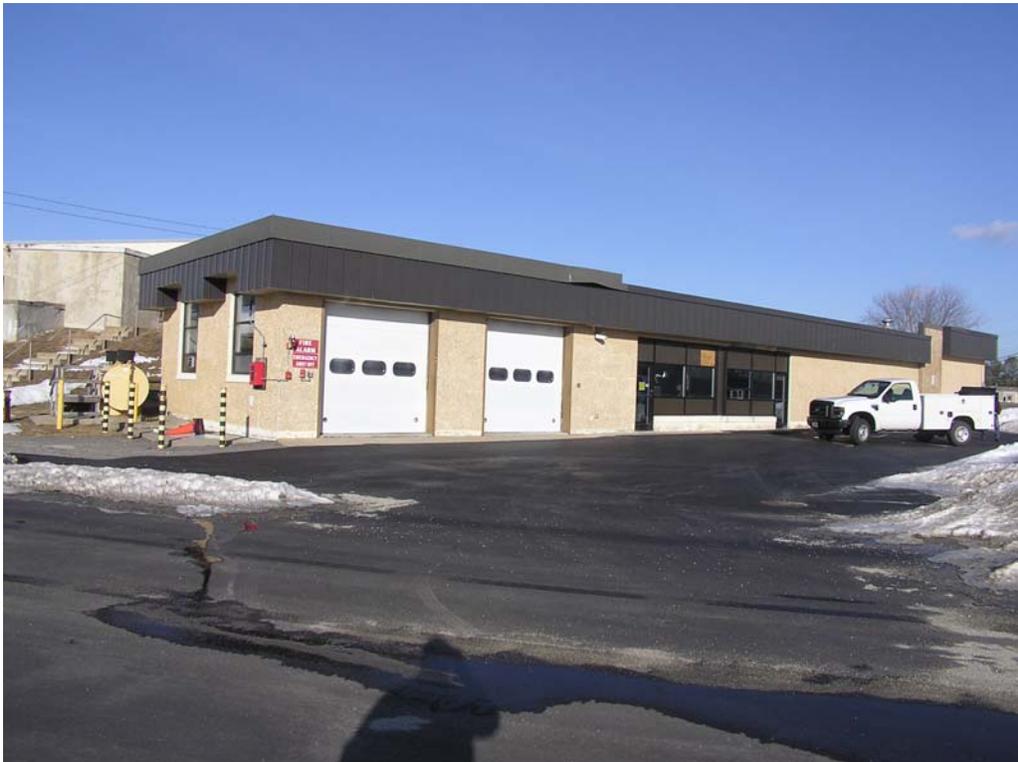
No. 2 Building 538 – NEX Service Station Parcel, NAS Brunswick February 2, 2010
NEX Service Station southwest elevation with service bay and retail store

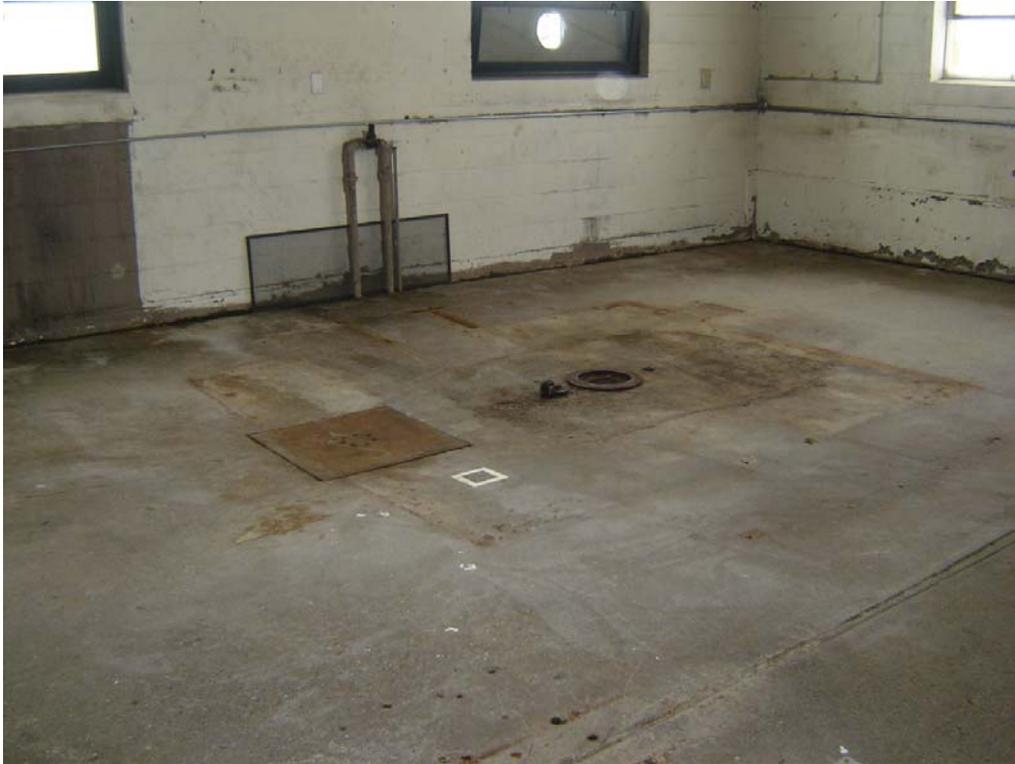
The west garage service bay area of Building 538 has two floor drains featuring O/W separators with capacities of 45 gallons that are connected to the base sanitary sewer system and one floor drain in the former repair bay (south of east garage) has featuring a 20-gallon OWS that is also connected to the base sanitary sewer system (PWD, 1996). No records were found that indicate a sump, holding tank, or dry well was ever used for fluids disposal. No OWS were registered to Building 605.

No. 3 Building 538 – NEX Service Station Parcel, NAS Brunswick February 1, 2011
NEX Service Station interior; west garage west bay floor drain and O/W separator

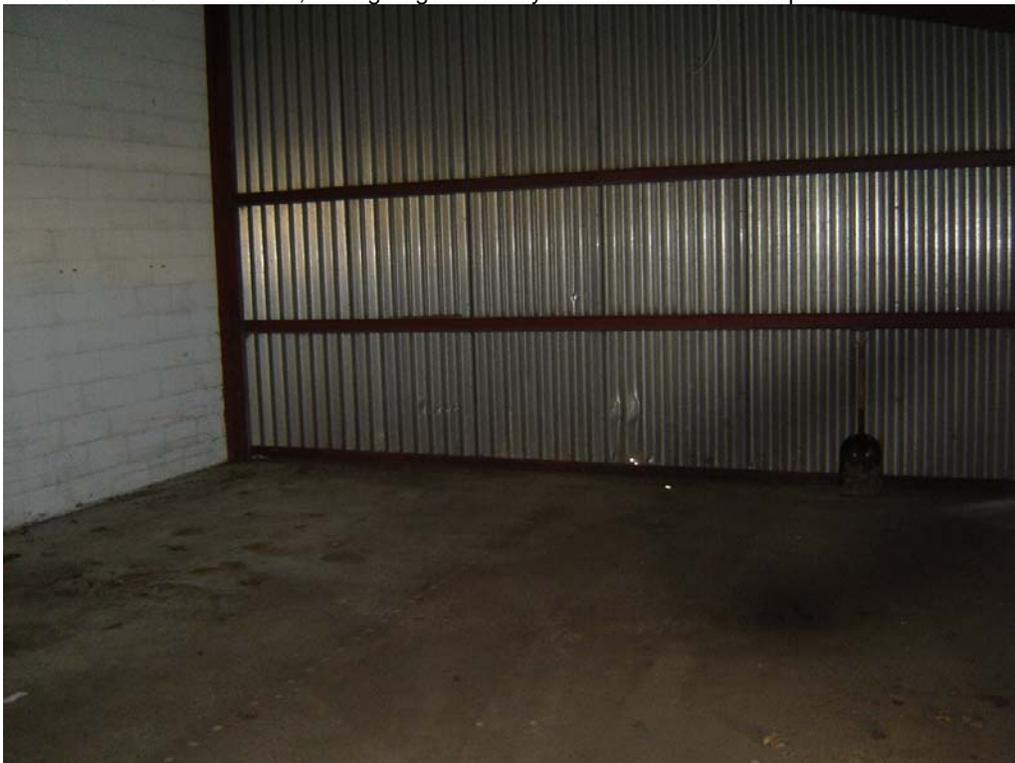
No. 4 Building 538 – NEX Service Station Parcel, NAS Brunswick February 2, 2010
NEX Service Station interior; east garage former bottle and can recycling area

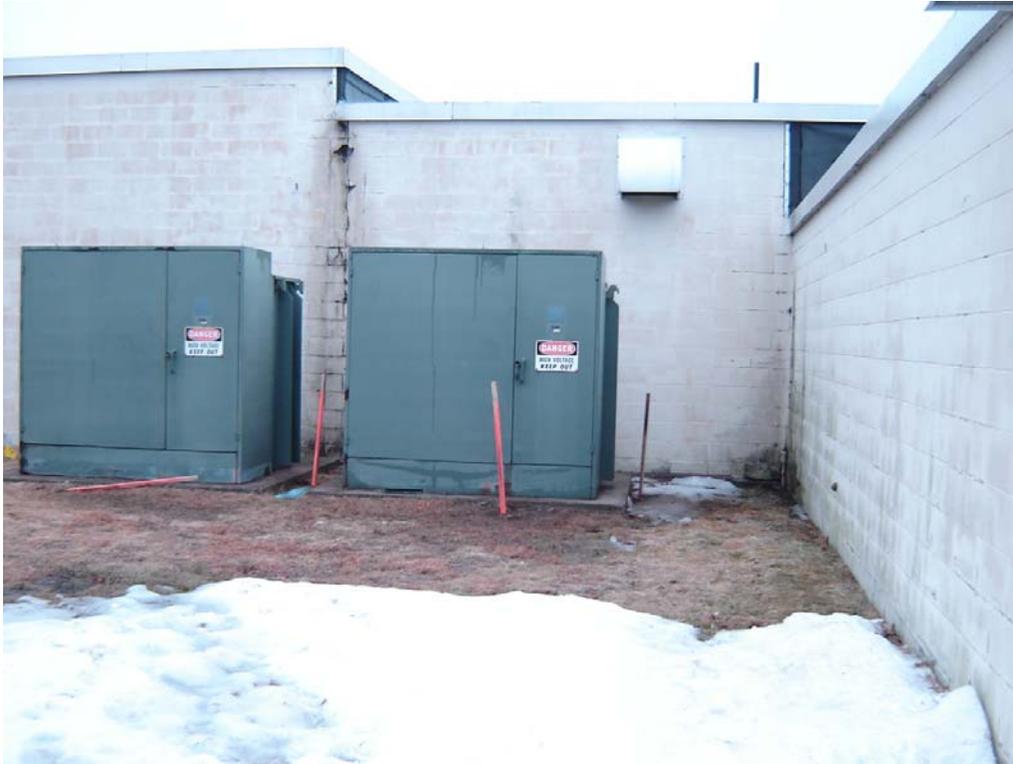
The NAS Brunswick Removed Transformer Database lists one non-polychlorinated-biphenyl (PCB)-containing electrical transformer for Building 538 (none were listed for Building 605). Information provided in the database for the transformer is listed below. The serial number for the RTE-manufactured unit indicates that it was manufactured after 1979 and therefore is unlikely to contain PCB. As of July 1, 1979, the United States Environmental Protection Agency (EPA) prohibited all manufacturing of new PCB electrical equipment (transformers and capacitors). However, due to the age of the building, it is possible that PCB-containing transformers were in service at the Building 538 transformer pad at some time in the past.

No. 5 Building 538 – NEX Service Station Parcel, NAS Brunswick February 2, 2010
Building 538 – pad-mounted transformers for Building 295 (left) and for Building 538 (right)

Due to the age of the building, soil sampling around the pad is recommended in order to confirm that the soil is free of PCBs from potential former transformers.

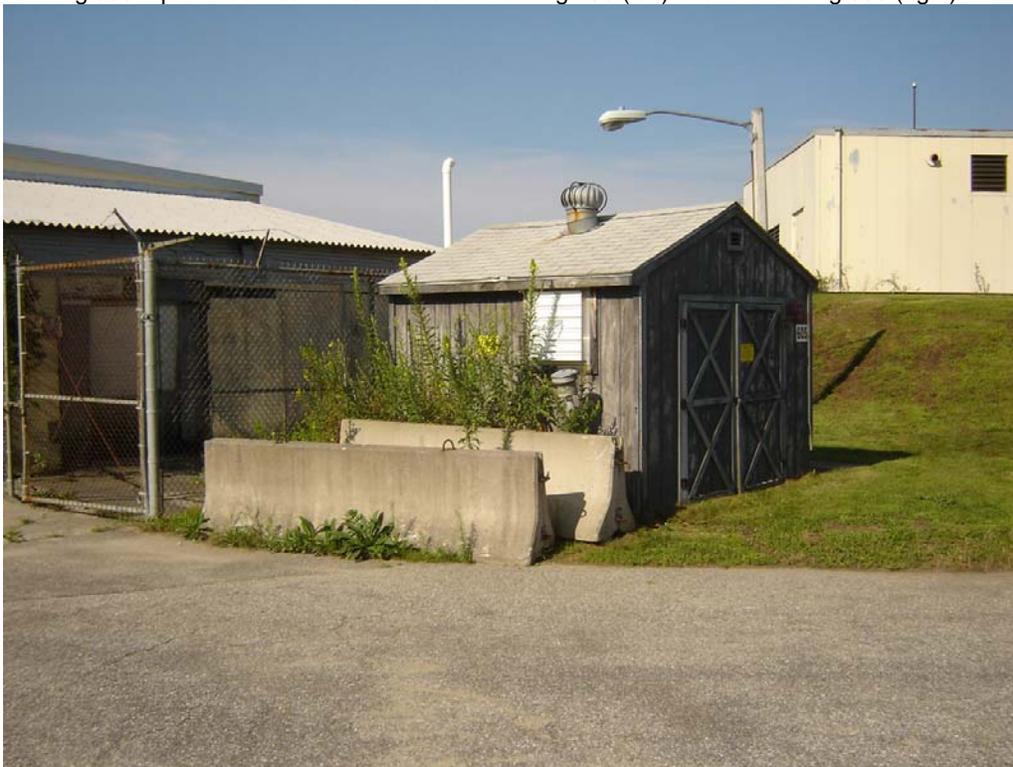
No. 6 Building 538 – NEX Service Station Parcel, NAS Brunswick July 22, 2010
Environmental Shed (Building 605) east elevation, Building 538 (NEX Service Station) at left of frame

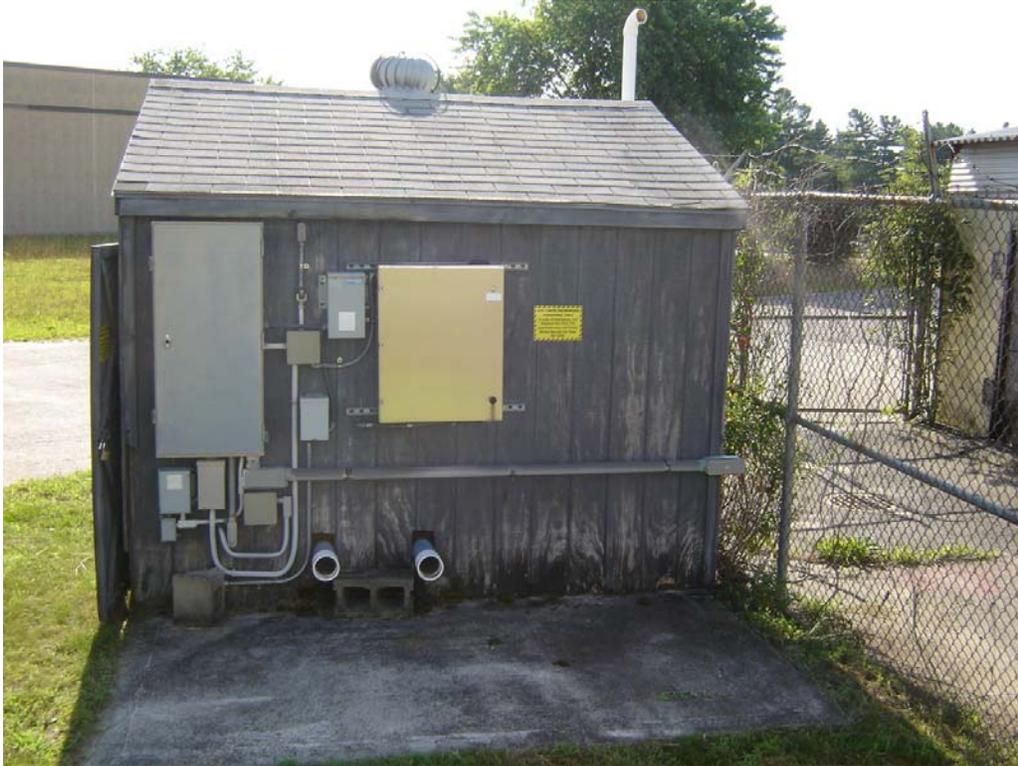
- At the time of inspection, Building 605 was unoccupied and in good condition.
- A small concrete pad was observed adjoining the west wall of Building 605, and two pipe stumps exited the building's west wall. It is believed that this pad is the former location of the GAC unit associated with the now inactive SVE system.

No. 7 Building 538 – NEX Service Station Parcel, NAS Brunswick July 22, 2010
Environmental Shed (Building 605) west elevation, Building 11 (Navy Exchange Retail Complex) in background

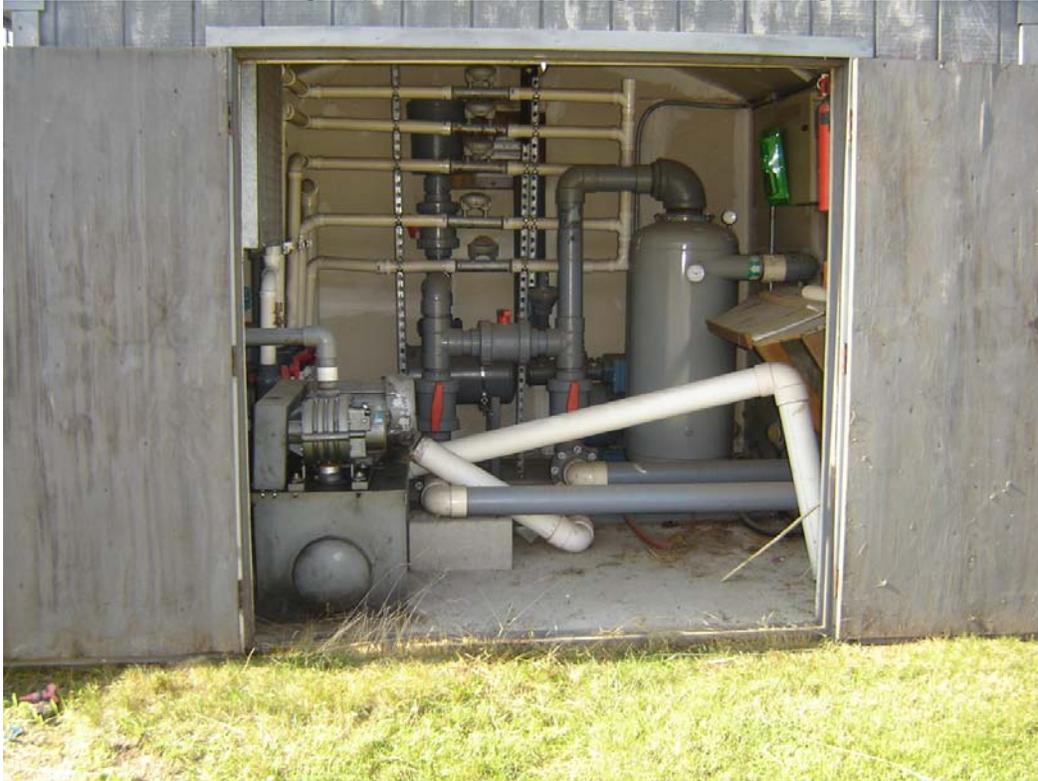
The air sparging components, designed to inject ambient air into the subsurface, are not likely to have any associated hazardous waste residue. The SVE system components (including granular activated carbon [GAC], no longer present at the building) were designed to remove the generated vapor-phase contamination, and these components contact the extracted soil vapors during system operation, however, the SVE system components remaining at the building do not contain any materials that can adsorb and retain organic vapors (i.e. activated carbon or other adsorbent media). The only remaining component with a potential to hold some contaminant residue is a moisture-separator tank, where water with organic compounds could accumulate during the system operation. The moisture-separator tank will be checked for the potential presence of liquid/waste residue prior to removal of the system.

No. 8 Building 538 – NEX Service Station Parcel, NAS Brunswick July 22, 2010
Environmental Shed (Building 605) interior of the shed with remedial equipment for air sparging and soil vapor extraction
