FINAL RESOURCE CONSERVATION AND RECOVERY ACT PARTIAL CLOSURE REPORT
FOR BUILDING 200 WITH TRANSMITTAL LETTER NAS BRUNSWICK ME
3/31/2011
NAS BRUNSWICK

Subj: Final RCRA Partial Closure Report for Building 200

RCRA PARTIAL CLOSURE REPORT
for
BUILDING 200 – OPERATIONS-CONTROL TOWER BUILDING PARCEL
NAVAL AIR STATION BRUNSWICK, MAINE
USEPA IDENTIFICATION NUMBER ME8170022018
MARCH 2011

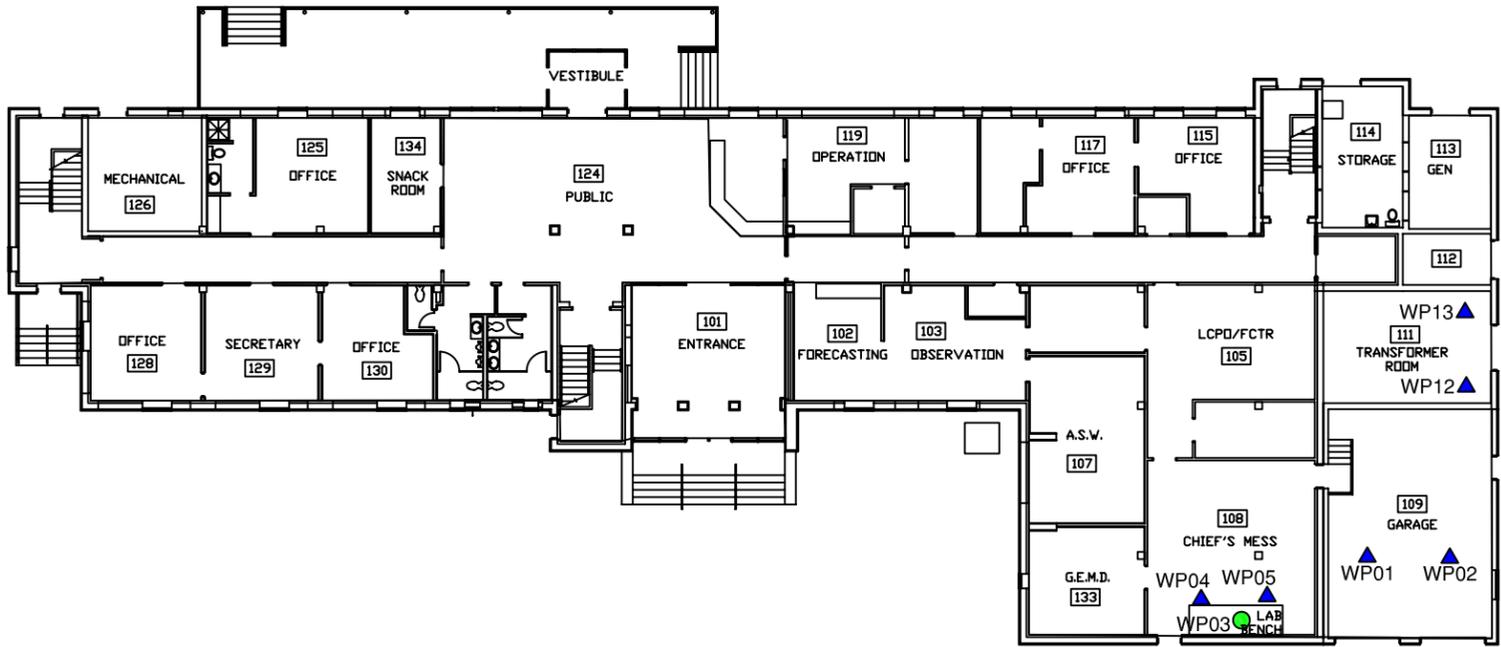
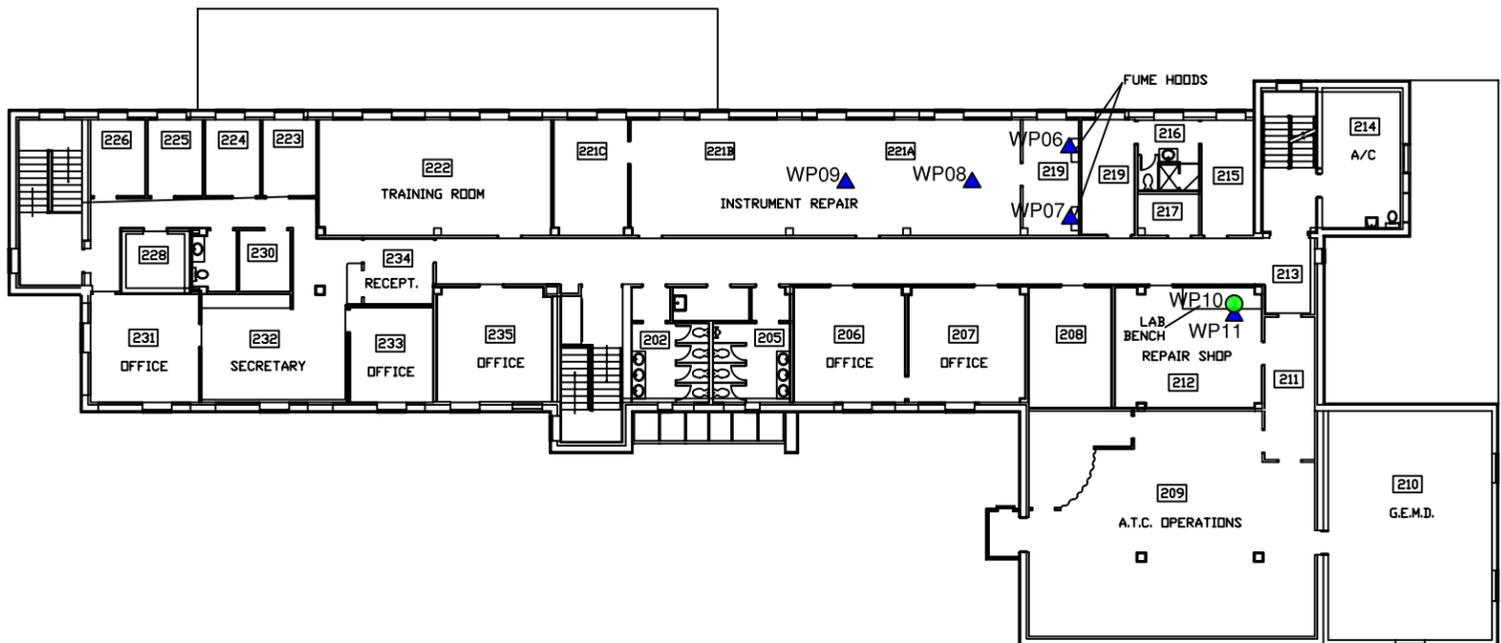
FILE \\.\NASB_BLDG_200_PRE.DWG	SCALE AS NOTED
FIGURE NUMBER FIGURE NO. 3	REV 0
	DATE 3/23/11

On December 15, 2010, wipe samples were collected from 13 locations in Building 200, including lab benches and floors, as shown on Figure 3. Eleven samples were analyzed for RCRA metals and two samples (collected from the floor of the Transformer Room [111]), were analyzed for PCBs. Wipe samples were collected with cotton gauze saturated with deionized water. A 10-centimeter (cm) by 10-cm sampling area was wiped with the cotton gauze while applying moderate pressure. The samples were submitted for analysis by Tetra Tech's subcontracted laboratory, Katahdin Analytical Services (Katahdin). The resulting analytical data underwent limited data validation consisting of blank contamination evaluation and completeness evaluation.

As shown in Table 2, the lead levels in four floor-wipe samples exceeded the MEDEP criterion for floors ($40 \mu\text{g}/\text{ft}^2$), ranging from 44 to $220 \mu\text{g}/\text{ft}^2$ (two exceedances in the Instrument Repair Room [Room 219] and two exceedances in the garage [Room 109]). All levels of other detected metals were below the RCRA clearance values. PCBs were not detected in the two wipe samples submitted for this analysis, as shown in Table 3.

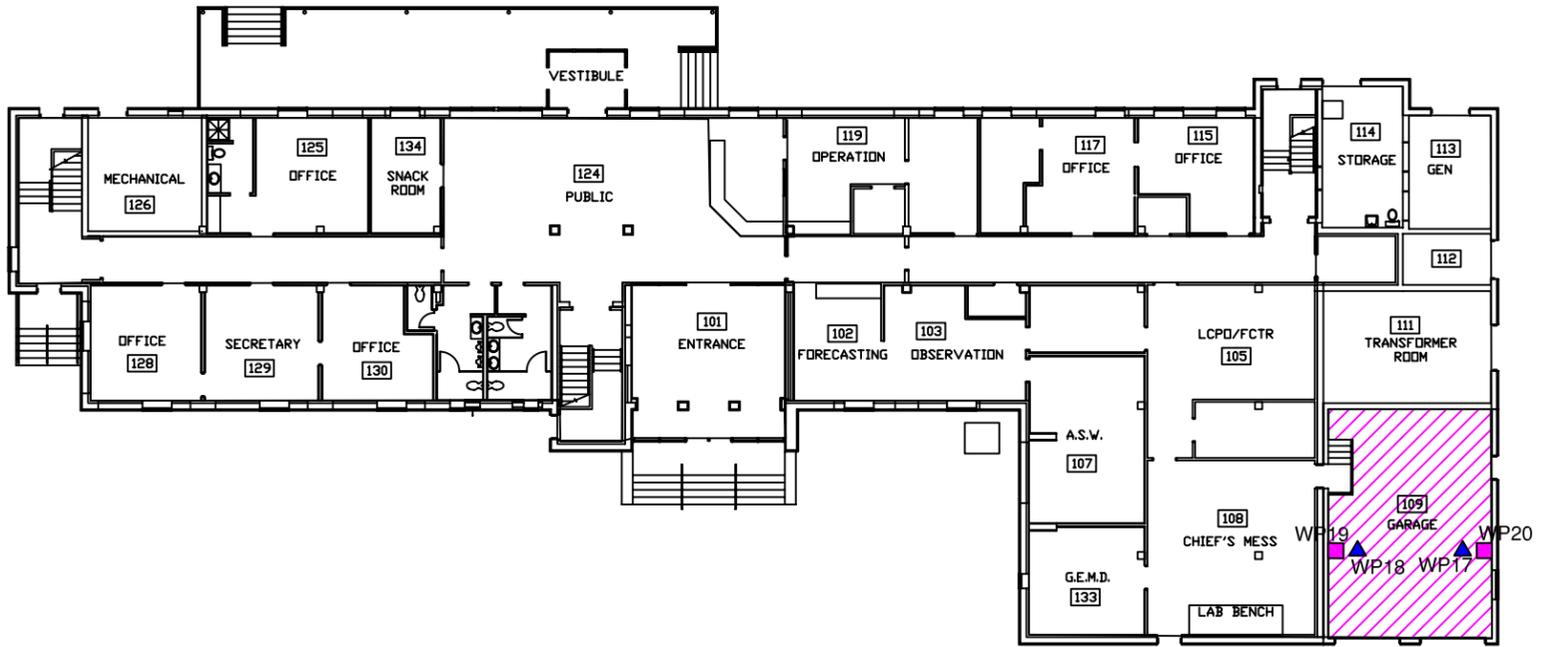
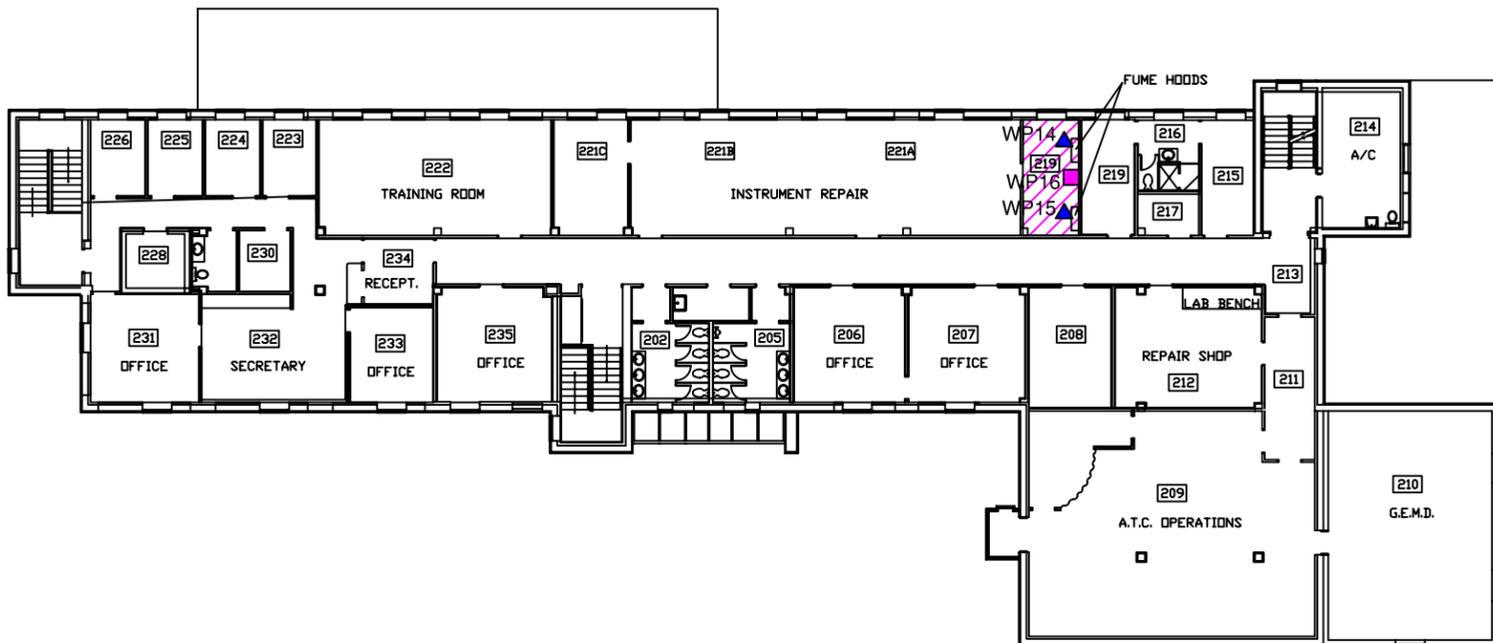
FILE \\.\NASB_BLDG_200_POST.DWG	SCALE AS NOTED
FIGURE NUMBER FIGURE NO. 4	REV 0
	DATE 3/23/11

After the work areas were allowed to dry, four post-cleaning floor-wipe samples (plus one duplicate) and three wall-wipe samples were collected from the cleaned areas on March 1, 2010 (Figure 4). Samples were submitted to Tetra Tech's subcontracted analytical laboratory, Katahdin, for lead analysis. The resulting analytical data underwent limited data validation consisting of field duplicate evaluation, blank contamination evaluation, and completeness evaluation. The March 1, 2010 wipe sample results are included in Table 4. Lead levels in these samples were well below the associated MEDEP criteria for floors and walls ($250 \mu\text{g}/\text{ft}^2$); therefore, additional closure action is not warranted at Building 200.

Tetra Tech's cleaning subcontractor (TK&K Services [TK&K]) performed floor- and wall- cleaning activities in Room 219 and in the garage of Building 200, based on lead criterion exceedances in floor wipe samples, as discussed in Section 4. The floors were vacuumed with a high-efficiency particulate air (HEPA) vacuum. After vacuuming, the floors and walls were then sprayed and scrubbed with a 2-percent, lead-specific detergent solution, and pressure washed using a 2,500 - pounds-per-square-inch (psi) hot-water pressure-washer. All cleaning wastewater was containerized using a wet-vacuum, placed in a 55-gallon drum, and transferred to the NAS Brunswick hazardous waste department for disposal. Upon completion, the Tetra Tech field representative performed a visual inspection of the cleaned areas.

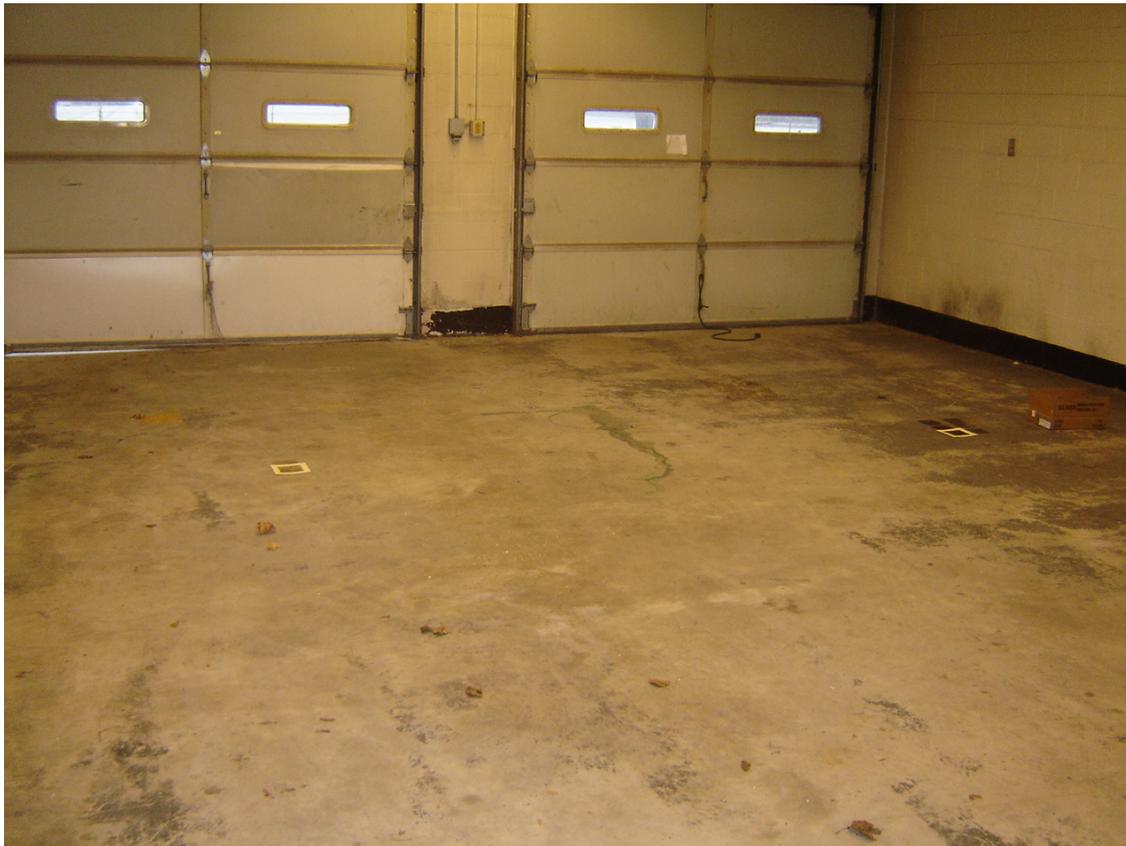
- The garage (Room 109) was used for vehicle storage and maintenance. Some staining was observed on the floor.
- The Instrument Repair Rooms (219 and 221) were used for radio repair and maintenance. Two fume hoods for soldering were installed in Room 219.

- Garage–Room 109 was used for vehicle storage and maintenance. Staining was observed on the floor.
- Instrument repair–Room 219 and Room 221 were used for radio repair and maintenance. Two fume hoods for soldering were installed in Room 219.

No. 3 Building 200– Operations-Control Tower Building, NAS Brunswick
Room 109 - Garage

Based on the analytical results, cleaning of Building 200 (discussed in Section 6) was required to remove lead-contaminated residue from the garage and from Room 219, where lead residue was present at levels that exceeded the associated MEDEP criterion for dust on floors.

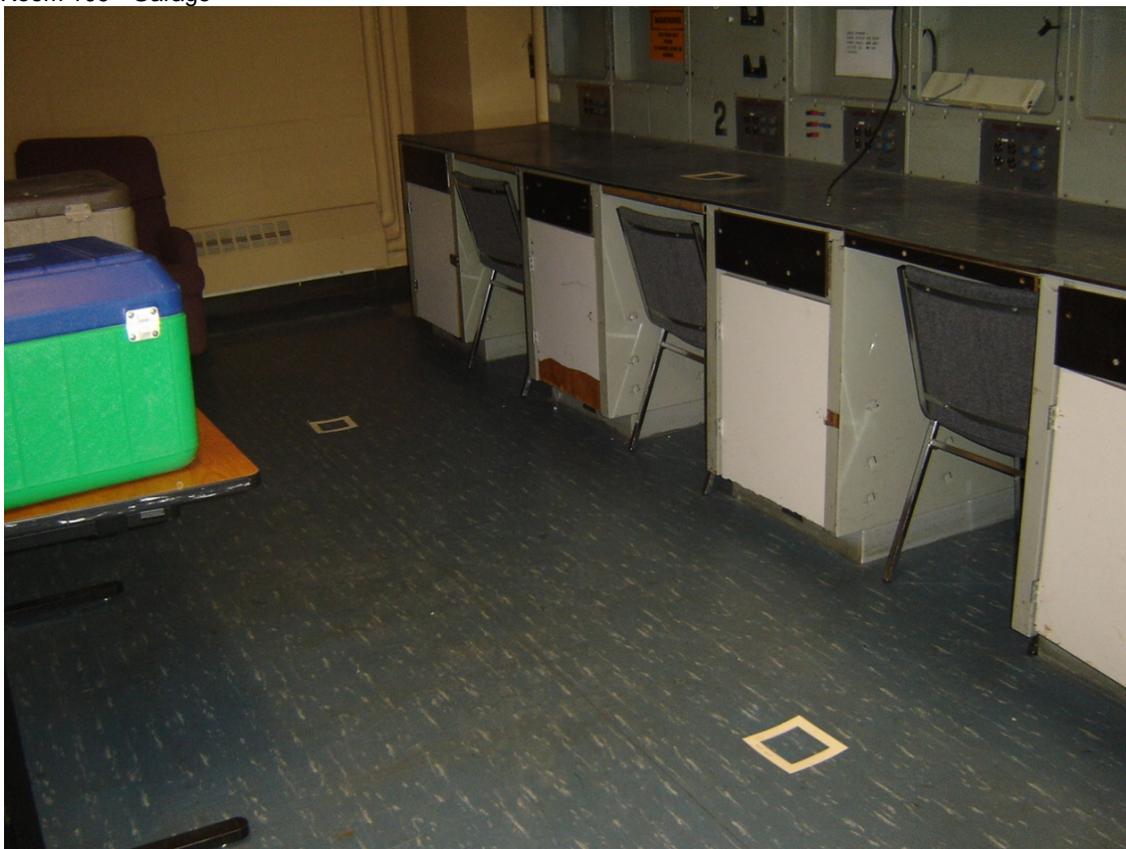
- The Repair Shop (Room 212) was used for radar repair and maintenance.
- The Chief's Mess (Room 108) was used as electronics repair room.
- The floor space where the former photography shop was located on the second floor is now office and administrative space.

No. 4 Building 200– Operations-Control Tower Building, NAS Brunswick
Room 108 – Chief's Mess

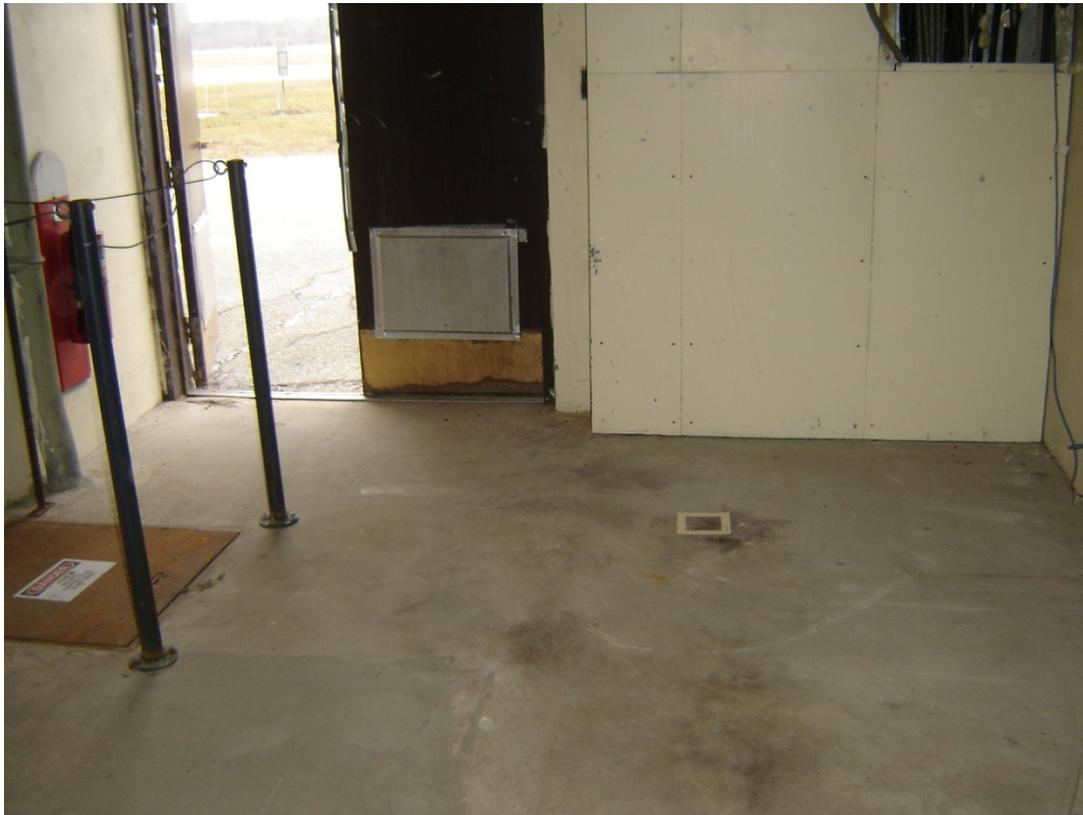
- No peeling or flaking paint was observed on the exterior or interior of the building.
- One non-polychlorinated-biphenyl (PCB), pad-mounted transformer was installed in Room 111. Staining was observed on the floor.

One pad-mounted transformer was observed in the Room 111 of Building 200. According to NASB records, the observed 300 kVA transformer was reported to have been manufactured in 1990 by Cooper Rural Transformer & Electric (RTE) with serial number 906005744. RTE transformers are non-PCB-containing.

No. 5 Building 200– Operations-Control Tower Building, NAS Brunswick
Room 111 – Transformer Room

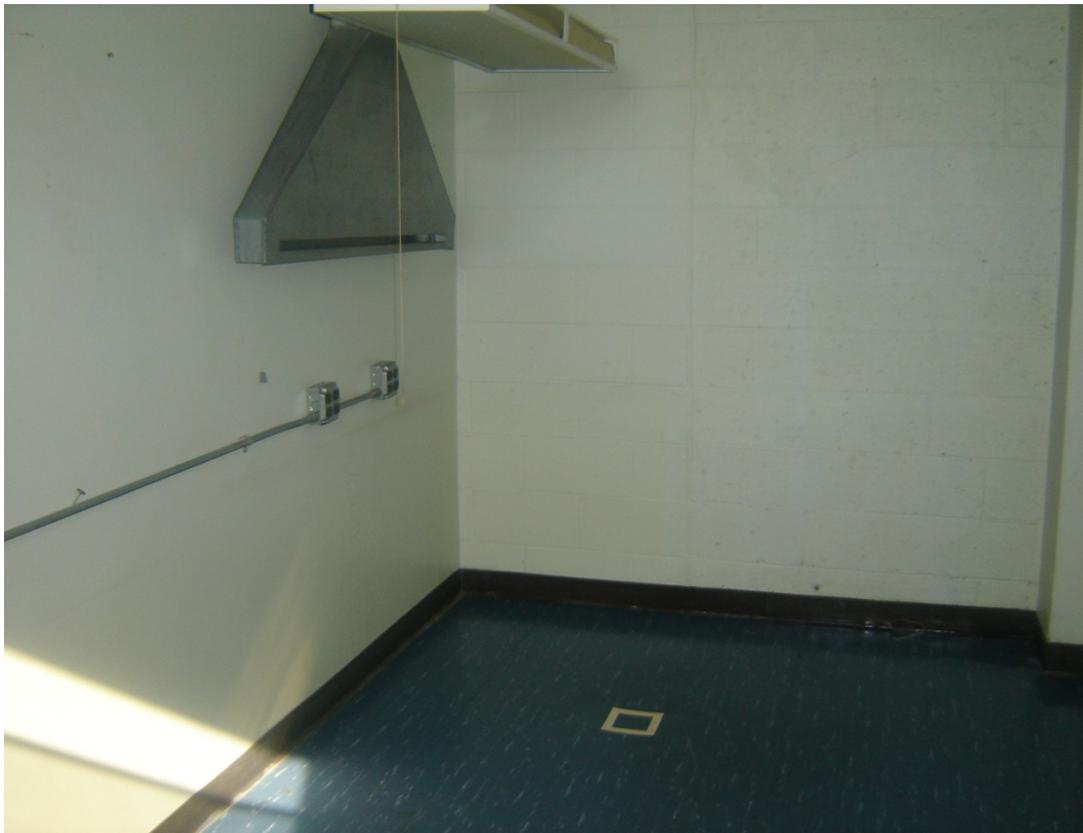
No. 6 Building 200– Operations-Control Tower Building, NAS Brunswick
Room 219 – Instrument Repair Room with fume hoods

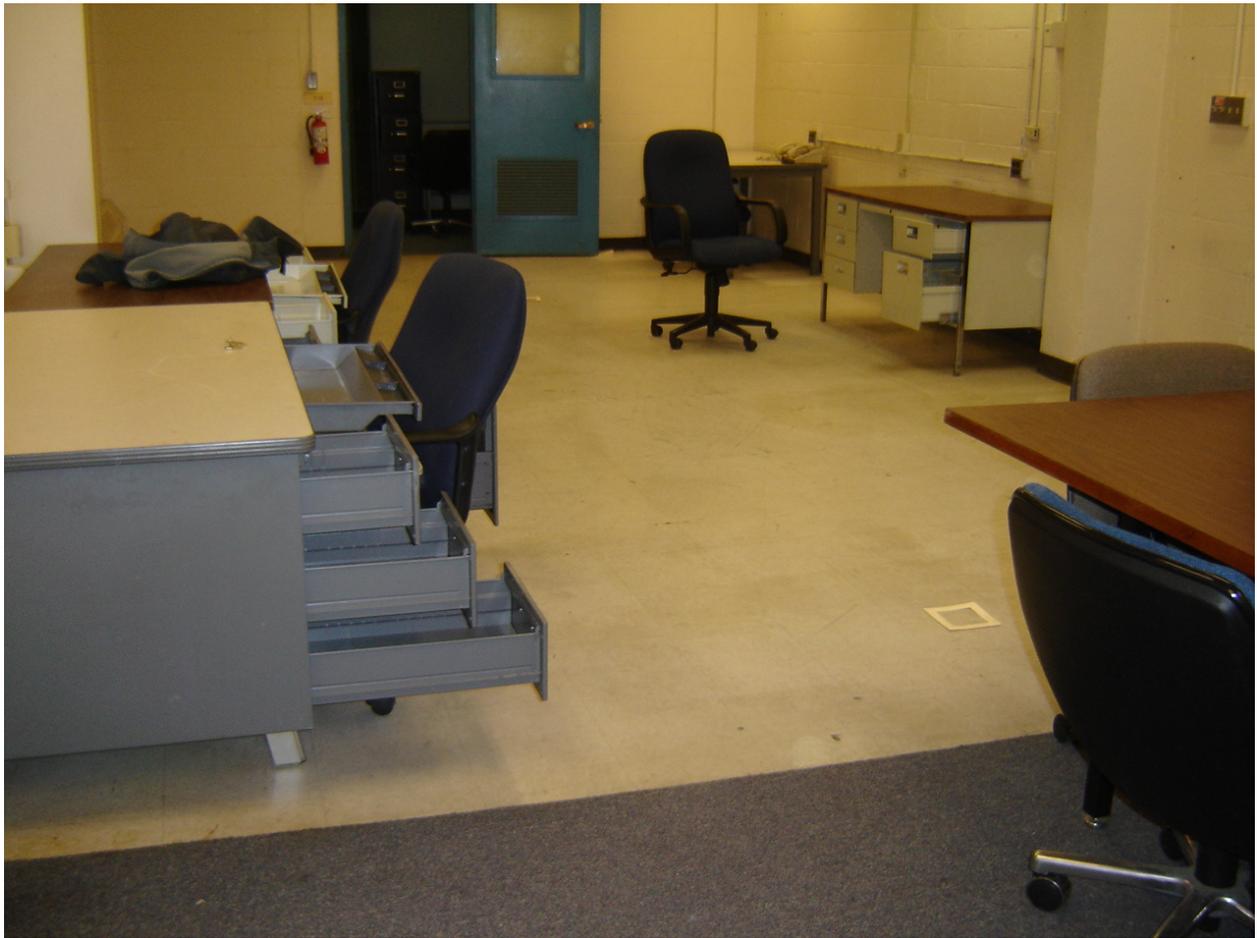
No. 7 Building 200– Operations-Control Tower Building, NAS Brunswick
Room 221 – Instrument Repair Room

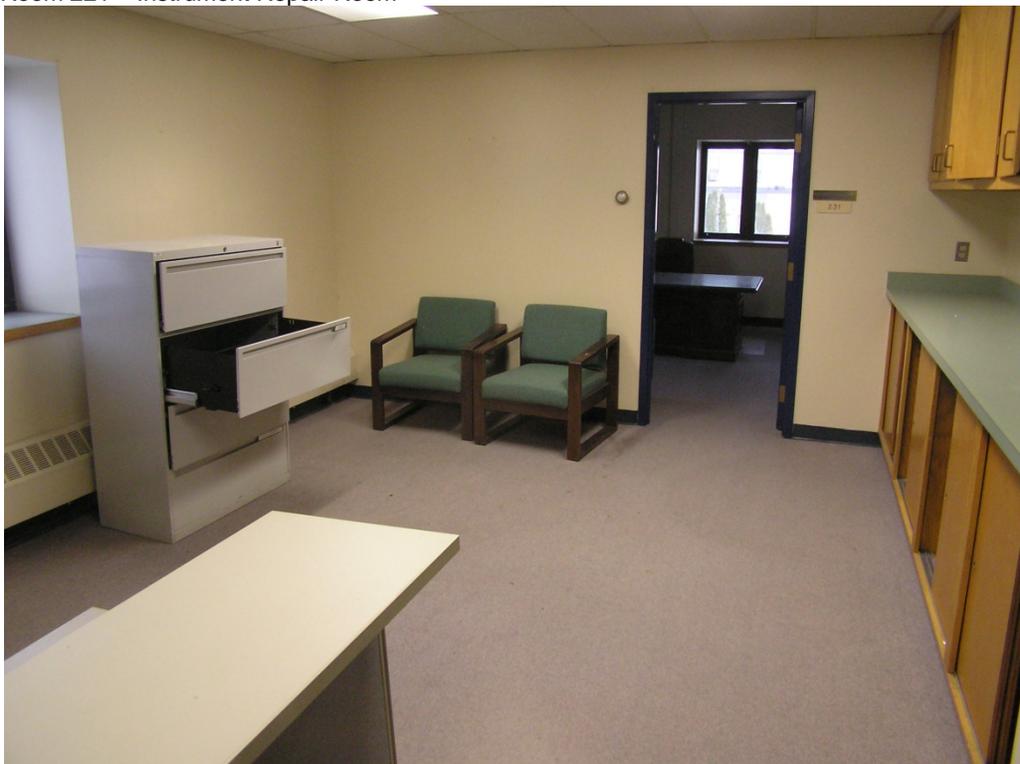
Historical plans dated 1985 and entitled “Repairs and Alterations to Operations Building 200” indicate that a photography shop was located in the southern portion of the second floor, occupying the area where current rooms 221B through 235 are located (Navy, 1985). The plans indicate the photography shop was removed and the area was converted to office space, in the current configuration.

No. 8 Building 200– Operations-Control Tower Building, NAS Brunswick
Room 232 – administrative area in the location of the former photography shop

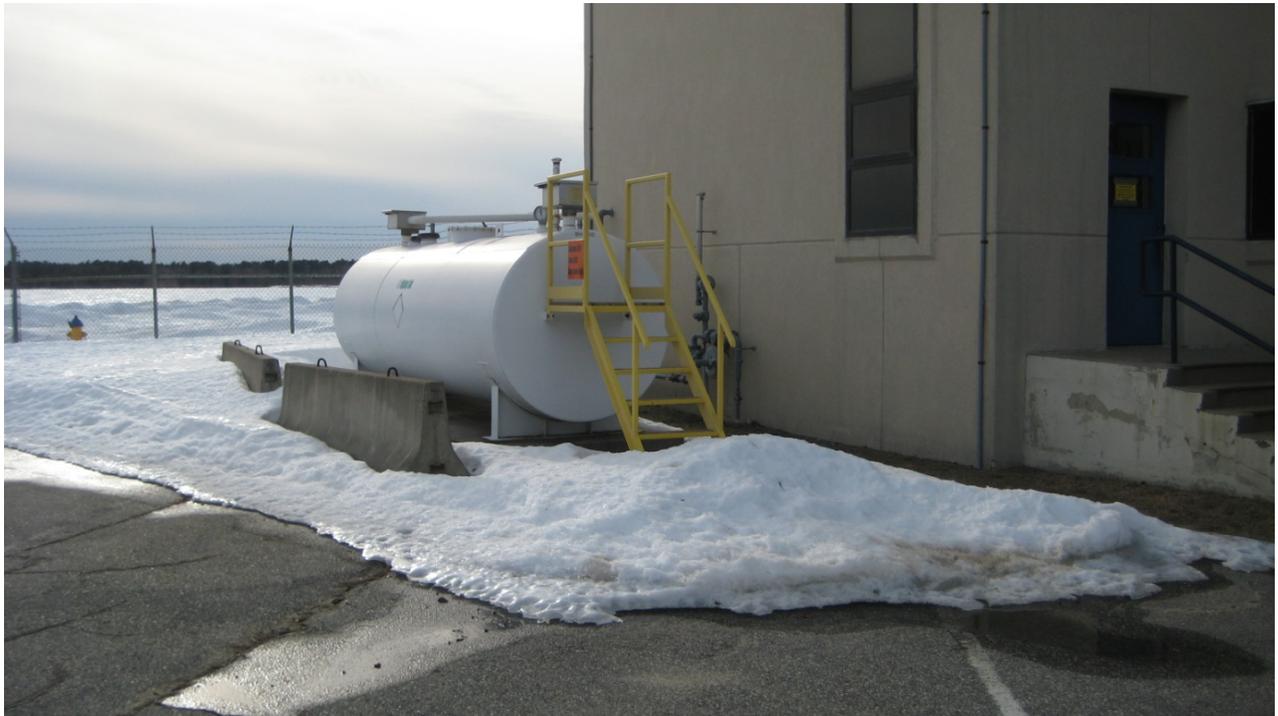
- A closed, 3,000-gallon, fuel oil AST (A200.1) was observed south of Building 200. The tank appeared to be in good condition and no evidence of a past leak from this AST was observed.

No. 9 Building 200– Operations-Control Tower Building, NAS Brunswick
Closed AST - Tank A200.1; 3,000-gallon-capacity tank for No.1 heating oil, south of Building 200

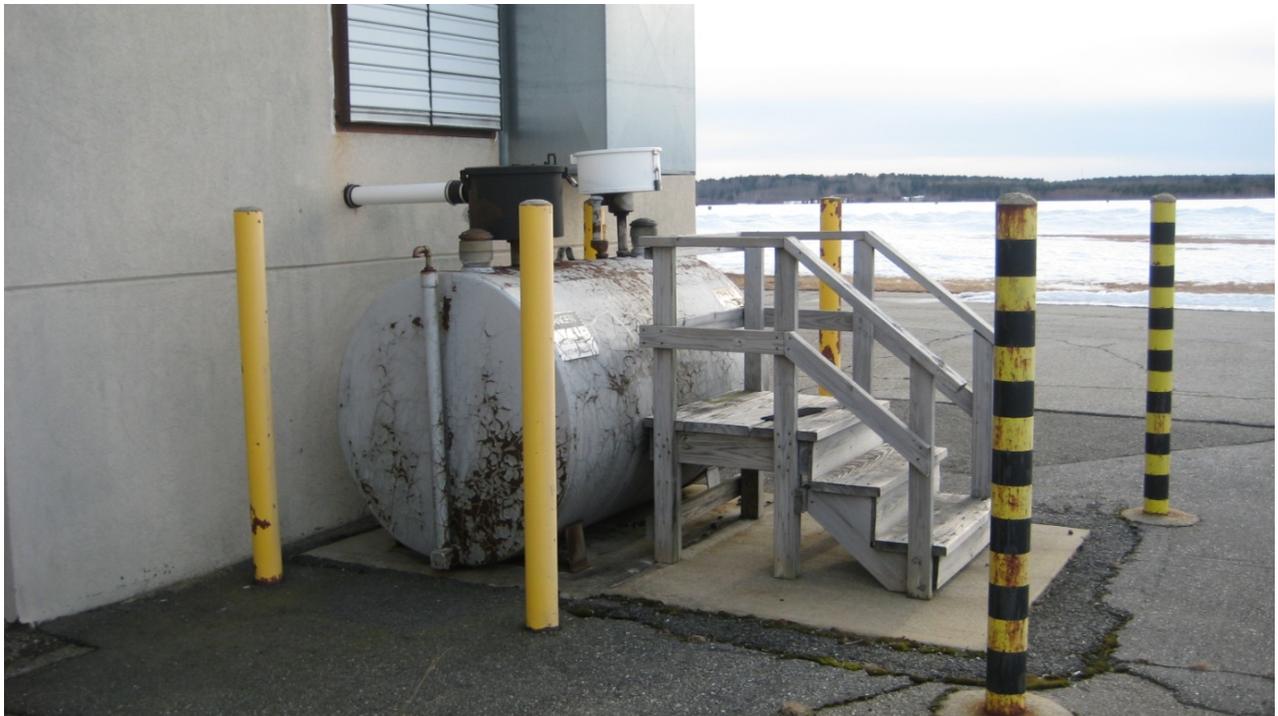
- A 500-gallon AST (A200.0) was observed at the northwest corner of Building 200. The AST is a double-walled steel tank for diesel fuel. No evidence of a past leak from this AST was observed.

No. 10 Building 200– Operations-Control Tower Building, NAS Brunswick
AST - Tank 200.0; 550-gallon-capacity tank for diesel oil, at northwest corner of Building 200
