FINAL RESOURCE CONSERVATION AND RECOVERY ACT PARTIAL CLOSURE REPORT
FOR BUILDINGS 22 AND 39 WITH TRANSMITTAL LETTER NAS BRUNSWICK ME
3/31/2011
NAS BRUNSWICK

Subj: Final RCRA Partial Closure Report for Buildings 22 and 39

RCRA PARTIAL CLOSURE REPORT
for
BUILDING 22 – GOLF MAINTENANCE BUILDING AWNING
BUILDING 39 – GOLF MAINTENANCE BUILDING
NAVAL AIR STATION BRUNSWICK, MAINE
USEPA IDENTIFICATION NUMBER ME8170022018
MARCH 2011

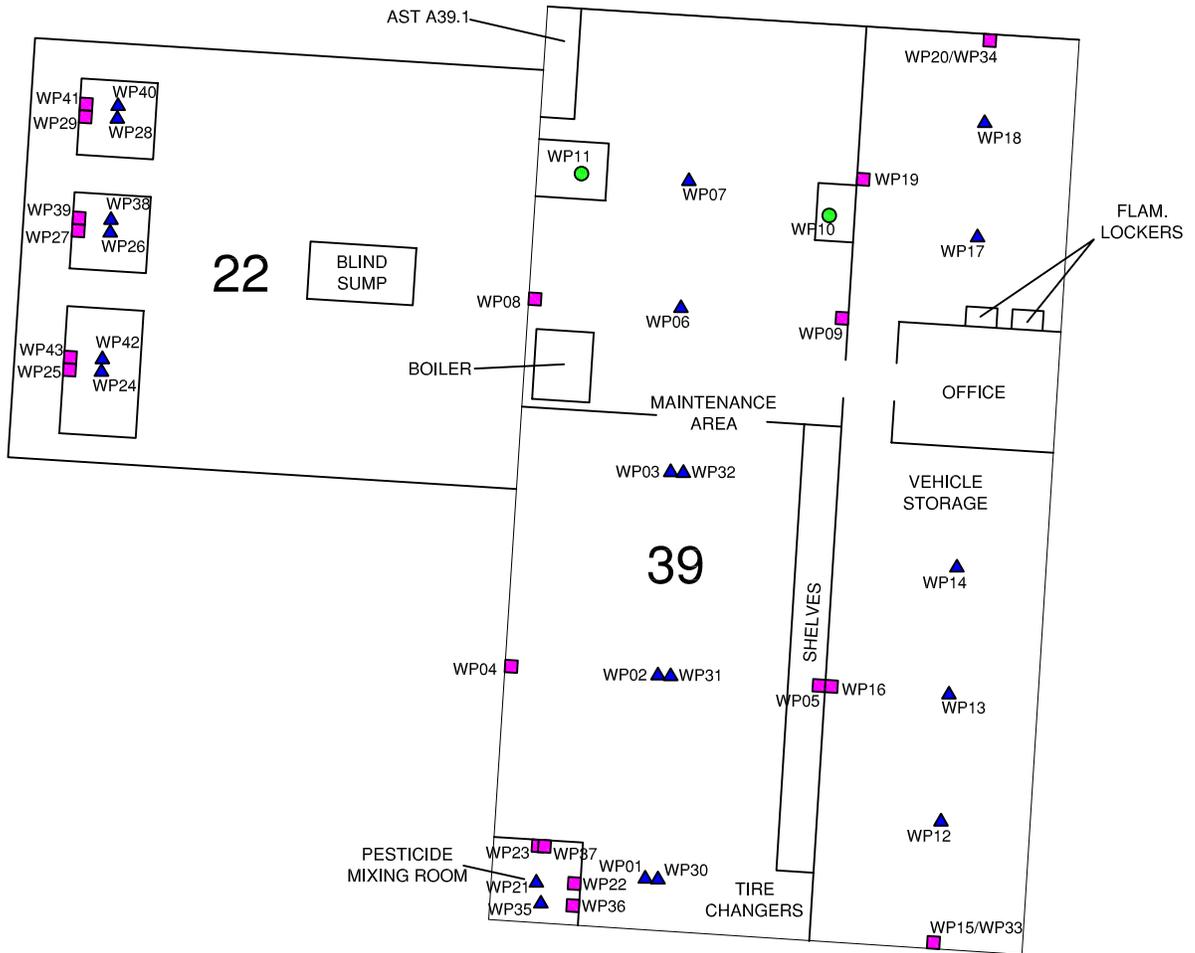
SCALE AS NOTED	
FILE \\.\NASB_BLDG_39_POST.DWG	
REV 0	DATE 3/18/11
FIGURE NUMBER 3

Five post-cleaning, confirmatory floor-wipe samples, five wall samples, and two bench samples were collected from the maintenance area on January 27, 2011 (Figure 3). Five post-cleaning, confirmatory floor-wipe samples and five wall samples were collected from the vehicle storage area on January 27, 2011. Wipe samples were collected with cotton gauze saturated with dilute nitric acid (1:4 nitric acid to distilled water) for metals analysis. A 10-centimeter (cm) by 10-cm sampling area was wiped with the cotton gauze while applying moderate pressure. Wipe samples were submitted for RCRA metals analysis by Tetra Tech's subcontracted analytical laboratory, Katahdin Analytical Services (Katahdin). The resulting analytical data underwent limited data validation consisting of field duplicate evaluation, blank contamination evaluation, and completeness evaluation.

As shown in Table 1, the lead level detected in one floor-wipe sample ($41 \mu\text{g}/\text{ft}^2$) from the maintenance area and one floor-wipe sample ($41 \mu\text{g}/\text{ft}^2$) from the vehicle storage area exceeded the MEDEP criterion for floors ($40 \mu\text{g}/\text{ft}^2$). One wall-wipe sample collected from the vehicle storage area also exceeded the respective MEDEP criterion for walls ($250 \mu\text{g}/\text{ft}^2$), with a lead level of $250 \mu\text{g}/\text{ft}^2$. Arsenic in one floor-wipe sample ($540 \mu\text{g}/\text{ft}^2$) from the maintenance area exceeded the WTC criterion for arsenic ($36 \mu\text{g}/\text{ft}^2$). All levels of other detected metals in these samples were below criteria.

Since floor-wipe and wall-wipe samples collected on January 27, 2011 were found to be above the associated MEDEP criterion, a second decontamination event (Event 2) was conducted at Building 39 on February 23, 2011. Floors and walls were scrubbed, and the floor, walls and the overhead surface were sprayed with a 2-percent, lead-specific detergent solution, and floors, and pressure-washed, using a 5,000-psi steam cleaner. All cleaning wastewater was containerized using a wet-vacuum, placed in one 55-gallon drum, and transferred to the NAS Brunswick hazardous waste department for disposal. Upon completion, the Tetra Tech field representative performed a visual inspection of the cleaned areas.

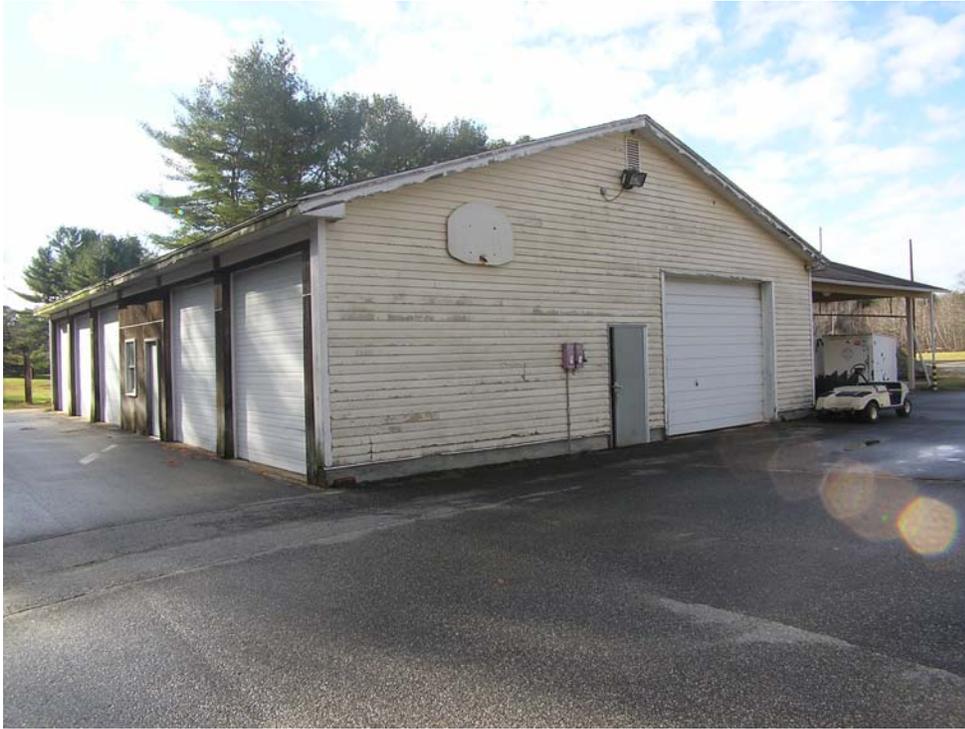
No 1 Buildings 22 and 39, NAS Brunswick December 2, 2010
Golf Maintenance Building (Building 39) northeast elevation; Golf Maintenance Building Awning (Building 22) visible at right of frame

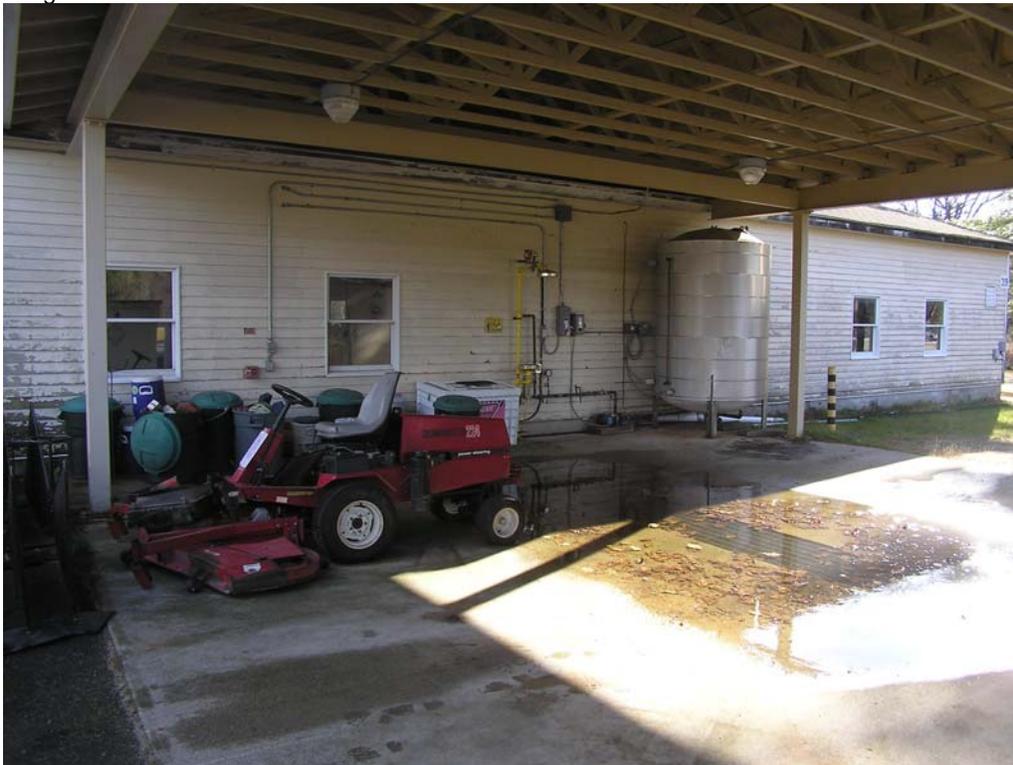
No 2 Buildings 22 and 39, NAS Brunswick December 2, 2010
Golf Maintenance Building Awning area; blind sump and insulated water tank for eye wash station at right center and Golf Maintenance Building in background

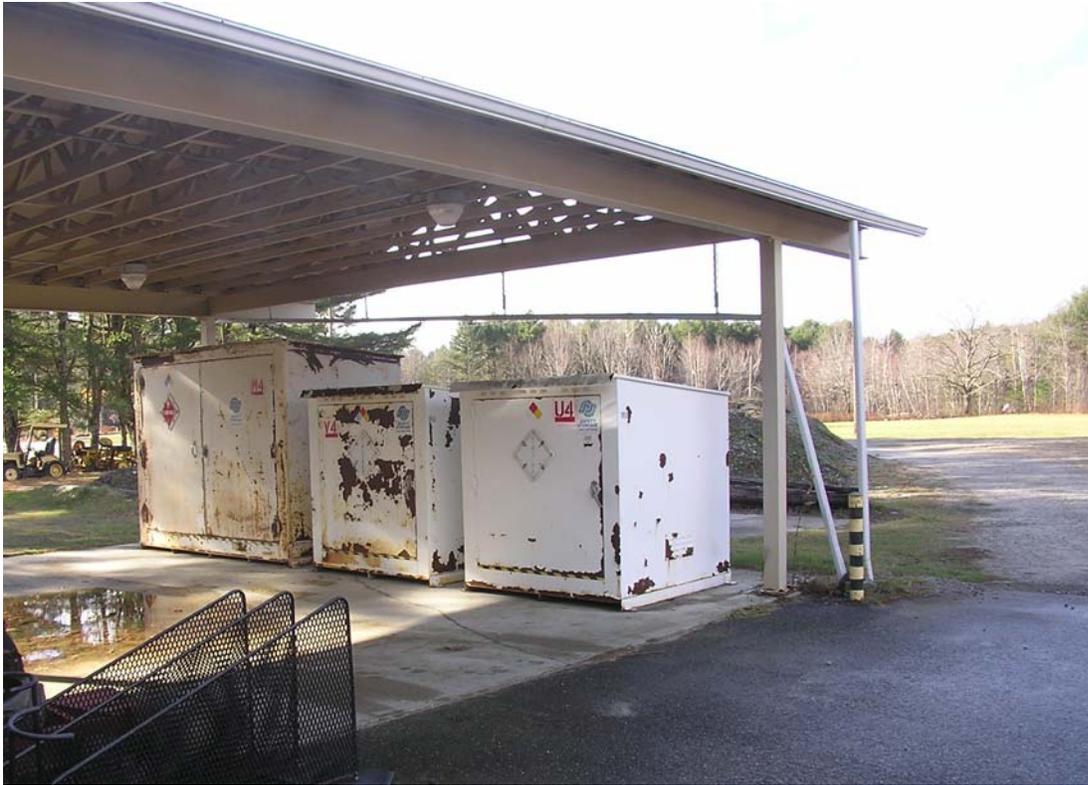
No 3 Buildings 22 and 39, NAS Brunswick December 2, 2010
Golf Maintenance Building Awning area Structures W4, V4 and U4 (left to right)

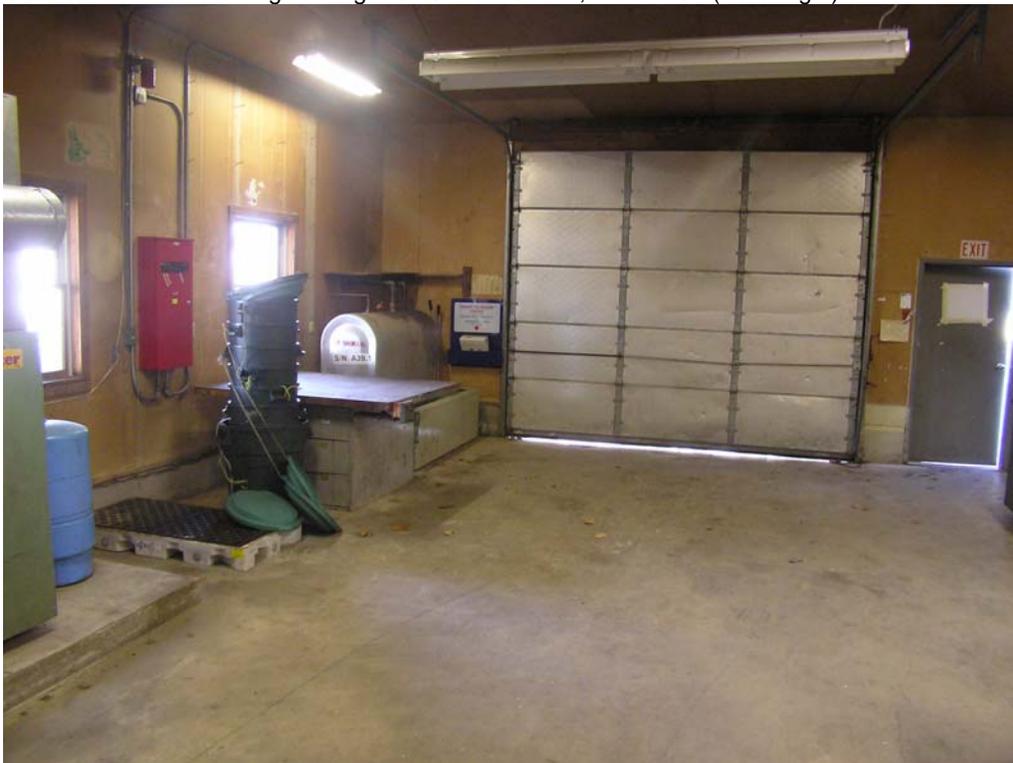
Evidence of hazardous waste residues was observed on the floor and work benches in the maintenance room.

No 4 Buildings 22 and 39, NAS Brunswick December 2, 2010
Golf Maintenance Building interior before cleaning; northwest maintenance area, aboveground tank A39.1 in corner

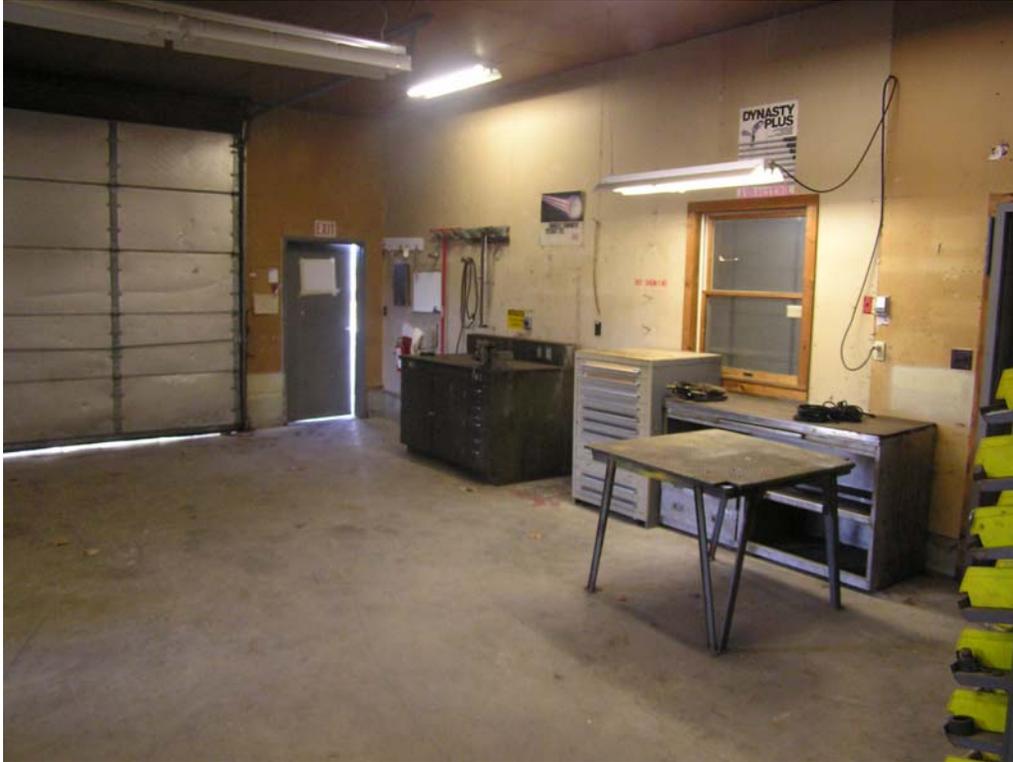
No 5 Buildings 22 and 39, NAS Brunswick December 2, 2010
Golf Maintenance Building interior before cleaning; northeast maintenance area

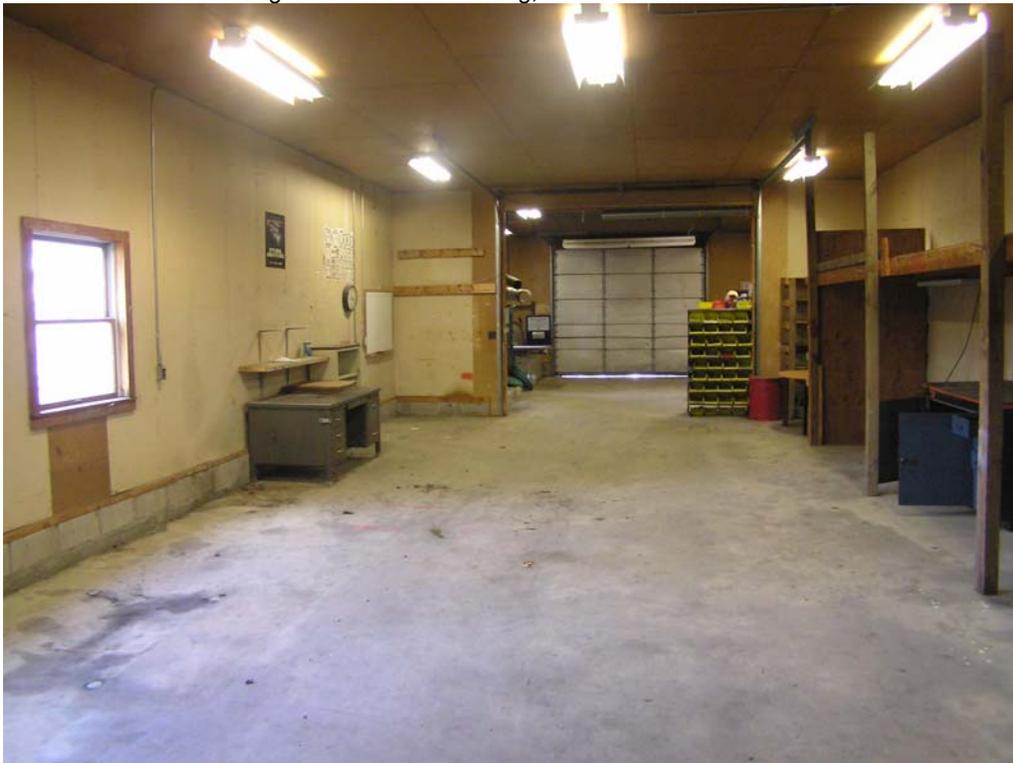
No 6 Buildings 22 and 39, NAS Brunswick December 2, 2010
Golf Maintenance Building interior before cleaning; south maintenance area

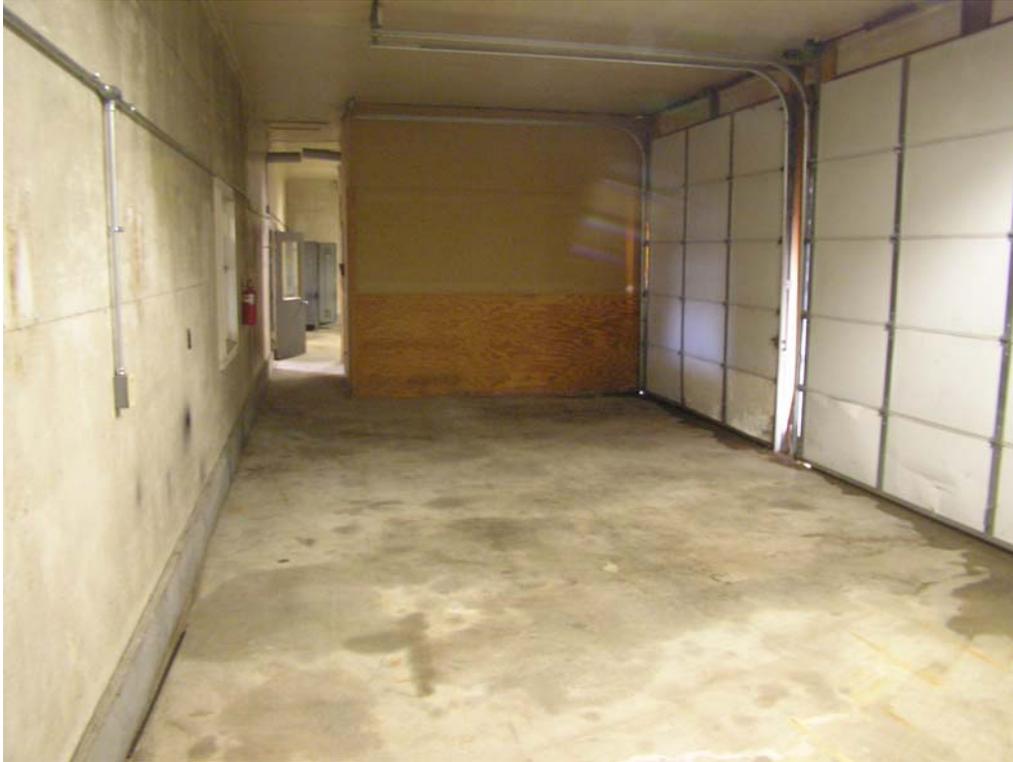
No 7 Buildings 22 and 39, NAS Brunswick December 2, 2010
Golf Maintenance Building interior before cleaning; south vehicle storage

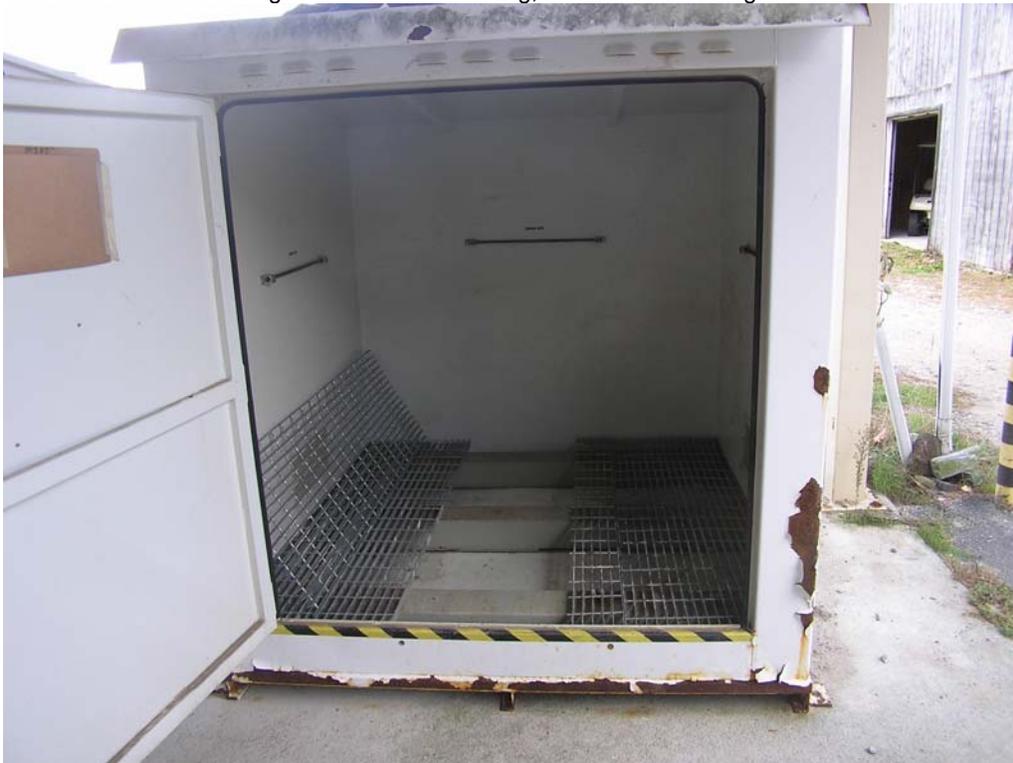
No 8 Buildings 22 and 39, NAS Brunswick November 3, 2010
Golf Maintenance Building Awning area Structure U4 interior before cleaning
