FINAL RESOURCE CONSERVATION AND RECOVERY ACT PARTIAL CLOSURE REPORT  
FOR BUILDING 309 WITH TRANSMITTAL LETTER NAS BRUNSWICK ME  
3/31/2011  
NAS BRUNSWICK

**RCRA PARTIAL CLOSURE REPORT  
for  
BUILDING 309 – GOLF PUMP HOUSE  
NAVAL AIR STATION BRUNSWICK, MAINE  
USEPA IDENTIFICATION NUMBER ME8170022018  
MARCH 2011**

**HWSA INSPECTION REPORT  
HAZARDOUS WASTE STORAGE AREAS CLOSURE  
NAS BRUNSWICK  
BRUNSWICK, MAINE  
CTO WE22**

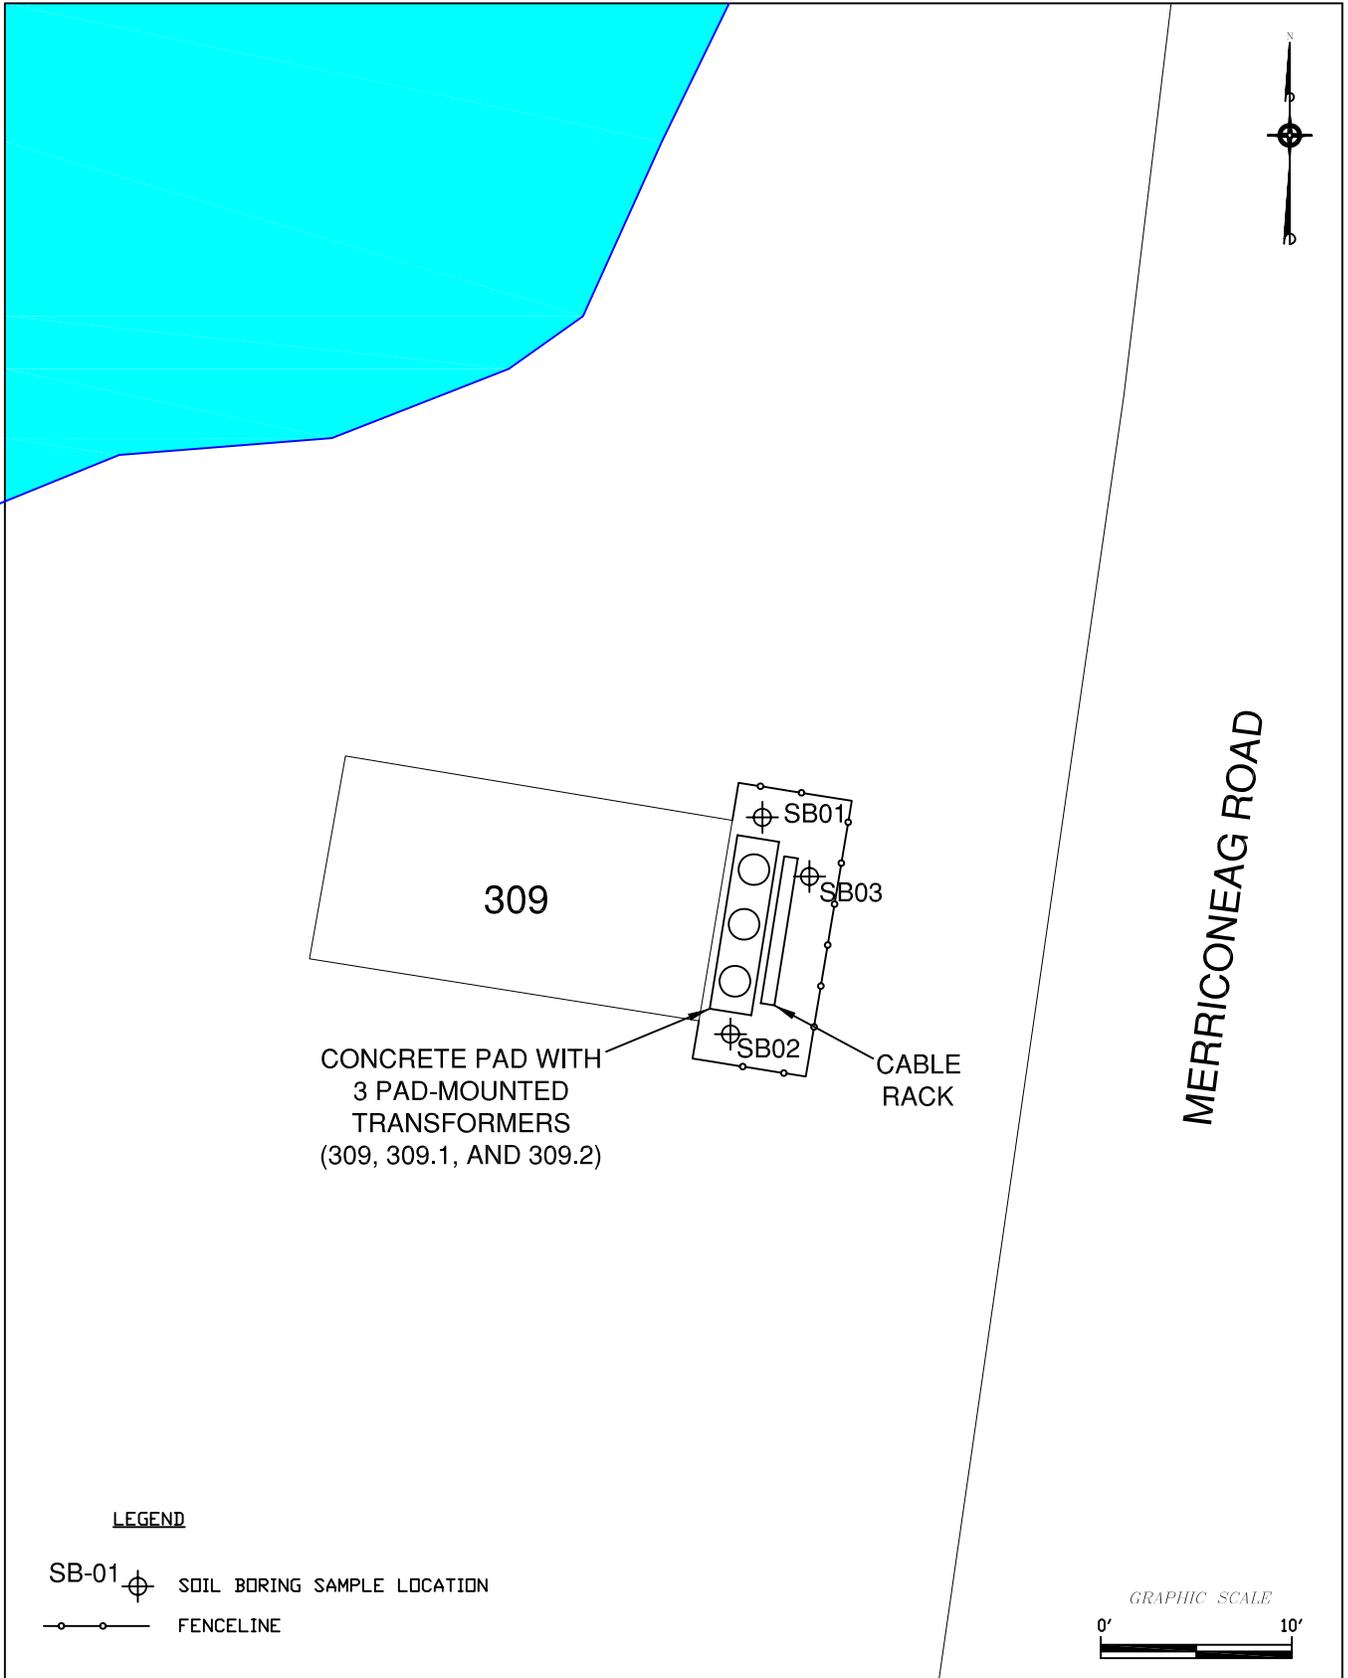
**SAMPLE LOCATIONS**  
**BUILDING 309 - GOLF PUMP HOUSE**  
**RCRA PARTIAL CLOSURE REPORT**  
**NAVAL AIR STATION BRUNSWICK, MAINE**

Due to the age of the building, and because previous transformers at the pad may have contained PCBs at sometime in the past, soil sampling was conducted to evaluate the possibility of a past PCB release. On December 15, 2010, hand-augers were used to collect soil samples adjacent to the transformer pad, from the north, east, and south sides of the pad (Figure 3). At each location, soil samples were to be collected from the 0- to 6-inch interval and the 6- to 24-inch interval below ground surface (bgs); however, as shown in Table 2, the sample depths were limited by auger refusal in each of the borings (total depths were 16 inches, 6 inches, and 10 inches bgs, respectively, for SB01, SB02, and SB03 sample locations).

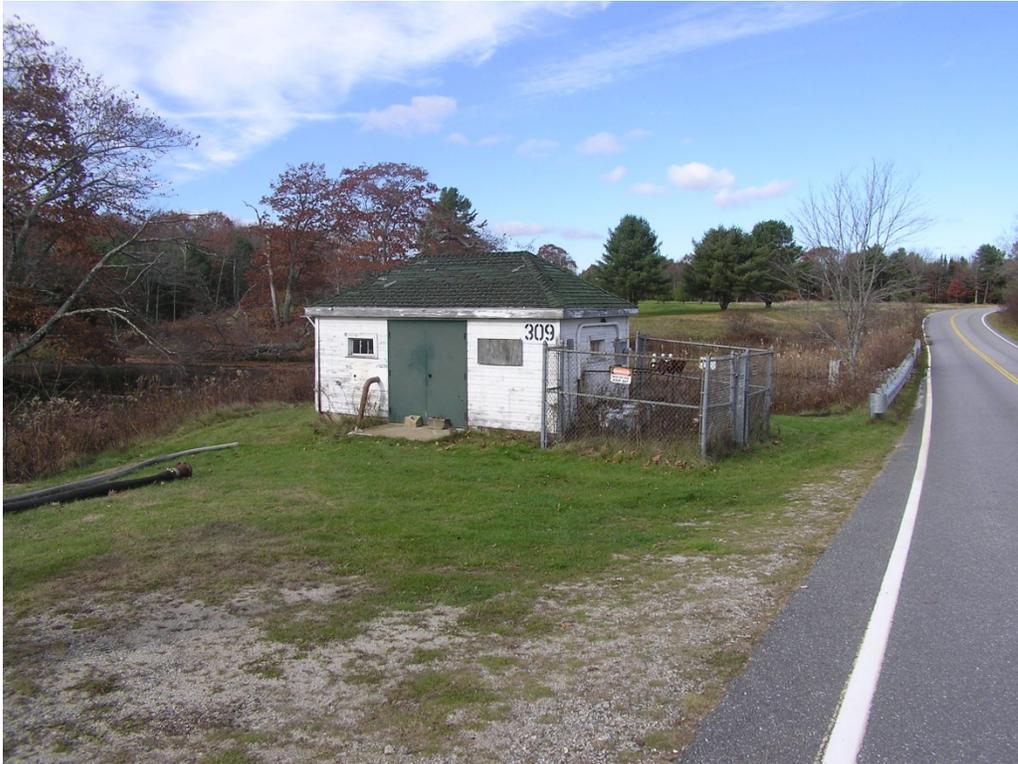
No. 1 Building 309 – Golf Pump House  
Golf course irrigation Golf Pump House southeast elevation

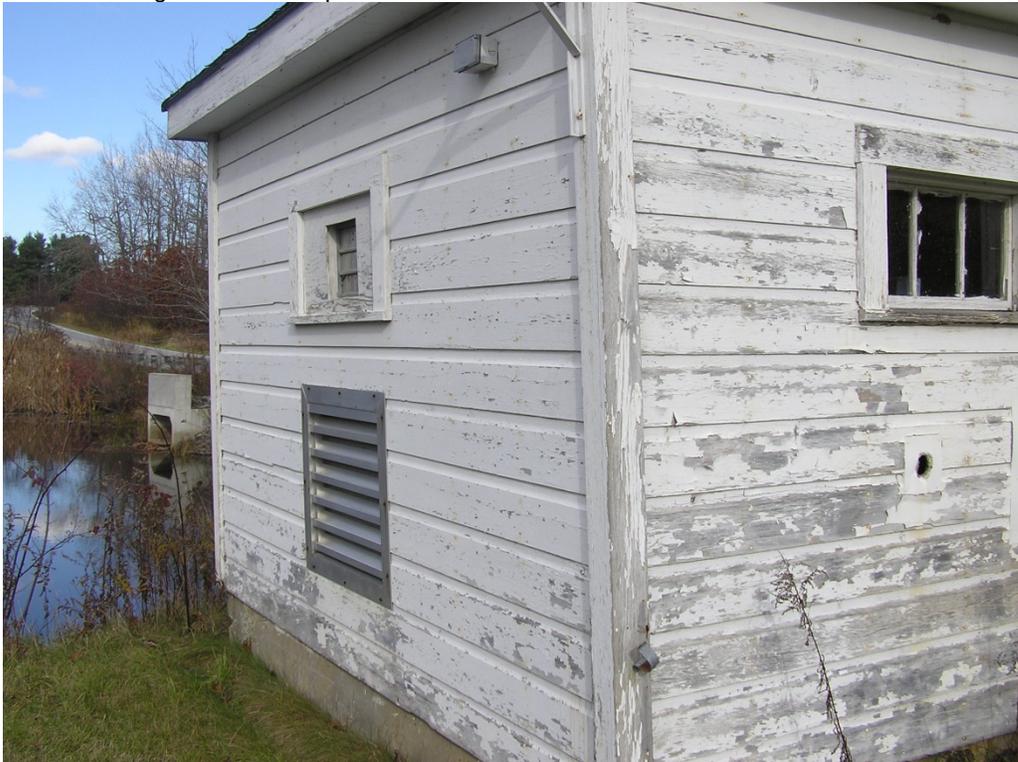
- Peeling and flaking paint was observed on the exterior, but not on the interior of the building.
- The asphalt roofing shingles were observed to be in the process of de-laminating.
- Three electric-powered water pumps supplying the golf course irrigation system were observed within the structure.
- No sink or bathroom facilities were observed within the building.
- The building is unheated with no air conditioning.

As indicated in Table 1, lead was reported in the paint-chip sample at 63.6 mg/L, over twelve times the associated TCLP limit of 5 mg/L. No other RCRA 8 metals exceeded the TCLP limits. Closure actions were required at the Building 309 exterior to remove peeling and chipping paint containing elevated levels of lead, exceeding the TCLP limit.

No. 2 Building 309 – Golf Pump House  
Golf Pump House southwest corner; loose exterior paint condition

Tetra Tech's cleaning subcontractor, TK&K Services (TK&K), removed loose paint and paint-chip from the at the Building 309 exterior on March 29, 2011. All loose paint was manually scraped off using metal scrapers and wire brushes. Paint chips and dust were then swept and then vacuumed with a high-efficiency, particulate-absorbing (HEPA) vacuum, placed in one 30-gallon drum, and transferred to the NAS Brunswick hazardous waste department for disposal. Upon completion, the Tetra Tech field representative performed a visual inspection of the paint removal areas.

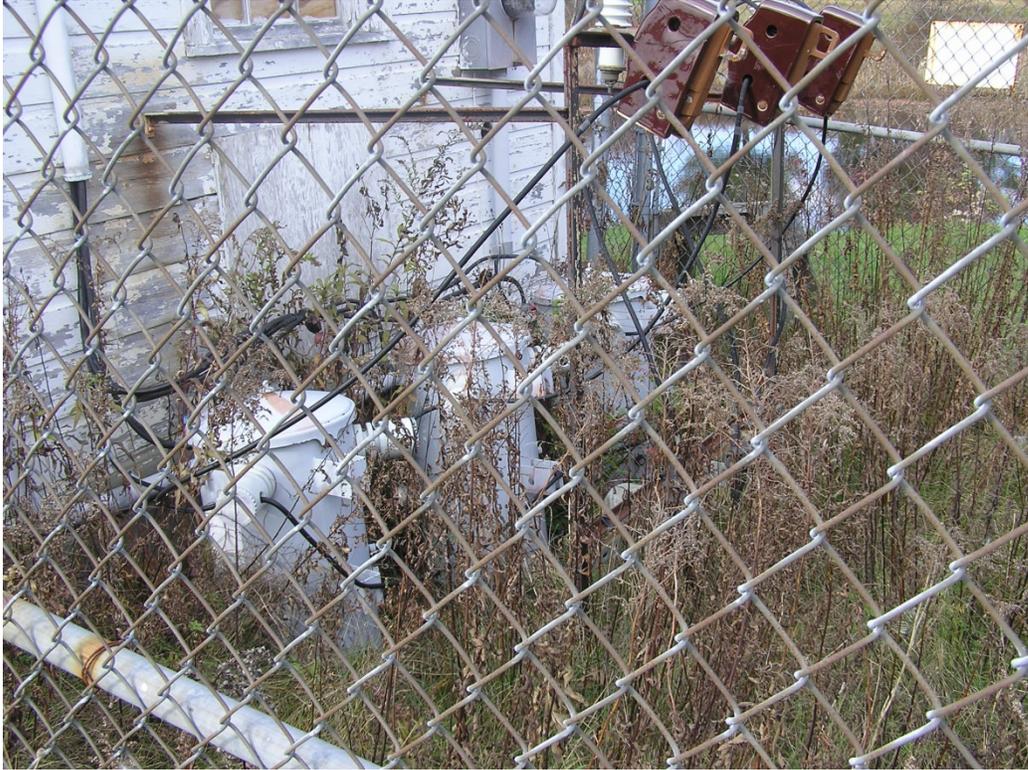
Three transformers are listed in the NASB transformer database for the Building 309 (ID Nos. 309, 309.1 and 309.2) as non- polychlorinated biphenyls (PCBs). Three pole-mount style transformers were observed pad-mounted and located within a fenced security area to the east of Building 309. These transformers may have been manufactured prior to the PCB ban in 1979, based on their NASB reported serial numbers (71AD3955, 71AD3953, and 71AD2057, respectively); and are reported to contain less than 50 parts-per-million (ppm) of PCBs. No additional information was available on the transformers; however, due to the age of the building, the transformer pad may have had PCB-containing transformers located there.

No signs of a past release (staining, unusual odors, stressed vegetation, etc.) were observed.

No. 3 Building 309 – Golf Pump House November 3, 2010  
Golf Pump House pole-mount type transformers located on eastern side of the building

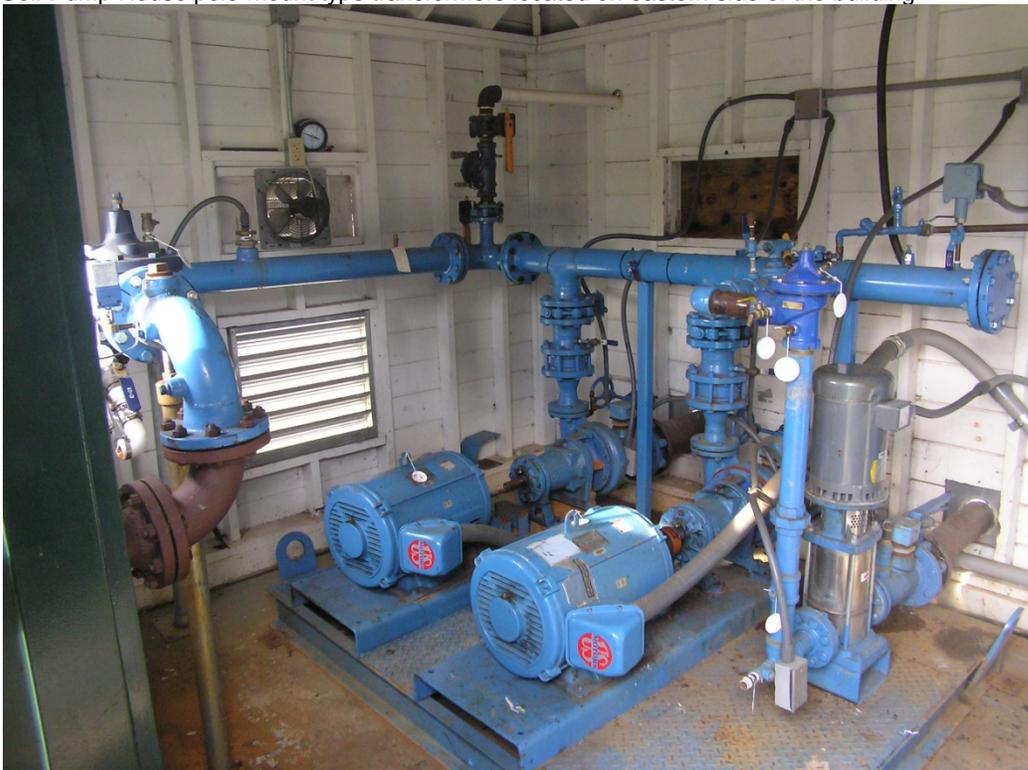
No. 4 Building 309 – Golf Pump House November 3, 2010  
Golf Pump House interior; electric-powered irrigation water pumps

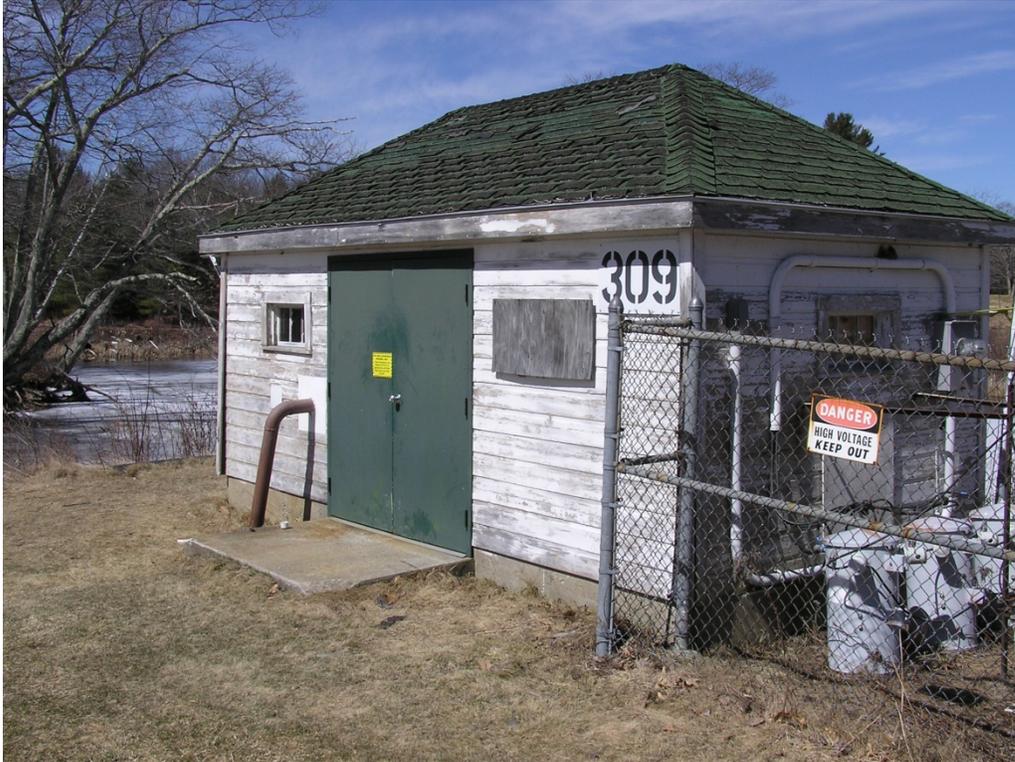
Building 309 – Golf Pump House March 29, 2011  
Golf Pump House southeast elevation; photograph taken following loose paint removal

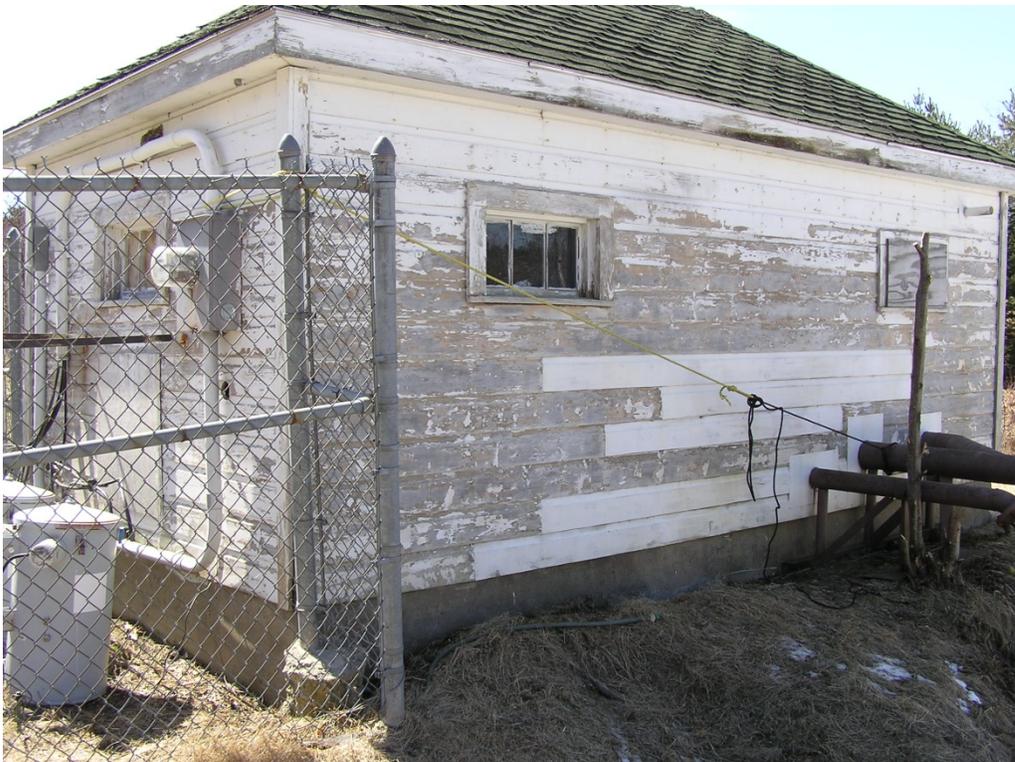
No. 5 Building 309 – Golf Pump House March 29, 2011  
Golf Pump House northeast elevation; photograph taken following loose paint removal
