FINAL RESOURCE CONSERVATION AND RECOVERY ACT PARTIAL CLOSURE REPORT
FOR BUILDINGS 543 AND 544 WITH TRANSMITTAL LETTER NAS BRUNSWICK ME
3/31/2011
NAS BRUNSWICK

RCRA PARTIAL CLOSURE REPORT
for
BUILDING 543 – HIGH EXPLOSIVE MAGAZINE
BUILDING 544 – HIGH EXPLOSIVE MAGAZINE
NAVAL AIR STATION BRUNSWICK, MAINE
USEPA IDENTIFICATION NUMBER ME8170022018
MARCH 2011

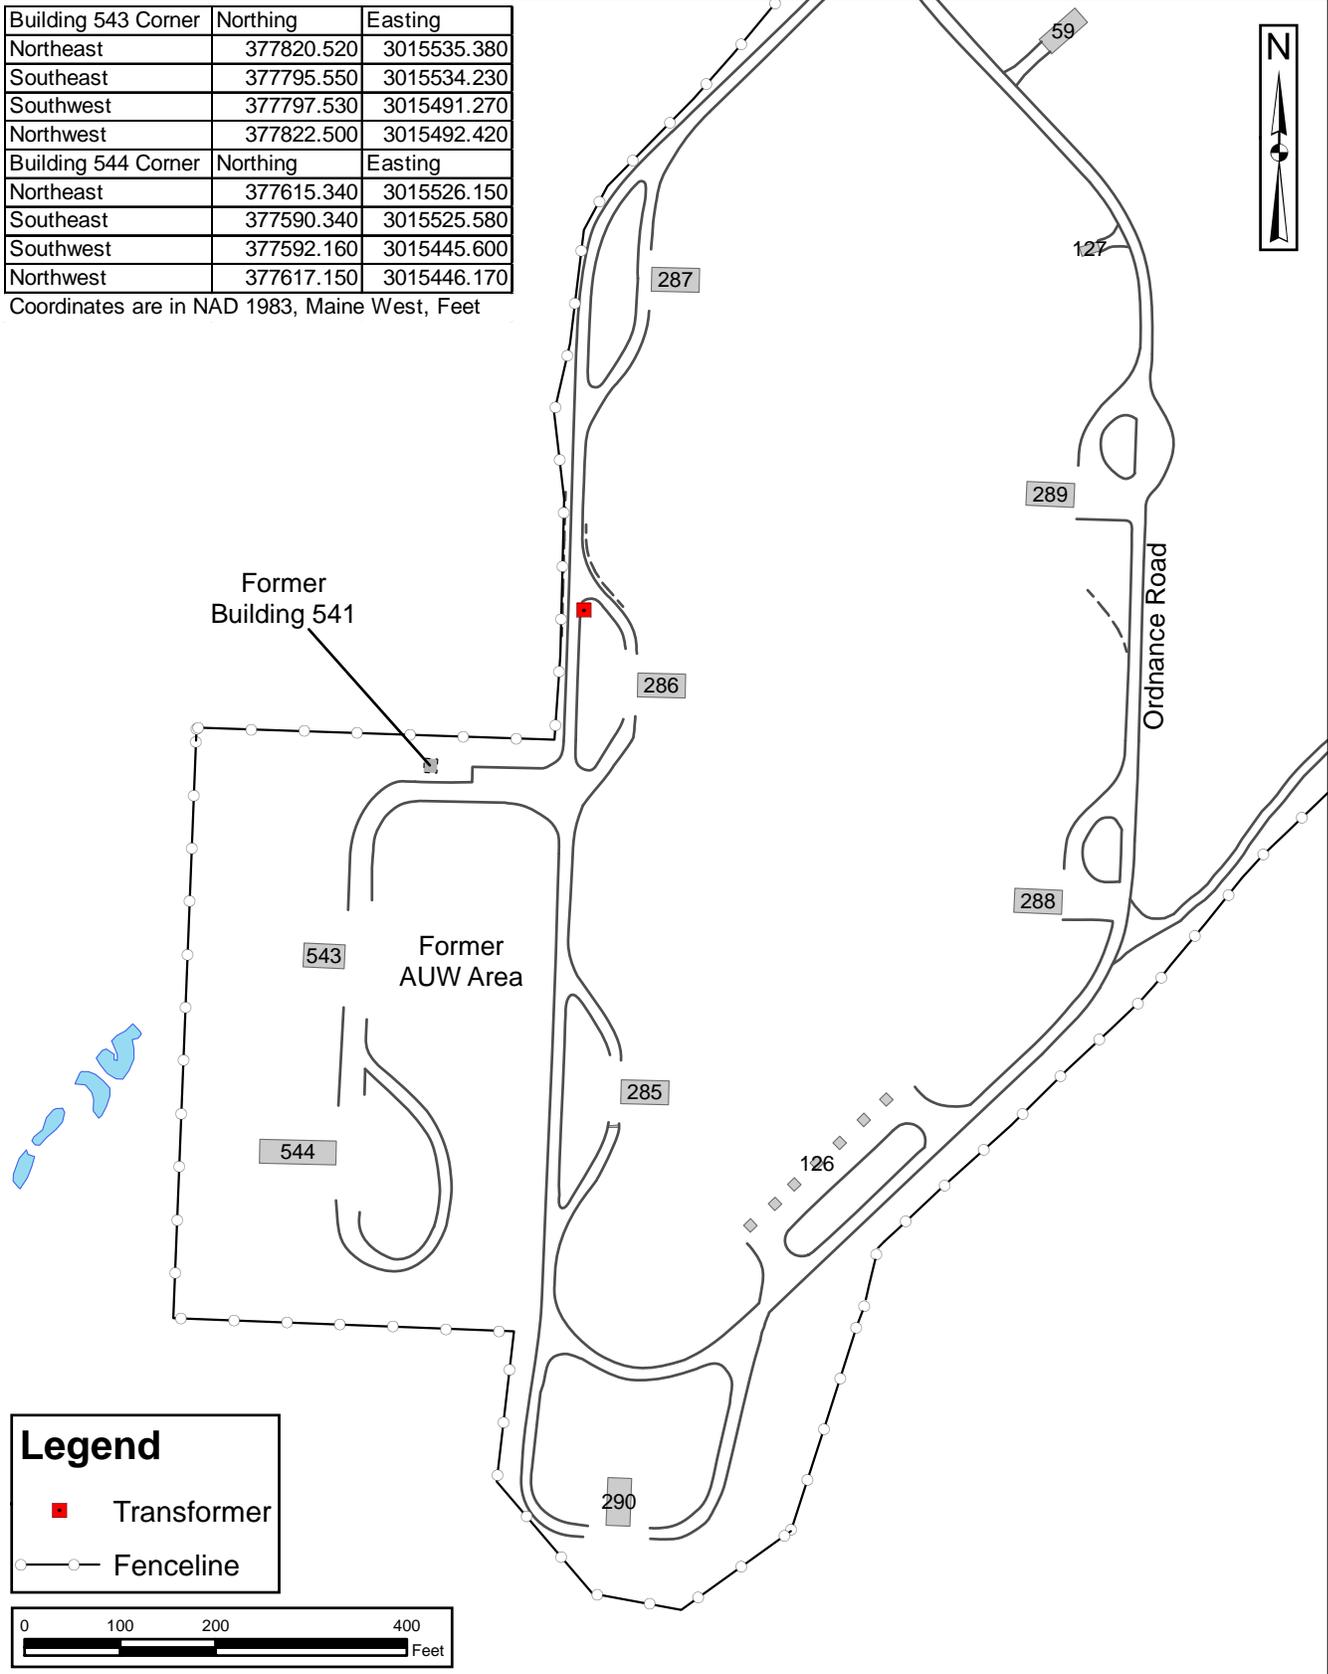
SCALE AS NOTED	
FILE I:\NASB_BLDG_543&544_SITE_MAP.MXD	
REV 0	DATE 03/25/11
FIGURE NUMBER 2

The investigation conducted under this report applies only to the building footprints of Buildings 543 and 544 (footprints as shown on Figure 2). The Weapons Magazine Area RCRA Partial Closure Report addresses the land surrounding and the groundwater underlying Buildings 543 and 544.

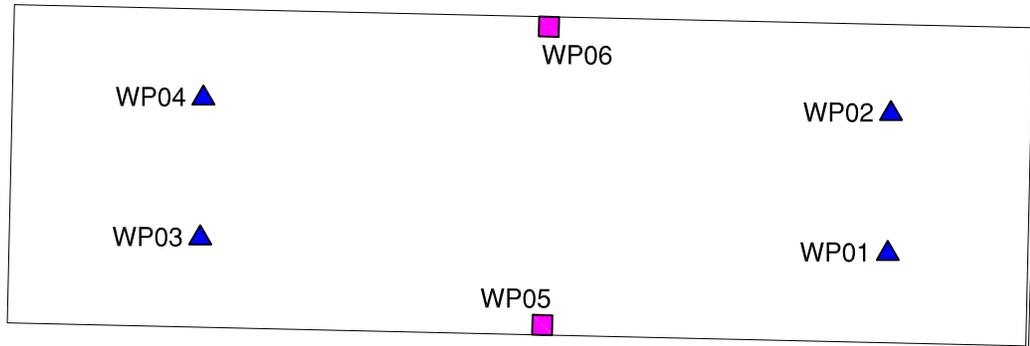
BUILDING 544

On September 17, 2010, wipe samples were collected from floors and walls inside Building 544. A total of six locations (plus two duplicates) were sampled (Figure 3). The wipe samples were collected with cotton gauze saturated with dilute nitric acid (1:4 nitric acid to distilled water), for RCRA metals analysis. A 10-centimeter (cm) by 10-cm sampling area was wiped with the cotton gauze while applying moderate pressure. Wipe samples were submitted for analysis by Tetra Tech's subcontracted analytical laboratory, Analytics Environmental Laboratories (Analytics). The resulting analytical data underwent limited data validation consisting of field duplicate evaluation, blank contamination evaluation, and completeness evaluation.

As shown in Table 1, lead was detected at levels exceeding the MEDEP lead criterion for floors ($40 \mu\text{g}/\text{ft}^2$) in all four floor-wipe samples. Cadmium was detected at levels exceeding the associated clearance value ($140 \mu\text{g}/\text{ft}^2$) at three of the four floor locations. Chromium was detected at levels exceeding the associated clearance value ($440 \mu\text{g}/\text{ft}^2$) at two of the four floor-wipe sample locations. No exceedances of the metal clearance values were reported for the two wall-wipe sample locations.

Based on the analytical results, cleaning of Building 544 was required to remove metals-contaminated residue exceeding the associated clearance values for floors (cleaning is discussed in Section 6). Based on the analytical results at Building 544, and based on its similar use and history, cleaning of Building 543 was also warranted to remove potential metals-contaminated residue exceeding criteria (discussed in Section 6).

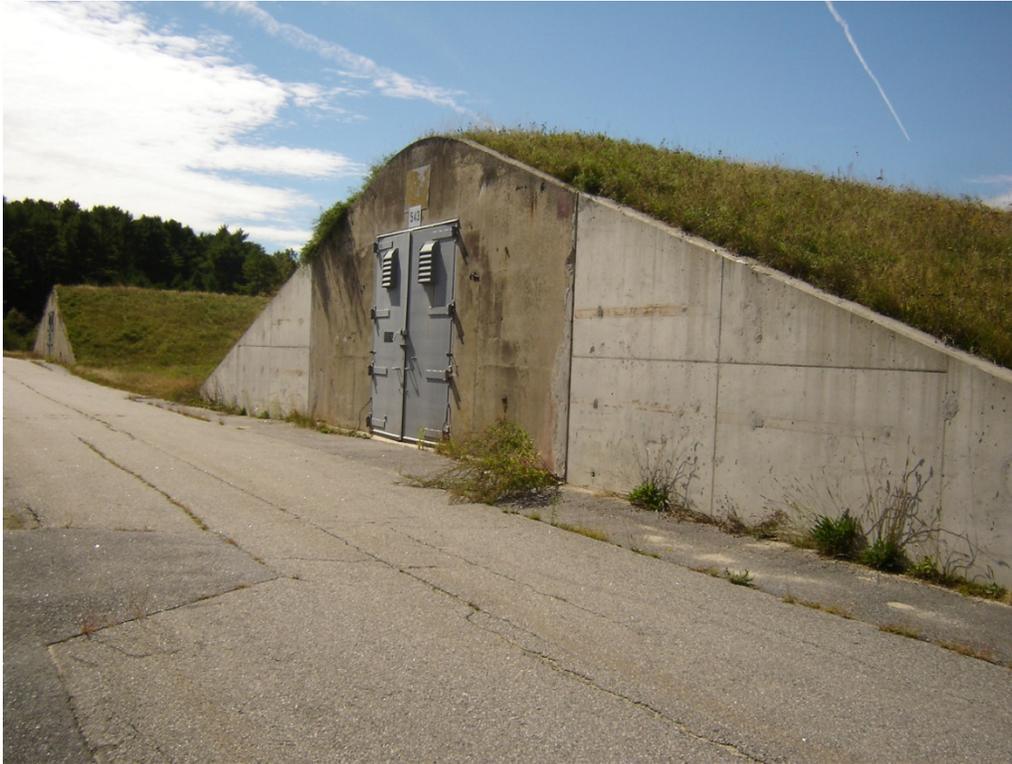
At the time of inspection, Building 543 was in fair condition; the building was empty.

No. 1 Building 543 – High Explosive Magazine, NAS Brunswick
Building 543 northeastern elevation

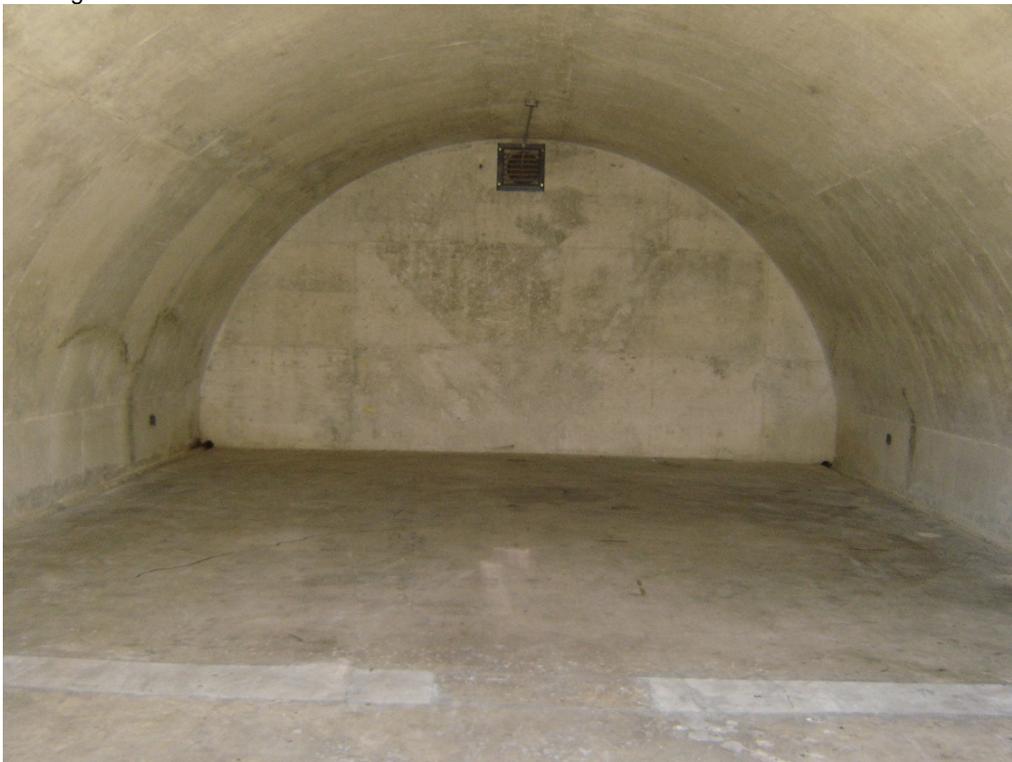
- At the time of inspection, Building 543 was vacant and in fair condition.
- No evidence of current or past hazardous waste generation was observed.
- No signs of a past release (staining, unusual odors, stressed vegetation, etc.) were observed.
- No modifications to the structure, which may conceal signs of a past release, were observed.
- Some localized rusted areas were observed on the exterior of the blast doors, where paint had deteriorated. No loose or flaking paint was observed on the interior of the blast doors.
- No floor drains were observed.

No. 2 Building 543 – High Explosive Magazine, NAS Brunswick
Building 543 interior (pre-cleaning).

Tetra Tech's cleaning subcontractor, TK&K Services (TK&K), performed floor- and wall-cleaning activities at Buildings 543 and 544 on March 4, 2011. Prior to cleaning, wall openings were covered and sealed with polyethylene sheeting. The floor was then manually swept and then vacuumed with a high-efficiency particulate air (HEPA) vacuum. After sweeping and vacuuming, floors were sprayed with a 2-percent, lead-specific detergent solution with a degreaser, and were scrubbed and washed using a 2,500-pounds-per-square-inch (psi), hot-water pressure-washer. All cleaning wastewater was containerized using a wet-vacuum, placed in six 55-gallon drums, and transferred to the NAS Brunswick hazardous waste department for disposal. Upon completion, the Tetra Tech field representative performed a visual inspection of the cleaned areas.

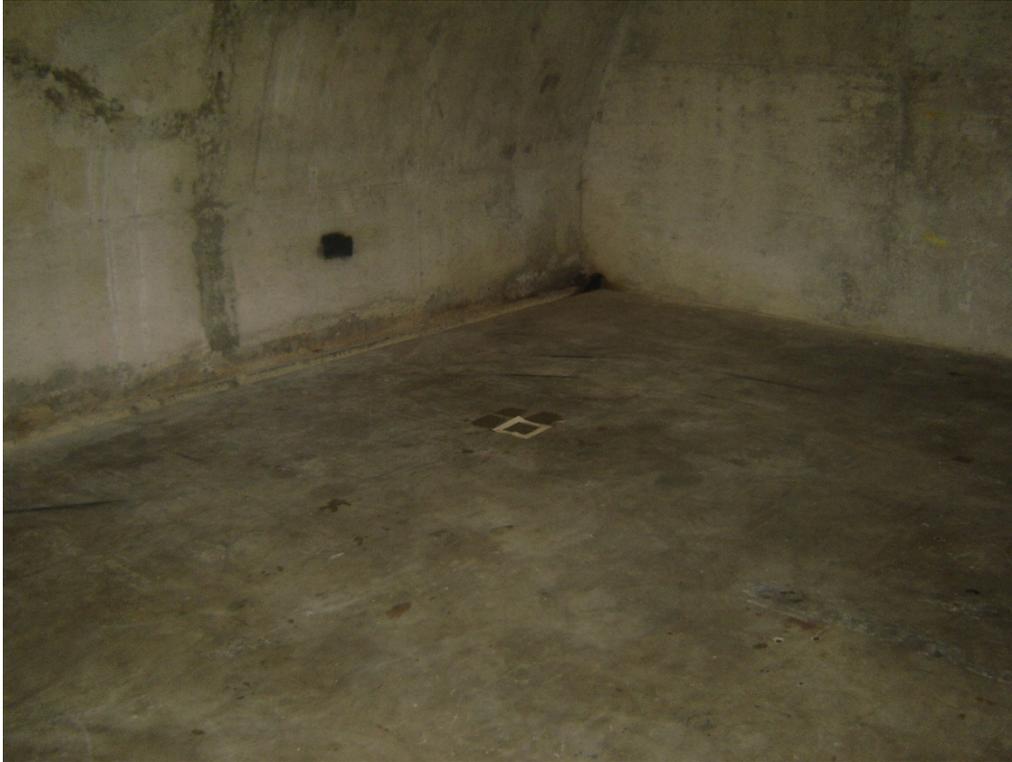
As shown in Tables 2 and 3, metals were not detected at levels exceeding the associated MEDEP-accepted clearance values for floors or walls in the post-cleaning, confirmatory wipe samples.

No. 3 Building 543 – High Explosive Magazine, NAS Brunswick
Building 543 interior (post-cleaning).

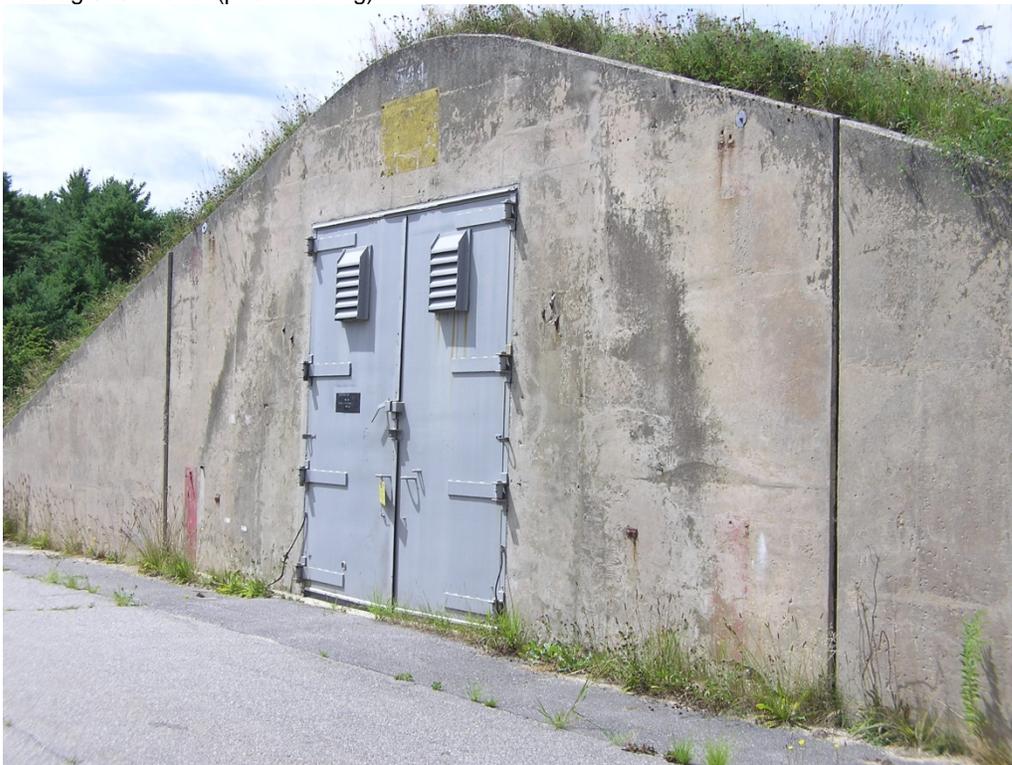
At the time of inspection, Building 544 was in fair condition; the building was empty.

No. 4 Building 544 – High Explosive Magazine, NAS Brunswick
Building 544 northeastern elevation.

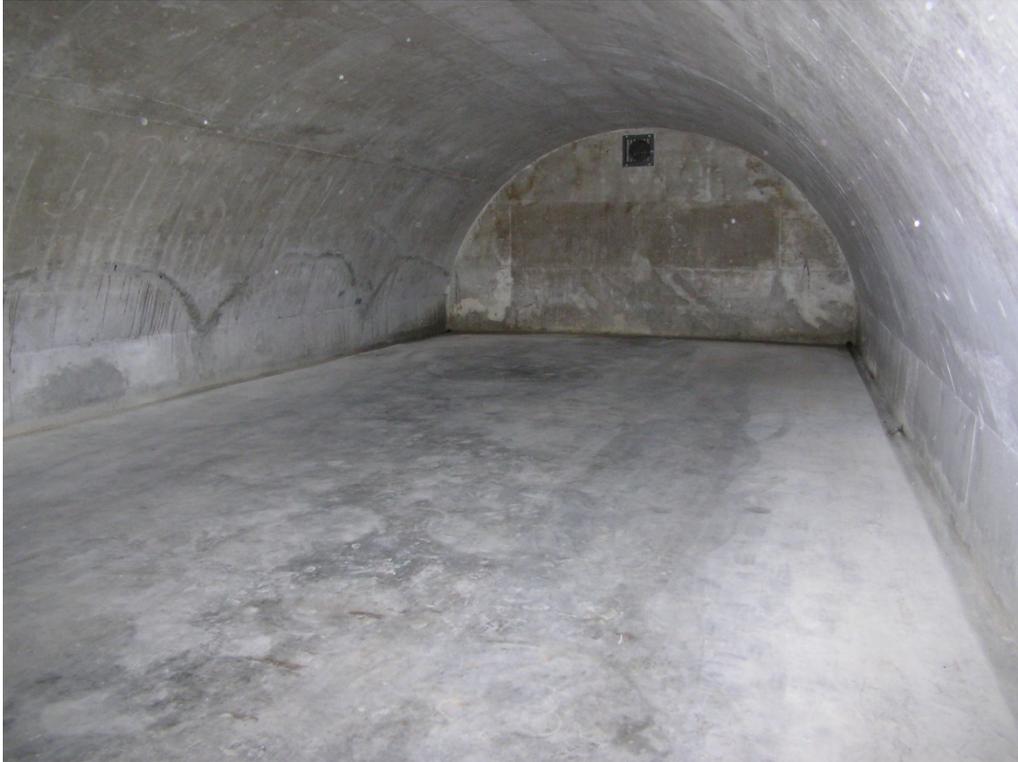
- At the time of inspection, Building 544 was vacant and in fair condition.
- No evidence of current or past hazardous waste generation was observed.
- Staining of the concrete floor was observed in the rear of the magazine.
- No modifications to the structure, which may conceal signs of a past release, were observed.
- Some localized rusted areas were observed on the exterior of the blast doors, where paint had deteriorated. No loose or flaking paint was observed on the interior of the blast doors.
- No floor drains were observed.

Staining were observed on the floor of the rear of the magazine. No modifications to the structure, which may conceal signs of a past release, were observed.

No. 5 Building 544 – High Explosive Magazine, NAS Brunswick
Building 544 interior (pre-cleaning).

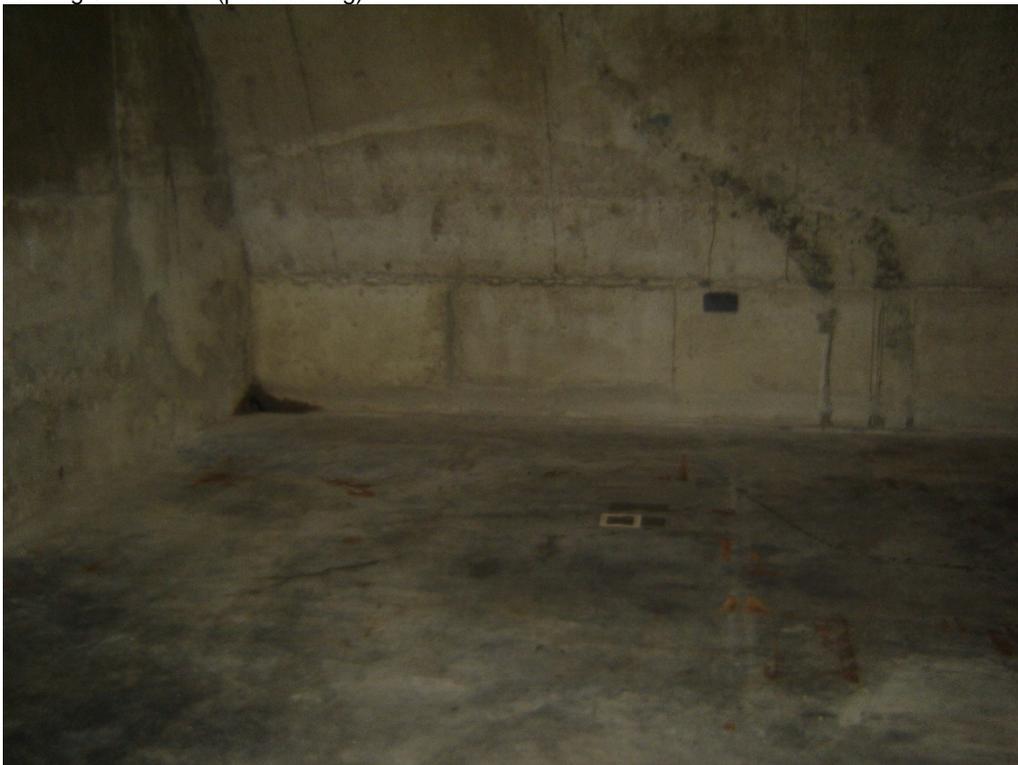
No. 6 Building 544 – High Explosive Magazine, NAS Brunswick
Building 544 interior (post-cleaning).
