FINAL RESOURCE CONSERVATION AND RECOVERY ACT PARTIAL CLOSURE REPORT
FOR BUILDING 288 WITH TRANSMITTAL LETTER NAS BRUNSWICK ME
4/6/2011
NAS BRUNSWICK

RCRA PARTIAL CLOSURE REPORT
for
BUILDING 288 – AMMO STORAGE FACILITY
NAVAL AIR STATION BRUNSWICK, MAINE
USEPA IDENTIFICATION NUMBER ME8170022018
MARCH 2011

**HWSA INSPECTION FORM
HAZARDOUS WASTE STORAGE AREAS CLOSURE
NAS BRUNSWICK
BRUNSWICK, MAINE
CTO WE22**

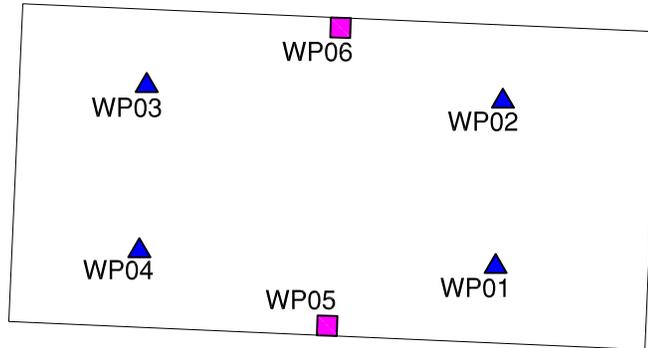
PRE-CLEANING SAMPLE LOCATIONS

On September 30, 2010, wipe samples were collected from the Building interior floors and walls. A total of six locations were sampled (Figure 3). The wipe samples were collected with cotton gauze saturated with dilute nitric acid (1:4 nitric acid to distilled water), for RCRA metals analysis. A 10-centimeter (cm) by 10-cm sampling area was wiped with the cotton gauze while applying moderate pressure. Wipe samples were submitted for analysis by Tetra Tech's subcontracted analytical laboratory, Analytics Environmental Laboratories (Analytics). The resulting analytical data underwent limited data validation consisting of blank contamination evaluation and completeness evaluation.

As shown in Table 1, lead was detected at levels exceeding the MEDEP lead criterion for floors ($40 \mu\text{g}/\text{ft}^2$) at all four floor-wipe sample locations. Arsenic and cadmium were both detected at levels exceeding the associated clearance values (36 and $140 \mu\text{g}/\text{ft}^2$, respectively) at two of the four floor-wipe locations. No exceedances of the metal clearance values were reported for the two wall-wipe sample locations.

Based on the analytical results, cleaning of Building 288 was required to remove metals-contaminated residue from the floor (including lead), where residue was present at levels that exceeded the associated MEDEP lead criterion for settled dust on floors and exceeded the associated MEDEP-accepted clearance values for other metals in settled dust (cleaning is discussed in Section 6).

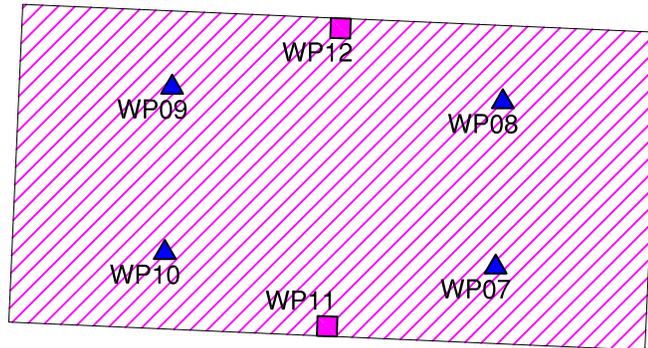
POST-CLEANING SAMPLE LOCATIONS

On March 25, 2011, four post-cleaning, confirmatory floor-wipe samples and two wall-wipe samples were collected (Figure 3). Wipe samples were collected for RCRA 8 metals analysis, using cotton gauze saturated with deionized water. A 10-centimeter (cm) by 10-cm sampling area was wiped with the cotton gauze while applying moderate pressure. Wipe samples were submitted for analysis by Tetra Tech's subcontracted analytical laboratory, Katahdin Analytical Services (Katahdin). The resulting analytical data underwent limited data validation consisting of field duplicate evaluation, blank contamination evaluation, and completeness evaluation. The post-cleaning wipe sample results for Building 288 are shown in Table 2.

As shown in Table 2, metals were not detected at levels exceeding the associated MEDEP-accepted clearance values for floors or walls in the post-cleaning, confirmatory wipe samples.

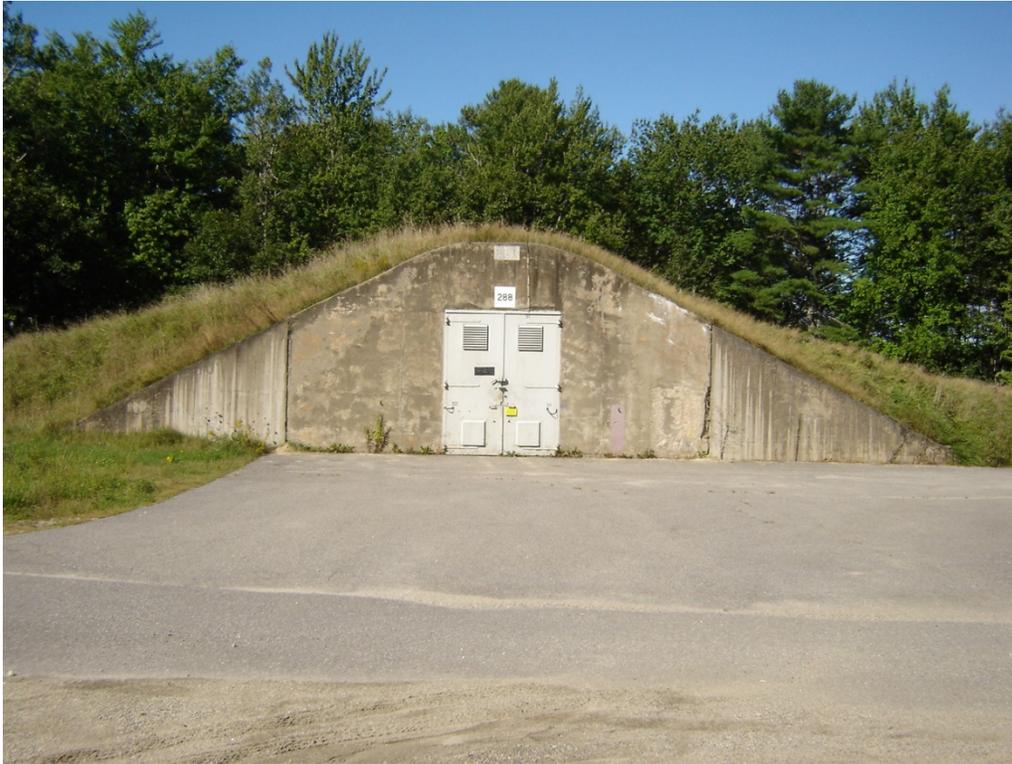
No. 1 Building 288 – Ammo Storage Facility, NAS Brunswick September 16, 2010
Building 288 eastern elevation

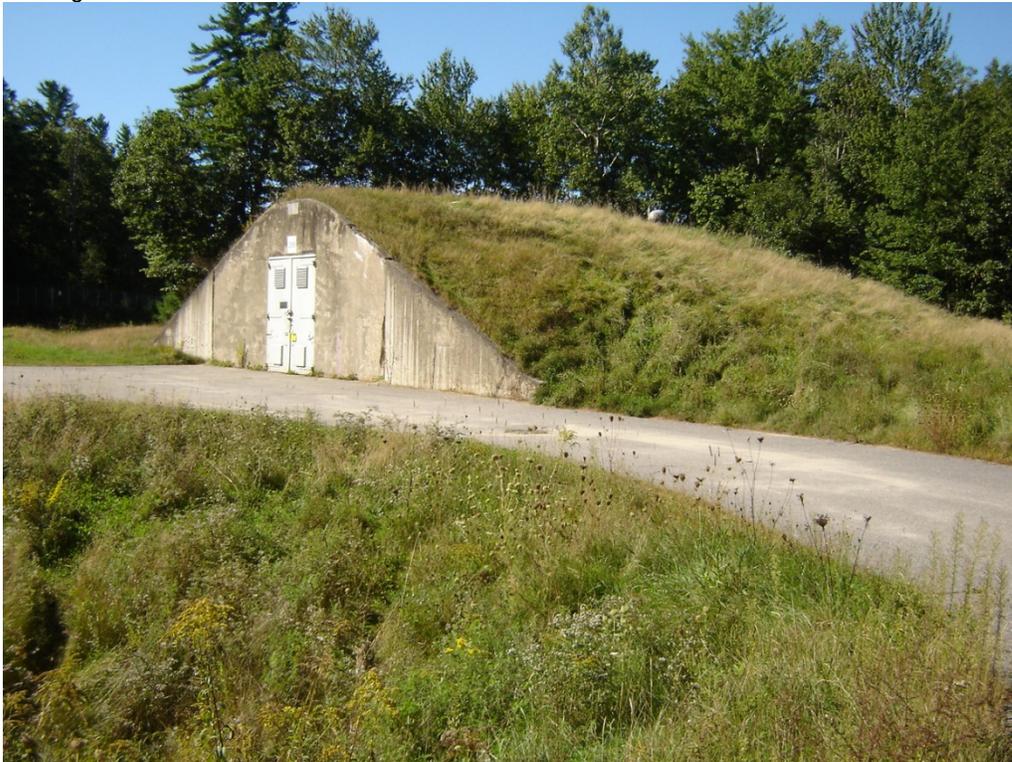
No. 2 Building 288 – Ammo Storage Facility, NAS Brunswick September 16, 2010
Building 288 northeastern elevation

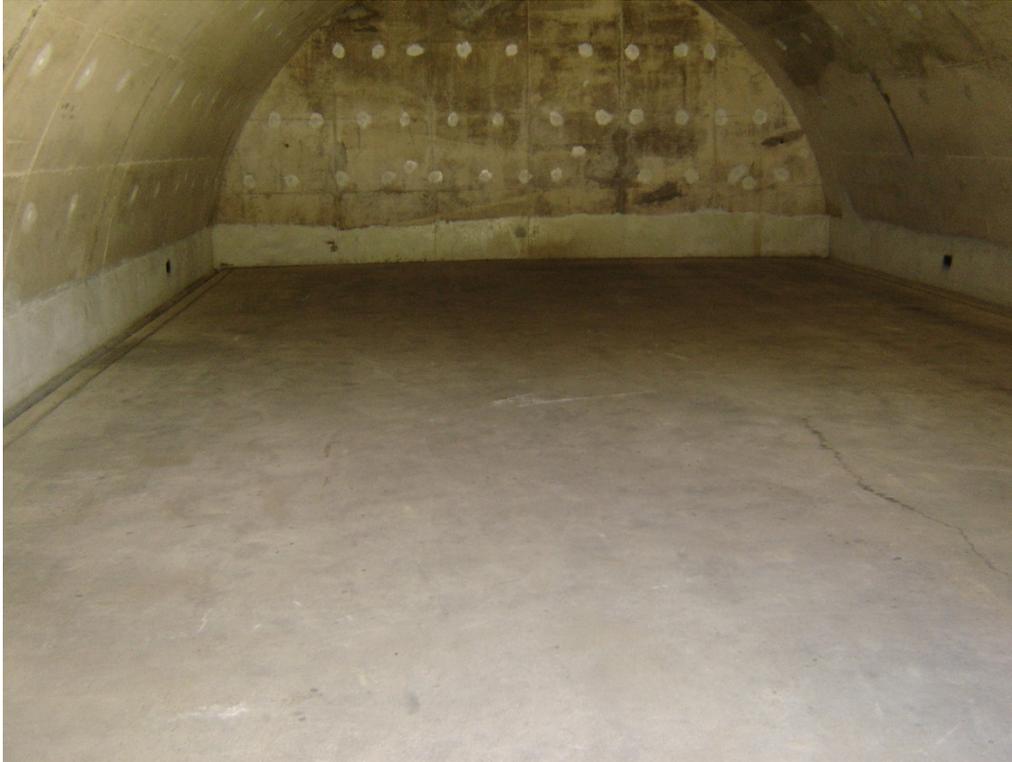
Minor staining in the back half of the magazine was observed.

No. 3 Building 288 – Ammo Storage Facility, NAS Brunswick September 16, 2010
Building 288 interior (pre-cleaning)
