FINAL RESOURCE CONSERVATION AND RECOVERY ACT PARTIAL CLOSURE REPORT
FOR GOLF COURSE AREA PARCEL WITH TRANSMITTAL LETTER NAS BRUNSWICK ME
4/6/2011
NAS BRUNSWICK

Subj: Final RCRA Partial Closure Report for Golf Course Area Parcel

RCRA PARTIAL CLOSURE REPORT
for
GOLF COURSE AREA
NAVAL AIR STATION BRUNSWICK, MAINE
USEPA IDENTIFICATION NUMBER ME8170022018
APRIL 2011

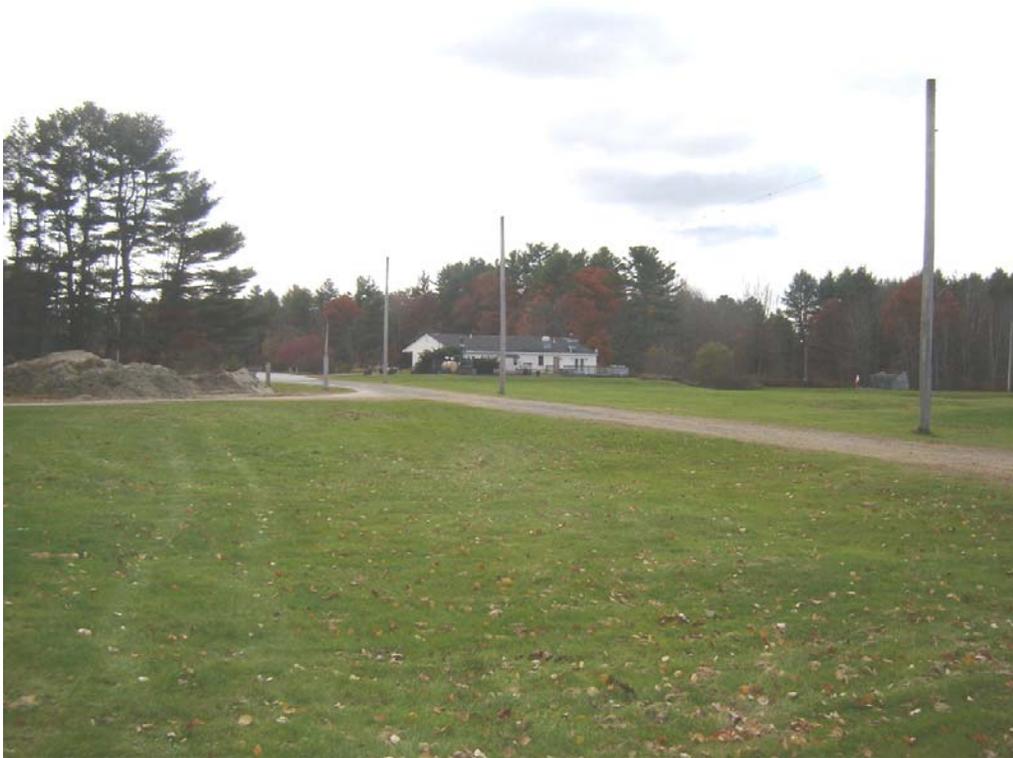
- One double-walled-steel AST (A78.0) was observed on the northern side of Building 78. The AST was used for No.1 heating oil.
- A pole-mounted-style transformer was observed in the vicinity of Building 78, southwest of the building and south of Middle Bay Road.

No. 3 Golf Course Area, NAS Brunswick November 3, 2010
Building 78 Club Clubhouse – view looking southwest from maintenance area

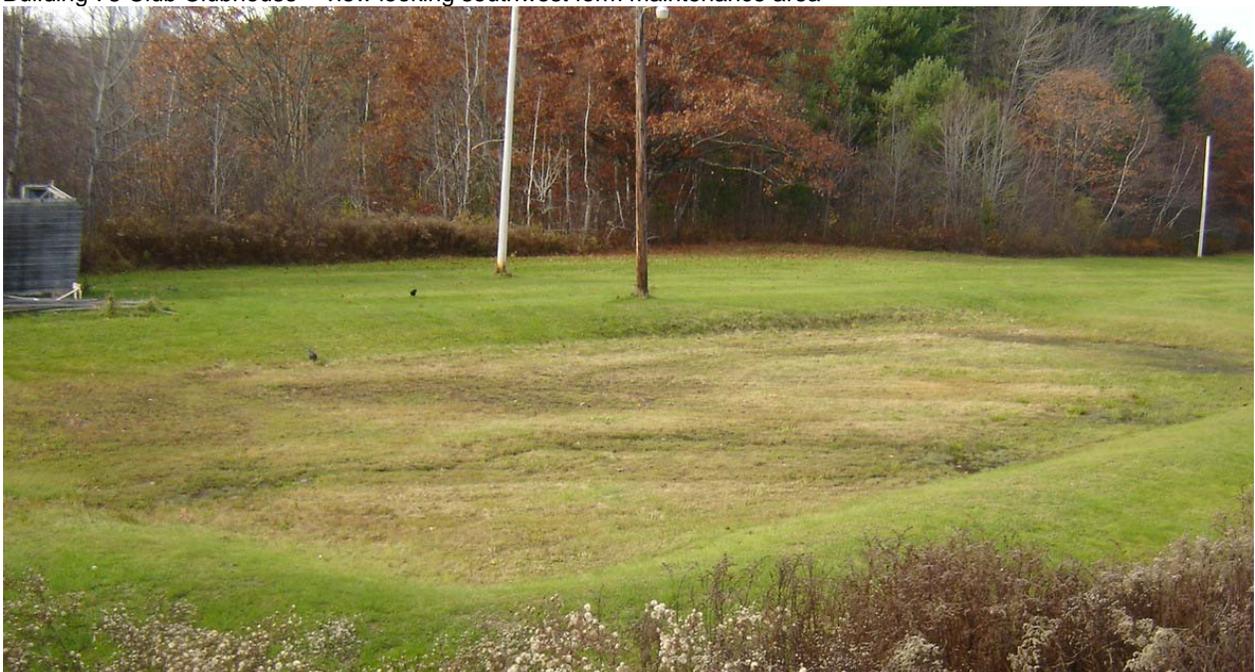
- In the 1984 aerial photograph, Building 39 is shown to the north of the current Building 34 location.
- In the 1989 aerial photograph, the outdoor skating rink and warming hut are present to

No. 4 Golf Course Area, NAS Brunswick November 3, 2010
Outdoor skating area northeast of Building 78 Club Clubhouse; warming shack (in disrepair) visible at left of frame

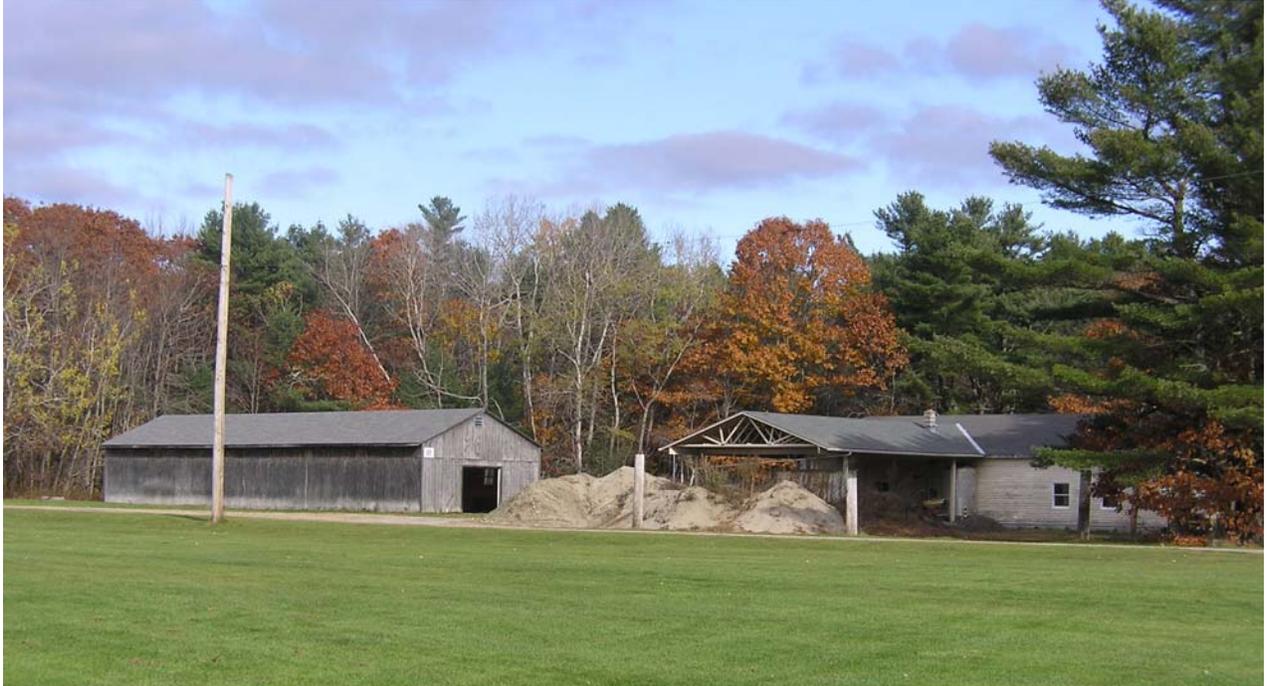
- Stockpiled material was observed in a staging area on the west side of Building 39. Most of this material (approximately 20 cubic yards) consists of street sweepings generated during the removal of sand that was applied to roadways at the base in winter. According to NAS Brunswick MWR personnel, this material is used as fill material for golf course repairs. Two smaller stockpiles (less than 3 cubic yards) of sand and asphalt material, also reported to be used in golf course maintenance activities, were observed.

No. 5 Golf Course Area, NAS Brunswick November 3, 2010
Building 18, 22 and 39 – view from southeast; material stockpiles in center of frame

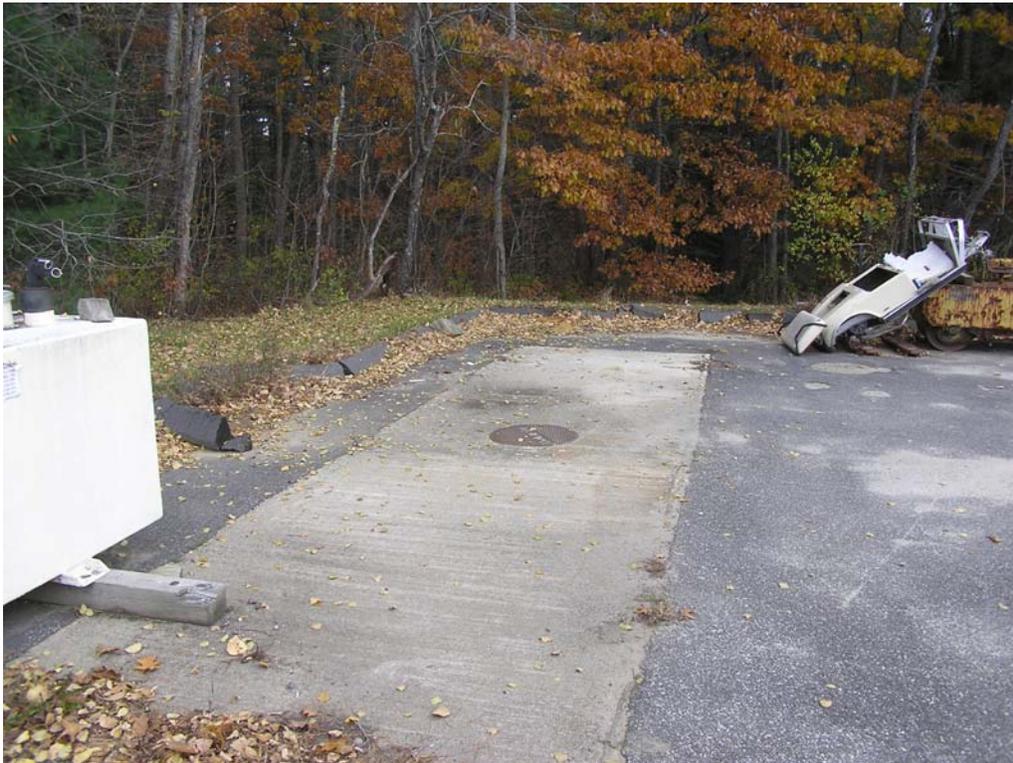
According to NAS Brunswick records, a steel chamber oil/water separator (O/W separator) with an oil capacity of 5,000 gallons is located northeast of Building 39 (Golf Maintenance) (Figure 2). The O/W separator treats stormwater from parking area north of Building 39, where three AST (A39.2, A39.3, and A39.4) are located, and discharges through an outfall into the unnamed tributary to Merriconeag Stream, located east of Building 39. The O/W separator receives no discharge from the interior of Buildings 18, 22 or 39, and is serviced annually as part of the base O/W separator maintenance program. The servicing of the O/W separator included removal of accumulated petroleum products and excessive sludge, and proper disposal of all collected petroleum-contaminated water, petroleum products, and sludge. This O/W separator was cleaned on March 29, 2011 during the most recent cleaning event (Clean Harbors, 2011). The water and sludges removed from the O/W separators during this base-wide cleaning event are collectively disposed of as non-hazardous, oil-contaminated liquid and solids (Clean Harbors, 2010).

- Most of the area is wooded and undeveloped, except for the landscaped portions of the golf course, which comprises the northern portion of the area.
- An O/W separator was observed northeast of Building 39. The O/W separator discharges east of the parking lot to an unnamed tributary located to the east.

No. 6 Golf Course Area, NAS Brunswick November 3, 2010
O/W Separator at paved area north of Building 39 – view looking east; waste oil AST 39.4 at right of frame

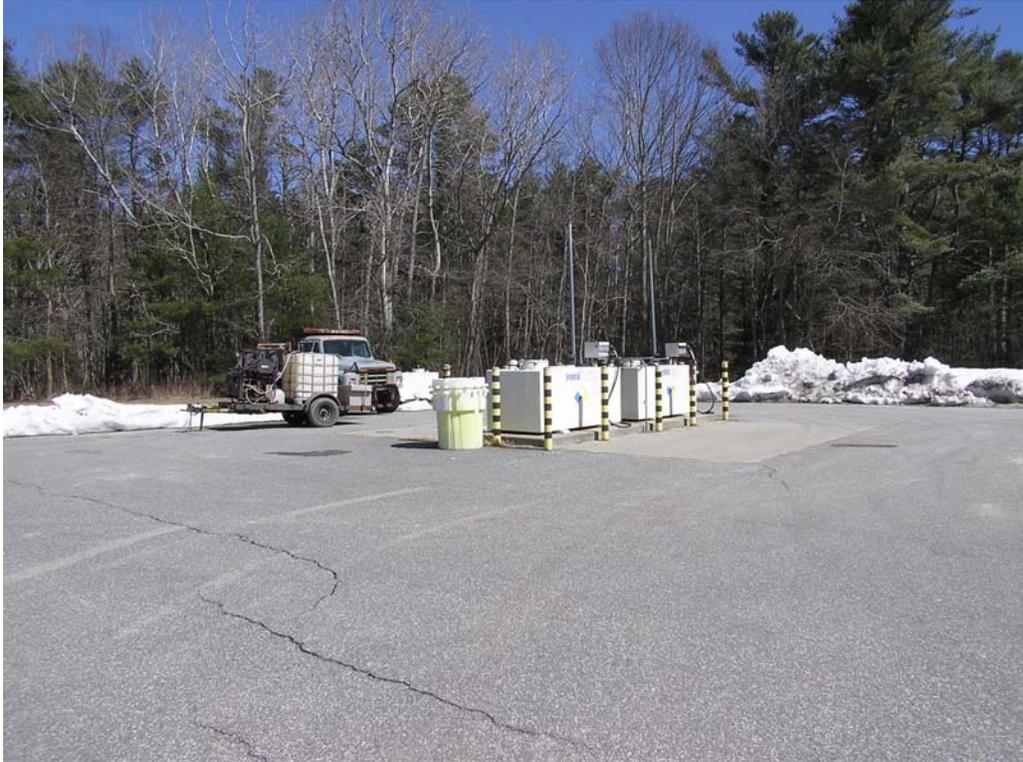
- Three double-walled-steel ASTs (A39.2, A39.3 and A39.4) were observed on the northern side of Building 39. The ASTs were used for storage of gasoline, diesel fuel, and waste oil, respectively.

No. 7 Golf Course Area, NAS Brunswick March 29, 2011
Double-walled, steel gasoline and diesel ASTs at paved area north of Building 39

Based on the findings of this investigation, with the exception of five ASTs located within the Golf Course Area that are planned for cleaning and closure in early April 2011, the hazardous waste closure of the Golf Course Area was completed in accordance with the provisions of MEDEP Regulations Chapter 851, Standards for Generators of Hazardous Waste, Section 11.

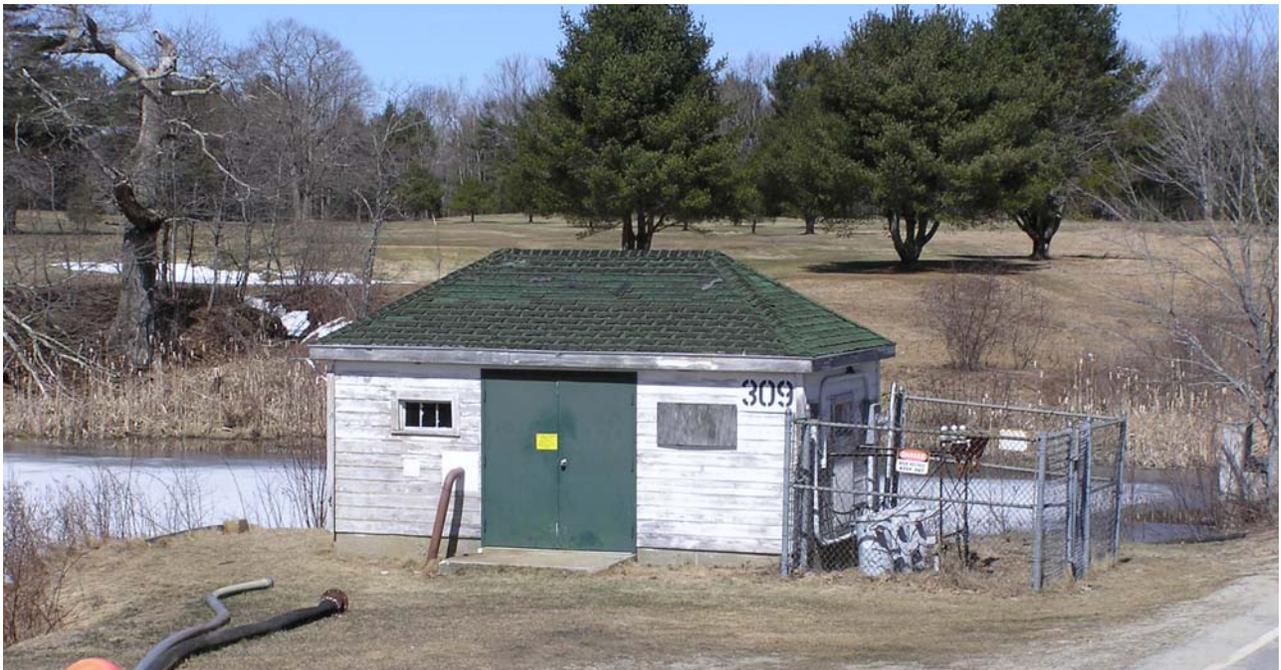
No. 8 Golf Course Area, NAS Brunswick March 29, 2011
Golf Pump House southeast elevation; photograph taken following loose paint removal
