SEWAGE TREATMENT PLAN SITE 7 TEST PIT REPORT FORMER NAS SOUTH
WEYMOUTH MA
10/06/2014
TETRA TECH EC INC

**SUBJECT: N62470-13-D-8007, CONTRACT TASK ORDER WE02
CERCLA and MCP SUPPORT
FORMER NAVAL AIR STATION, SOUTH WEYMOUTH, MA
SEWAGE TREATMENT PLANT SITE 7 TEST PIT REPORT**

Test Pit Log

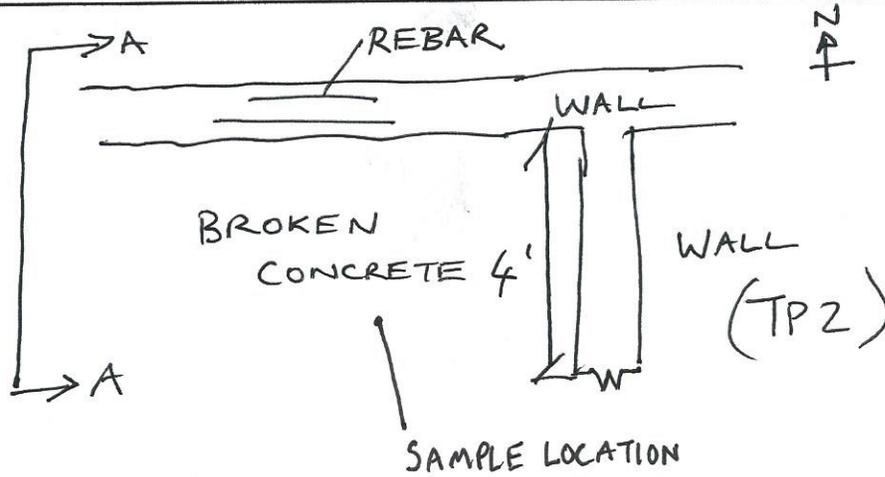
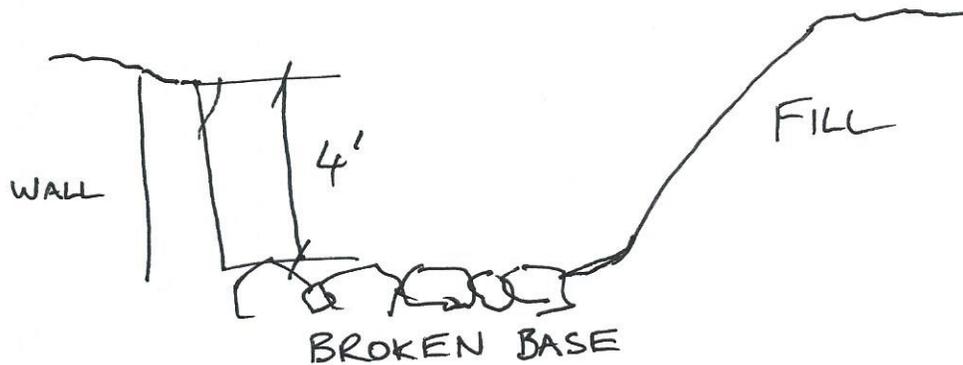
Test Pit Number: TP1

Test Pit 1 is located within the secondary settling tanks. The north wall was identified along with a wall that separates the secondary tank from the chlorine mixing and detention tank. The structure was previously demolished to two feet below the existing surface. The floor was four feet below the existing surface and a broken floor was felt with the excavator. Groundwater was present above the floor. A soil sample was collected from the broken tank bottom at approximately four feet below existing surface.

Description: SECONDARY TANK CHLORINE MIXING AND DETENTION CHAMBER

Notes: WALL OF SECONDARY SETTLING TANK FOUND TO EAST
DEMOED TO GRADE (2' BELOW EXISTING SURFACE)
BASE BROKEN.
WATER ABOVE BASE @ 2' BELOW GRADE

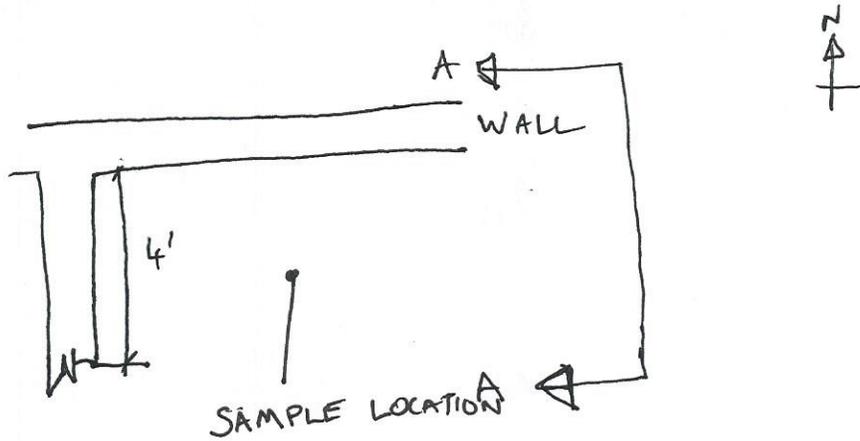
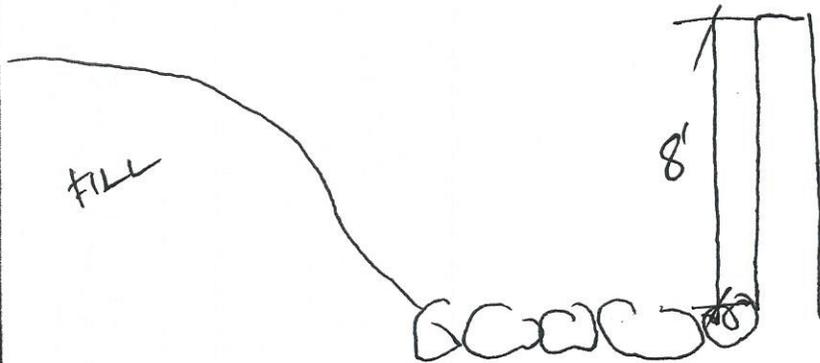
Test Pit Number: TP2

Test Pit 2 is adjacent to Test Pit 1 to the east of the separation wall. Again the north wall was identified and a broken floor was felt with the excavator at approximately eight feet below existing surface. A soil sample was collected from the broken tank bottom at approximately eight feet below existing surface.

Description: SECONDARY SETTLING TANK

Notes: EAST OF TP-1
DEMOED TO GRADE (2' BELOW EXISTING SURFACE)
BASE BROKEN
WATER AT 2' BELOW GRADE

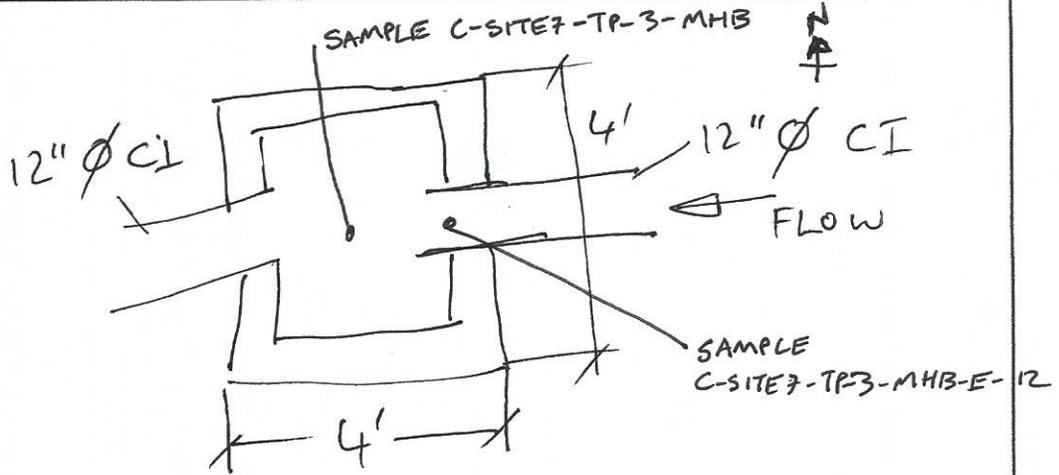
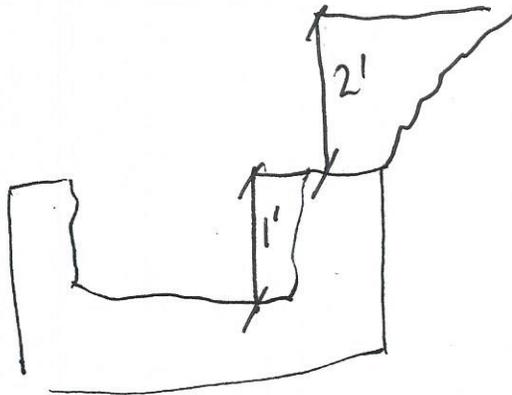
Test Pit Number: TP-3

Test Pit 3 is Manhole B in the secondary tank bypass system. The structure was previously demolished to two feet below existing surface, with a 12" diameter cast iron (CI) pipe entering the east wall and exiting the west wall. A soil sample was collected from the chamber floor at approximately three feet below existing surface, and another soil sample was collected from the incoming pipe on the eastern side of the manhole.

Description: MANHOLE B

DEMOED TO 2' BELOW GRADE

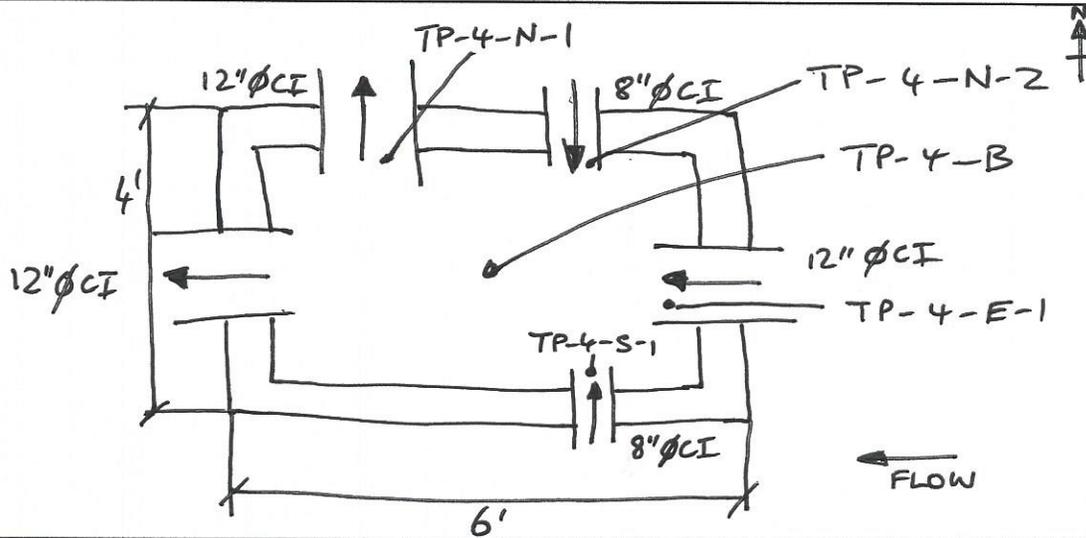
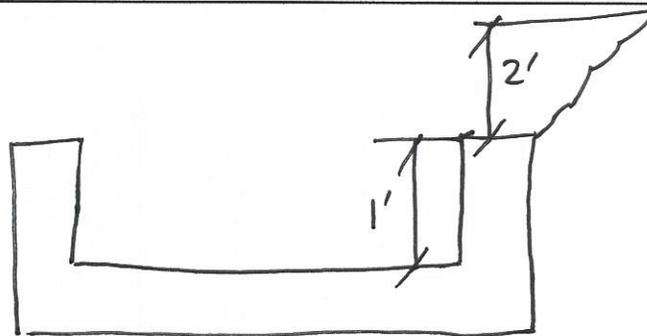
Test Pit Number: TP-4

Test Pit 4 is a chamber in the center of the site with a 12" diameter CI pipe from Manhole A (bypass for trickling filters) entering from the east, two 8" diameter CI pipes from each trickling filter on the north and south sides along with a 12" diameter CI pipe to Manhole B (bypass for secondary tanks) and a 12" diameter CI pipe to the secondary tanks. The structure was

previously demolished to two feet below existing surface and the floor and piping were intact. A soil sample was collected from the chamber floor at approximately three feet below existing surface. Soil samples were also collected from the incoming pipes and the outgoing pipe to Manhole B.

Description: CONNECTION CHAMBER.

PIPE FROM MANHOLE A 12" CI EAST
 PIPE FROM TRICKLING FILTER (SOUTH) 8" CI
 PIPE FROM TRICKLING FILTER (NORTH) 8" CI
 PIPE TO MANHOLE B 12" CI NORTH
 PIPE TO SECONDARY TANKS 12" CI WEST

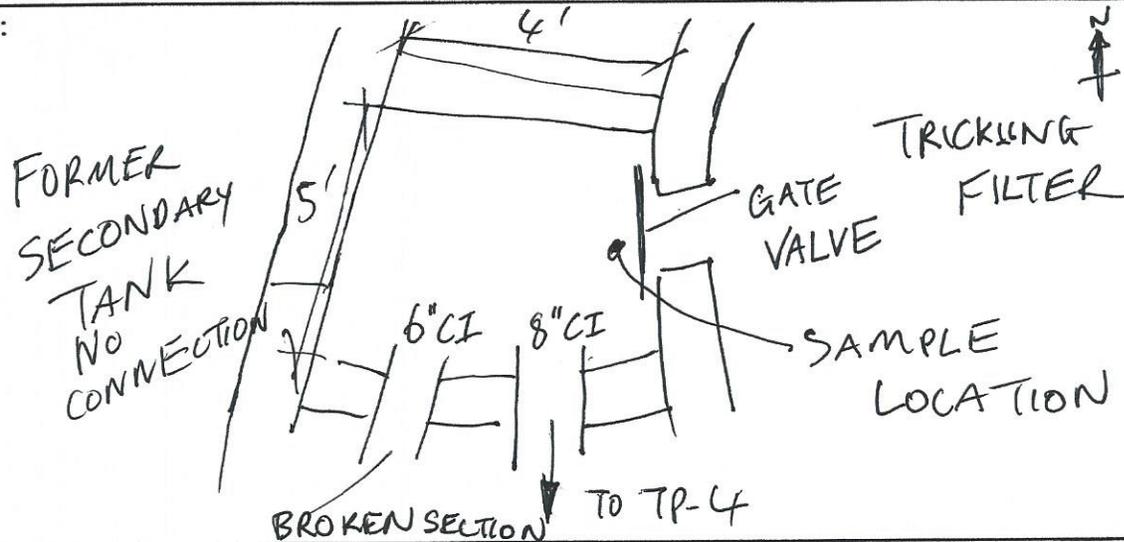
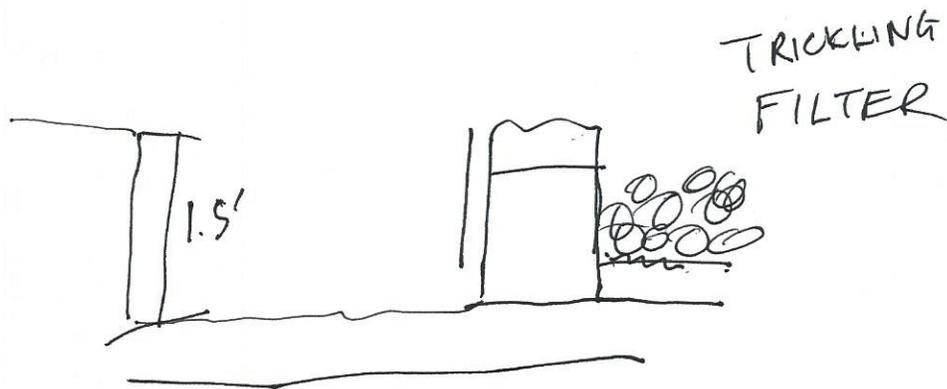
Test Pit Number: TP 5

Test Pit 5 is located in a chamber adjacent to the northern trickling filter. The east side contains a gate valve to the trickling filter and the south side has an 8" CI pipe to the TP-4 chamber and 6" CI pipe that appeared to connect to the other trickling filter but was broken to less than two feet in length. The structure was previously demolished to two feet below existing surface and the floor was solid. A soil sample was collected from the floor of the structure at approximately three and a half feet below existing surface.

Description: BOX BETWEEN NORTH TRICKLING FILTER AND
FORMER SECONDARY TANK.

Notes: 6" ϕ CI PIPE SECTION BROKEN OFF 1.5' LONG
DEMOED TO 2" BELOW GRADE

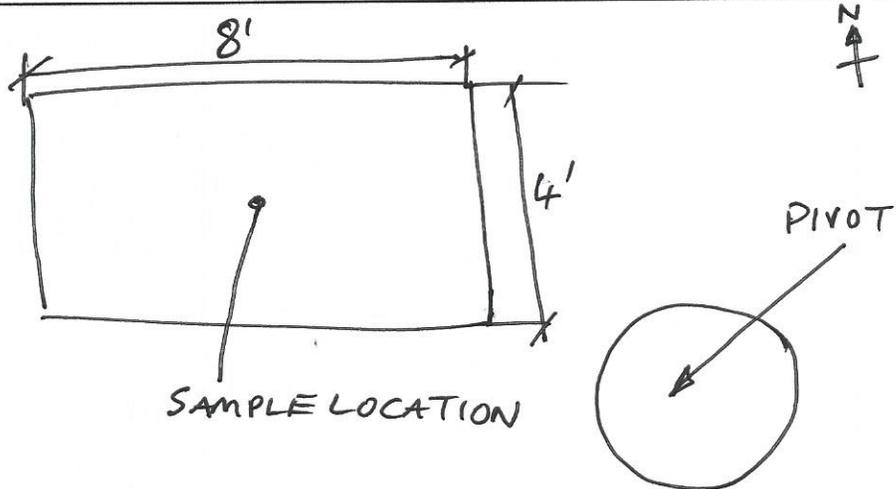
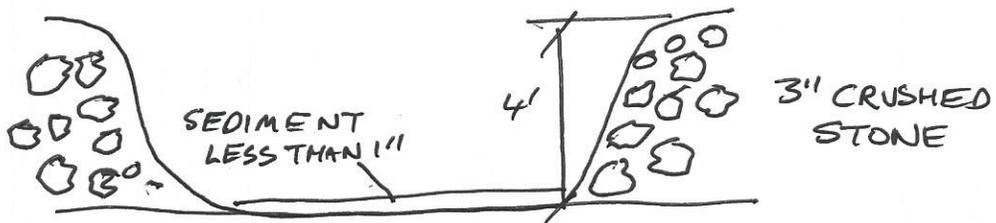
Test Pit Number: TP-6

Test Pit 6 is located at the same location as sample A2-B-04-B in the southern trickling filter. The filter was previously demolished to the existing grade and filled with 3" crushed stone that appears to have been removed and replaced in the structure during demolition as broken pieces of the underdrain tiles were intermixed with the stone and the underdrain was not present directly above the floor. The floor was intact. Most of the material in the filter was 3" crushed rock with only a small layer of soil less than one inch directly on the concrete floor. A soil sample was collected from the floor of the structure at approximately four feet below existing surface.

Description: SOUTH TRICKLING FILTER

DEMOED TO 2" BELOW GRADE (AT CURRENT GRADE)
SOLID FLOOR

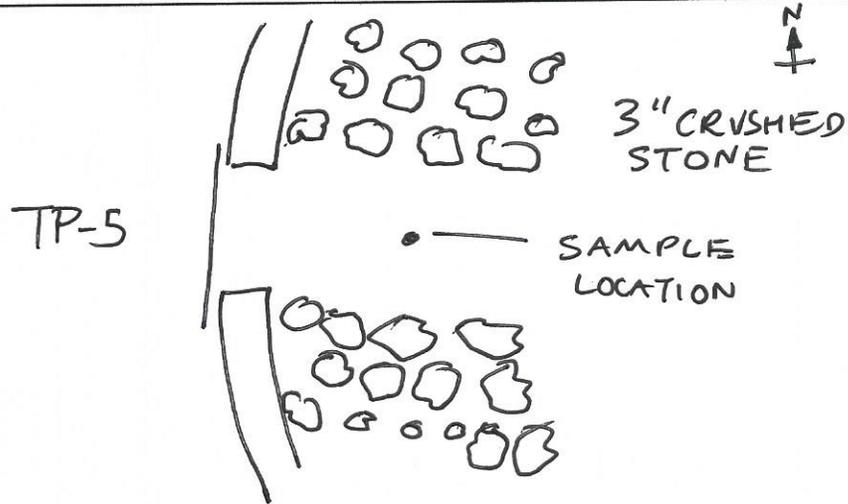
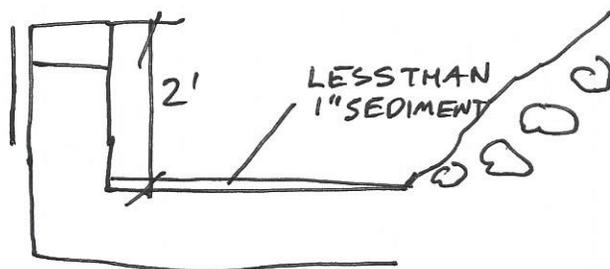
Test Pit Number: TP-7

Test Pit 7 is located adjacent to Test Pit 5 in the northern trickling filter. The filter was previously demolished to the existing grade and filled with 3" crushed stone that that appears to have been removed and replaced in the structure during demolition as broken pieces of the underdrain tiles were intermixed with the stone and the underdrain was not present directly above the floor. The floor was intact. Most of the material in the filter was 3" crushed rock with only a small layer of soil less than one inch directly on the concrete floor. A soil sample was collected from the floor of the structure at approximately four feet below existing surface.

Description: NORTH TRICKLING FILTER

Notes: DEMOED TO 2' BELOW GRADE
SOME BASE TILES MIXED IN WITH 3" CRUSHED
STONE AND FILL
SOLID FLOOR

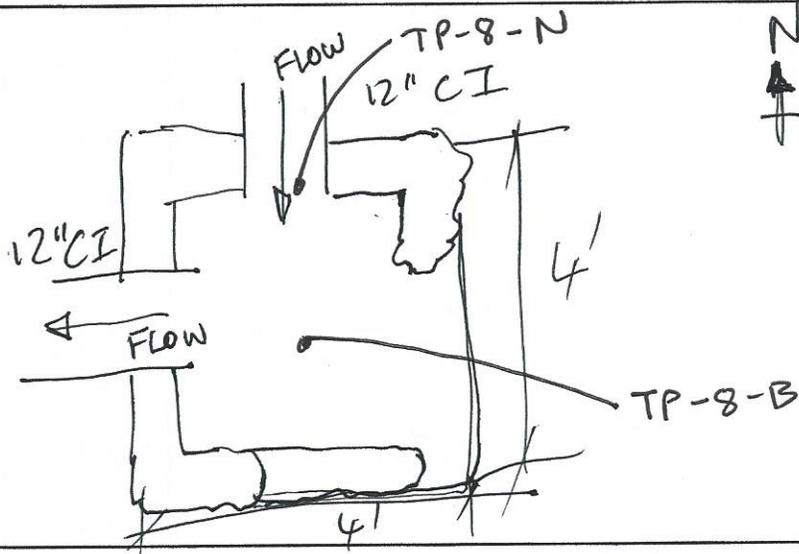
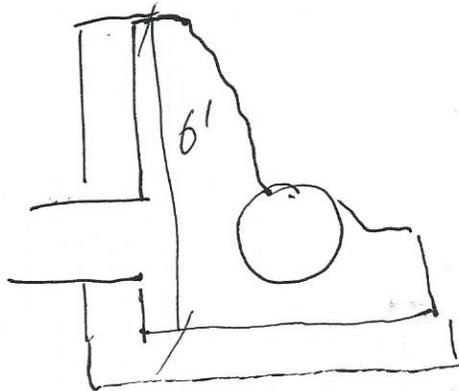
Test Pit Number: TP-8

Test Pit 8 is located in Manhole A in the Trickling Filter bypass system with a 12" diameter CI pipe from the primary tank in the north wall and a 12" diameter CI pipe to the TP-4 chamber in the west wall. The west wall was previously demolished to two feet below existing surface and the east was demolished to the base with the north and south walls tapering to meet the floor, which was intact. A soil sample was collected from the manhole floor at approximately eight feet below existing surface and a soil sample was collected from the incoming pipe on the northern side of the manhole.

Description: MANHOLE A

Notes: DEMO'ED TO 2' BELOW GRADE
12" CI FROM PRIMARY TANKS
12" CI TO COLLECTION CHAMBER TP4

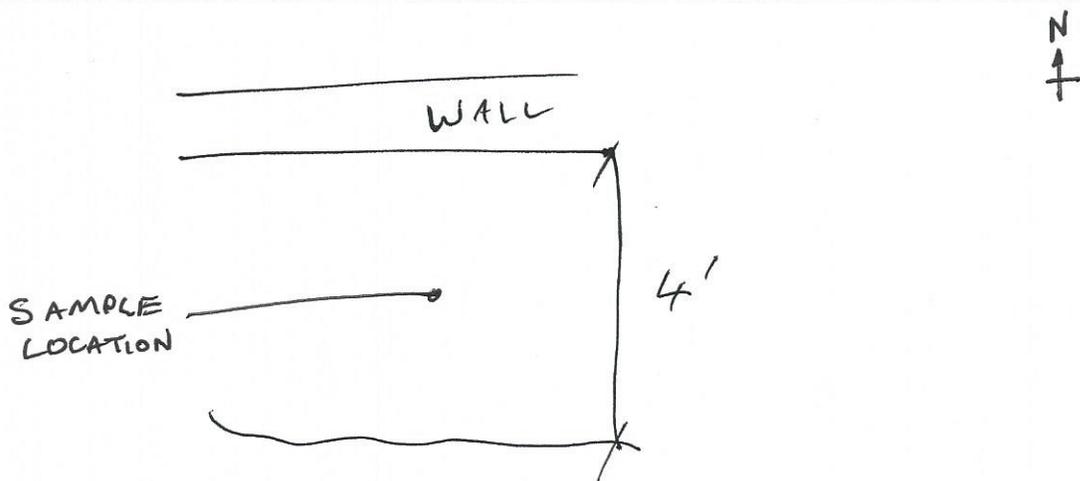
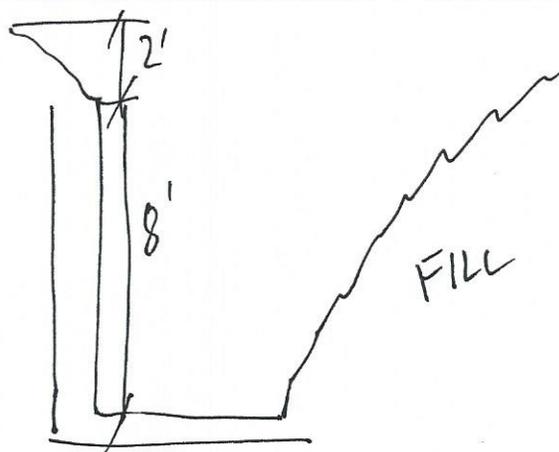
Test Pit Number: TP9

Test Pit 9 is located in the primary tanks. The north wall was identified. The structure was previously demolished to two feet below existing surface and an intact floor was found about 10 feet below existing surface. This tank was filled with material that resembled the 3" crushed stone and broken underdrain tile as in the northern trickling filter (Test Pit 7). A soil sample was collected from the floor of the structure at approximately 10 feet below existing surface.

Description: PRIMARY TANKS

Notes: FILLED WITH TRICKLING FILTER STONE
SOLID FLOOR
REMOVED TO 2' BELOW GRADE

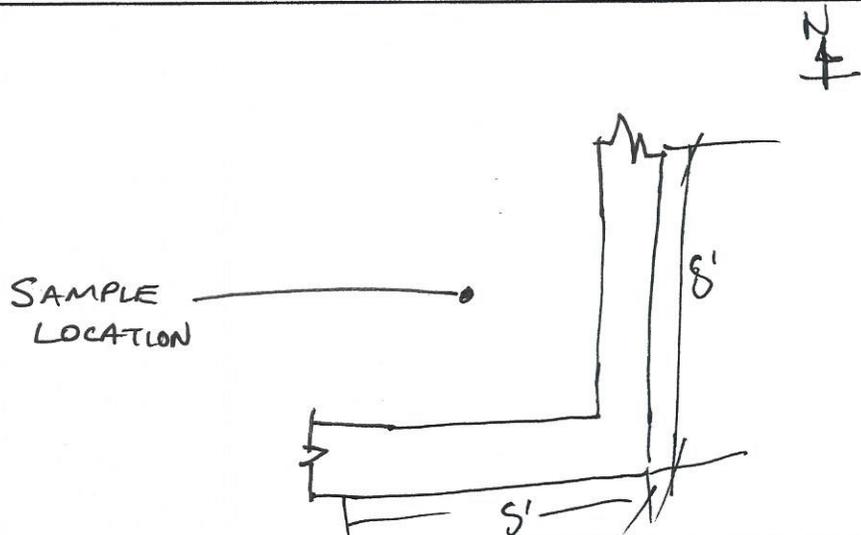
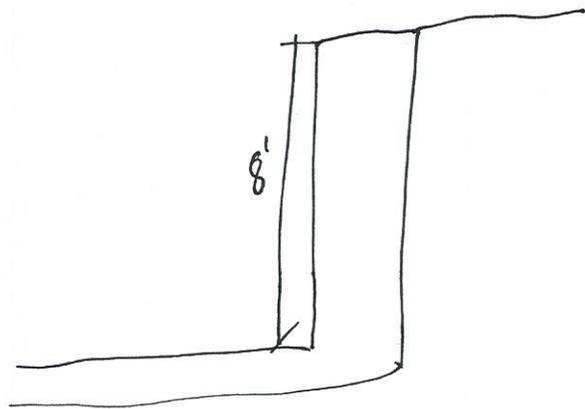
Test Pit Log	
Test Pit Number:	TP 10
Description:	FORMER PRIMARY TANK
Plan:

Test Pit 10 is located in the primary tank of the original treatment system. The south and east walls were identified. The structure was previously demolished to existing grade and the floor was solid at about eight feet below existing grade. The material encountered within one foot of the floor was black and exhibited a petroleum odor along with an 86.2 ppm reading on a PID. A

soil sample was collected from the floor of the structure at approximately 10 feet below existing surface. The primary tank is 22' long by 19' wide by 8' deep and contains an approximate volume of 124 cubic yards of material.

Notes:	PID READING 86.2 PPM BLACK SMELLY MATERIAL ON FLOOR SOLID FLOOR. DEMOLISHED TO GRADE
Samples:	C-SITE 7 - TP - 10

The next proposed action is to remove the pipes and clean or remove the chambers that contain elevated levels of Arsenic, along with the material in the Former Primary Settling Tanks (TP-10). A second sample has been collected from the location of TP-10 and will be analyzed for the constituents of a waste characterization sample. In addition, holes will be broken in any tank floors that were found to be intact.

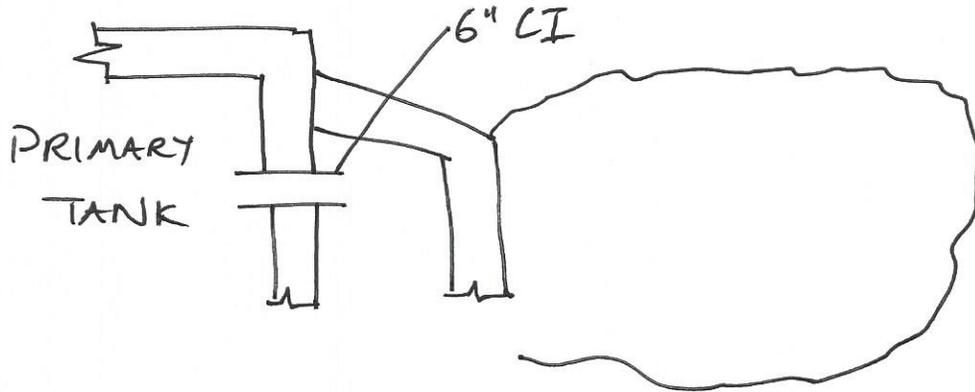
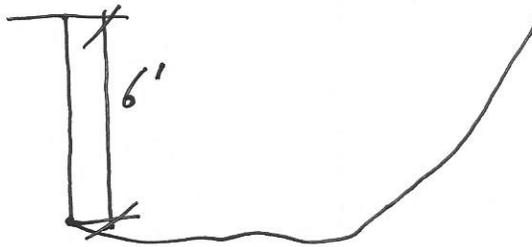
Test Pit Number: TP-11

Test Pit 11 was the stilling basin. No structure was located east of the primary tanks, indicating it had previously been removed. No sample was collected.

Description: STILLING BASIN

Notes: NOTHING LOCATED NO STRUCTURE
