LEAD BASE PAINT SURVEY OF 12 DUPLEX FAMILY UNITS SECTION 4 CNC
CHARLESTON SC
4/1/2001
PRECISION ENVIRONMENTAL MANAGEMENT, INC.

**LEAD BASE PAINT SURVEY OF
12 DUPLEX FAMILY UNITS AT
CHARLESTON NAVAL COMPLEX
CHARLESTON, SC**

April 5, 2001

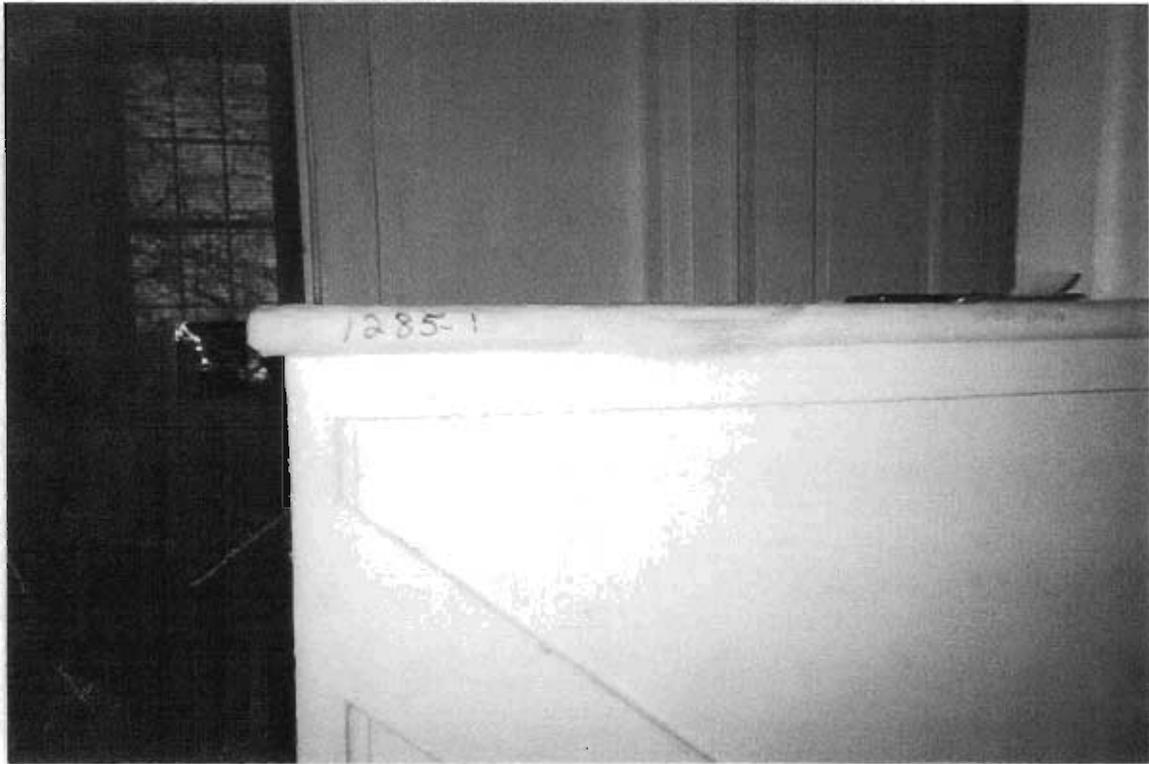
SAMPLE # 1285-1 STAIRCASE LEFT SIDE

Sample ID	Room	Building Component	Matrix	Date Collected	Damaged surface area-sq.ft
1285-1	Staircase	Staircase left side	Chips	03/13/01	8.7
1285-2	Room 3 1	Wall B	Chips	03/13/01

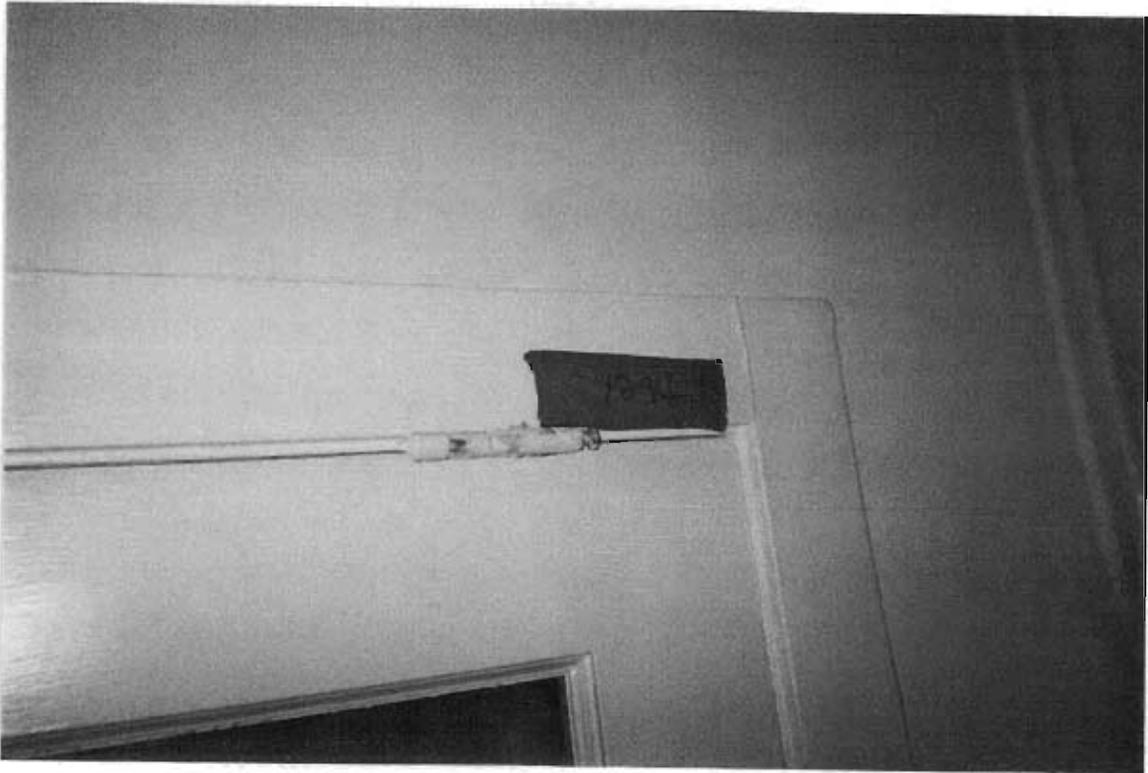
SAMPLE # 1294-1 ROOM # 1, WALL - B (LIVING ROOM; PORCH DOOR

Sample ID	Room	Building Component	Matrix	Date Collected	Damaged surface area-sq.ft
1294-1	Room # 1	Molding on Porch door	Chips	03/09/01	0.05
1294-2	Bathroom # 1	Ceiling	Chips	03/09/01	0.05
1294	Bathroom # 2	Bedroom wall		03/09/01	0.05

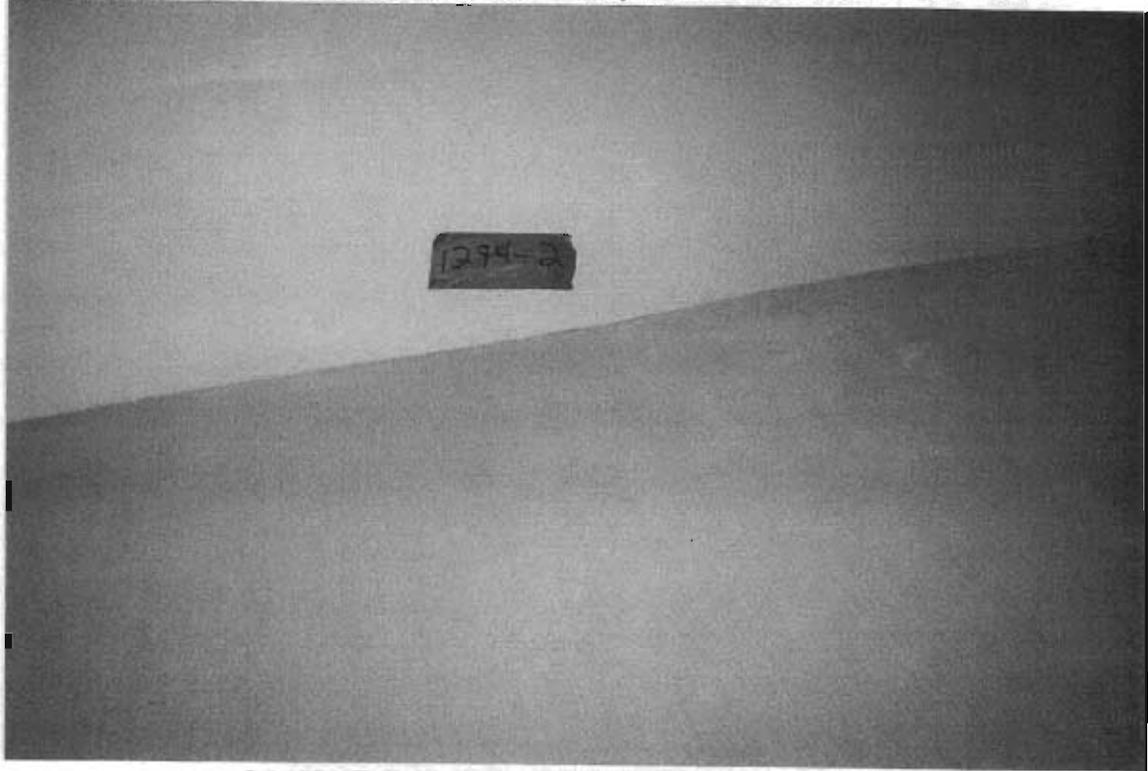
SAMPLE # 1294-2 BATHROOM # 1, CEILING

Sample near 2' x 4"
 1294-2 Ceiling

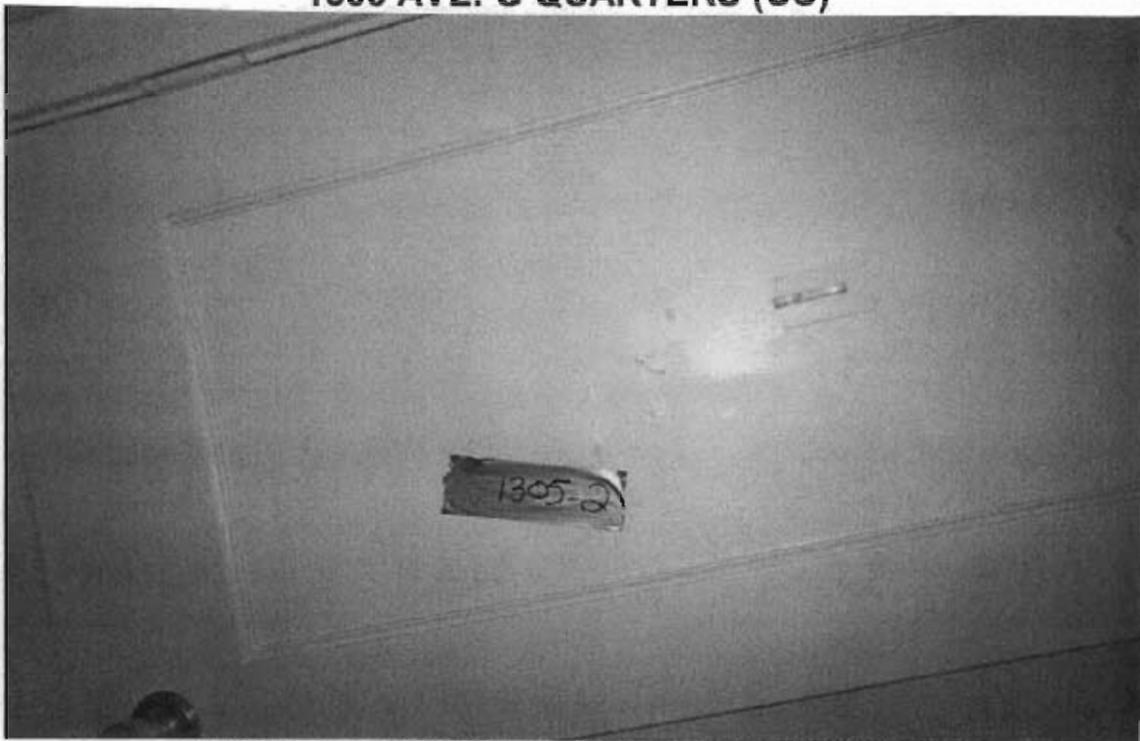
SAMPLE # 1305-2 BATHROOM #1, INTERIOR DOOR

- 1305-1 Mech Room door / substrate - wood 1 sq ft. damage area
- 1305-2 Bathroom #1 door / substrate - wood 1 sq ft. damage area
- 1305-3 Kitchen Ceiling - water damage - / substrate - sheet rock 1 sq ft damage

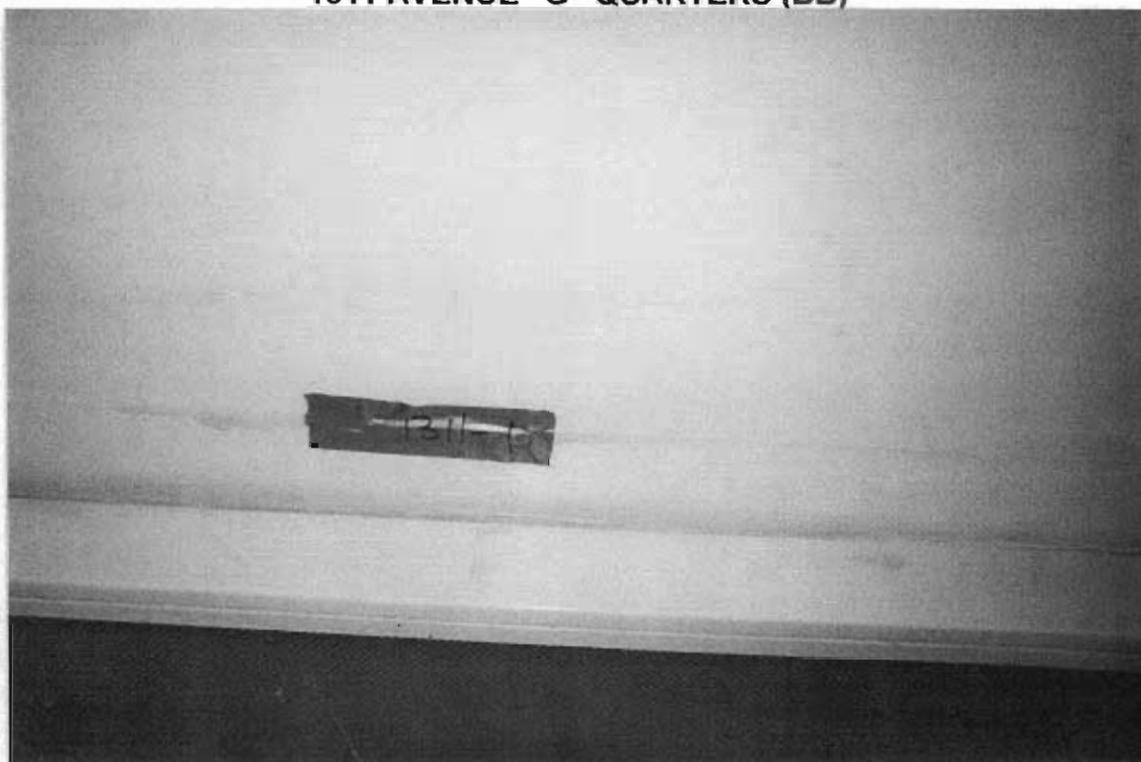
SAMPLE # 1311-1 KITCHEN CEILING

- 1311-1 Kitchen Ceiling - substrate sheetrock - cause by water damage 1 sq ft
- 1311-2 Bedroom #3 Baseboard - (B wall) substrate - wood - 1/2 sq ft
- 1311-3 Kitchen (A wall) Vent substrate - metal - 1/2 sq ft.

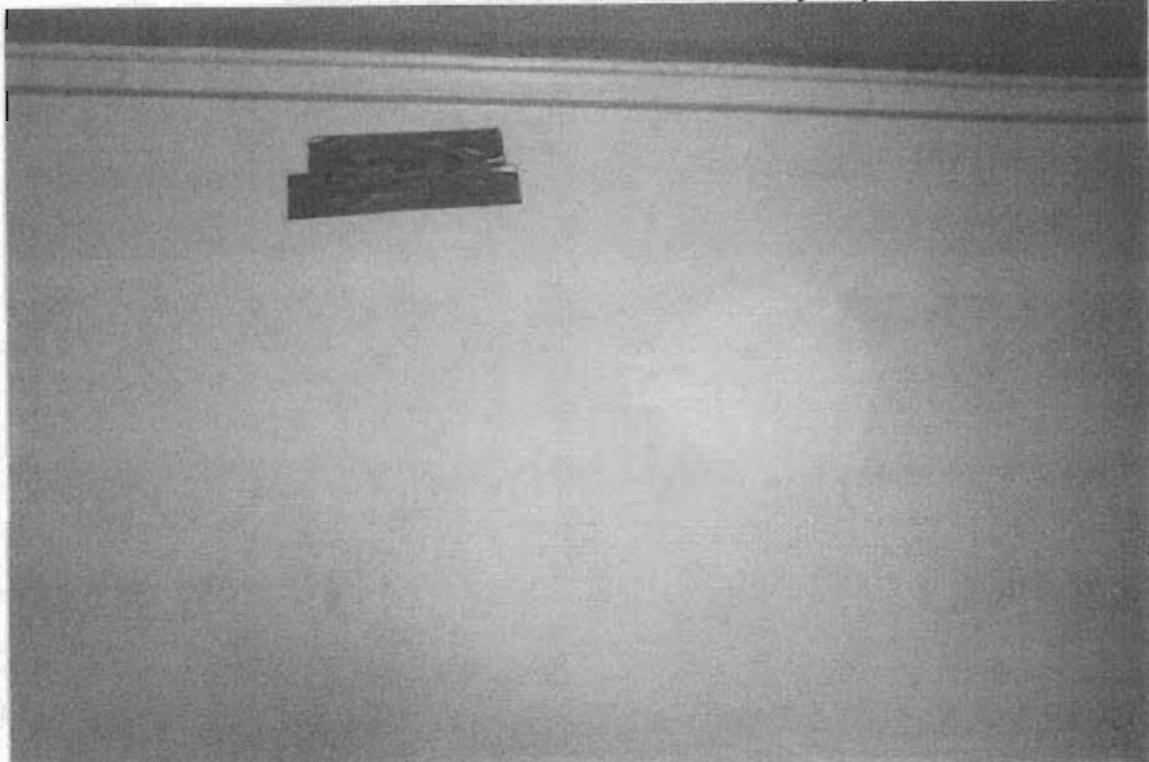
SAMPLE # 1356-2, BEDROOM # 1, WALL D, 2ND FLOOR, ROOM 1D

Sample ID	Room	Building Component	Matrix	Date Collected	Damaged surface area-sq.ft
1356-1	Living room # 1	Wall D	Chips	03/08/01	1.0
1356-2	Bedroom # 1	Wall D-2 nd floor room #1D	Chips	03/08/01	1.0
1356-3	Bedroom # 2	Wall D- Room 2 B	Chips	03/08/01	1.0
