ASBESTOS WALK-THRU INSPECTIONS PHASE 3 ROUND 2 CNC CHARLESTON SC
10/1/2002
CH2MHILL

PHASE III ASBESTOS WALK-THRU INSPECTIONS

(ROUND 2)

CH2MHILL / J.A. JONES

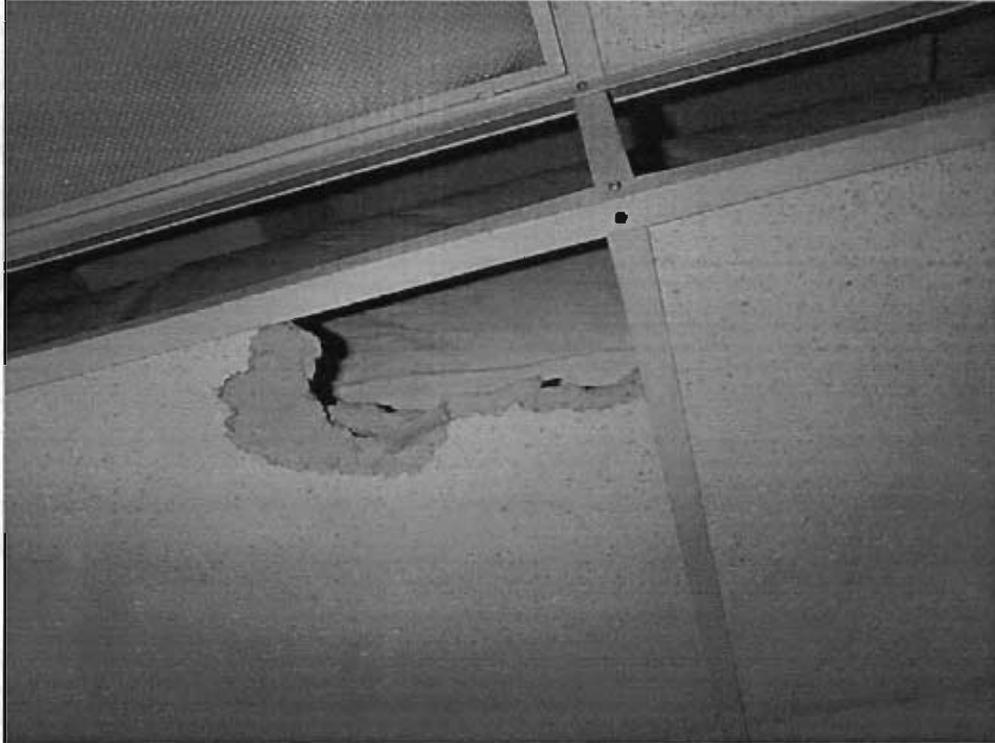
- H-10 - Ceiling tiles w/various size pinholes – friable – damaged
 - H-11 - 12" Light gray floor tile & mastic – non-friable – good condition
 - H-12 – Ventilation expansion joint – non-friable – good condition

Ceiling tiles – (H-10) damaged (NOT ACM)

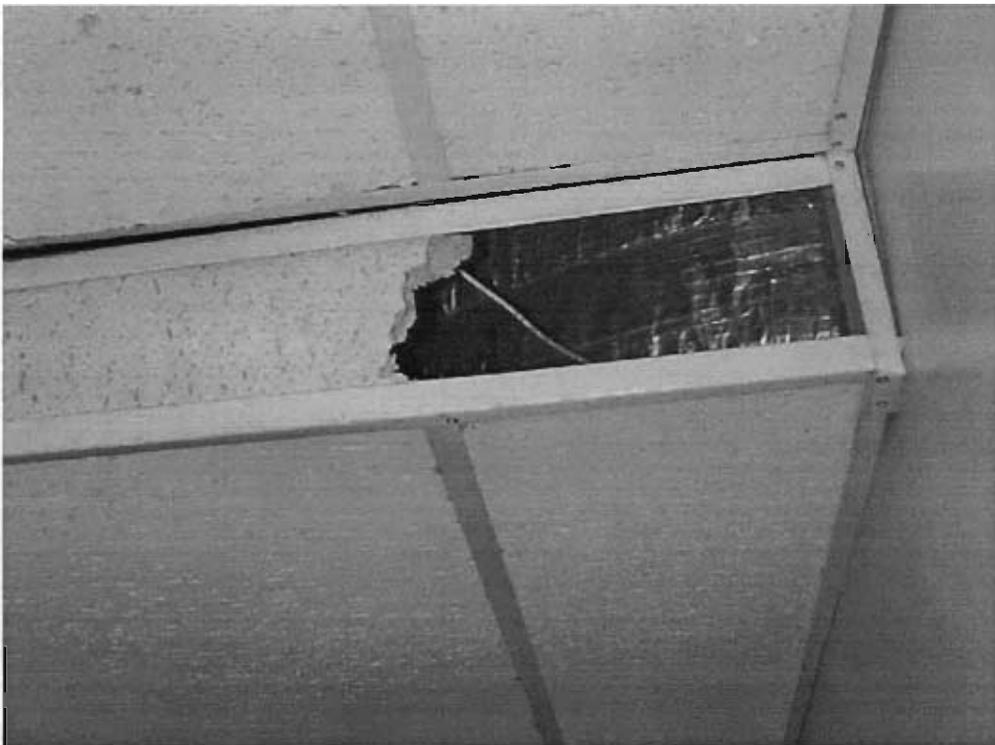
- H-7 – 12" Acoustical tiles w/pinholes – friable – good condition
 - H-8 - Ceiling tiles w/grooves & pinholes – friable – damaged
 - H-9 - 9" Green floor tile & mastic – non-friable – good condition

Ceiling tiles – (H-8) damaged (NOT ACM)

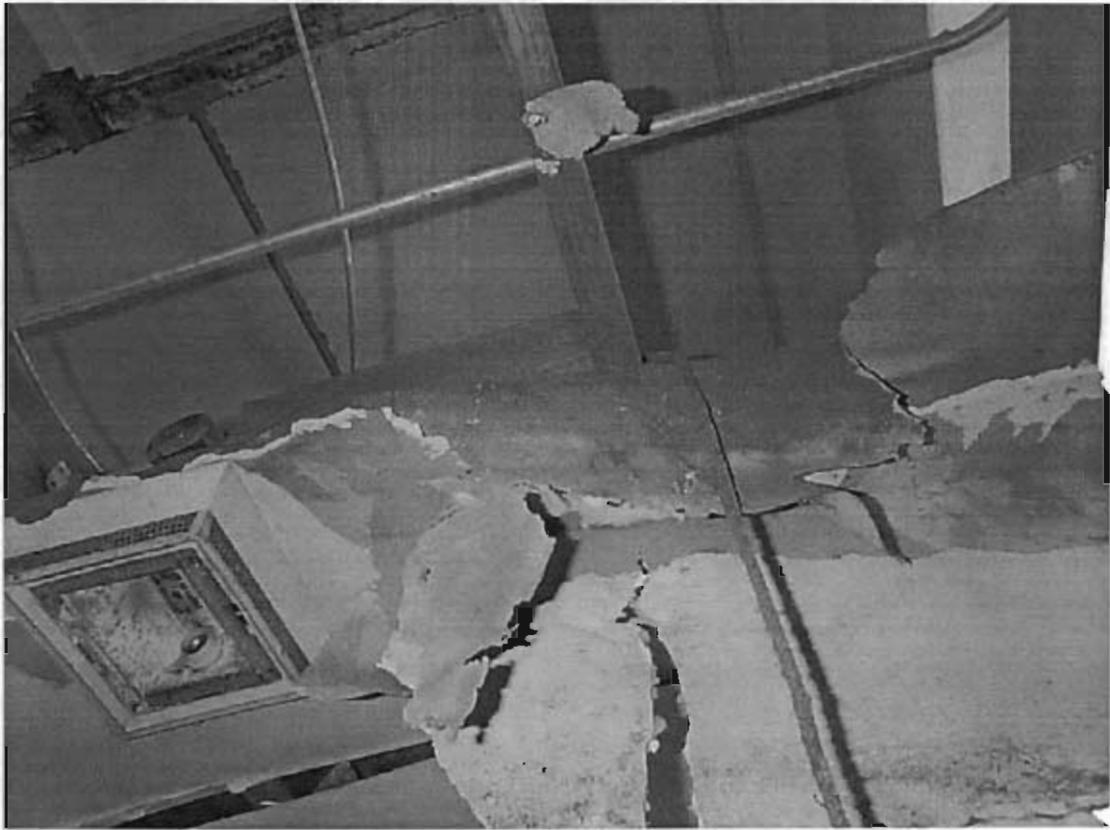
Suspect Matl. No.	Description	Approx. Quantity	Location(s)	Friable Y/N	Current Condition	Approx. % Damage (if Applicable)	Comments
1	TSI - HARD FITTINGS	200 Pcs	THROUGH OUT	Y	G	<1	
2	TSI PIPING	900 LF	THROUGHOUT	Y	G	<1	
3	SHEETROCK / MUD	300 SF	REST ROOM	Y	SD	40	
4	WINDOW GLAZING	350 LF	WINDOWS	N	D	10

Sheetrock / mud – (H-3) damaged (NOT ACM)

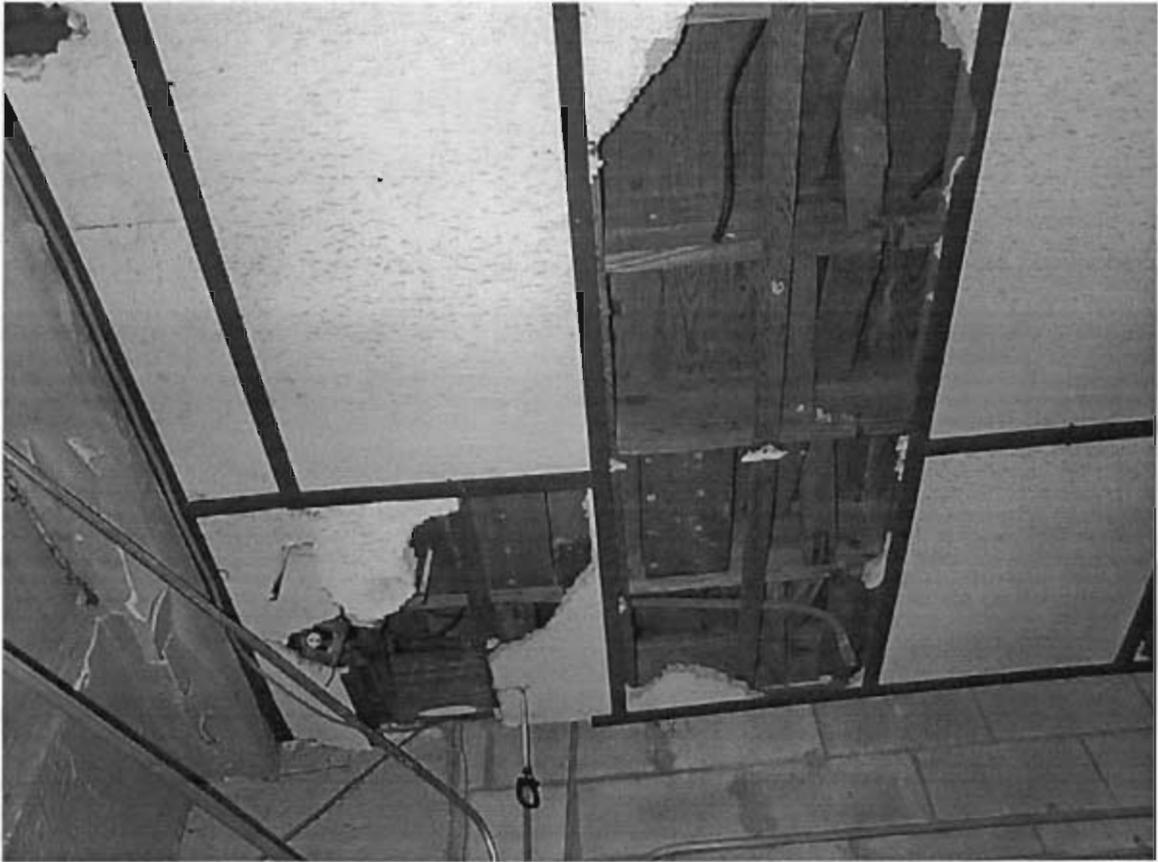
Suspect Matl. No.	Description	Approx. Quantity	Location(s)	Friable Y/N	Current Condition	Approx. % Damage (if Applicable)	Comments
1	CEILING TILE w/ GROOVES & PINHOLES	140 SF	OFFICE	Y	D	20	
2	SHEETROCK/MUD	120 SF	CLASSROOM	N	G		
3	12" LT. BROWN FLOOR TILE/MASTIC	300 SF	OFFICE	N	G

Ceiling tiles – (H-1) damaged (NOT ACM)
