COMPLETION REPORT PROCESS CLOSURE FOR SOLID WASTE MANAGEMENT UNIT 83
(SWMU83) BUILDING 9 FOUNDRY WITH TRANSMITTAL CNC CHARLESTON SC
4/11/1997
U S NAVY

**PROCESS CLOSURE FOR
SWMU 83 (BUILDING 9 FOUNDRY)
NAVAL BASE CHARLESTON
CHARLESTON, SC**

Subj: COMPLETION REPORT FOR PROCESS CLOSURE SWMU-83 FORMER BUILDING 9 FOUNDRY

March 25, 1997

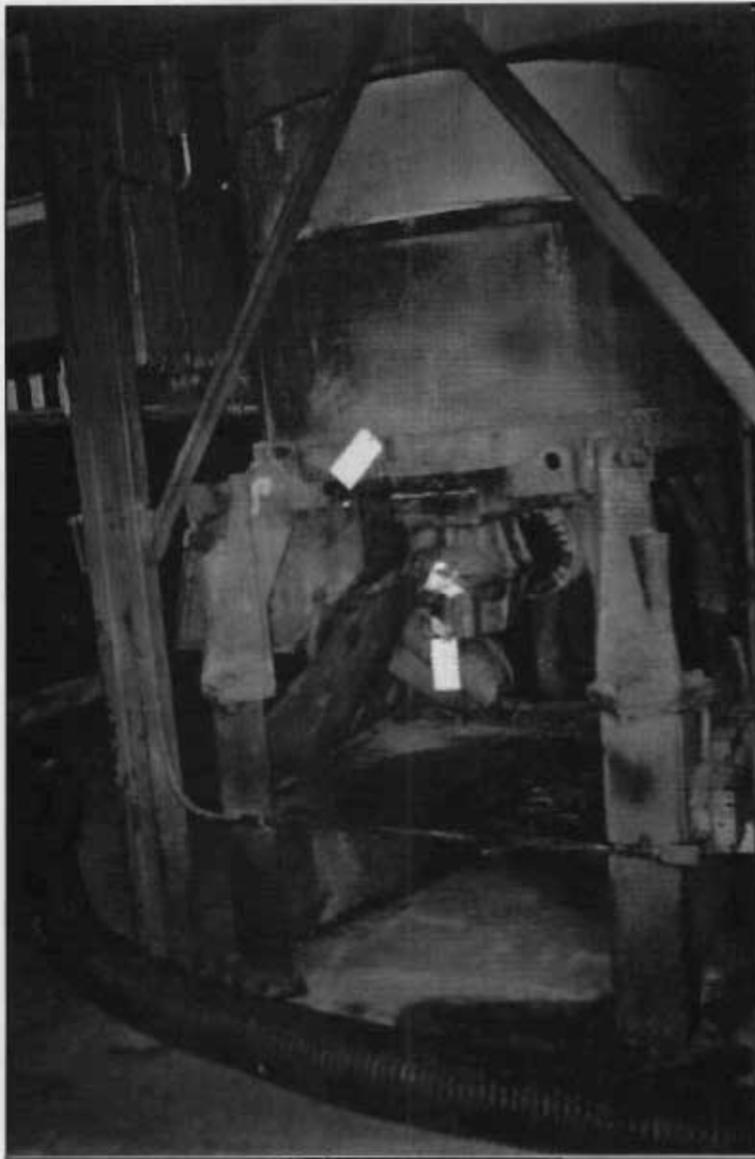
1. Equipment leaking gear oil: One sand mixing machine and one sand hopper was found leaking gear oil onto the deck areas.

Sand Hopper Leaking Gear Oil

1. Cleaned up oil spill produced from sand mixer and sand hopper with absorbent material.
2. Drained oil from the leaky gearbox of the sand mixer and sand hopper and tagged both machines to note that gearbox oil has been drained.
3. Placed oily waste in a 5 gallon drum and shipped to Environmental Detachment Charleston (DET) Waste Disposal Division (estimated waste - 5 gallons).

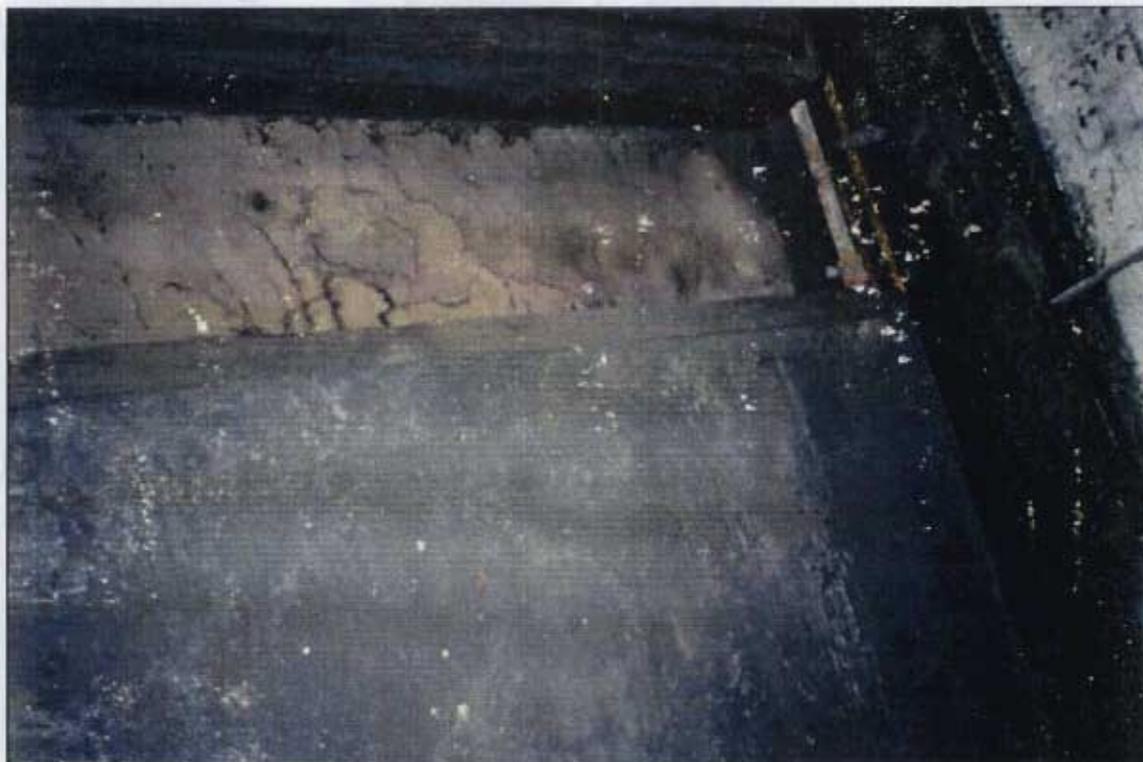
2. Oil/oily waste below deck level covered drains/passageways: Two areas of the foundry were found to have this problem. The first area located underneath metal storage racks just outside the restroom area was stained with oil. The drain catch passageways in this area contained approximately 5 cubic yards of oily waste. The second area was the hydraulic piping passageway that supplied hydraulic fluid to the Hydro Arc furnace. This piping passageway was filled with sand that was used to absorb hydraulic fluid leaks and contained approximately 1 cubic yard of sand/liquid waste.

Cleaned Below deck Passage, North Wall

1. Removed covers, removed waste, and placed in 55 gallon drums.

2. Used detergent (Gamlin) to clean concrete in oil stained areas.
3. Placed waste material in 55 gallon drums and shipped to DET Hazardous Waste Disposal Division (estimated waste - four 55 gallon drums).

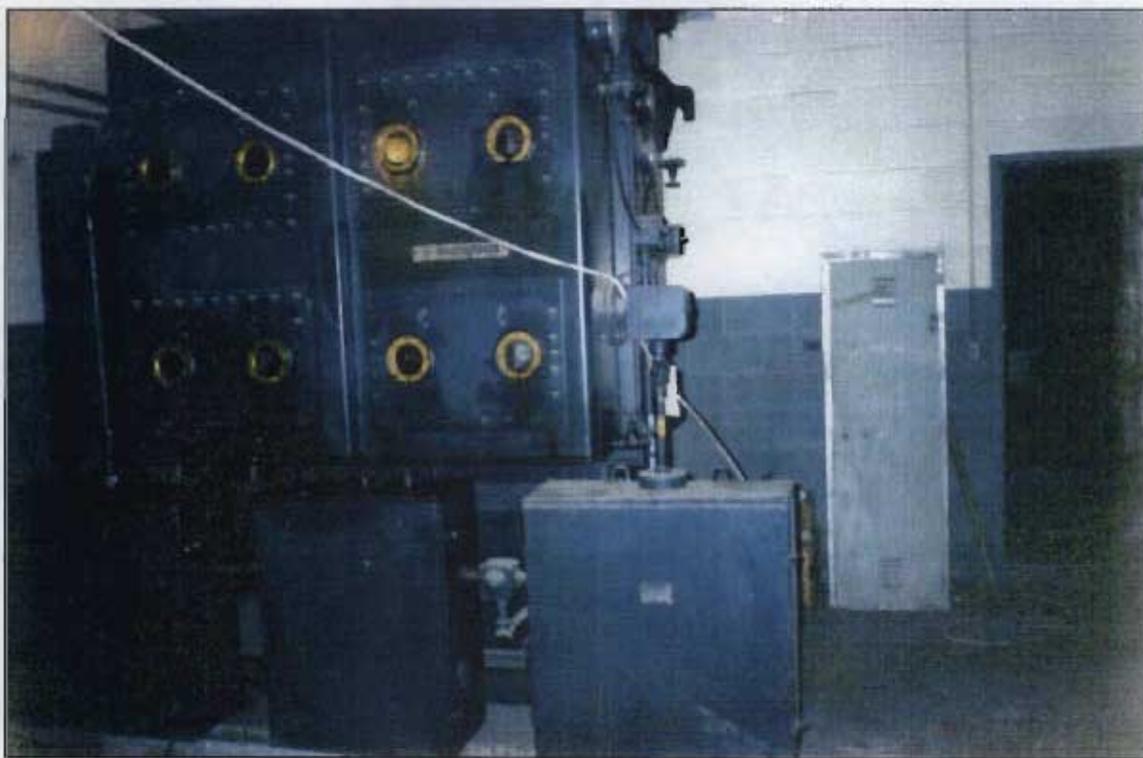
5. Hydro Arc Furnace Transformer: This transformer supplied the power for the Hydro Arc electric furnace. The transformer was built in 1968 and was filled with 9,150 pounds of oil. A slight amount of oil was found leaking out of the sightglass gaskets. An oil stained area was visible on the deck beneath the transformer. A swipe screening sample taken on 30 April, 1996 from below the transformer sightglass window was analyzed by GEL for PCB verification. The swipe results revealed PCB 1254 @ 15 ug/100 cm² and PCB 1260 @ 7.5 ug/100 cm².

A follow-up screening sample taken by the DET on 10 May, 1996 and analyzed by GEL establish the PCB content of the transformer oil. The sample results revealed PCB 1254 @ 25 PPM and PCB 1260 @ 10 PPM.

Hydro Arc Transformer

1. Oil was drained from the transformer and shipped to DET Hazardous Waste Disposal Division. The surface of the transformer was cleaned to <10 ug/100 cm² PCB.

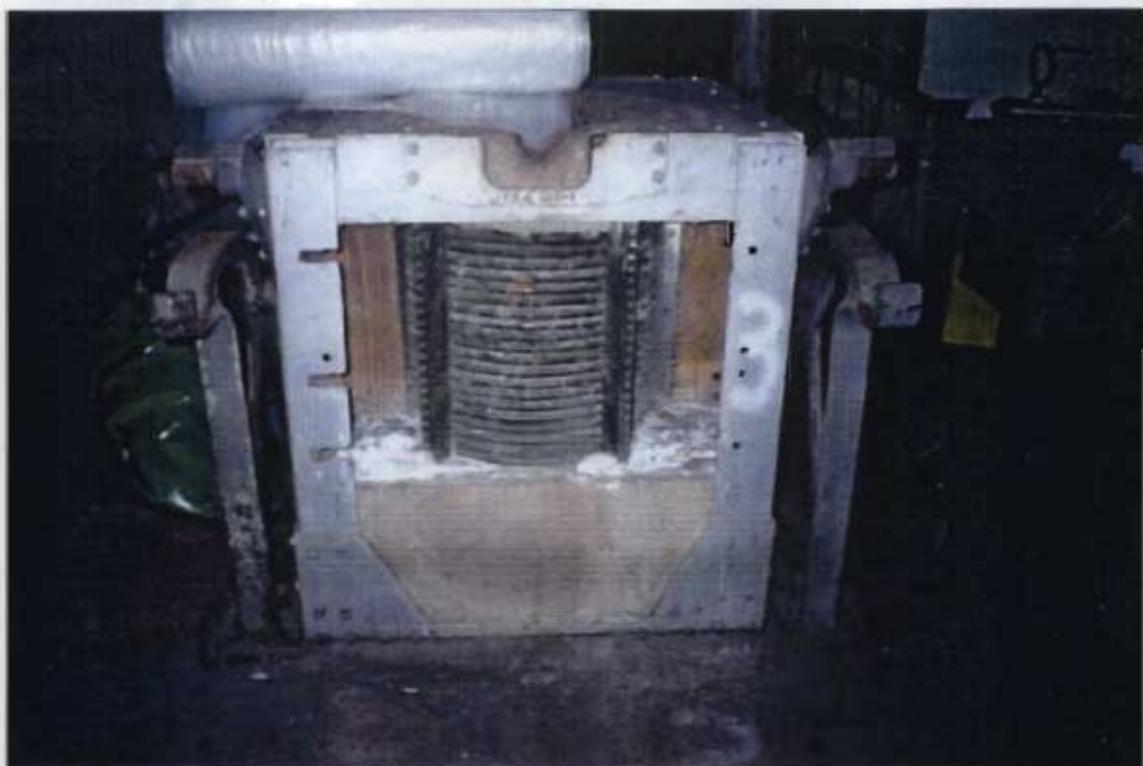
4. Smoldering Pots: One induction fired smoldering pot oven had damaged friable asbestos insulation.

Friable Asbestos Removed From Smoldering Pot Oven

1. The friable asbestos was removed and disposed per Building 9 Asbestos Removal Site Specific Work Plan.

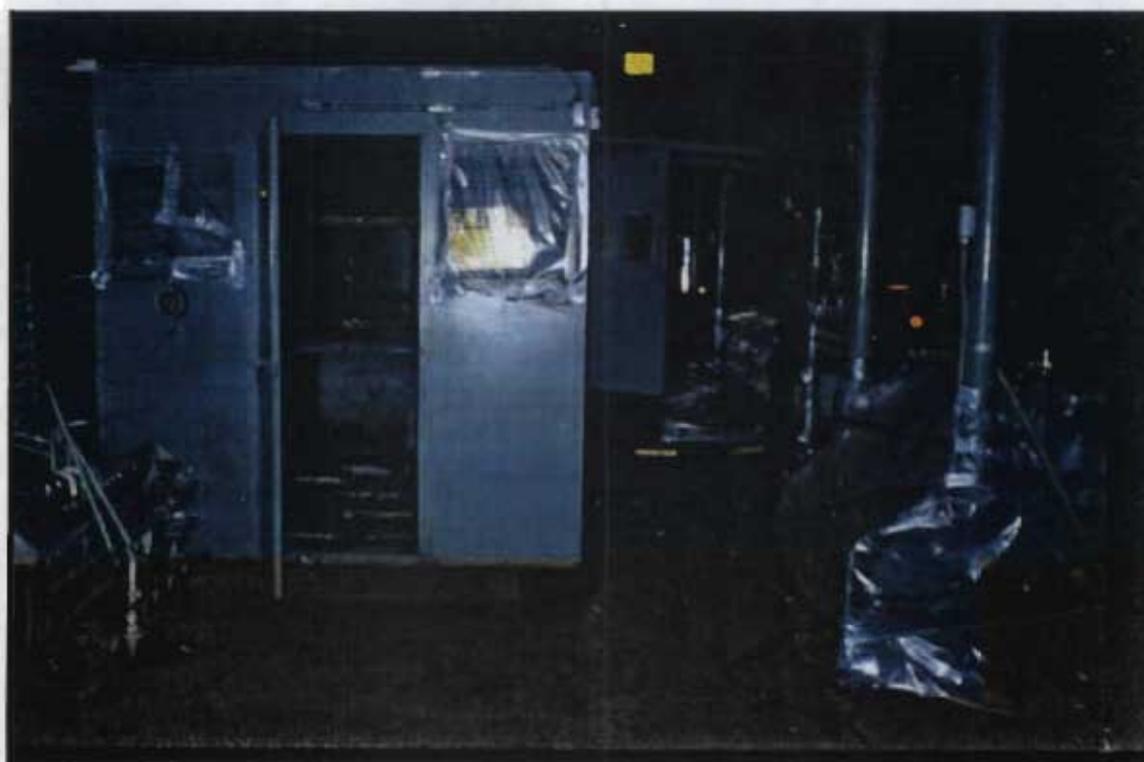
3. Ajax power supply: The Resource Conservation Recovery Act (RCRA) Facility Assessment for Zone E, dated June 6, 1995, states that a capacitor exploded in the Ajax power supply on September 18, 1984. Burned Pyranol oil sprayed inside the power supply's 8' x 6' x 7' enclosure. The enclosure was subsequently sealed off and posted with PCB warning labels.

A swipe screening sample taken by the DET in June, 1995, in an oil stained area on the wooden base, was analyzed by General Engineering Laboratories (GEL) for PCB verification. The swipe results revealed PCB 1254 @ 54,800 ug/100 cm² and PCB 1260 @ 20,300 ug/100 cm². A core sample from the concrete pad taken by the DET on December 16, 1996, was analyzed by GEL for PCB verification. The core results revealed PCB 1254 @ 28.4 PPM and PCB 1260 @ 11.9 PPM

Ajax Power Transformer Enclosure

1. Contacted South Carolina Electric & Gas (SCE&G) to disconnect power supply from supply transformer. Disconnected wiring between power supply and motor generator. Cut wiring, cooling supply and return piping.
2. The interior of the power supply was disassembled by sections and components. Each component was swiped for PCB presence and designated as scrap or PCB waste according to the lab results. The outer shell or housing of the power supply was disassembled and disposed in the same manner.
3. The motor generator was cleaned with Gamlin. Swipe results indicated no PCB's present.
4. The wooden deck portion of the power supply was removed. The blower portion was disassembled along with the power supply enclosure. The wooden

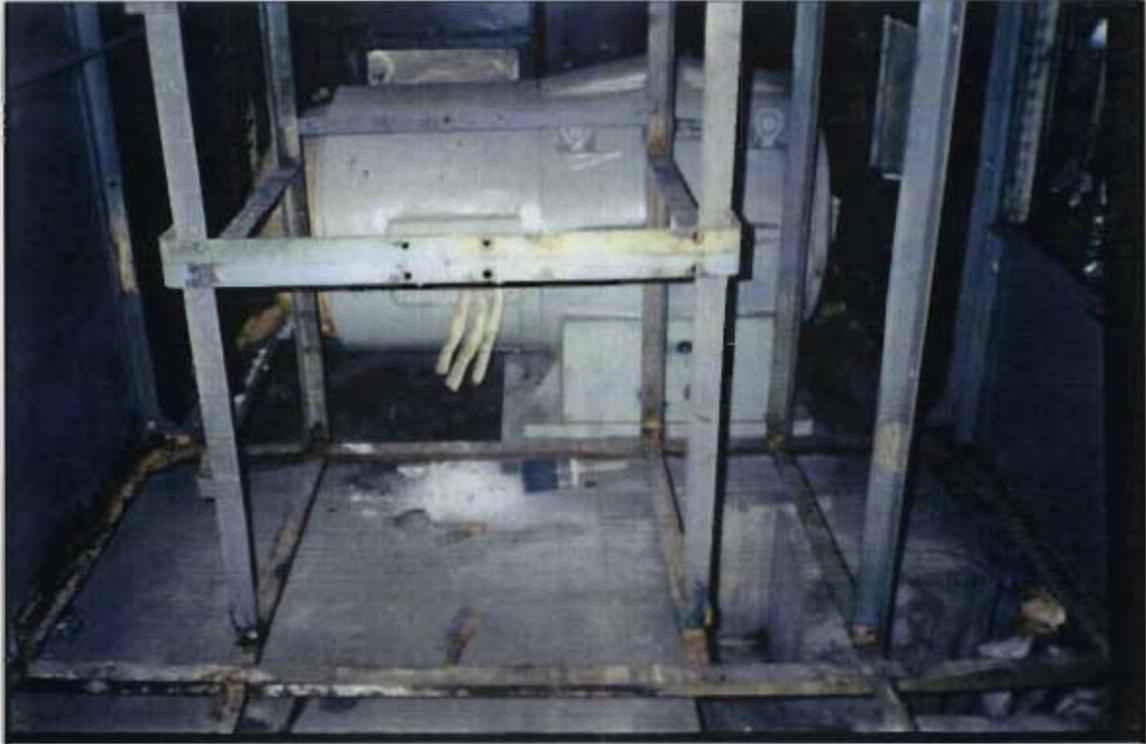
Ajax Power Transformer Generator In Partially Dismantled Enclosure

deck, blower portion and power enclosure were disposed of as PCB hazardous waste.

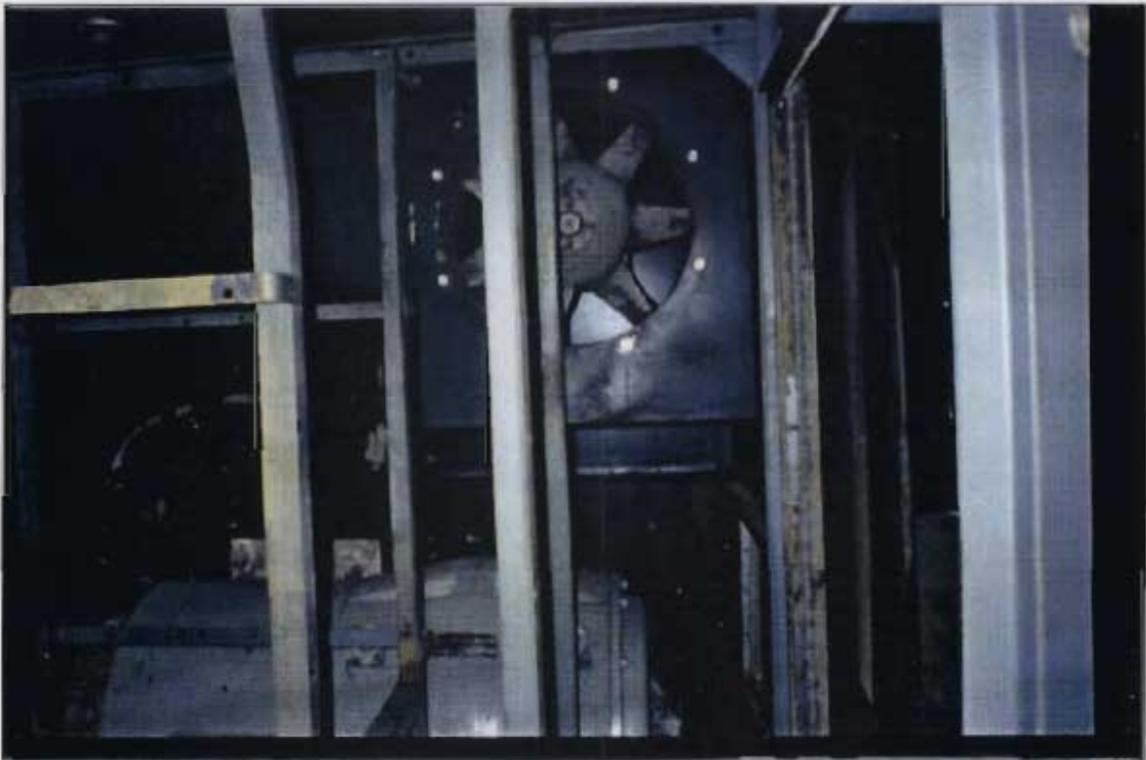
Ajax Power Transformer Blower In Partially Dismantled Enclosure

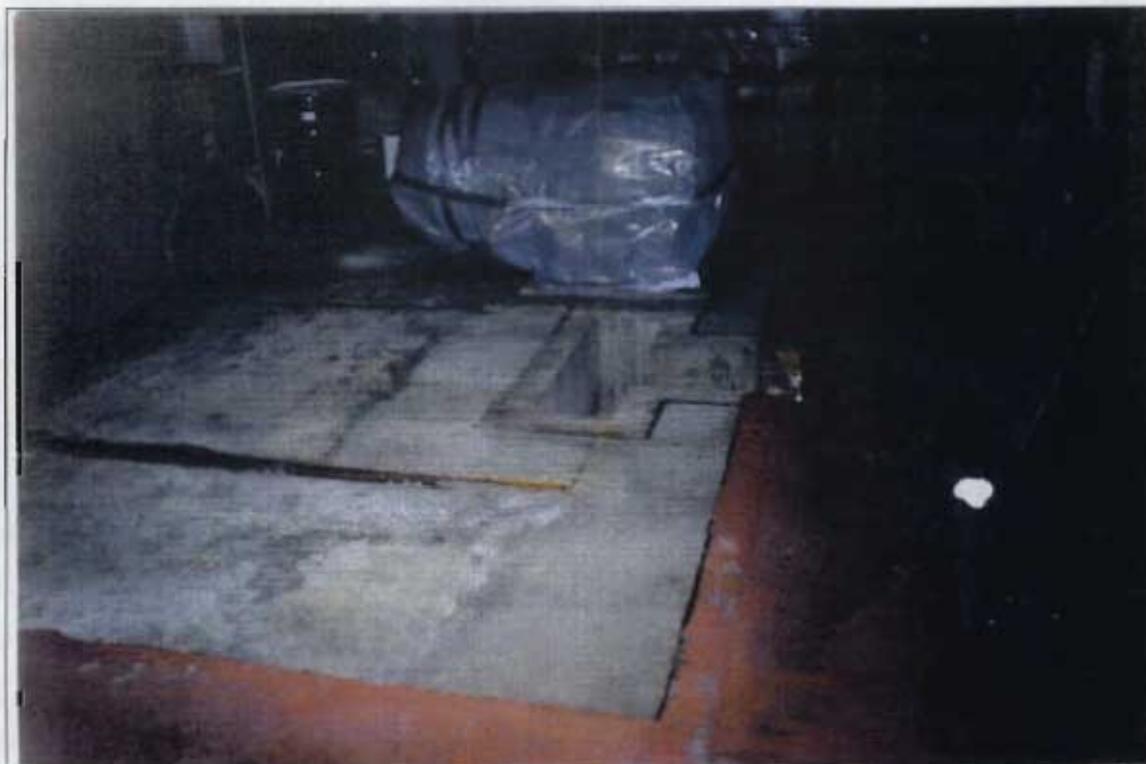
Ajax Transformer Concrete Pad After "CAPSUR" Treatment

5. Approximately 4" of the concrete pad's surface was removed and disposed of as PCB hazardous waste after physical cleaning with CAPSUR failed to yield satisfactory results. Six samples taken after removal of the surface revealed all PCB levels were < 1 PPM. Sample locations are shown on page 16 of this report.

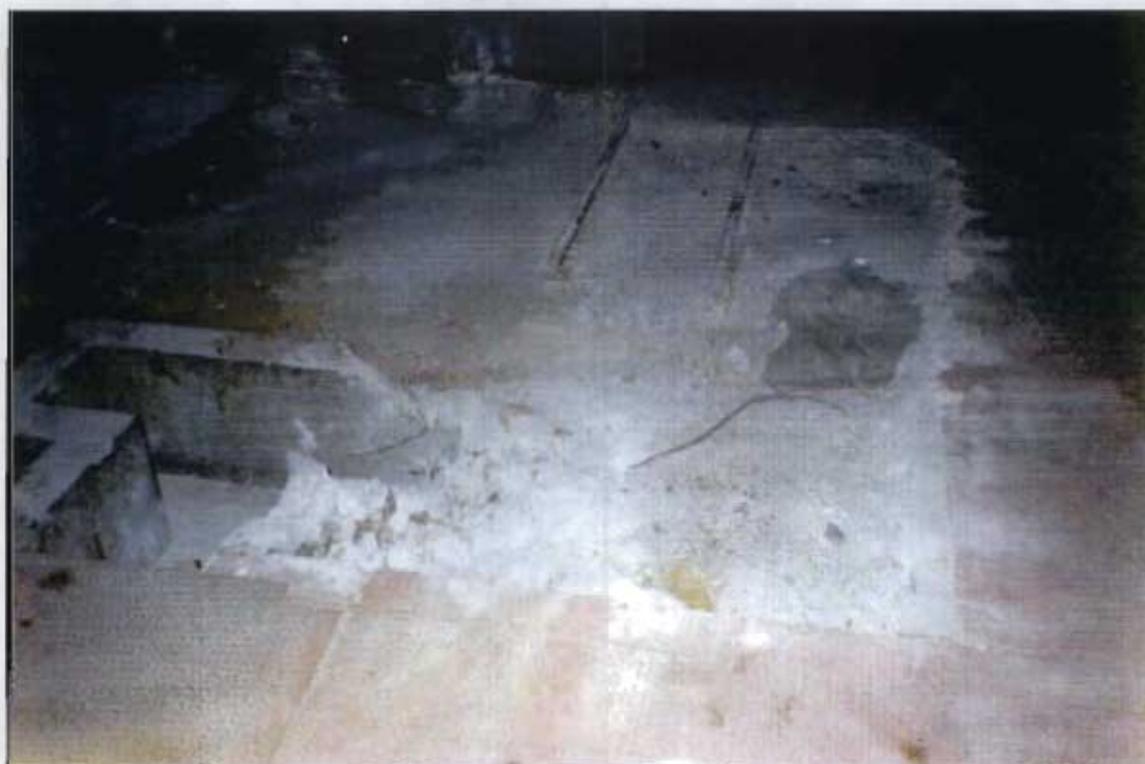
Ajax Transformer Concrete Pad After 4" Surface Removal

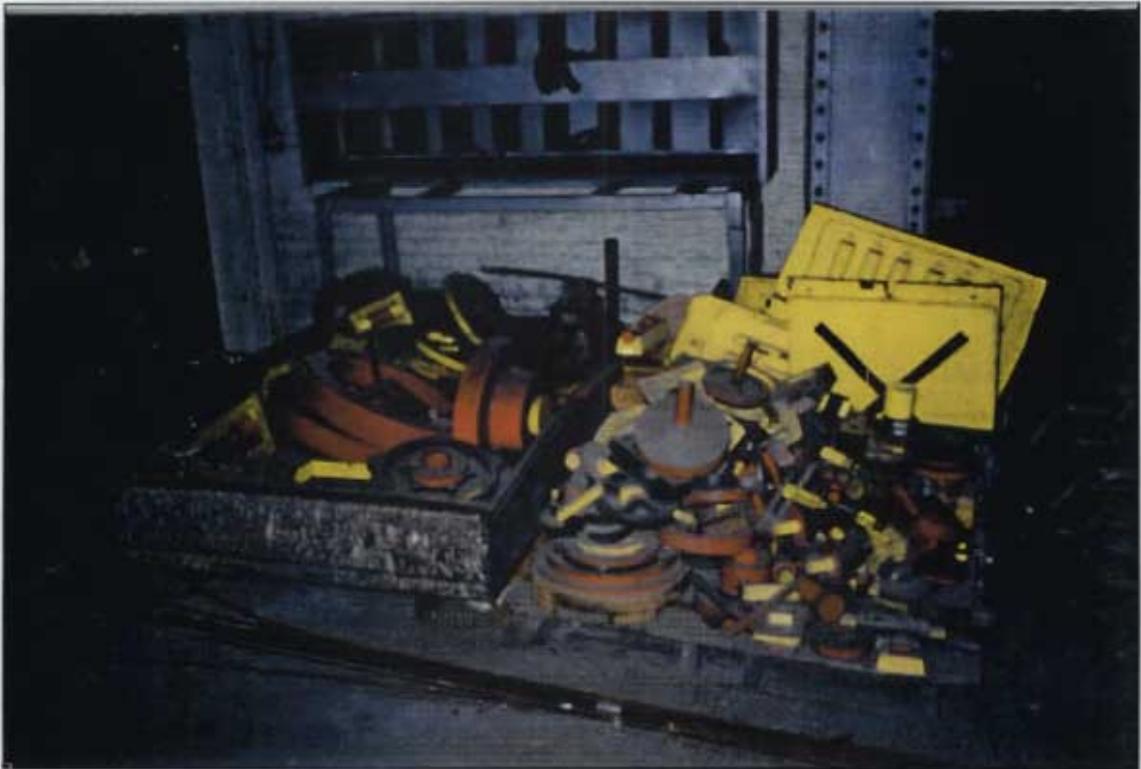
7. Lead Containing Surface Dust: The horizontal surfaces of the building were coated with lead-containing surface dust. Wipe sample results were as follows:

Above the Floor Samples: Eight samples were taken at locations above the floor level ranging from 111 ug/100 cm² to 11,500 ug/100 cm² with an average of 1,920 ug/100 cm²

Wooden Molds Covered With Lead Dust

1. Placed sandbags at the entrances to prevent any rinsate water from exiting the building.
2. Covered all electrical panels with 6 mil poly and other items that could be damaged by water.
3. Pressure washed all interior building horizontal surfaces excluding the ceiling and wooden floors. Washed down walls and other vertical surfaces. Pressure washed all molds bearing lead dust. Items that could not be pressure washed

were cleaned by High Efficiency Particulate Air (HEPA) vacuum or hand wiped with soap and water.

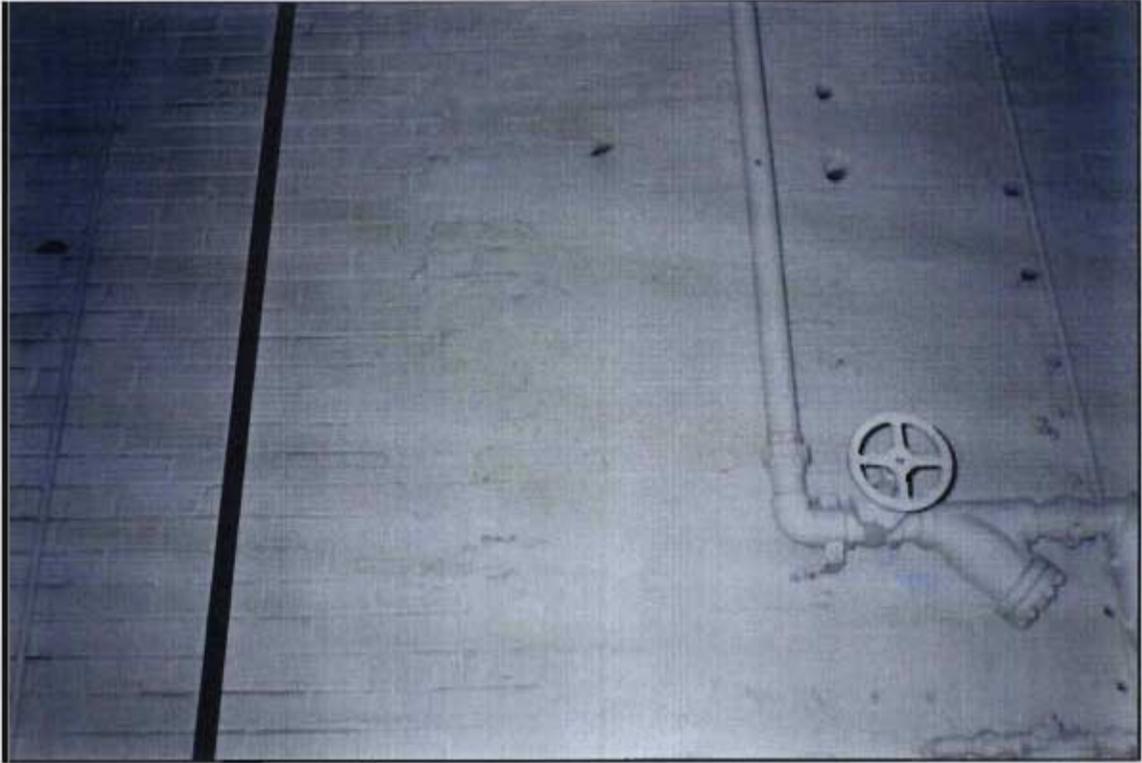
Pressure Washed Wall

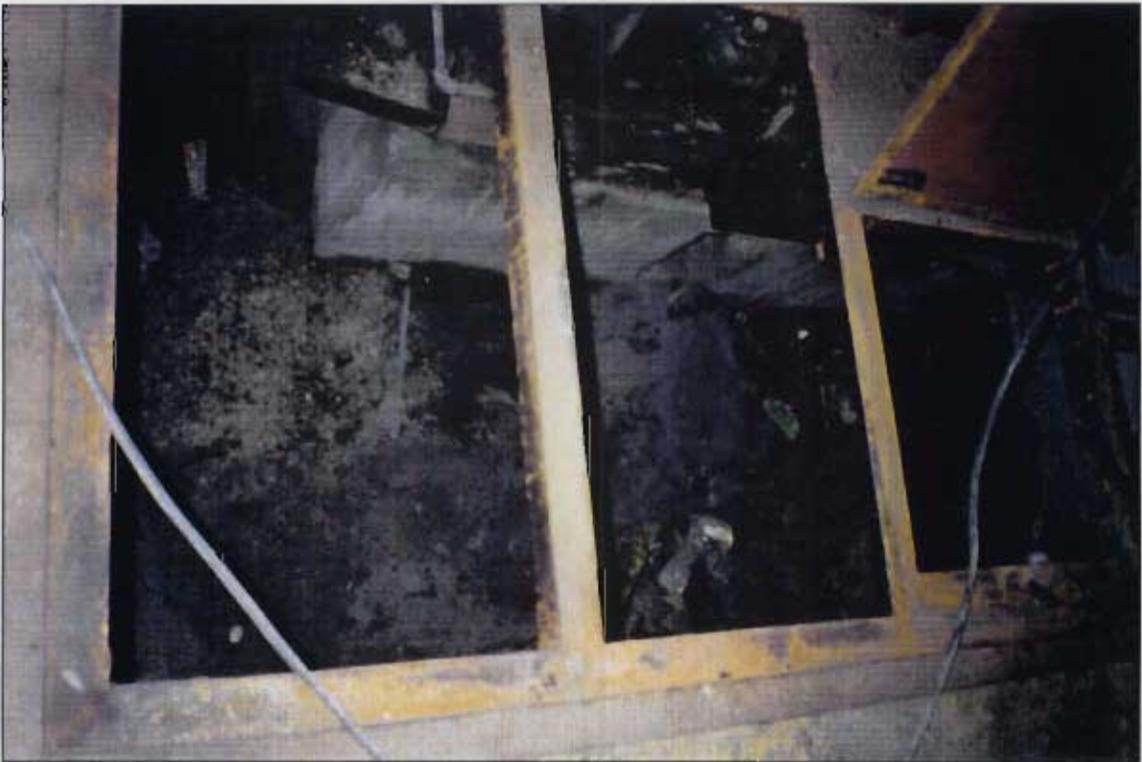
Hydraulic Press Sump With Oily Waste

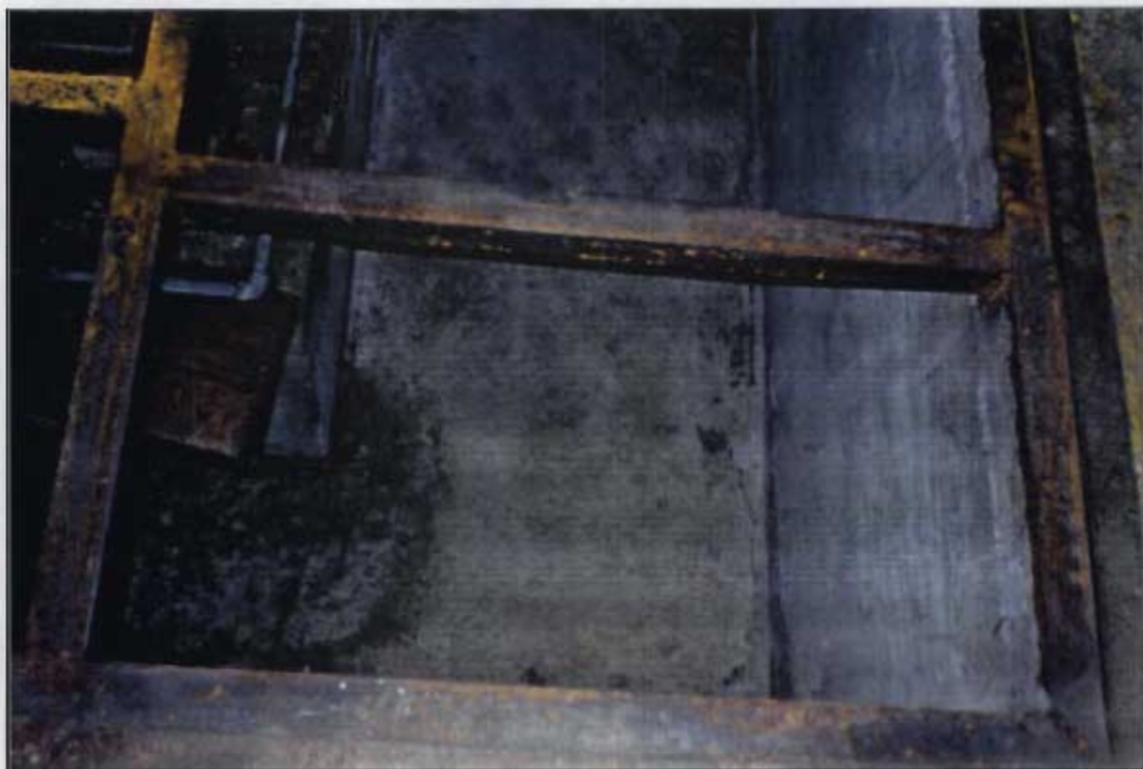
Cleaned Hydraulic Press Sump

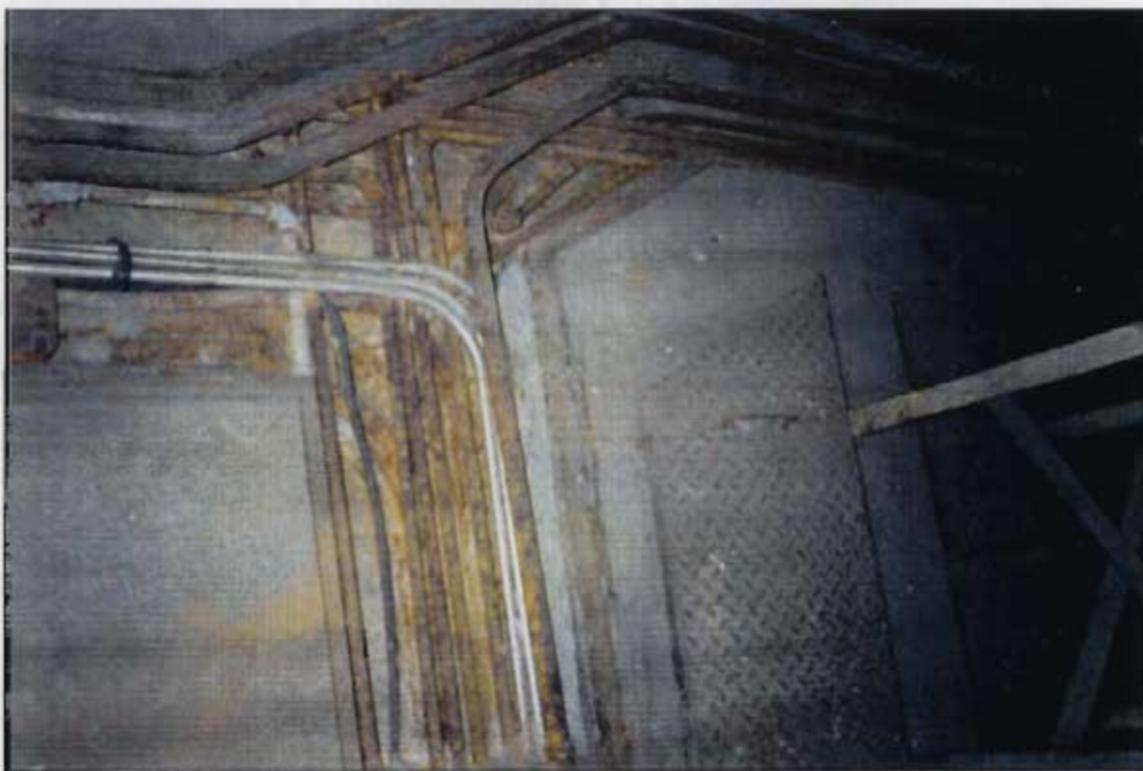
Cleaned Below Deck Passageway In Hydro Arc Transformer Room
