DRAFT CONTAMINATION ASSESSMENT CHICORA TANK FARM (CTF) CNC CHARLESTON
SC
11/01/1986
ENVIRONMENTAL SCIENCE AND ENGINEERING. INC.

DRAFT
CONTAMINATION ASSESSMENT
CHICORA TANK FARM
NAVBASE CHARLESTON
CHARLESTON, SOUTH CAROLINA

ENVIRONMENTAL SCIENCE AND ENGINEERING, INC.
Tampa, Florida

November, 1986

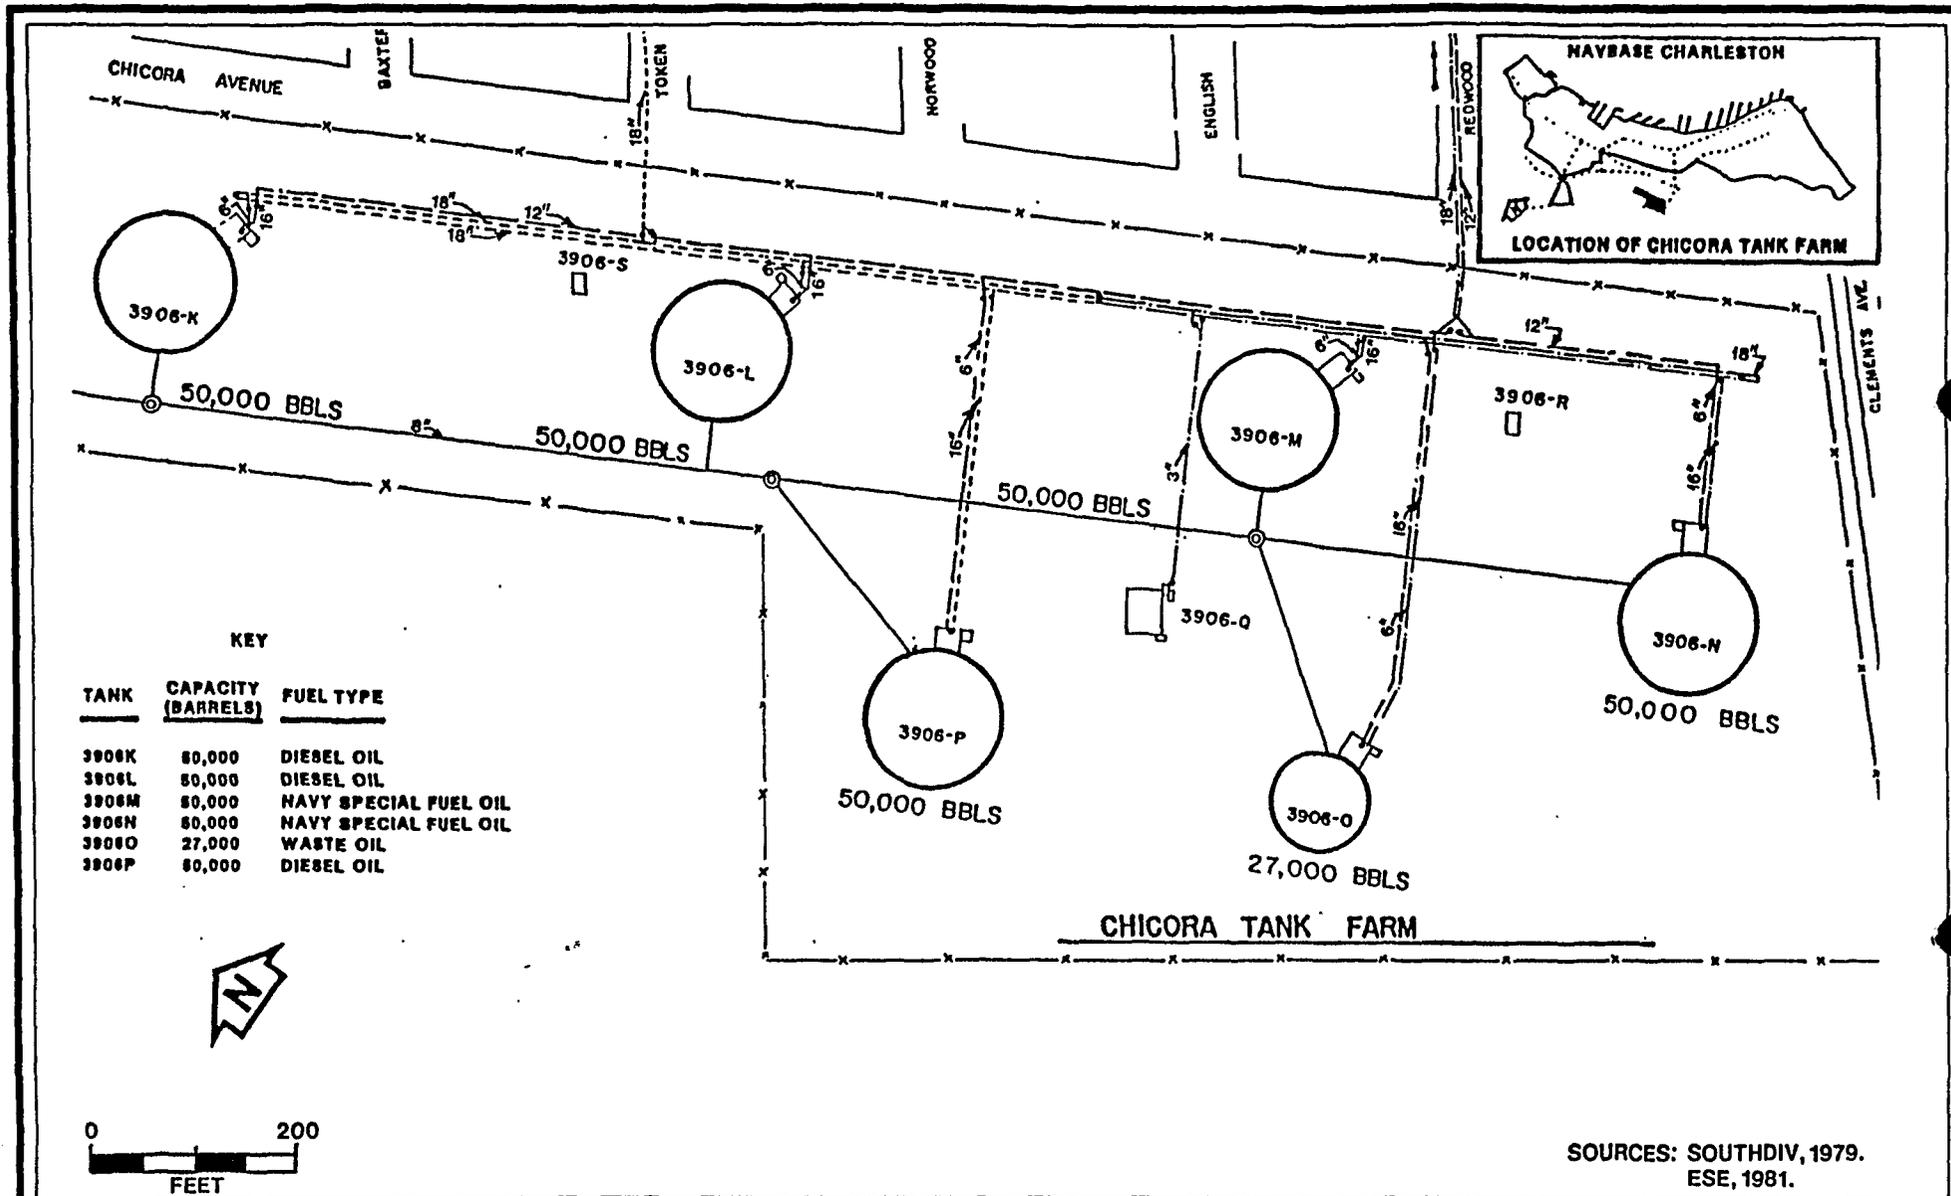
Figure 1.0-1
CHICORA TANK FARM LAYOUT

The Chicora Tank Farm is part of the Naval Supply Center, (NSC) Charleston, S.C.. Six storage tanks comprise the tank farm as shown in Figure 1.0-1. The tanks are constructed of reinforced concrete, are partially below ground, and are covered (above normal grade) with soil and grass. Each tank is underlain by a french drain system designed to collect potential petroleum product seepage. The french drain system discharges into a holding pond equipped with an oil skimmer. The french drain system and pond are sampled periodically, and samples analyzed for oil and grease content. Of the six tanks, three (3906-K, 3906-L, and 3906-P) are suspected of leaking diesel oil. Seepage is occurring through the tank walls into the pump room associated with each of the tanks.

Seepage from the tank walls into the pump rooms of tanks 3906-K, 3906-L, and 3906-P has been observed over the past several months. Periodic sampling and analysis of the french drain system provides no evidence of petroleum seepage into the french drain system. Tank capacities and fuel types are listed on Figure 1.0-1.

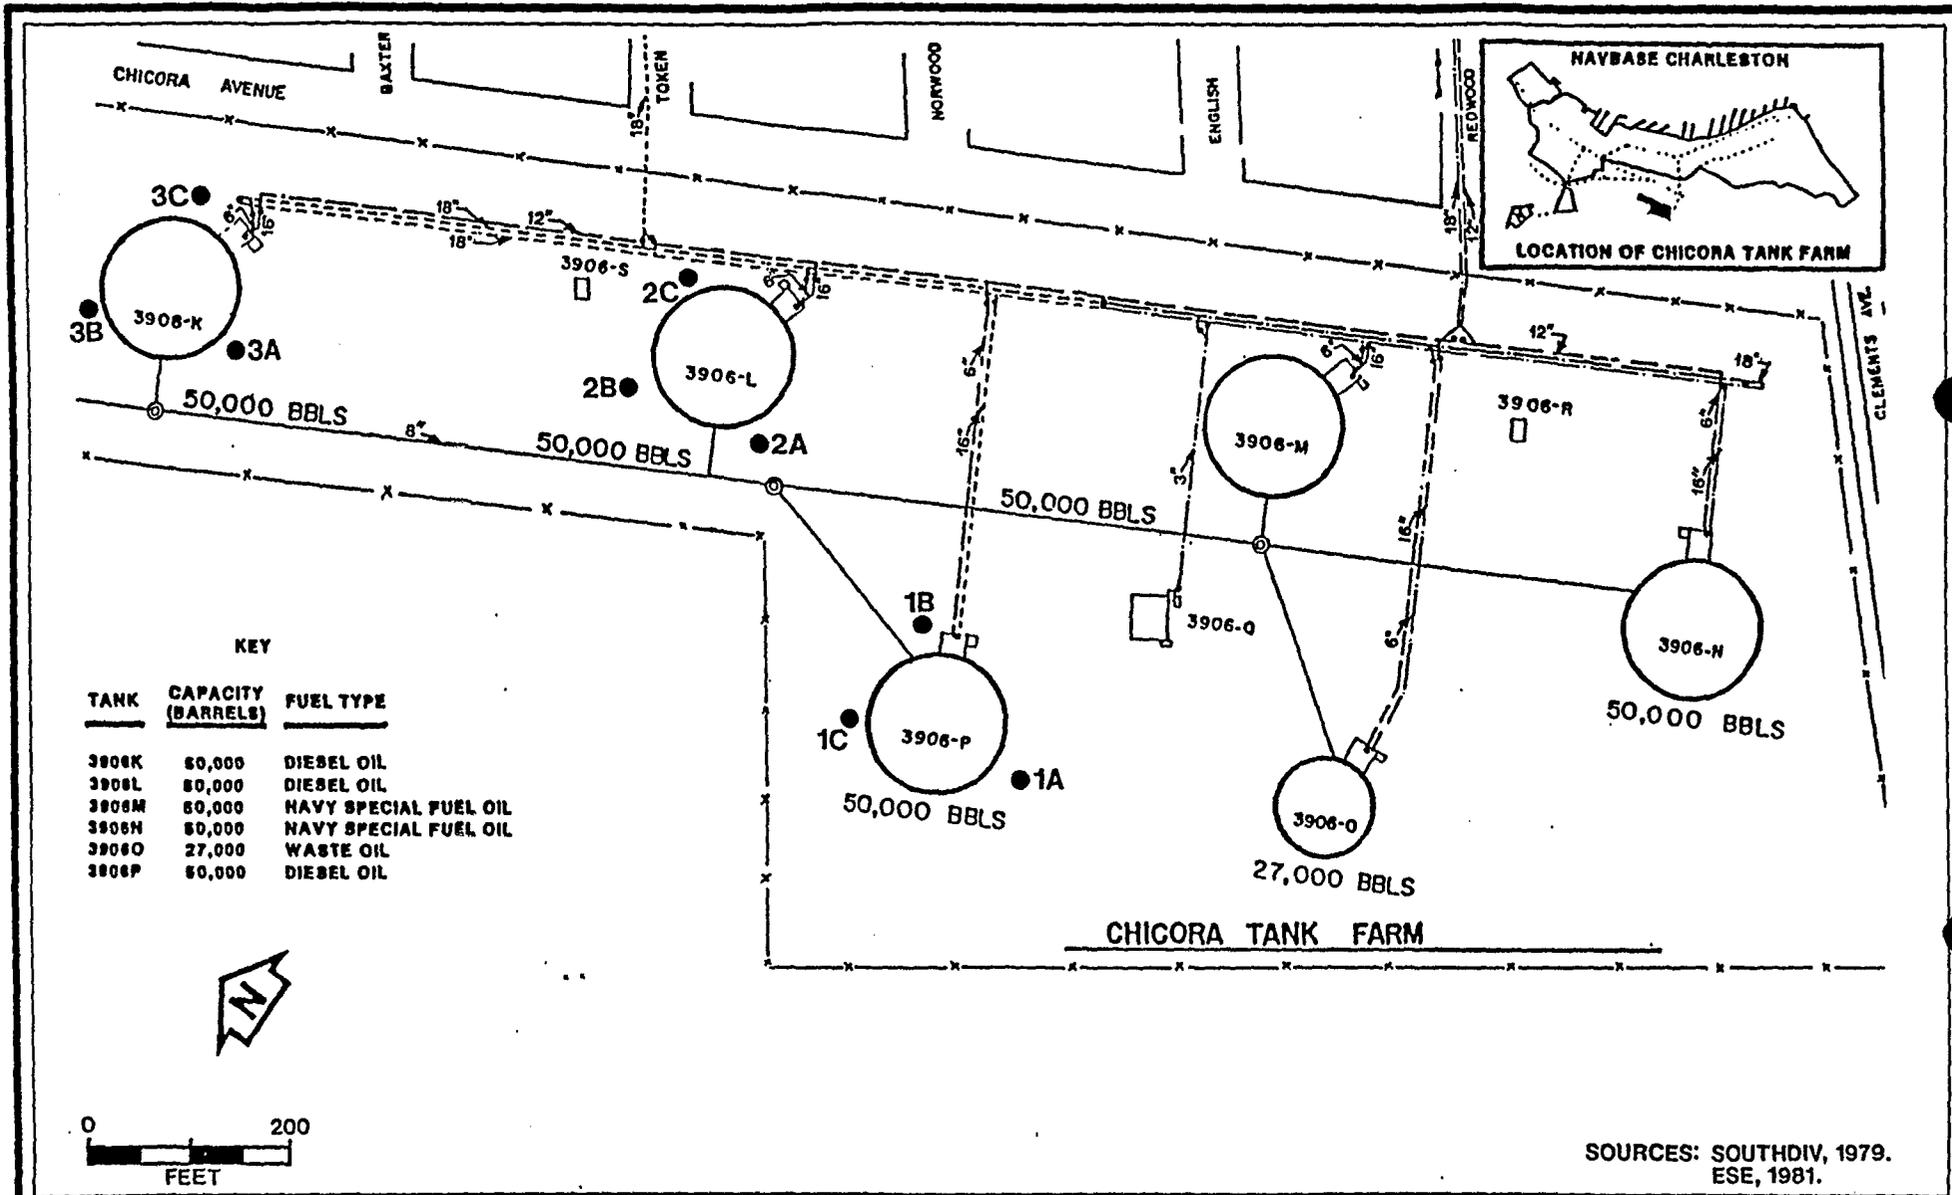
Figure 3.1-1
LOCATIONS OF SOIL BORINGS

A total of nine soil borings were constructed at the Chicora Tank Farm, to include three borings constructed around each of the three tanks, as shown on Figure 3.1-1. The soil borings were constructed utilizing a track mounted hollow-stem auger drilling rig with 4-inch diameter soil augers. Prior to construction of each boring, the auger flights were thoroughly steam cleaned and allowed to air-dry. Each boring was constructed to the soil/water table interface. Soil cuttings were retrieved and described by the ESE site geologist. Soil boring logs are included herein as Appendix A.

Water samples were collected from each boring for visual and olfactory observation. None of the water samples exhibited a petroleum odor. Only the water sample from Boring 3B exhibited a petroleum sheen.

The results of the analysis of soil samples collected from the Chicora Tank Farm are provided in Table 4.2-1. Concentrations of BTX and TRPH are below detectable limits for all nine soil samples analyzed.

Based on the analytical results presented in Section 4.2, Tanks 3906-K, 3906-L, and 3906-P do not appear to be releasing diesel oil into the soil surrounding the tanks. Since the concrete walls within the pump rooms are not supported by soil, it is possible that the structural integrity of these walls will deteriorate more rapidly than the remaining portions of the tanks. However, ESE recommends that the tank walls be inspected by a concrete specialist to determine the potential for further structural deterioration. In addition, ESE recommends that the TRPH analysis (EPA Method 418.1) be utilized to analyze samples collected from the french drain system. The TRPH analysis has a lower limit of detection and will more accurately identify petroleum product seepage. It may also be appropriate to install shallow groundwater monitor wells downgradient of each of the tanks. The monitor wells should be sampled quarterly and samples analyzed for TRPH concentrations.
