HYDROGEOLOGIC INVESTIGATION AT THE KEY WEST TERMINAL OF CHEVRON U S A
NAS KEY WEST FL
3/1/1982
GERAGHTY AND MILLER INC

**HYDROGEOLOGIC INVESTIGATION
AT THE
KEY WEST, FLORIDA, TERMINAL**

**SMATHERS AND THOMPSON
ATTORNEYS FOR CHEVRON U.S.A., INC.
MIAMI, FLORIDA**

MARCH 1982

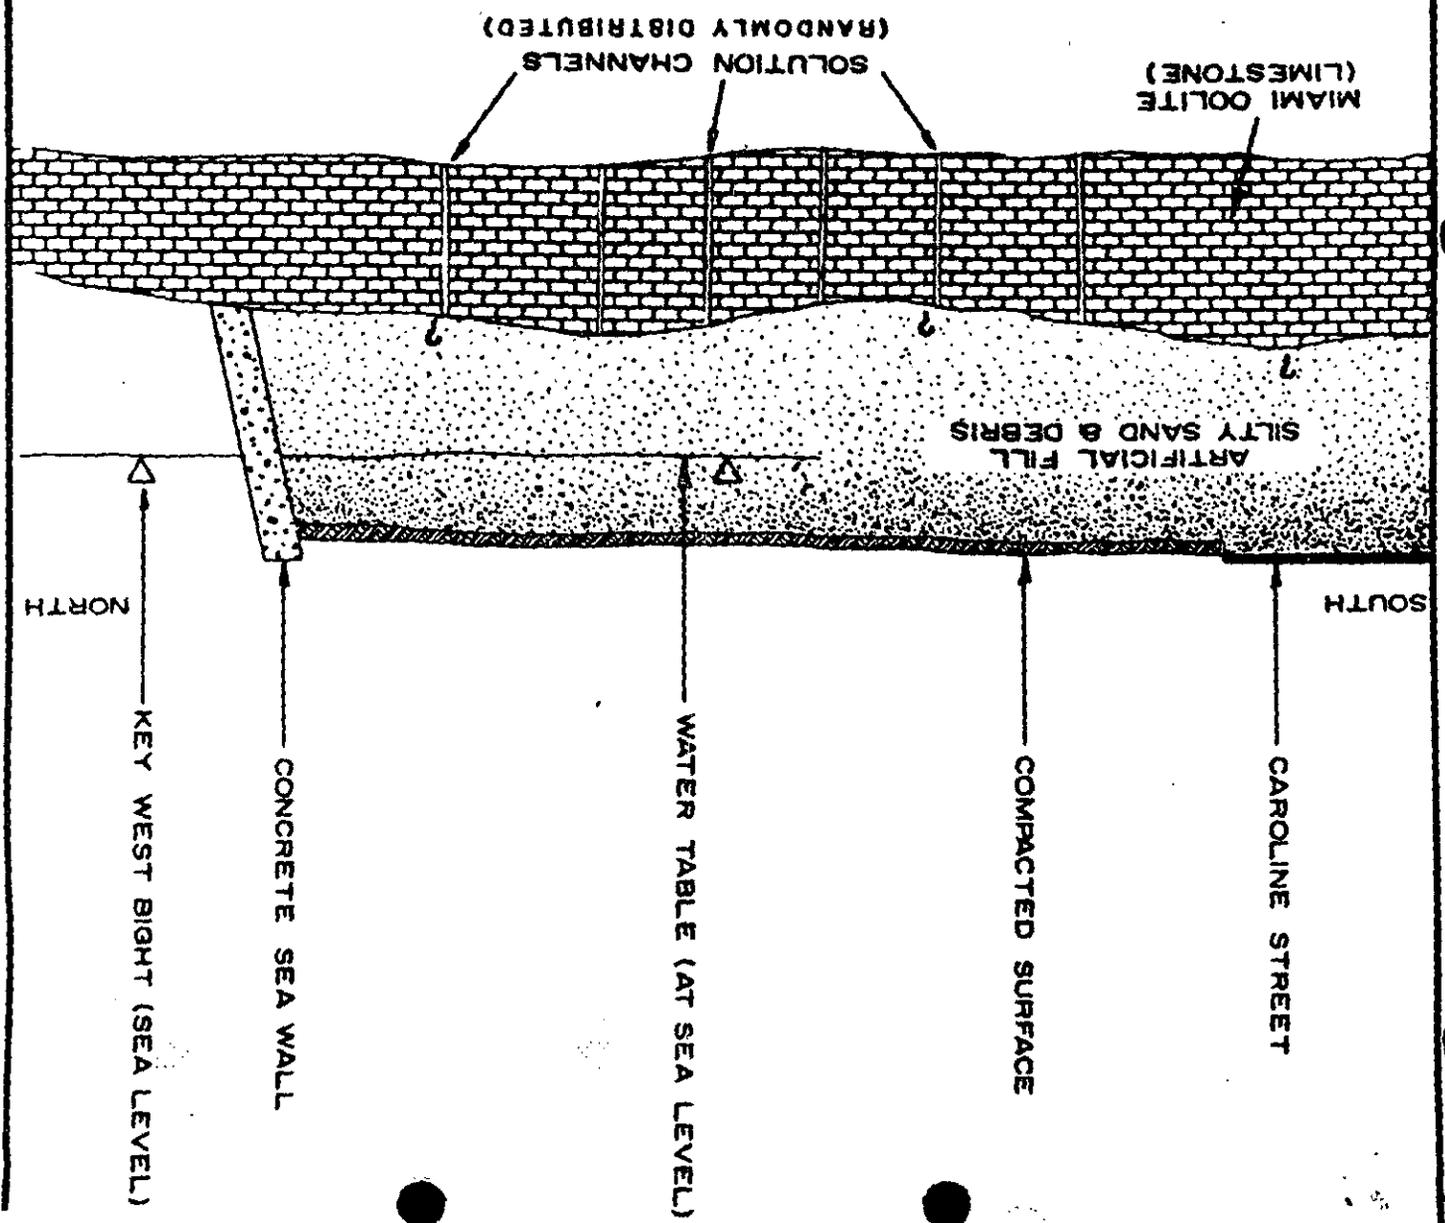
PREPARED FOR		CHEVRON, U.S.A.	
TITLE			
SCHEMATIC CROSS SECTION			
Key West Terminal			
COMPILED BY	V.P. Army	DATE	March 1962
DRAWN BY	R.G. BROWN	REVISED	
CHECKED BY	V.P. Army	Geraghty & Miller, Inc.	
SCALE	None	West Palm Beach, Florida	
FIGURE 2

A schematic cross section of the terminal site showing the relationships between the various parts of the system is given on Figure 2.

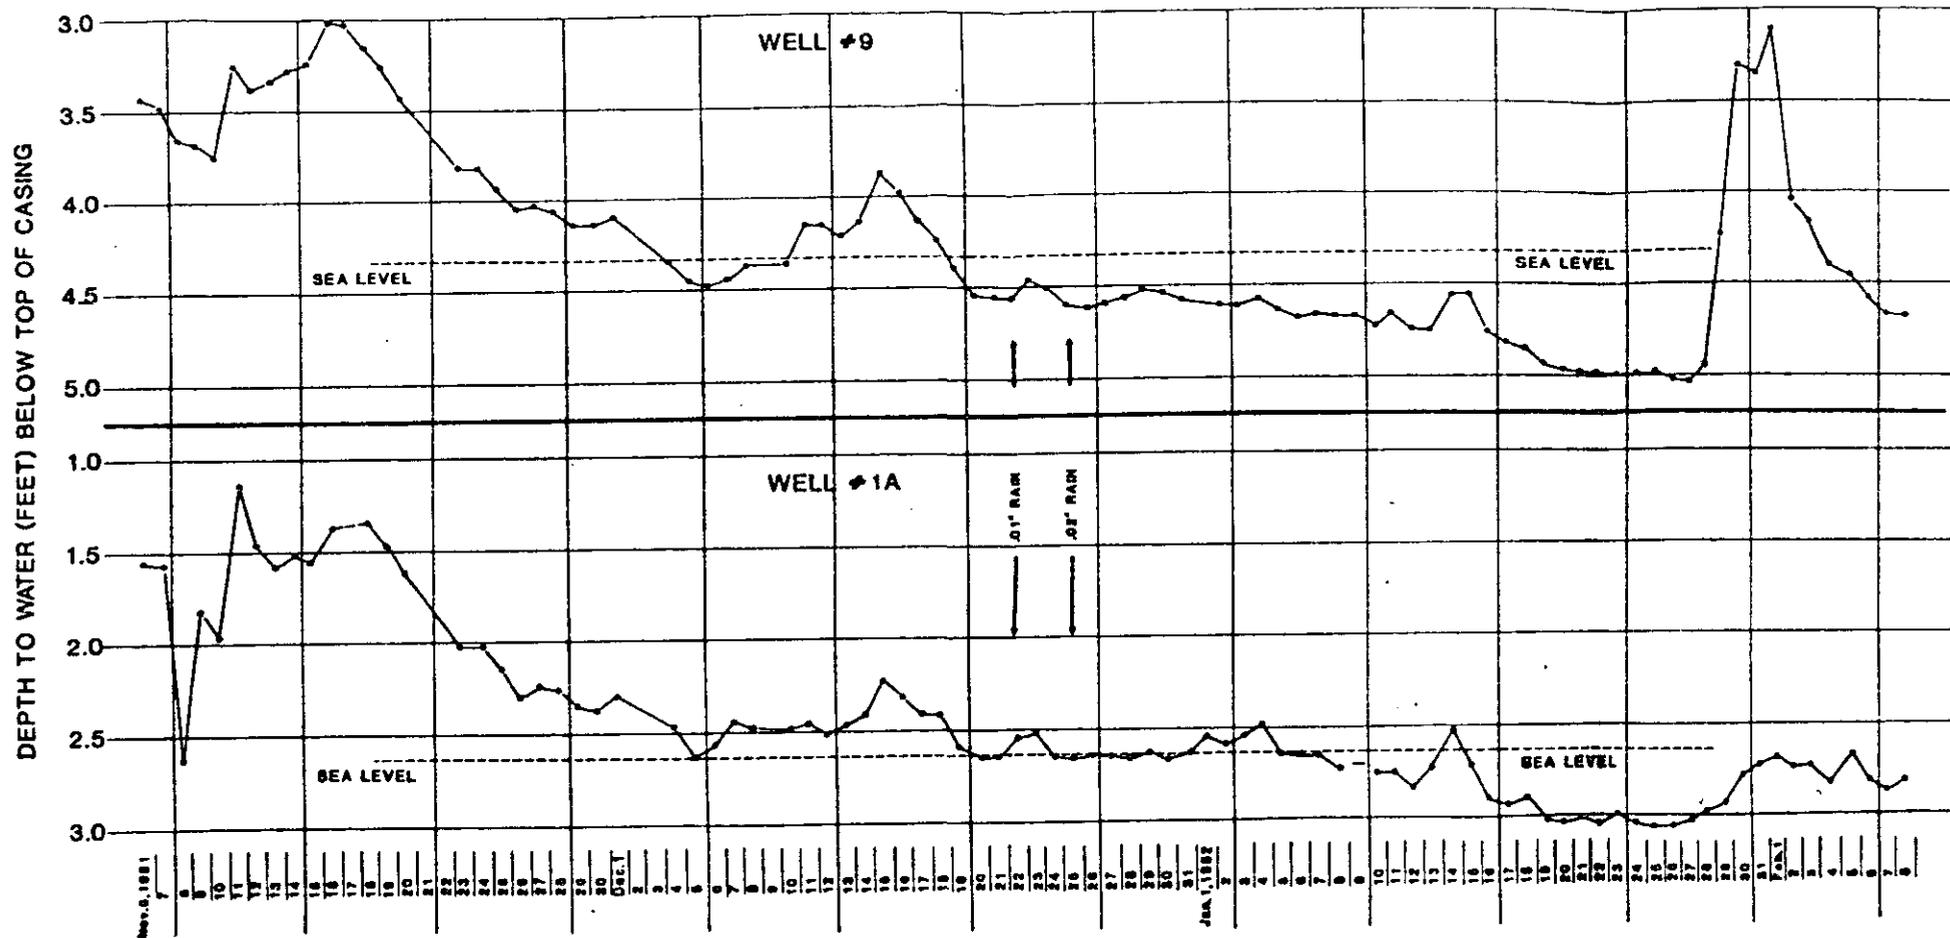
PREPARED FOR		CHEVRON, U.S.A.	
TITLE			
HYDROGRAPH OF WATER LEVELS IN WELL 9 AND WELL 1A			
Key West Terminal			
COMPILED BY V.P. Amy	Geraghty & Miller, Inc.	DATE March 1982	NO. OF PAGES
DRAWN BY Smith	Key West, Florida		
CHECKED BY P. Amy			FIGURE 3

Recovery operations were stopped temporarily on November 7, 1981, to eliminate the effect of pumping and make it possible to investigate the behavior of the water table under static conditions. Hydrographs of the water levels in Wells 1A and 9 are shown on Figure 3. The period of record ends on February 8, 1982. Hydrographs of Wells 11 and 16 are given on Figure 4; these cover the period from December 5, 1981, through February 8, 1982. These wells were selected because of their widely-distributed locations on the property. Wells 1A and 9 are near Key West Bight, while Wells 11 and 16 are inland. Consequently, the data are representative of water-level behavior over the entire property. Evaluation of the water-level data from the other wells shows similar behavior.

Examination of Figure 3 shows that the water levels rose for about 10 days (until November 17th) or so after the shut down of recovery operations, and then began to decline slowly, reaching sea-level elevation in early December. Thereafter, the level continued to fluctuate at elevations close to sea level for the remainder of the period of record. The fluctuation of the water level in Wells 11 and 16 (shown on Figure 4) is essentially the same. Overall, the behavior of water levels in all four wells is essentially the same; highs and lows correlate well with each other.

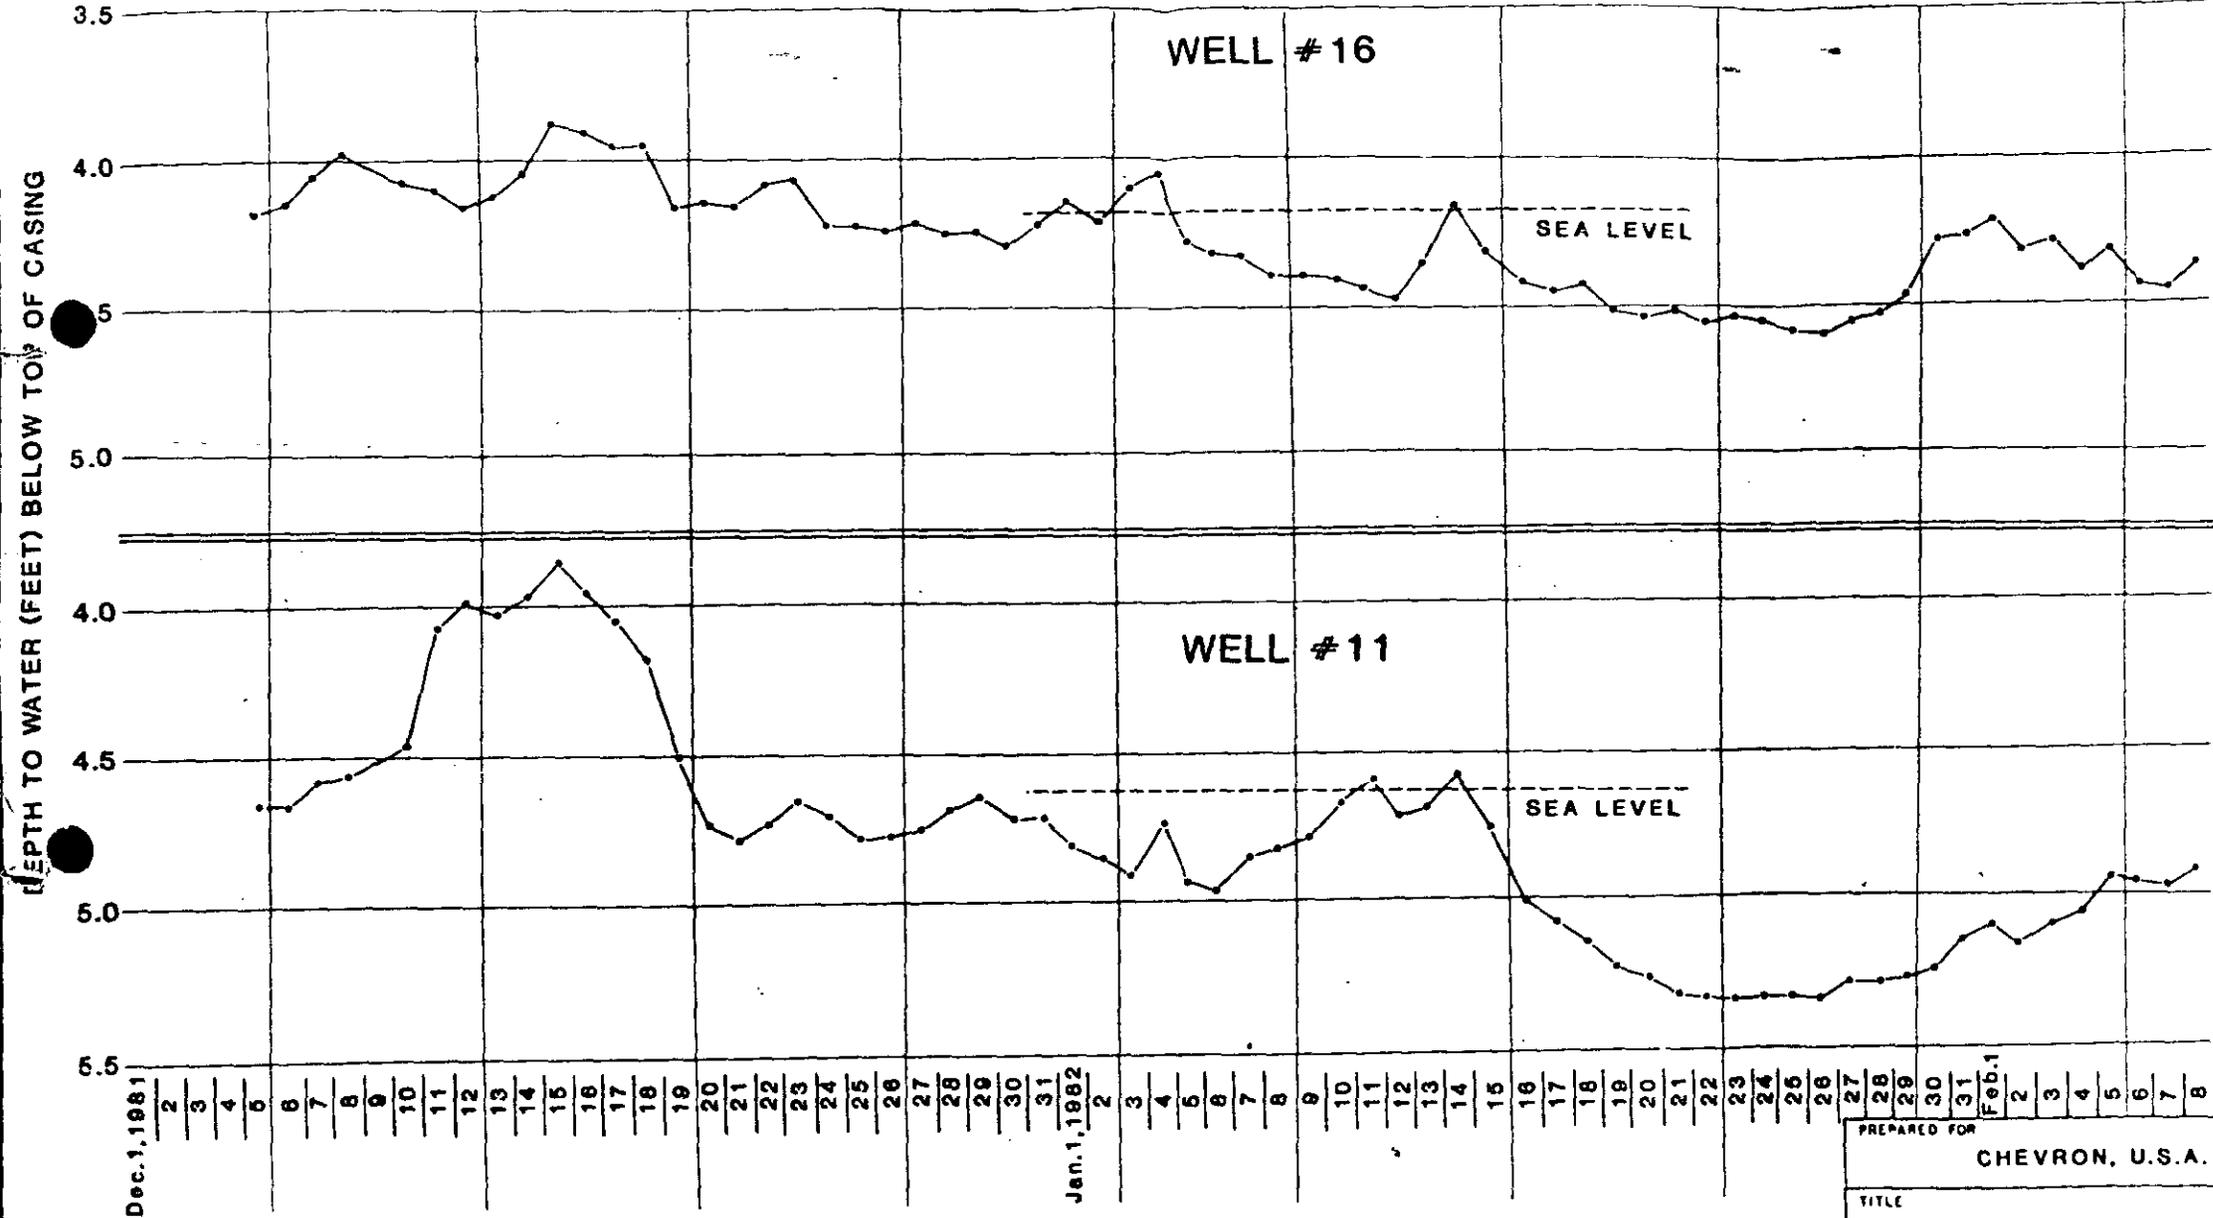
PREPARED FOR		CHEVRON, U.S.A.	
TITLE			
HYDROGRAPH OF WATER LEVELS IN WELL 16 AND WELL 11 Key West Terminal			
EGP-ED BY	DATE	Gerard A. Miller, Inc.	March 1982
V.P. Amy		West Palm Beach, Florida	REC-125
Checked by			FIGURE 4

Examination of Figures 3 and 4 show no noticeable change of water levels that can be correlated with the rainfall occurring during the period of record.

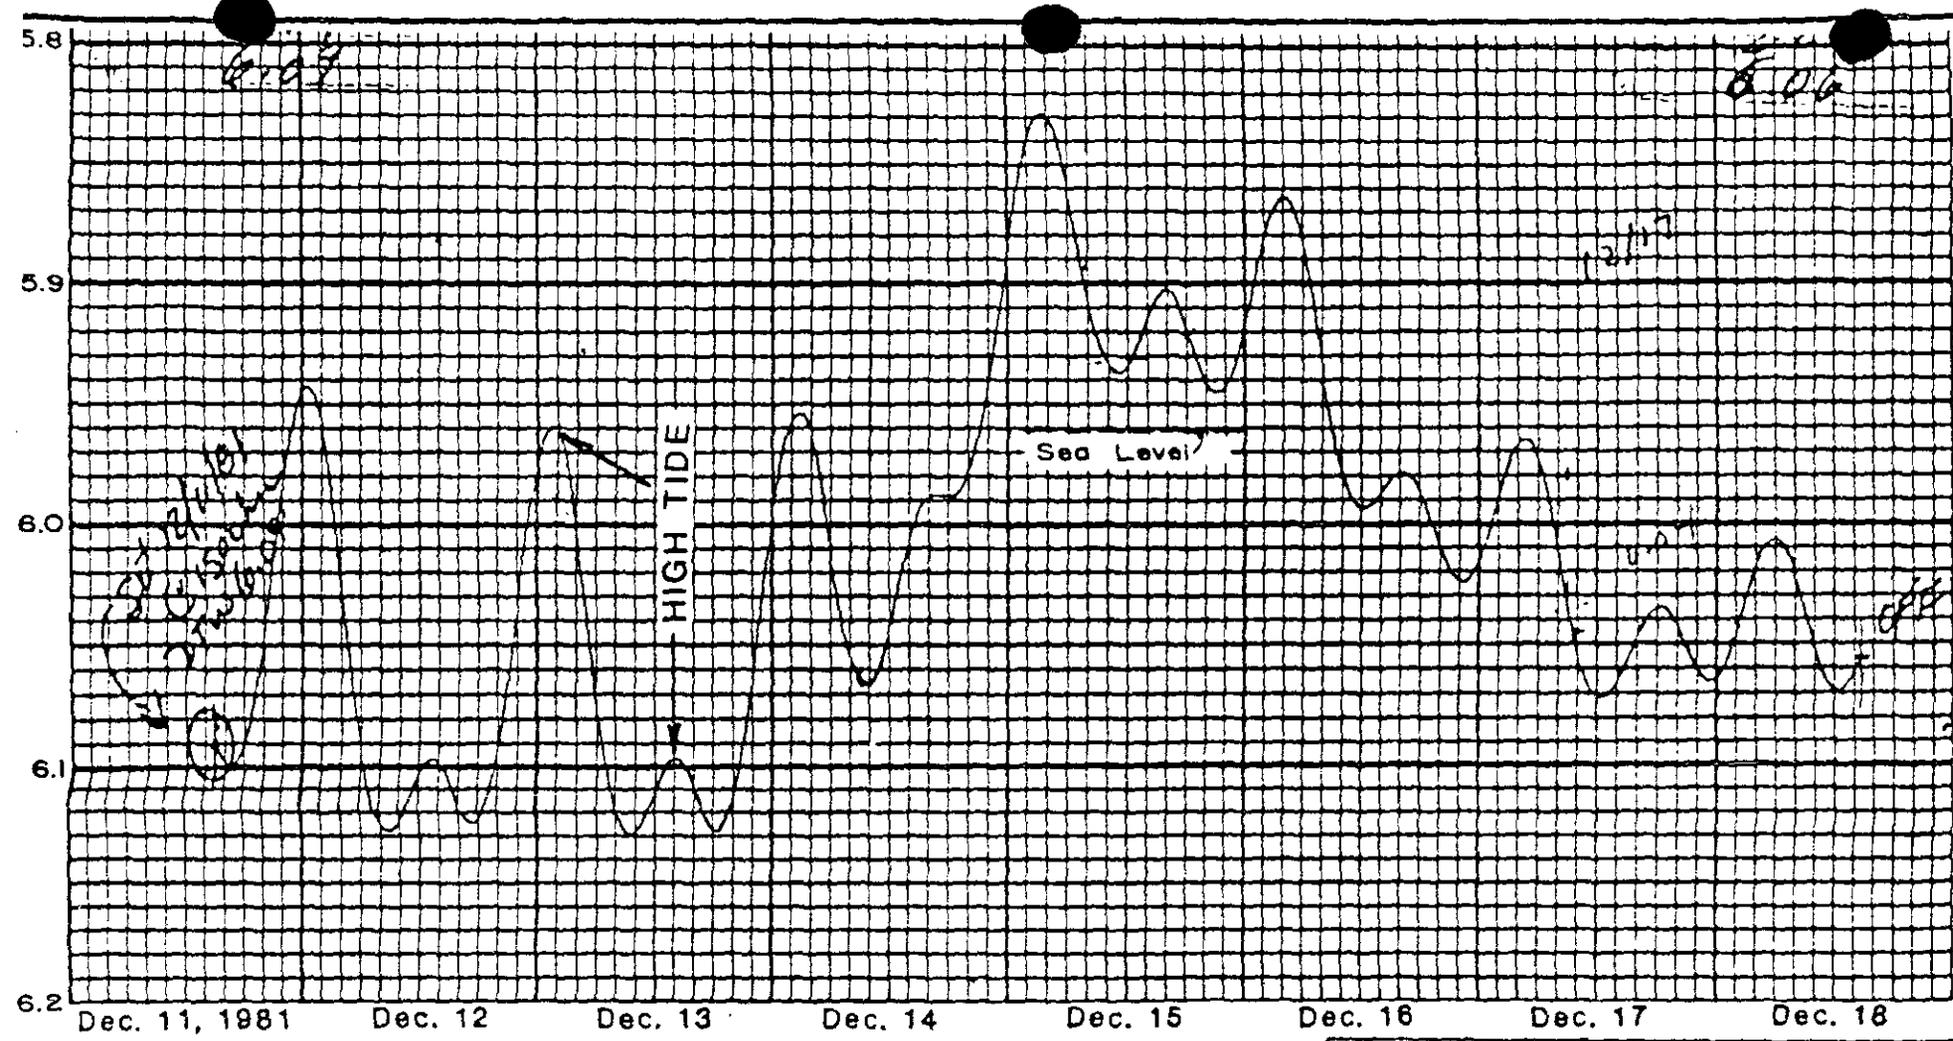
PREPARED FOR		CHEVRON, U.S.A.
TITLE		TIDAL INFLUENCES ON WATER LEVELS Key West Terminal
COMPILED BY V.P. Amy	Geraghty & Miller, Inc. West Palm Beach, Florida	DATE March 1982
DRAWN BY P.O. Smith		REVISED
CHECKED BY V.P. Amy	SCALE	FIGURE 5

The continuous water-level records show the influence of tidal fluctuations in Key West Bight on the water table. Tidal fluctuations in the Key West area are somewhat unusual; two highs and lows occur each day (actually slightly more than 24 hours). However, the amplitudes of the tidal highs differ. Each day there is one "very" high tide and one that is high, but lower in elevation. The "very" high tide will have an elevation of roughly +2 feet NGVD under normal conditions, while the other will be about +1 foot NGVD. Daily lows will range from as much as +.7 foot NGVD to -.7 foot NGVD. A typical example is shown on Figure 5, which is a record of water levels from Culvert 4 for the period December 11 through 18, 1981. The same type of fluctuations were noted on the records from the other wells.

Examination of the table shows that the times of both high and low tides occur consistently later in Culvert 1 than in Well 10. Normally the time lag between tidal highs and lows in a surface-water body and a nearby well is least in wells closest to the shore and increases with increasing distance from the coastline. This is analogous to a wave starting at the shoreline, influencing a nearby well, and traveling inland to influence a well at a later time. The observed lags at the Key West terminal are the reverse of what would be expected and are attributed to the presence of the sea wall which acts as a barrier to the movement of water. Because of the presence of the sea wall, Well 10 is closer hydraulically to the Bight than Culvert 1, and therefore, it responds sooner to tides than does the level in Culvert 1. In this case, the sea wall acts as a barrier to the movement of water and product and aids in preventing discharges of hydrocarbons floating on the water table at the terminal into Key West Bight. *perhaps, but has*

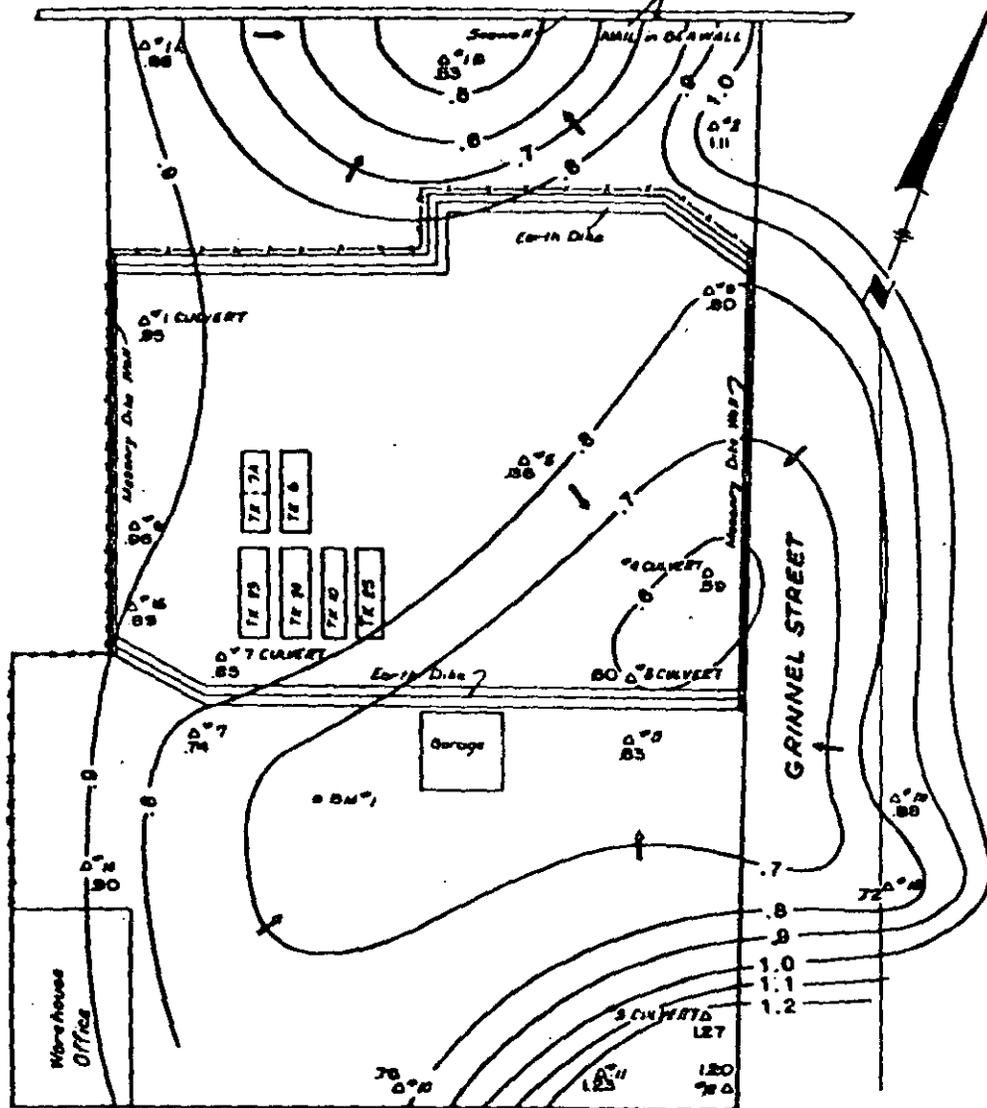
PREPARED FOR		
CHEVRON, U.S.A.		
TITLE		
FLUID LEVELS RELATIVE TO LOW TIDE IN KEY WEST BIGHT		
December 17, 1981		
Key West Terminal		
COMPILED BY	Geraghty & Miller, Inc.	DATE
V.P. Amy		March 1982
DRAWN BY	West Palm Beach, Florida	REVISED
P.O. Smith		
CHECKED BY	SCALE	FIGURE 6
V.P. Amy	None

Examination of the maps reveals features that are significant insofar as the behavior of fluids in the subsurface is concerned. Figure 6 is the contour map of levels relative to low tide on December 17, 1981 (That date was selected because the time when the water levels were measured was close to the low tide in Key West Bight. Similarly, other dates were selected for preparing the other maps because the time of data collection coincided with high and mean tides in the Bight.). Figure 6 shows water levels that are positive with respect to the level in the Bight. In general, they appear to increase in elevation with increasing distance inland from the sea wall. The map also shows that two depressions exist in the water table; one is in the general vicinity of Well 1B, and the other in the area formed by the east-central and eastern portion of the property near the garage Culverts 4 and 8, and Well 8. These two depressions represent sinks towards which fluids would move. The general direction of movement is indicated by the arrows on the map.

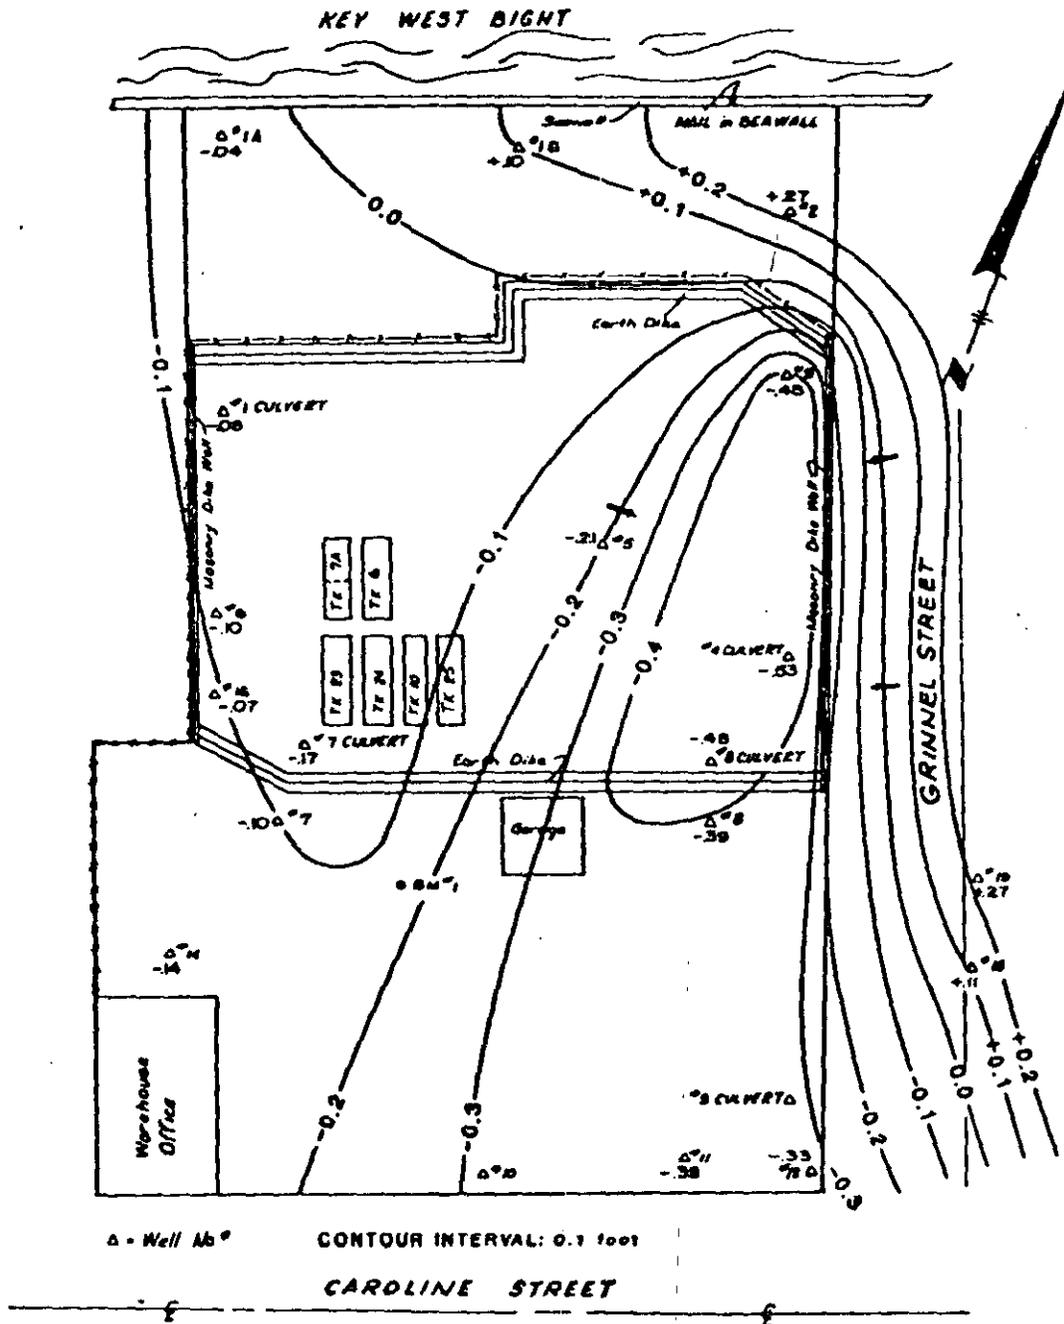
PREPARED FOR		
CHEVRON, U.S.A.		
TITLE		
FLUID LEVELS RELATIVE TO HIGH TIDE IN KEY WEST BIGHT		
January 4, 1982 Key West Terminal		
COMPILED BY V.P. Amy	Geraghty & Miller, Inc. West Palm Beach, Florida	DATE March 1982
DRAWN BY P.O. Smith		REVISED
CHECKED BY V.P. Amy	SCALE None	FIGURE 8

Figure 8 shows water-level relationships at high tide. In this case, levels appear to be higher closer to the sea wall and lower inland, although they are higher at Wells 18 and 19 which are located on the east side of Grinnel Street. The water-table depression in the vicinity of Well 1B is not present. However, the larger depression in the vicinity of Well 8 and Culvert 8 still persists. The general direction of movement, particularly from the east towards the terminal property, remains the same.

The high and low tide maps show an apparent reversal of the overall gradient. The depression centered on Well 1B disappears and the major one centered on Well 8 and Culvert 8 remains. This is a temporary situation occurring only at high tide. Long-term conditions with two depressions existing are best represented by the mean tide conditions depicted on Figure 7.

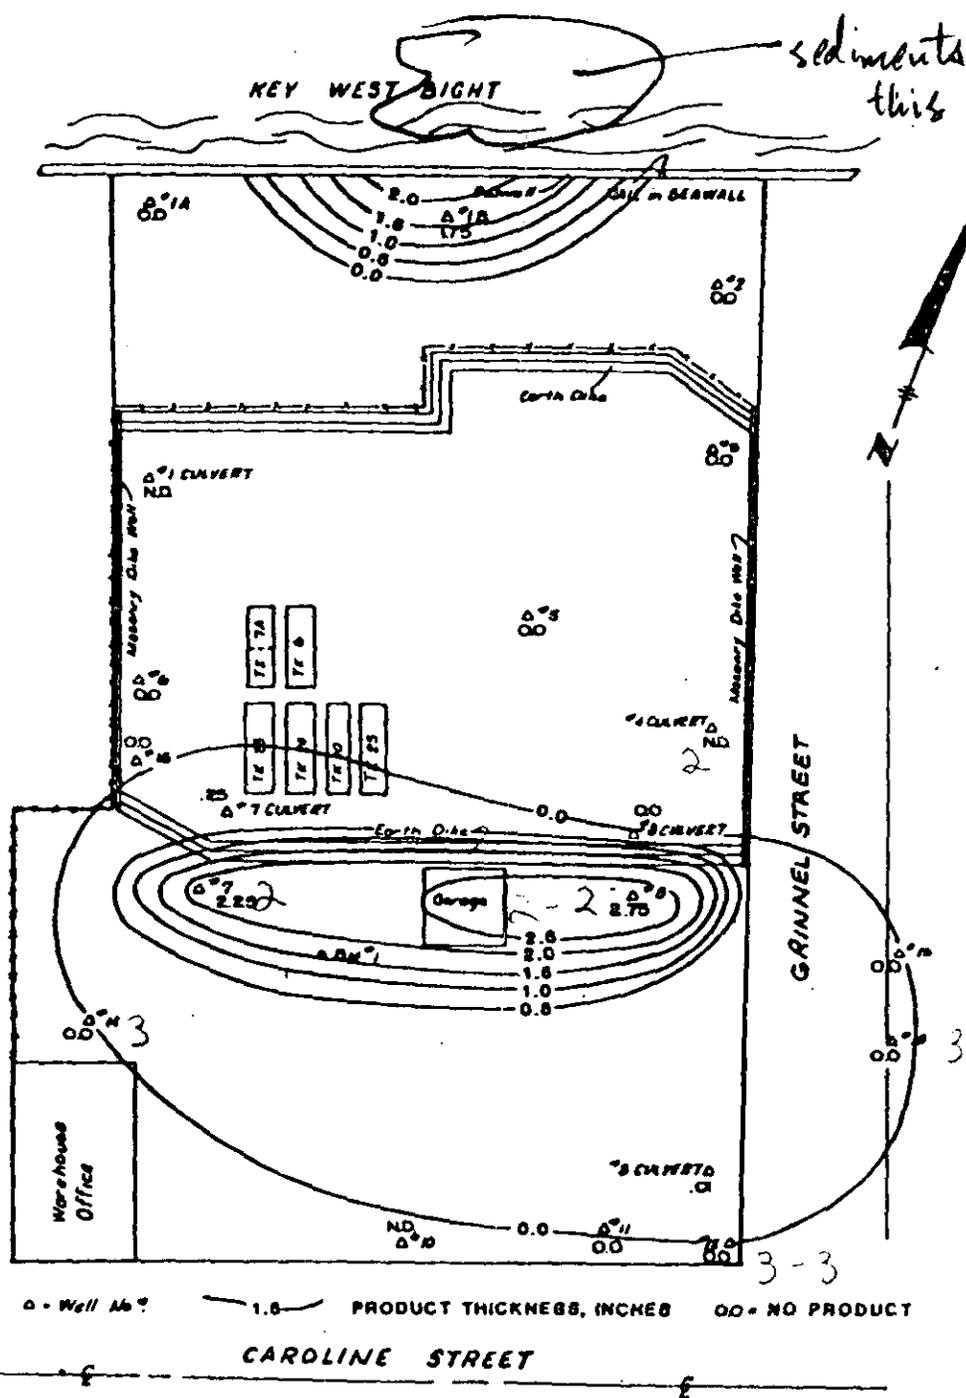
PREPARED FOR		
CHEVRON, U.S.A.		
TITLE		
PRODUCT ISOPACH MAP		
December 14, 1981		
Key West Terminal		
COMPILED BY	Geraghty & Miller, Inc.	DATE
V.P. Amy		March 1982
DRAWN BY	West Palm Beach, Florida	REVISED
P.Q. Smith		
CHECKED BY	SCALE	FIGURE 9
V.P. Amy	None

Comparison of product thickness in Well 8 between the two dates (November 6th and December 14th) shows that it was greater on November 6th than it was December 14th. The difference may be due to the fact that on December 14th the water level was at a depth of 68.75 inches, while on November 6th it was at 61.5 inches. The apparent reduction in thickness may be due to the fact that some of the product was not part of the lens because it was suspended above the water table and capillary zone. The product probably is less mobile than water and remained suspended when the water table declined. The December 14th data on product thickness were collected at a time of low tide. This relationship has no significant influence on the behavior of the product and does not alter any conclusions; it is presented simply to illustrate the difficulty associated with attempting to determine quantities of product in the ground based on the thickness observed in a well.
