**Environmental Baseline Survey
Water and Wastewater Utility System
Privatization
Naval Station Mayport
Mayport, Florida**

March 2005

**Southern Division
Naval Facilities Engineering Command
North Charleston, South Carolina**

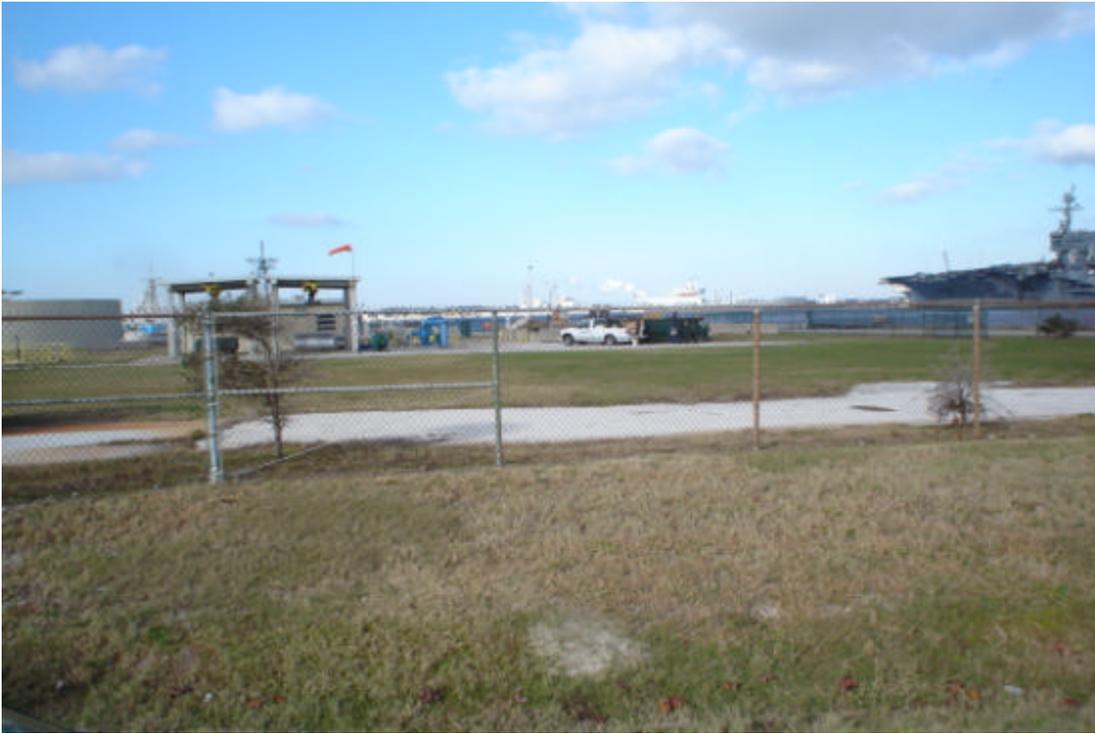
1. View of fueling stands at the Navy Fuel Depot at NS Mayport.

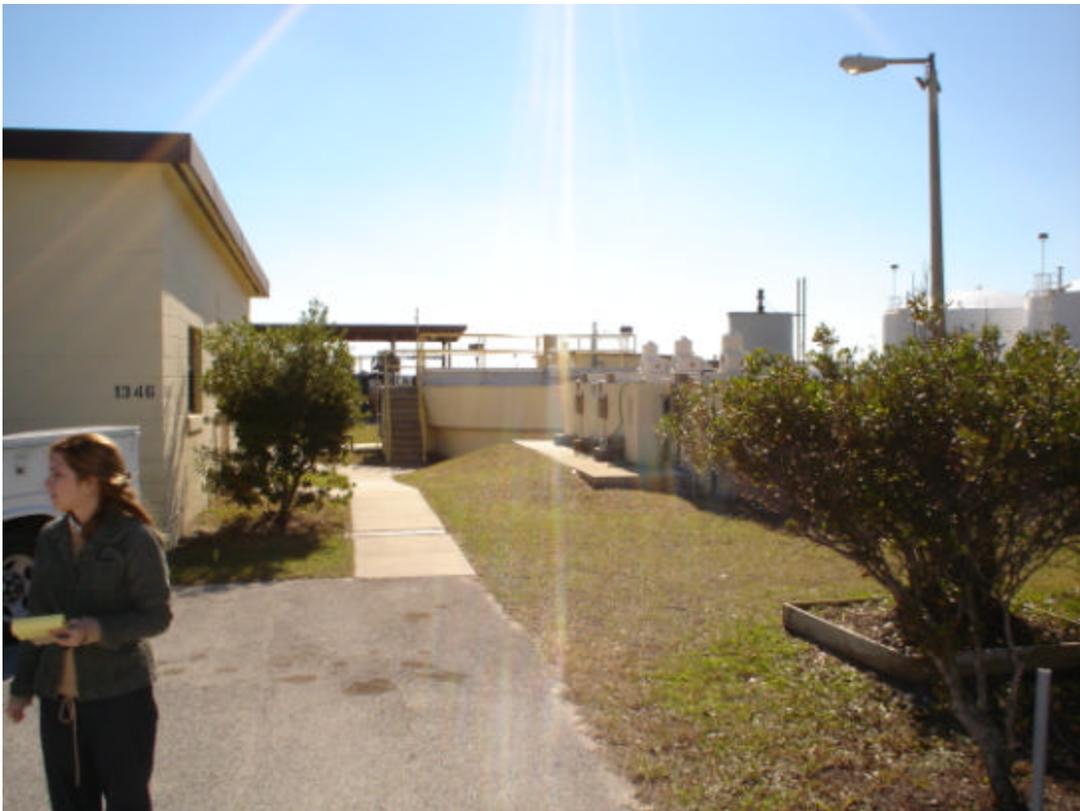
2. View of Oily Waste Treatment Plant and SWMUs 6, 7, 8, and 9.

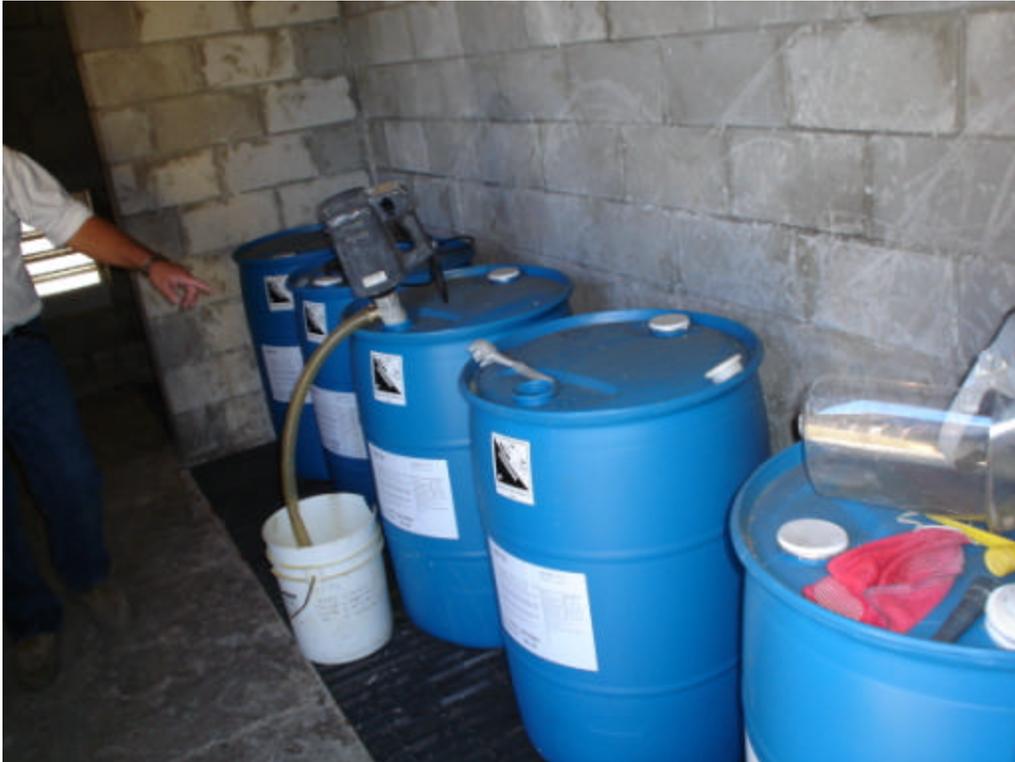
3. View of SWMU 10, Hazardous Waste Storage Area.

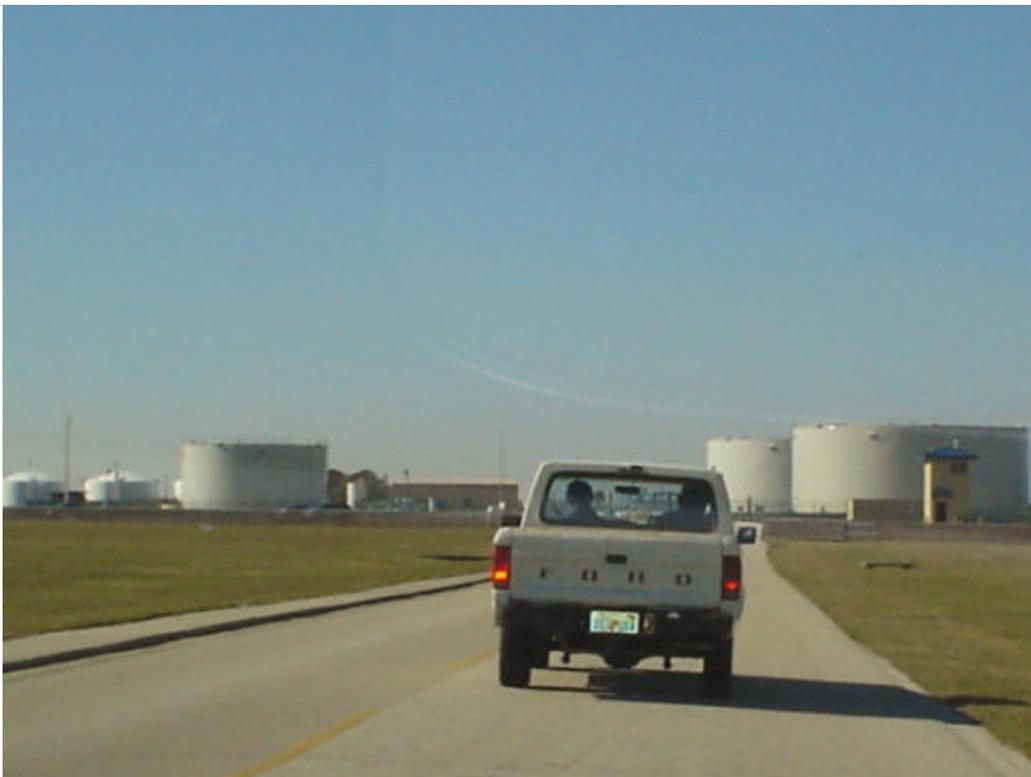
4. View of Navy Fuel Depot.

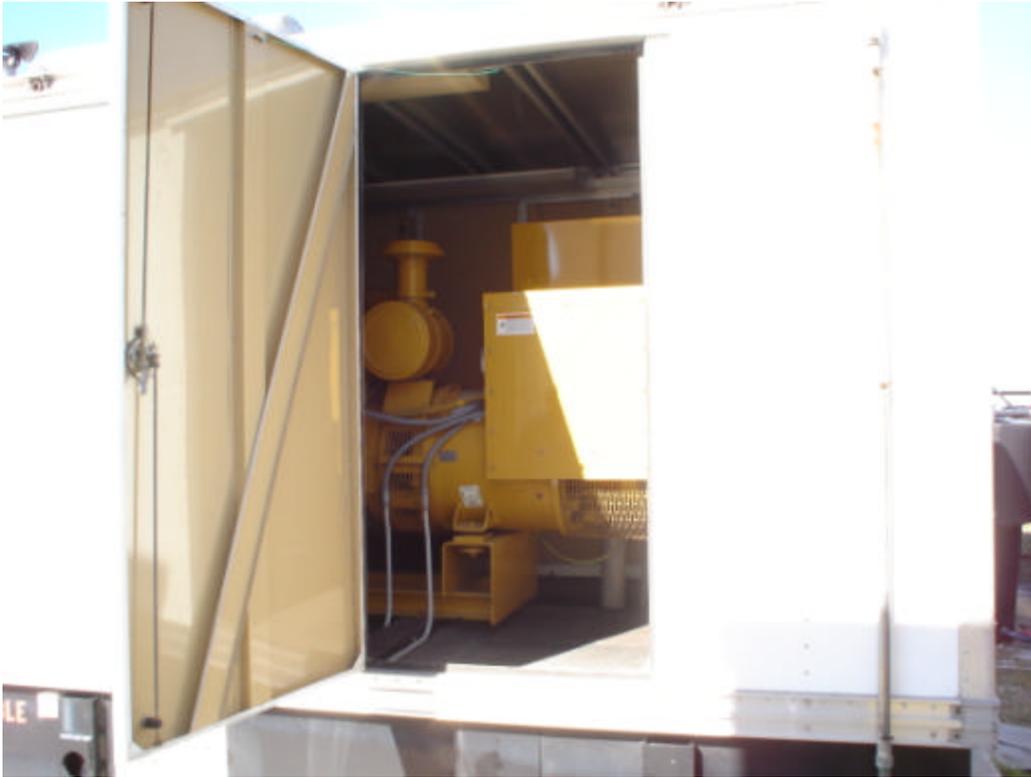
5. Diesel Generator Sump at Fleet Training Center, site of SWMU 18.

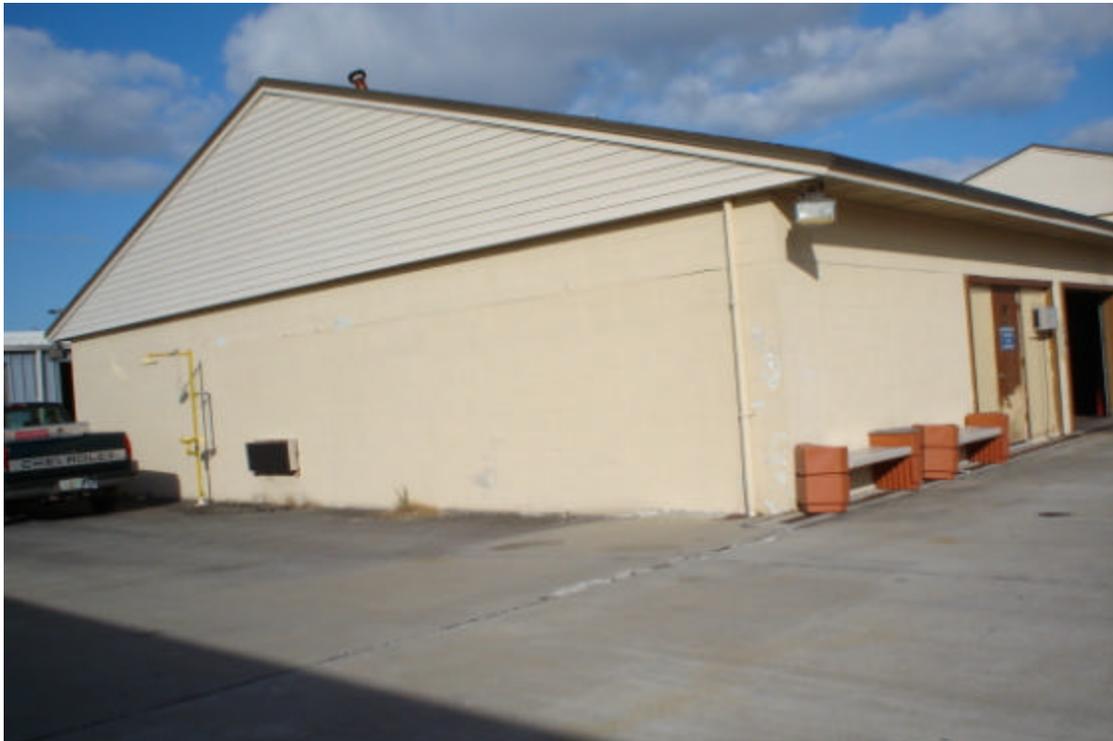
6. View of SWMU 20, Hobby Shop Drain.

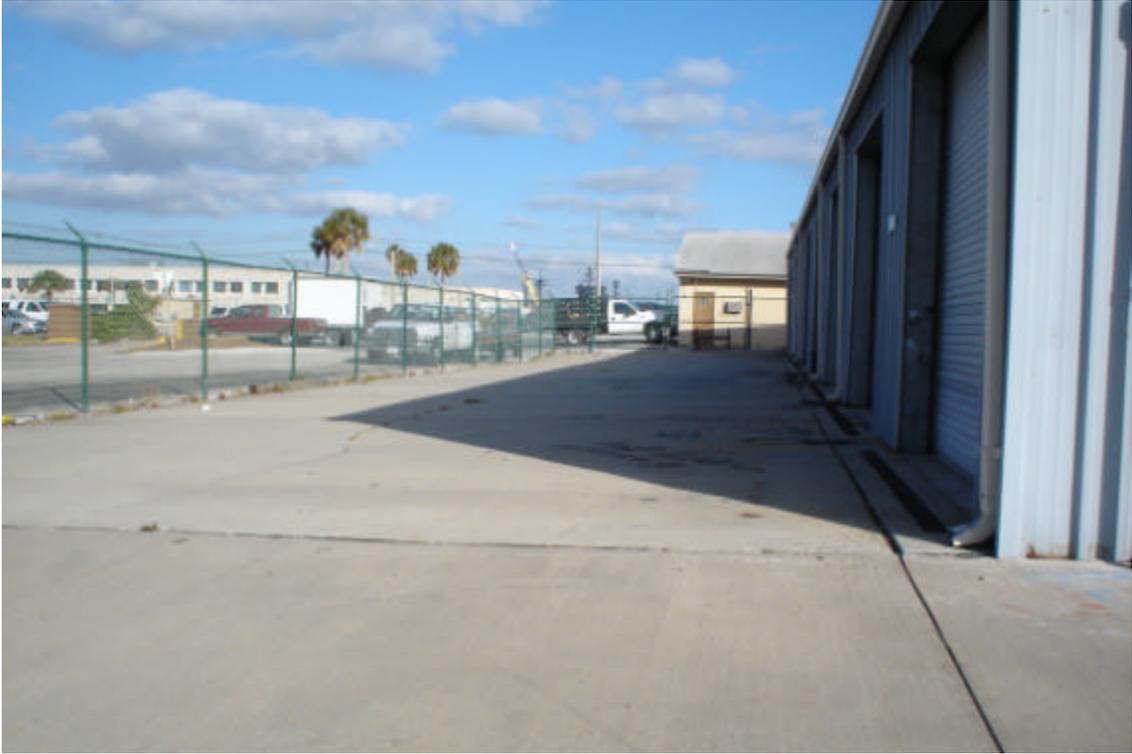
7. View of SWMU 21, Hobby Shop Scrap Storage Area.

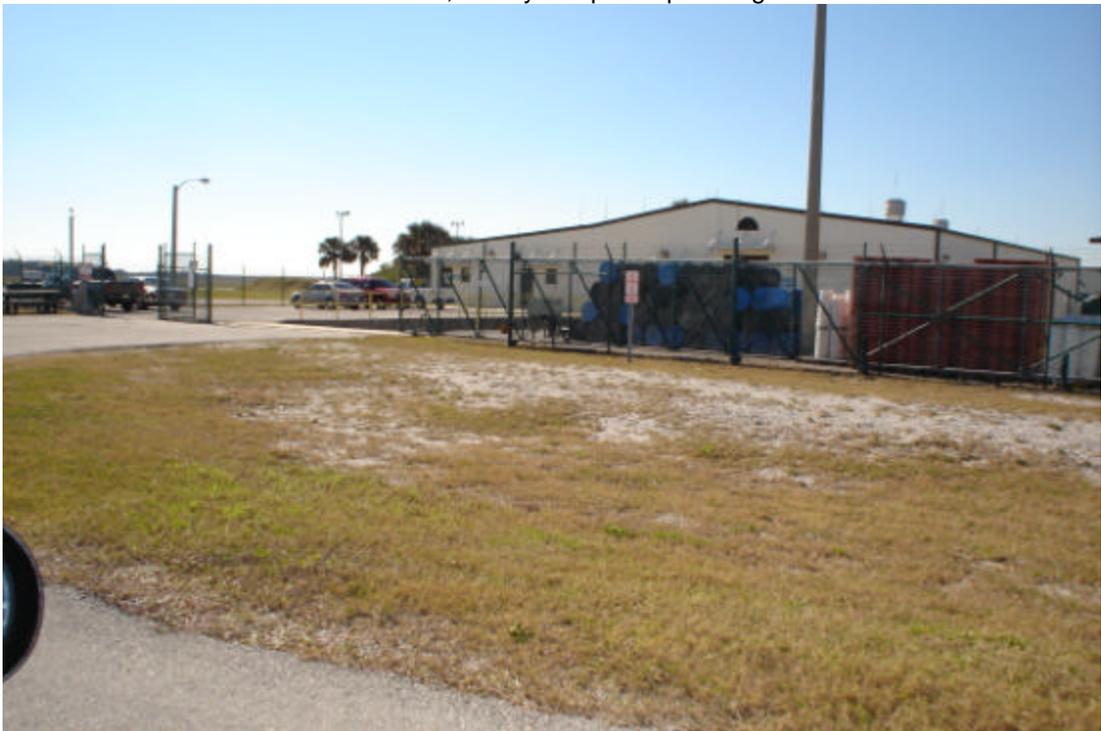
8. View of SWMU 28, Defense Reutilization Marketing Office Yard.

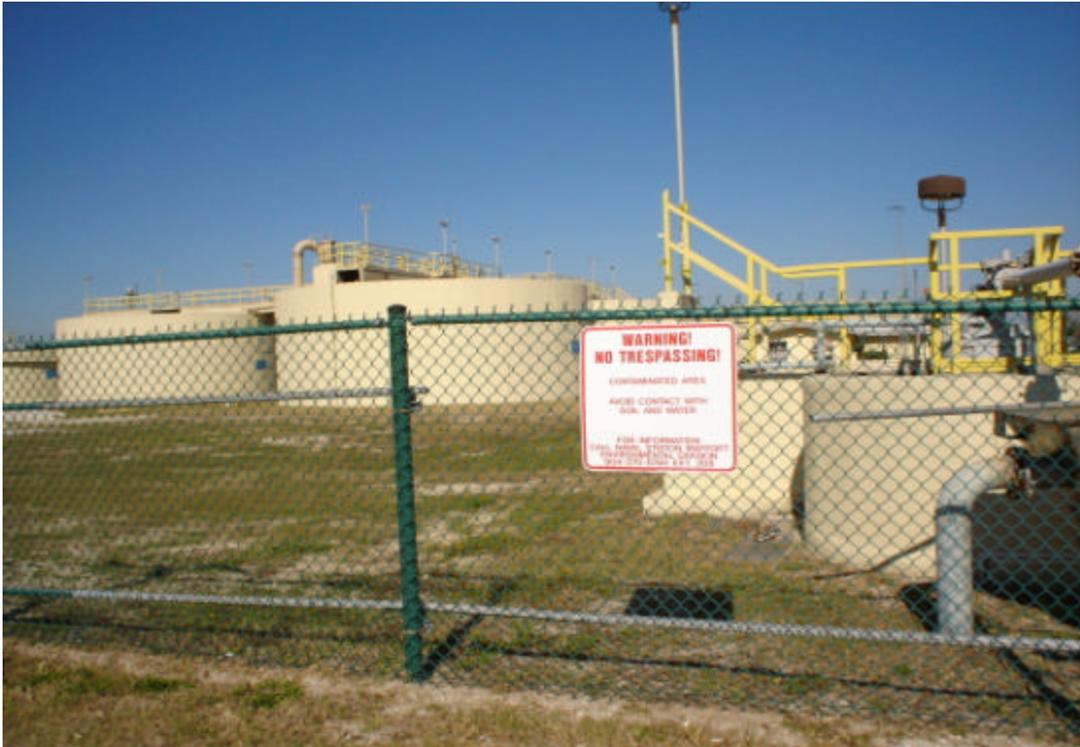
9. View of SWMU 44, Wastewater Treatment Facility Clarifiers 1 and 2.

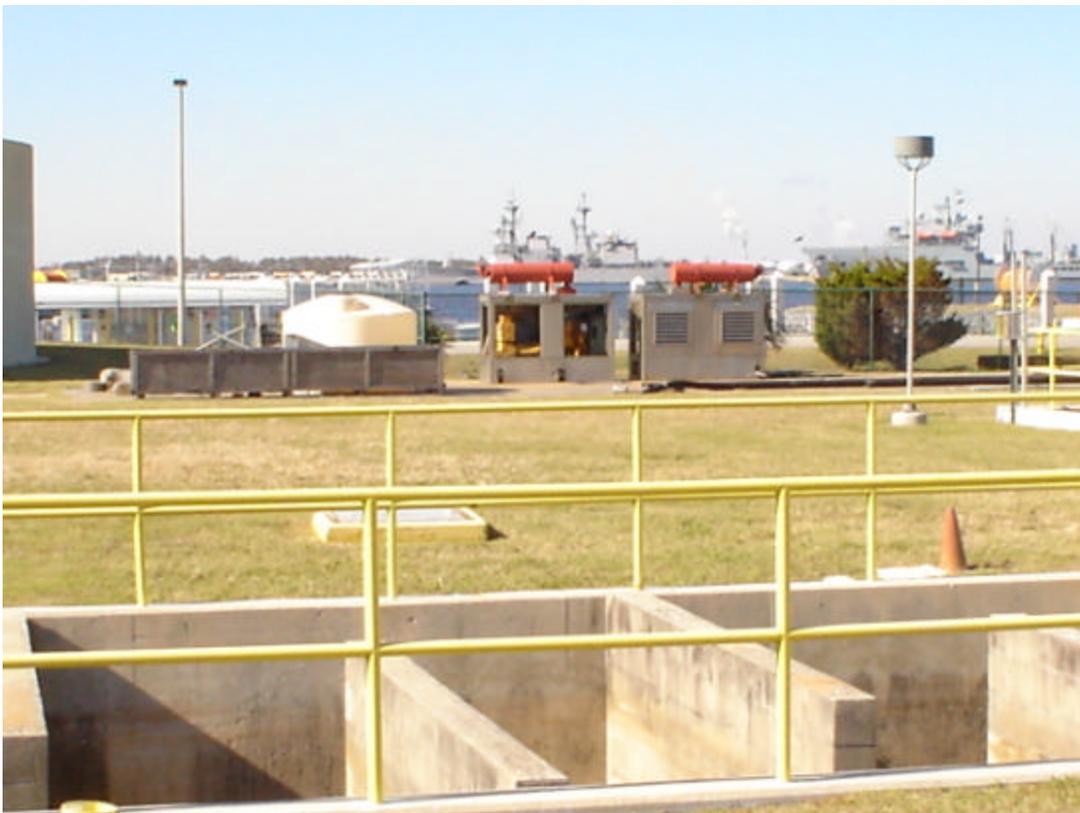
10. View of the new Wastewater Treatment Facility sludge drying beds.
