Final
Asbestos Inspection Report
for

Naval Activity Puerto Rico
Ceiba, Puerto Rico

Volume 4 of 7

Buildings 1706 through 1994

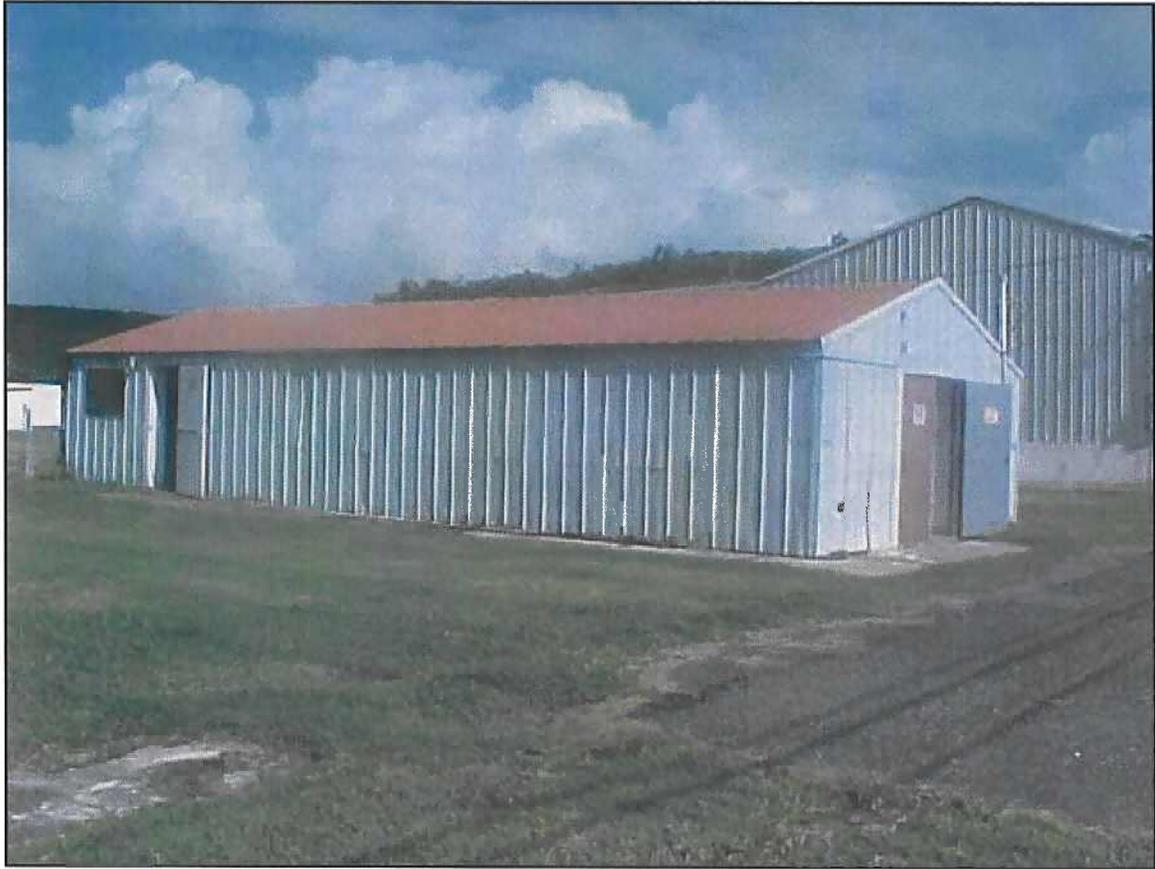
BUILDING 1706

Building 1706 is identified as “TEMP CPO Hut/Pier 3 Pub” and is approximately 960 square feet in size. Five suspect homogeneous materials were identified and sampled. One material, floor adhesive (Material #002), was found to be an ACM. Note that “31” was accidentally included in the sample identifications instead of “1706”. No friable, damaged, and accessible ACM was identified.

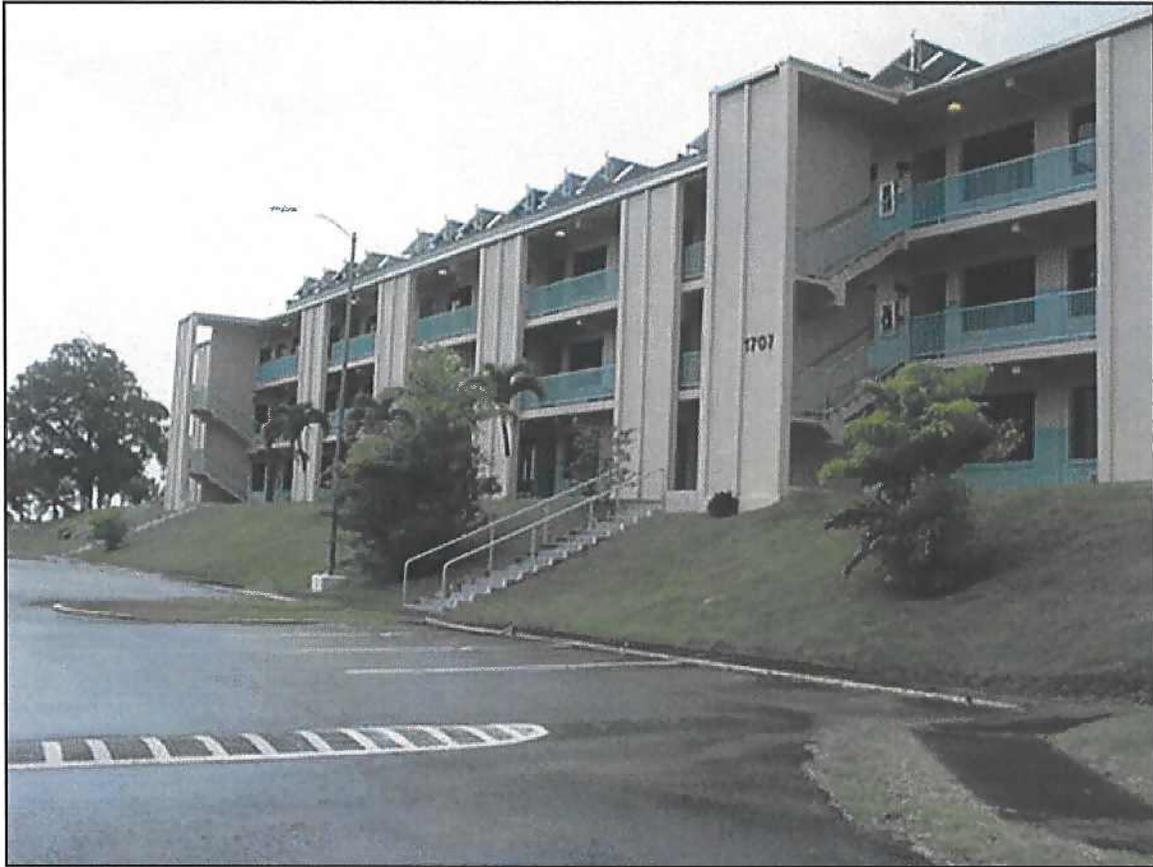
BUILDING 1707

Building 1707 is identified as “BEQ” and is approximately 32,583 square feet in size. Nine suspect homogeneous materials were identified and sampled. None of these materials were found to be ACM.

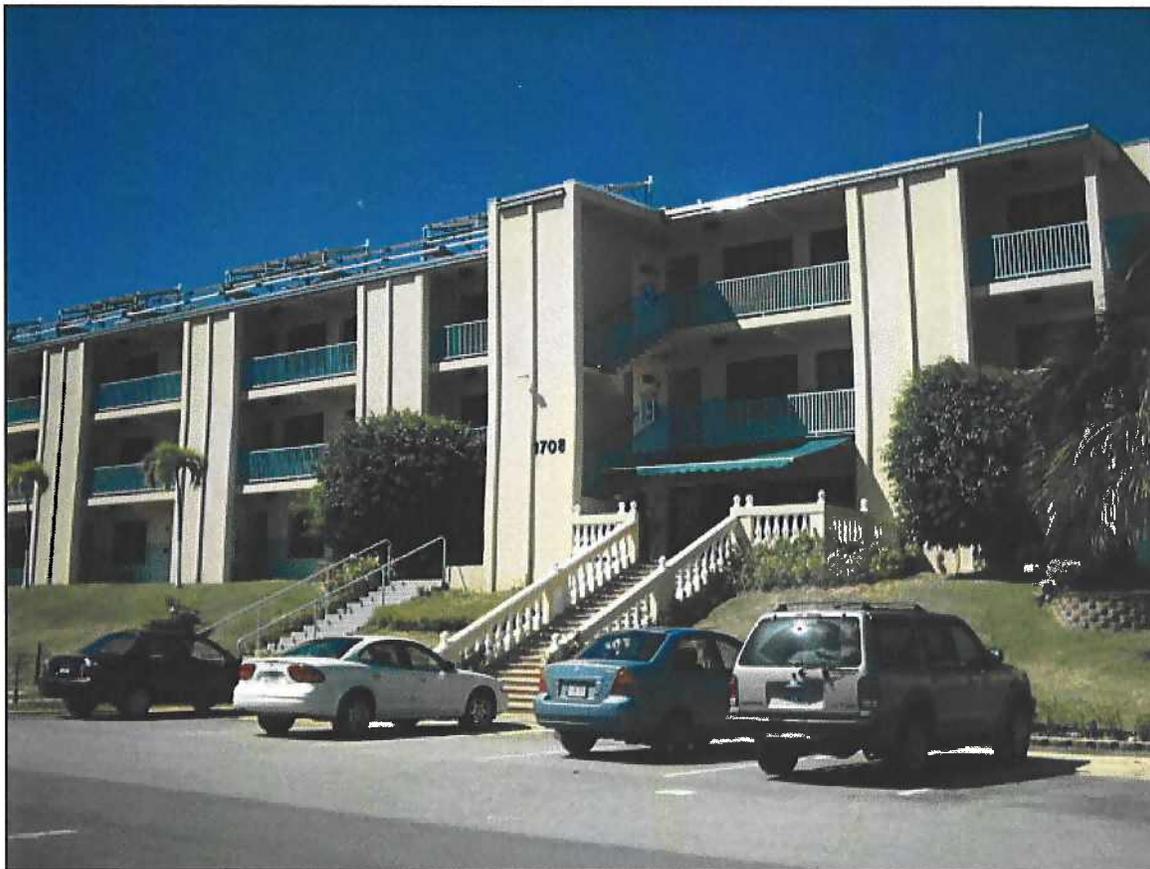
BUILDING 1708

Building 1708 is identified as “BEQ” and is approximately 32,583 square feet in size. Nine suspect homogeneous materials were identified and sampled. One material, floor adhesive (Material #005), was found to be ACM. The sample that contained asbestos contained a residual black floor adhesive in addition to the brown adhesive present in the other samples. No friable, damaged, and accessible ACM was identified.

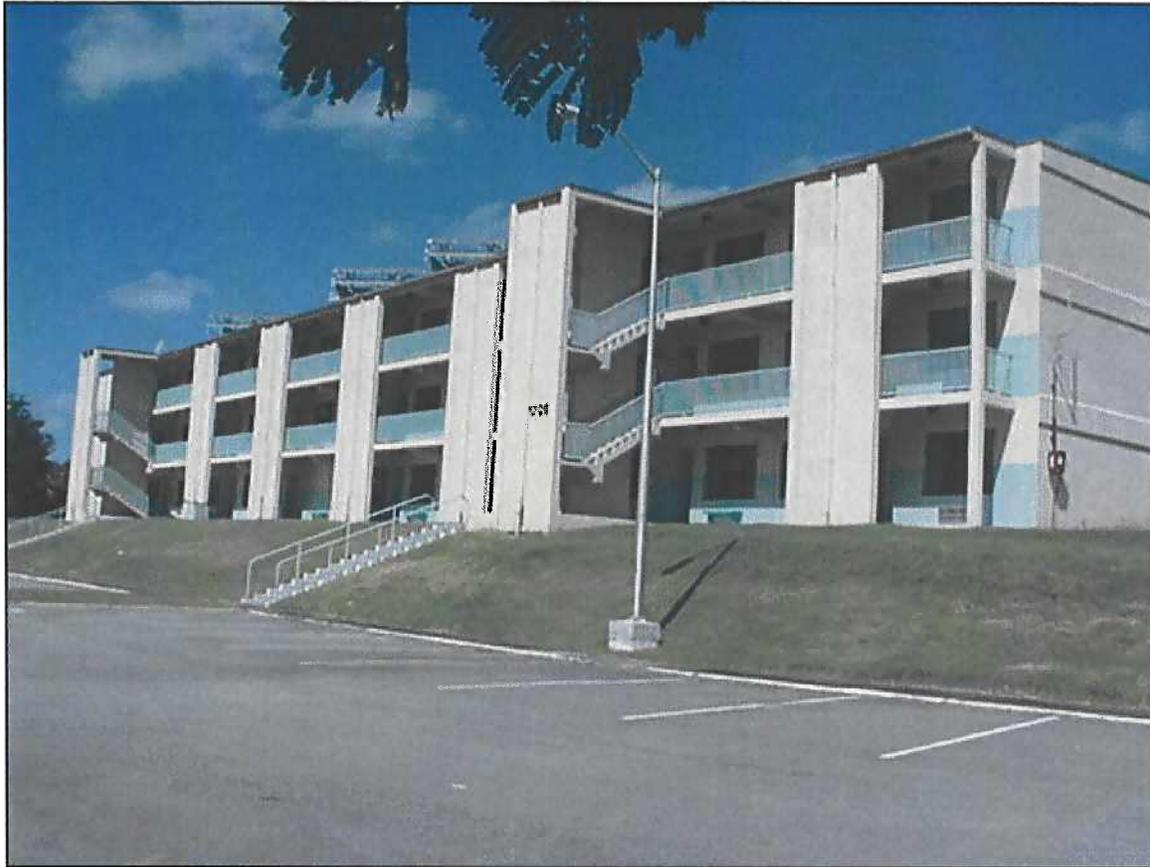
BUILDING 1709

Building 1709 is identified as “BEQ” and is approximately 32,583 square feet in size. Eight suspect homogeneous materials were identified and sampled. None of these materials were found to be ACM.

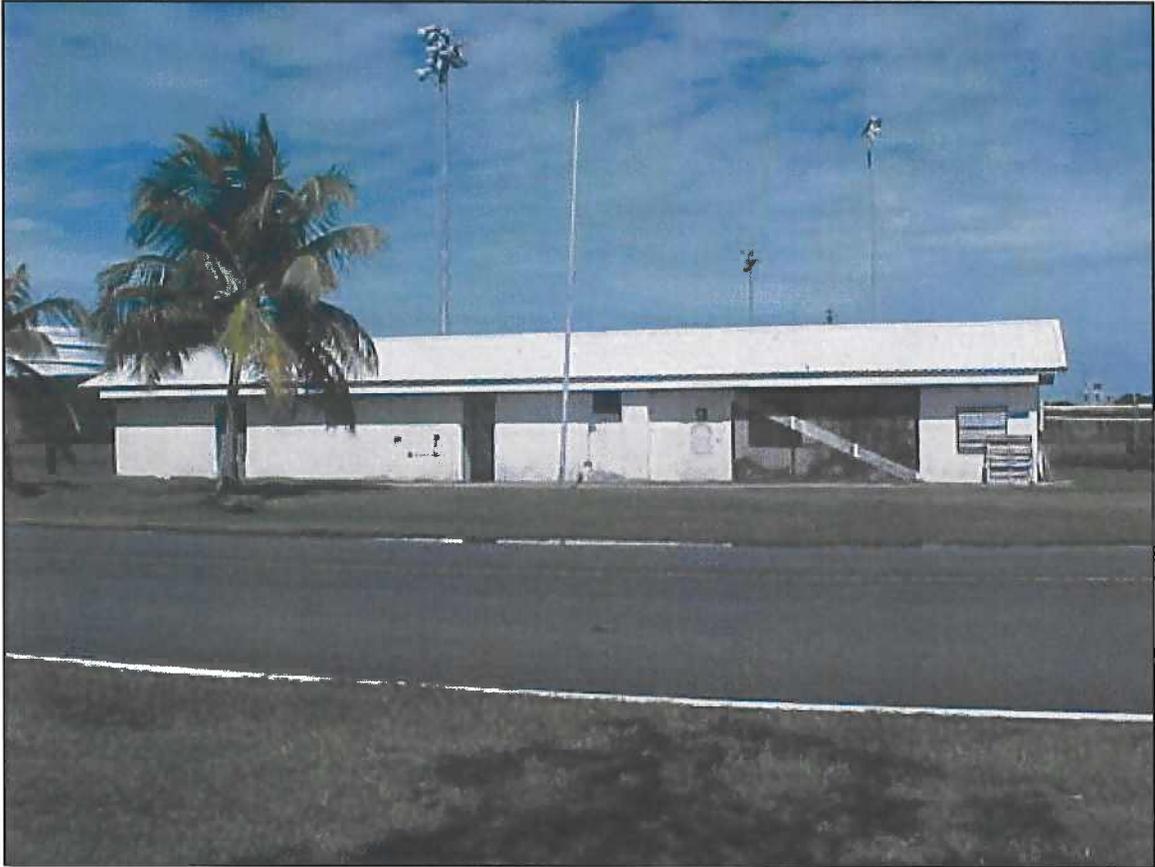
BUILDING 1715

Building 1715 is identified as “Fleet Rec Park” and is approximately 1,600 square feet in size. No suspect materials were identified. Therefore, no sampling was conducted.

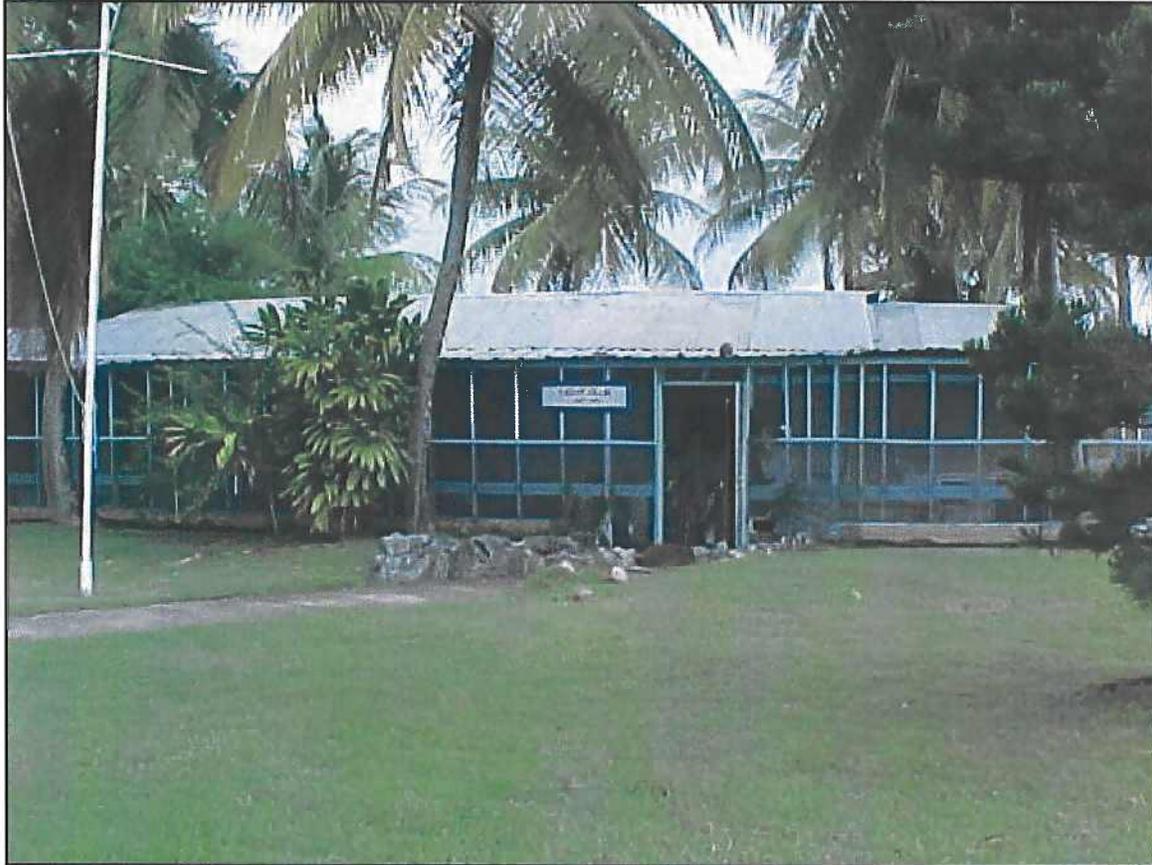
Building 1724 is identified as “Yacht Club” and is approximately 1,300 square feet in size. Four suspect homogeneous materials were identified and sampled. One material, sink coating (Material #004), was found to be an ACM. No friable, damaged, and accessible ACM was identified.

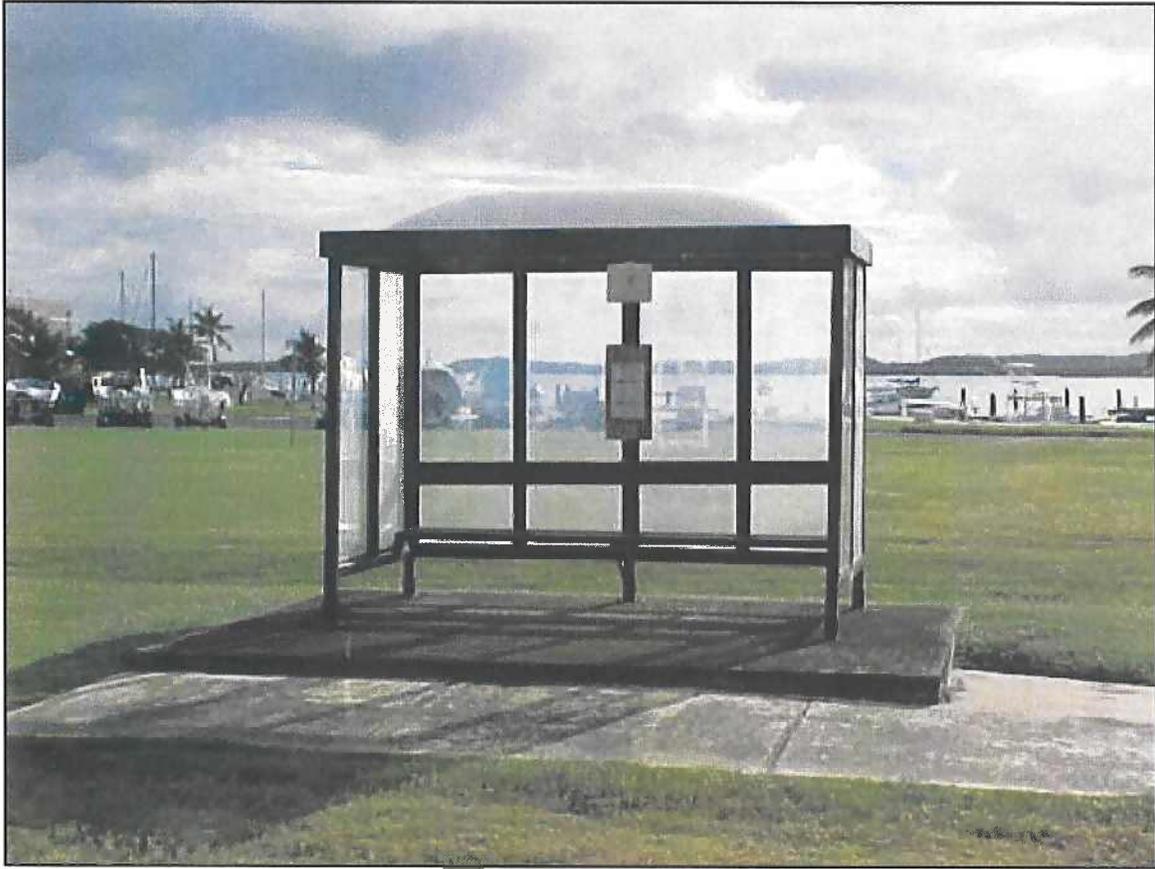
Building 1725 is identified as “Bus Stop Shelter by Marina” and is approximately 50 square feet in size. No suspect materials were identified. Therefore, no sampling was conducted.

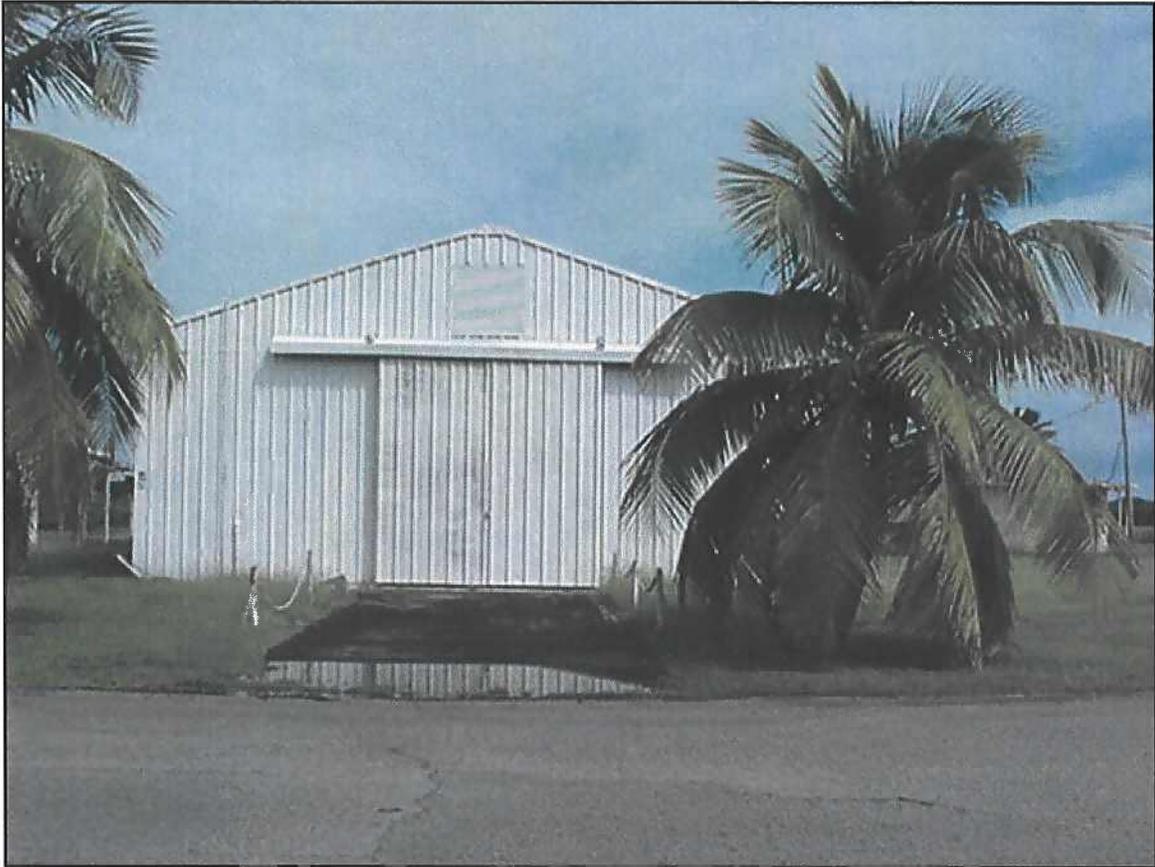
Building 1728 is identified as “Mech. and Elec. Maint. Shop” and is approximately 4,000 square feet in size. Six suspect homogeneous materials were identified and sampled. Two of these materials, vinyl floor tile (Material #001) and floor adhesive (Material #004) were found to be ACM. No friable, damaged, and accessible ACM was identified.

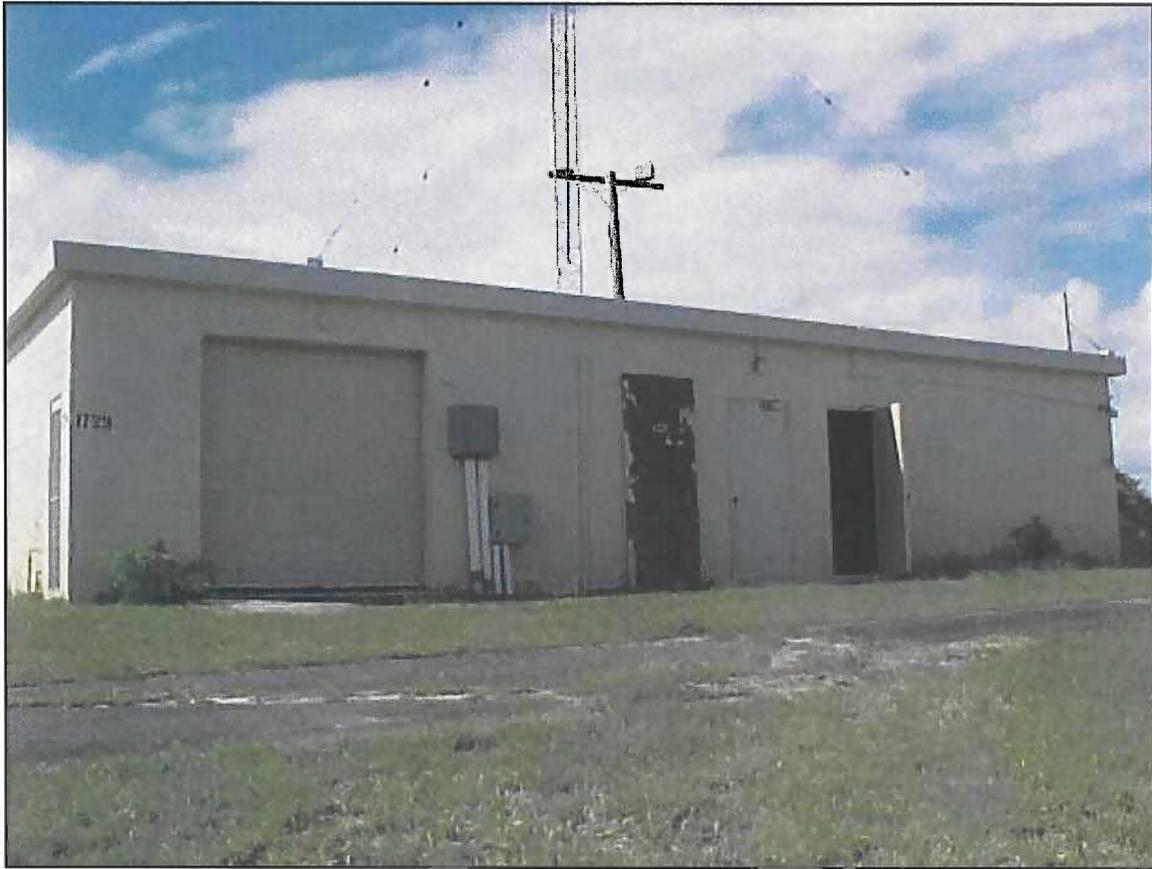
Building 1729 is identified as “Link 11 (Comm Bldg)” and is approximately 1,000 square feet in size. Four suspect homogeneous materials were identified and sampled. One material, floor adhesive (Material #002), was found to be an ACM. No friable, damaged, and accessible ACM was identified.

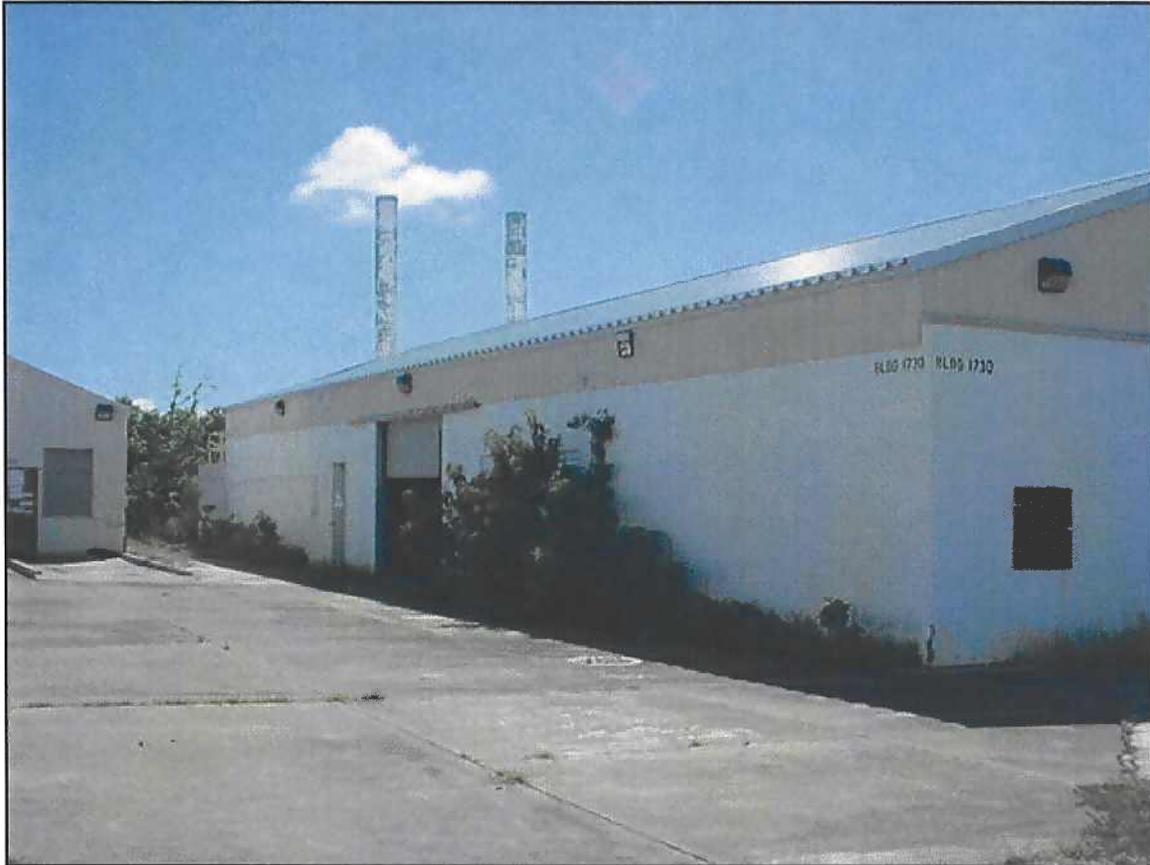
Building 1730 is identified as “MK-48 Torpedo Shop” and is approximately 4,000 square feet in size. Ten suspect homogeneous materials were identified and sampled. None of these materials were found to be ACM.

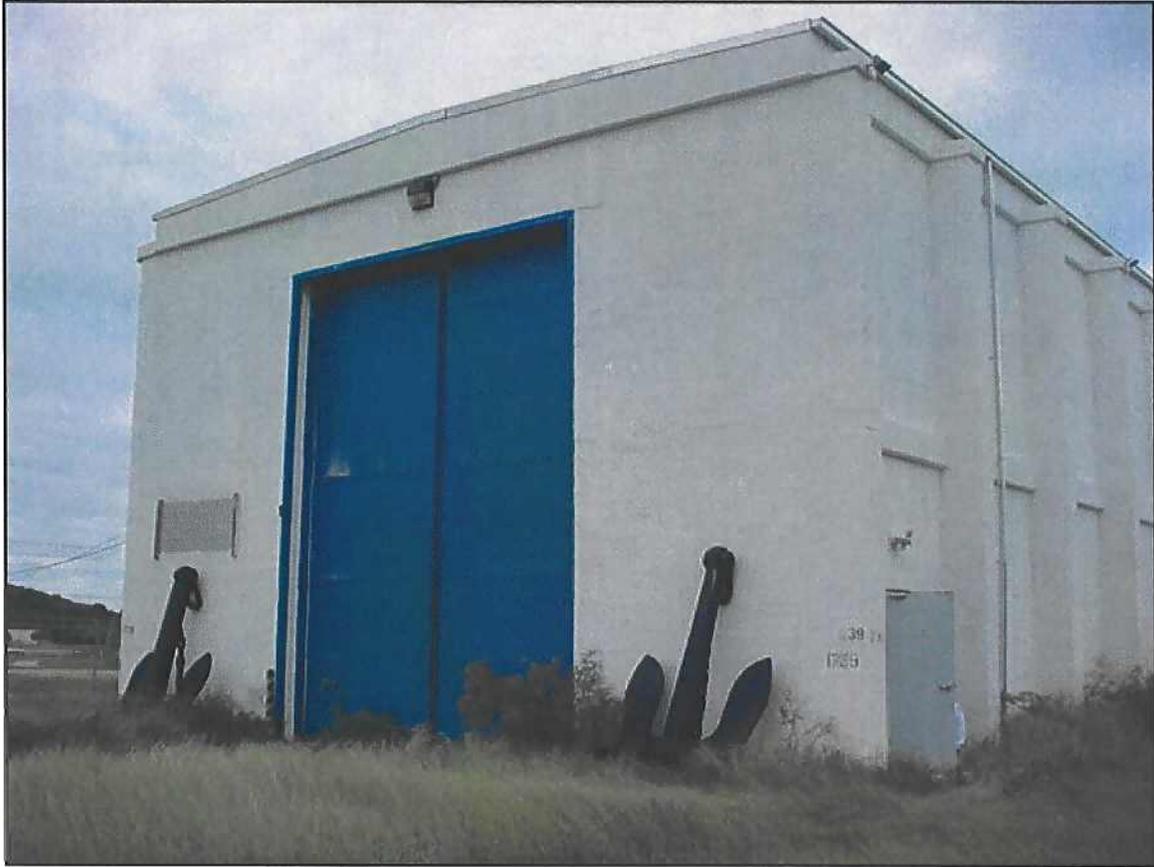
Building 1739 is identified as “Naval Research Lab (NRL)” and is approximately 4,479 square feet in size. Twelve suspect homogeneous materials were identified and sampled. Four materials, two types of plaster (Materials #001 and #010) and two types of vinyl floor tile (Materials #004 and #008), were found to be ACM. No friable, damaged, and accessible ACM was identified.

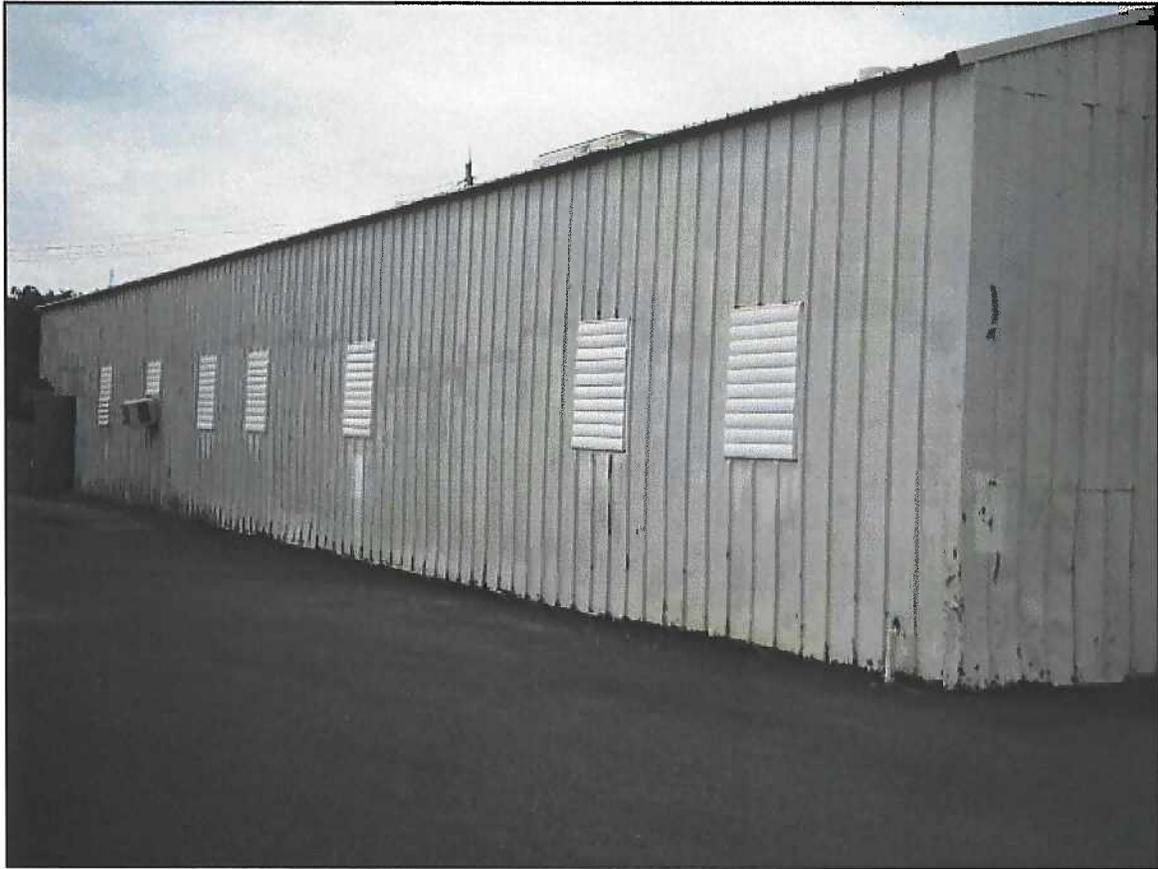
Building 1755 is identified as “Housing Maintenance Shop” and is approximately 4,000 square feet in size. Three suspect homogeneous materials were identified and sampled. One material, floor adhesive (Material #002), was found to be ACM. No friable, damaged, and accessible ACM was identified.

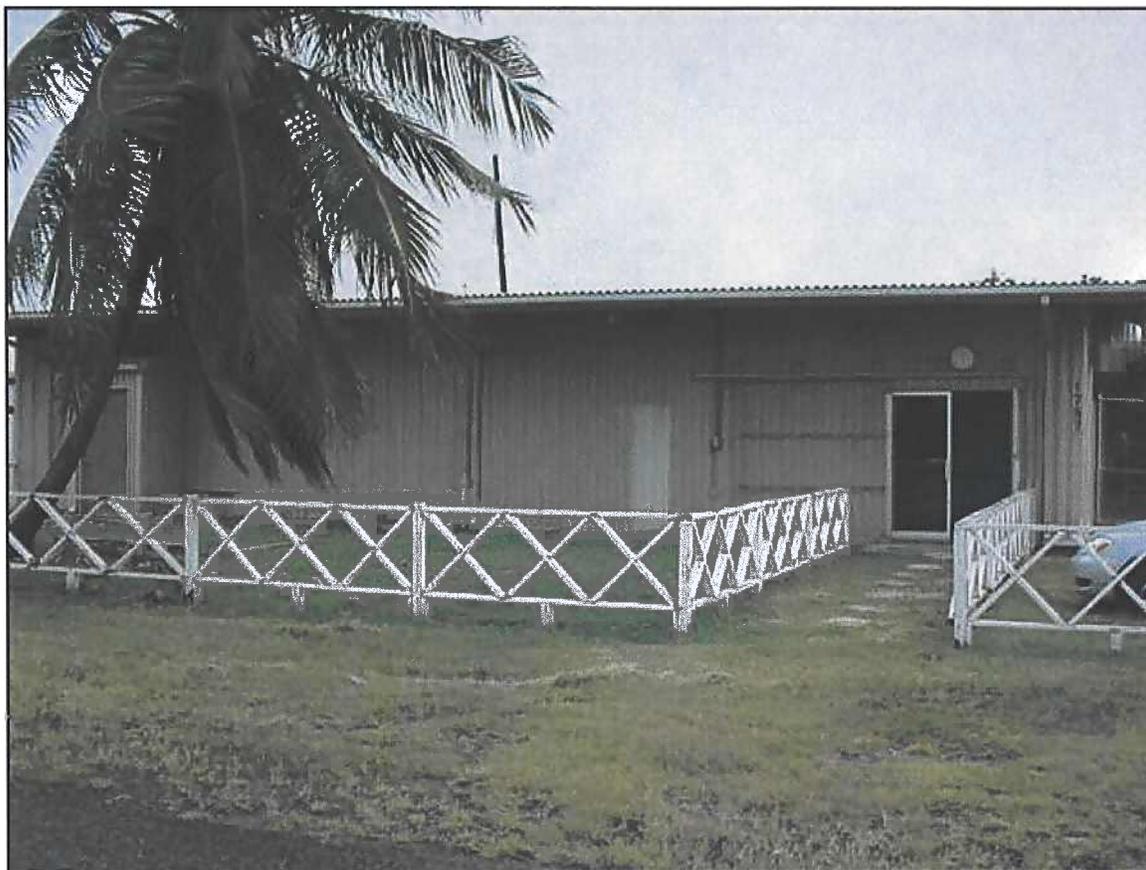
Building 1787 is identified as “Zoonosis Control” and is approximately 1,302 square feet in size. Twenty suspect homogeneous materials were identified and sampled. Four materials, two types of vinyl floor tile (Material #013 and #018), and two types of floor adhesive (Materials #014 and #019), were found to be ACM. No friable, damaged, and accessible ACM was identified.

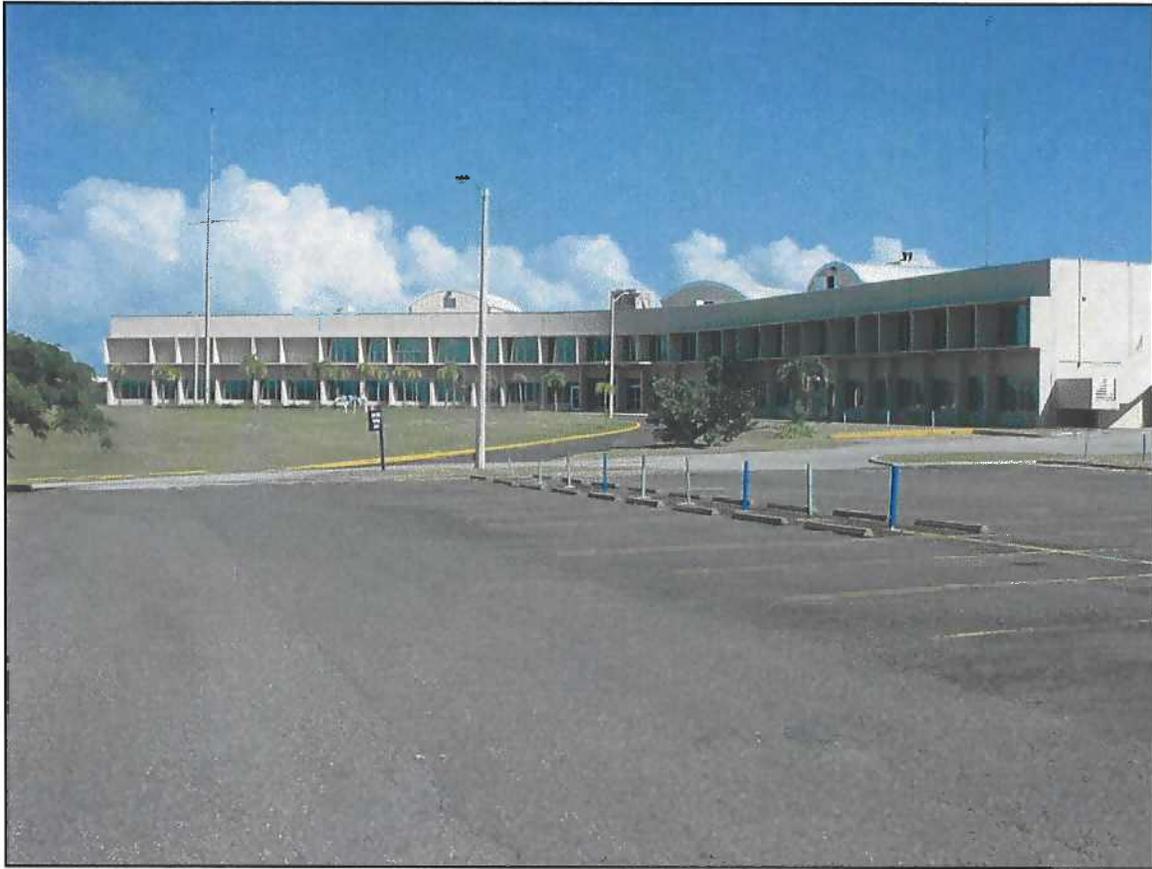
Building 1790 is identified as “Hospital” and is approximately 130,906 square feet in size. Forty-four suspect homogeneous materials were identified and sampled. Nine materials were found to be ACM, including: sink coating (Material #005), duct insulation seam sealant (Material #006), and seven types of floor adhesive (Materials #014, #017, #020, #022, #024, #039 and #044). No friable, damaged, and accessible ACM was identified.

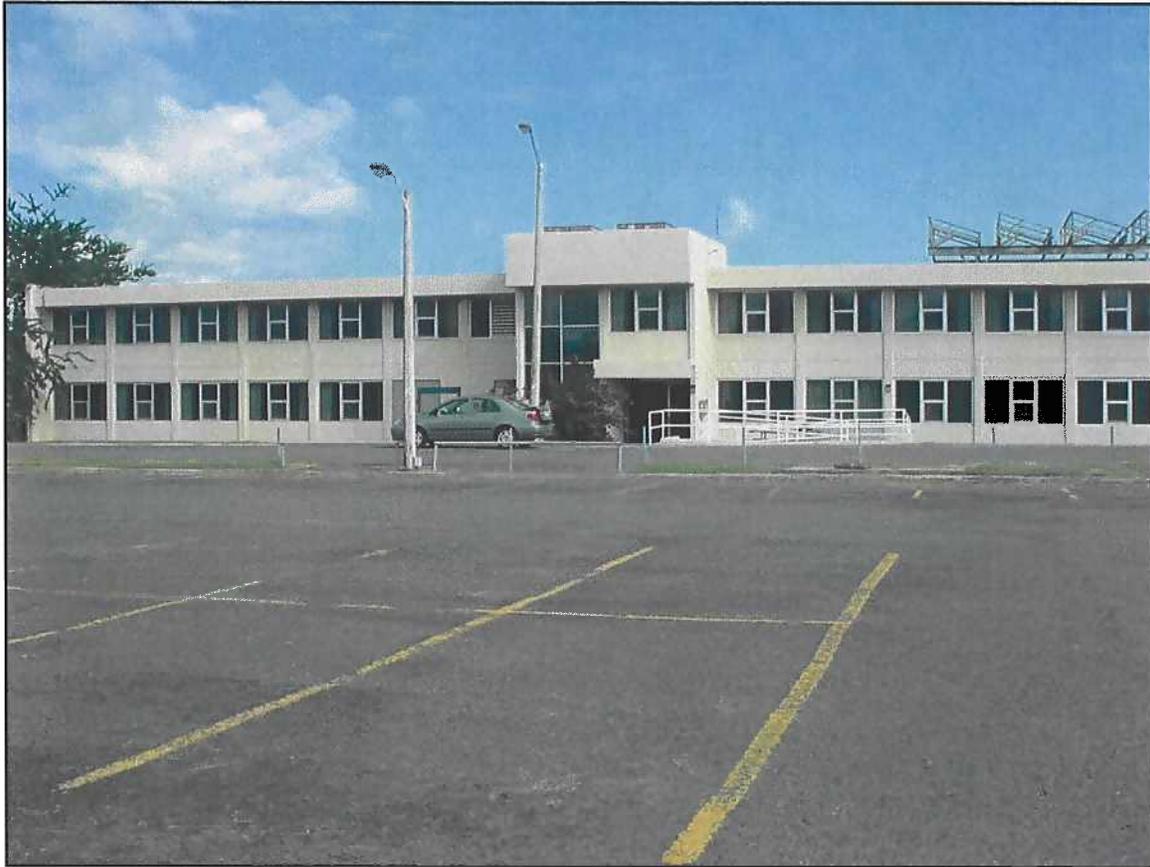
Building 1791 is identified as “BEQ Hosp Corpsman” and is approximately 12,422 square feet in size. Eleven suspect homogeneous materials were identified and sampled. Two materials, asphaltic roofing material (Material #010) and sheet gasket (Material #011), were found to be ACM. No friable, damaged, and accessible ACM was identified.

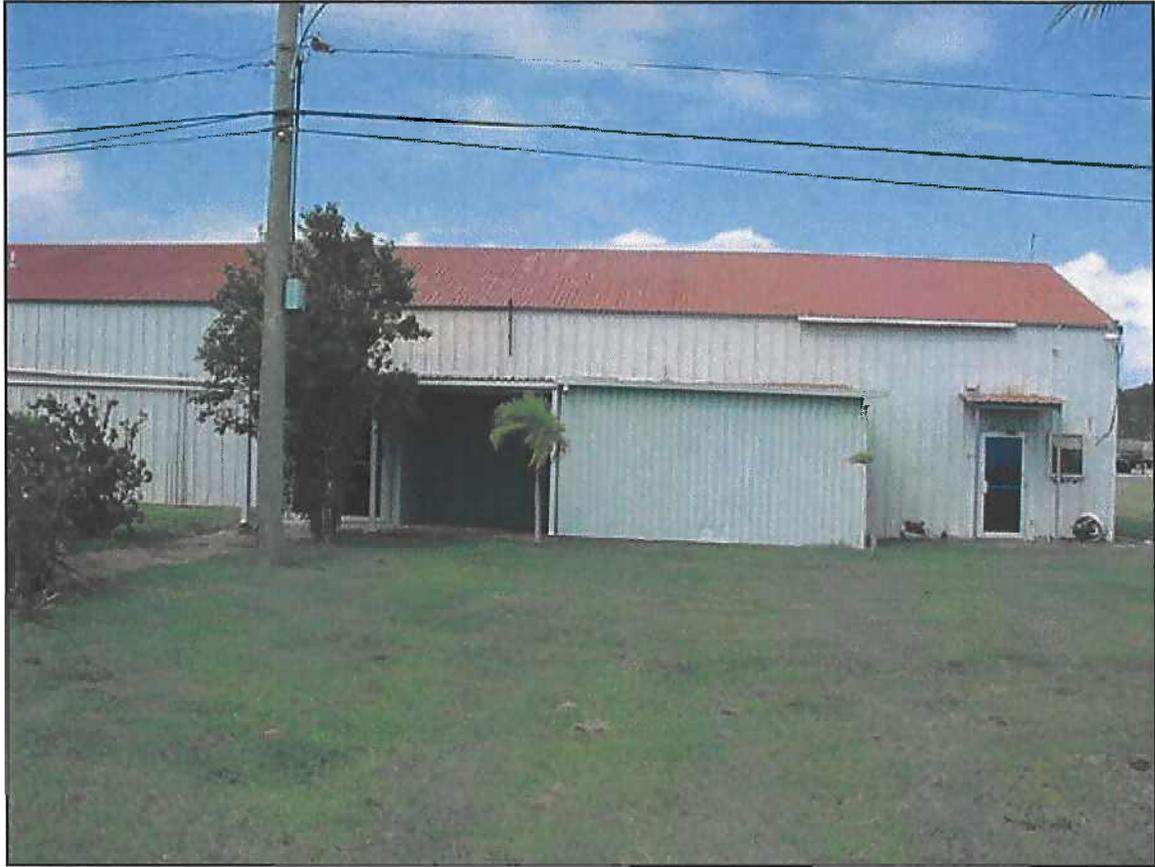
Building 1795 is identified as “Exchange Laundry Facility” and is approximately 4,064 square feet in size. Eighteen suspect homogeneous materials were identified and sampled. Six materials, vinyl floor tile (Material #014) and five types of floor adhesive (Materials #003, #006, #010, #013 and #015), were found to be ACM. No friable, damaged, and accessible ACM was identified.

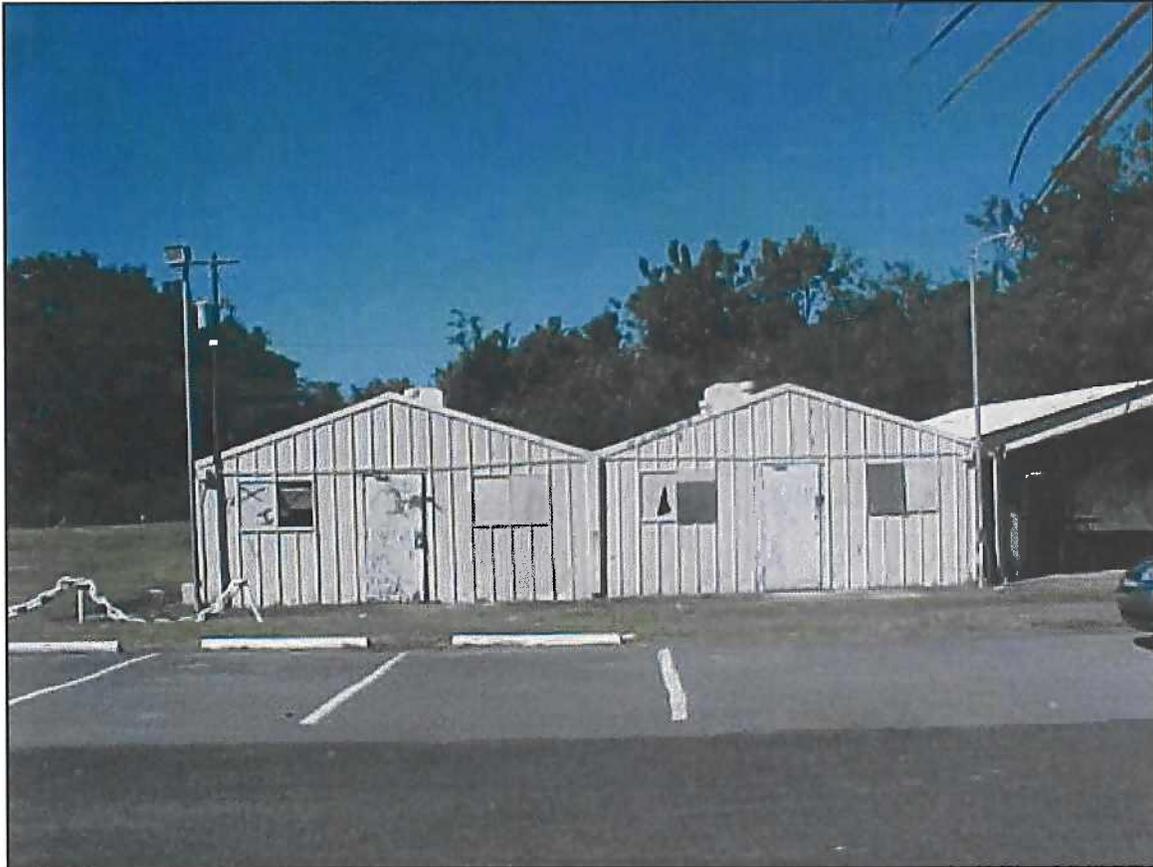
Building 1801 is identified as “Training Bldg” and is approximately 1,920 square feet in size. Three suspect homogeneous materials were identified and sampled. Two materials, vinyl floor tile (Material # 002) and its associated floor adhesive (Material #003), were found to be ACM. No friable, damaged, and accessible ACM was identified.

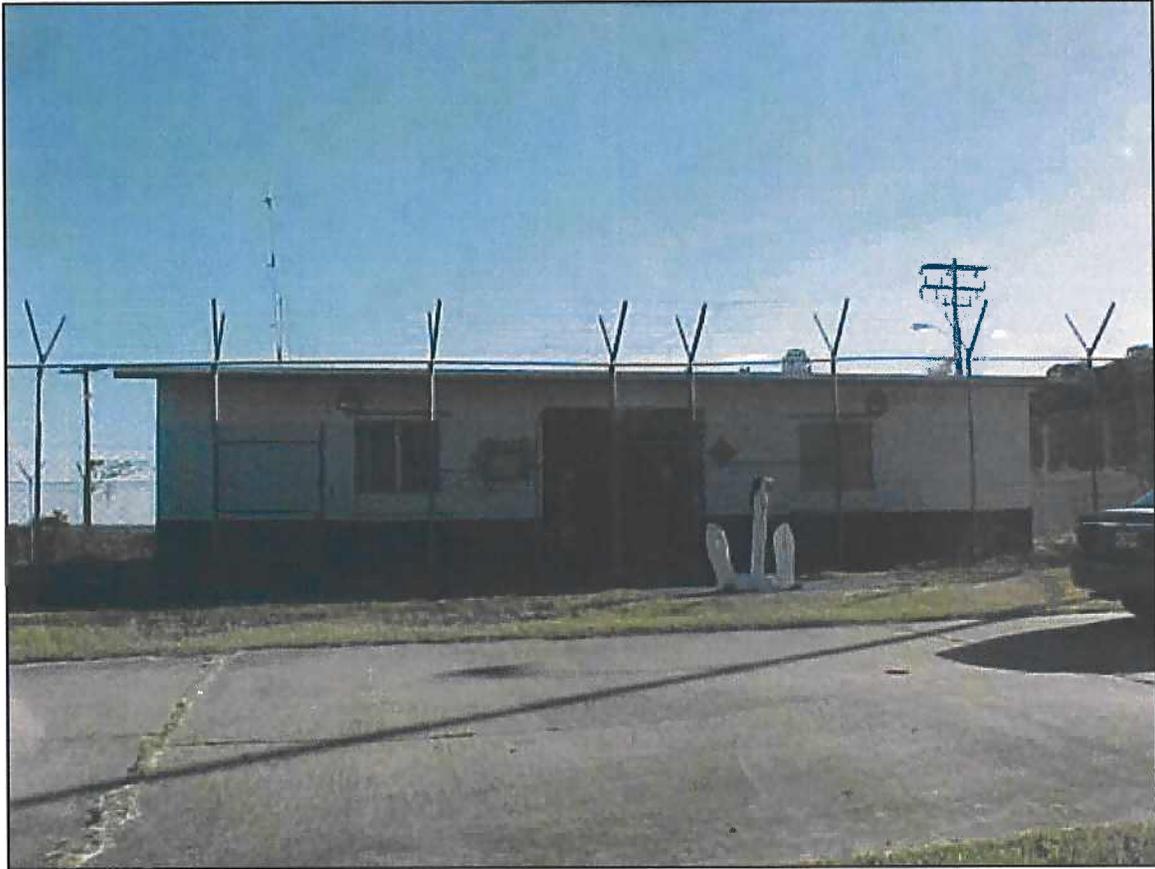
Building 1807 is identified as “Brig” and is approximately 3,893 square feet in size. Four suspect homogeneous materials were identified and sampled. One material, 1’x1’ tan vinyl floor tile (Material #001), was found to be an ACM. No friable, damaged, and accessible ACM were identified.

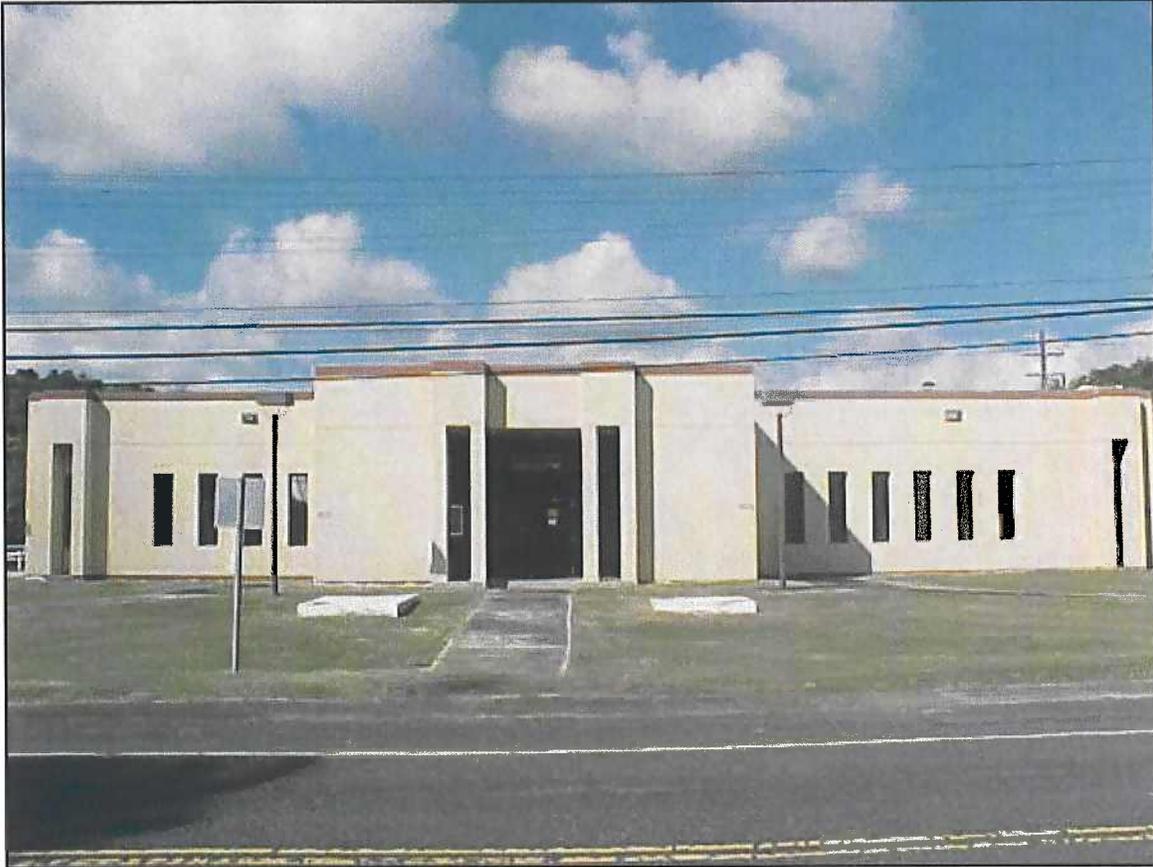
Building 1808 is identified as “Enlisted Men’s Dining Hall” and is approximately 14,430 square feet in size. Eleven suspect homogeneous materials were identified and sampled. Four materials, vinyl floor tile (Material #001), its associated floor adhesive (Material #002), asphaltic roofing material (Material #008), and sheet gasket (Material #011), were found to be ACM. No friable, damaged, and accessible ACM was identified.

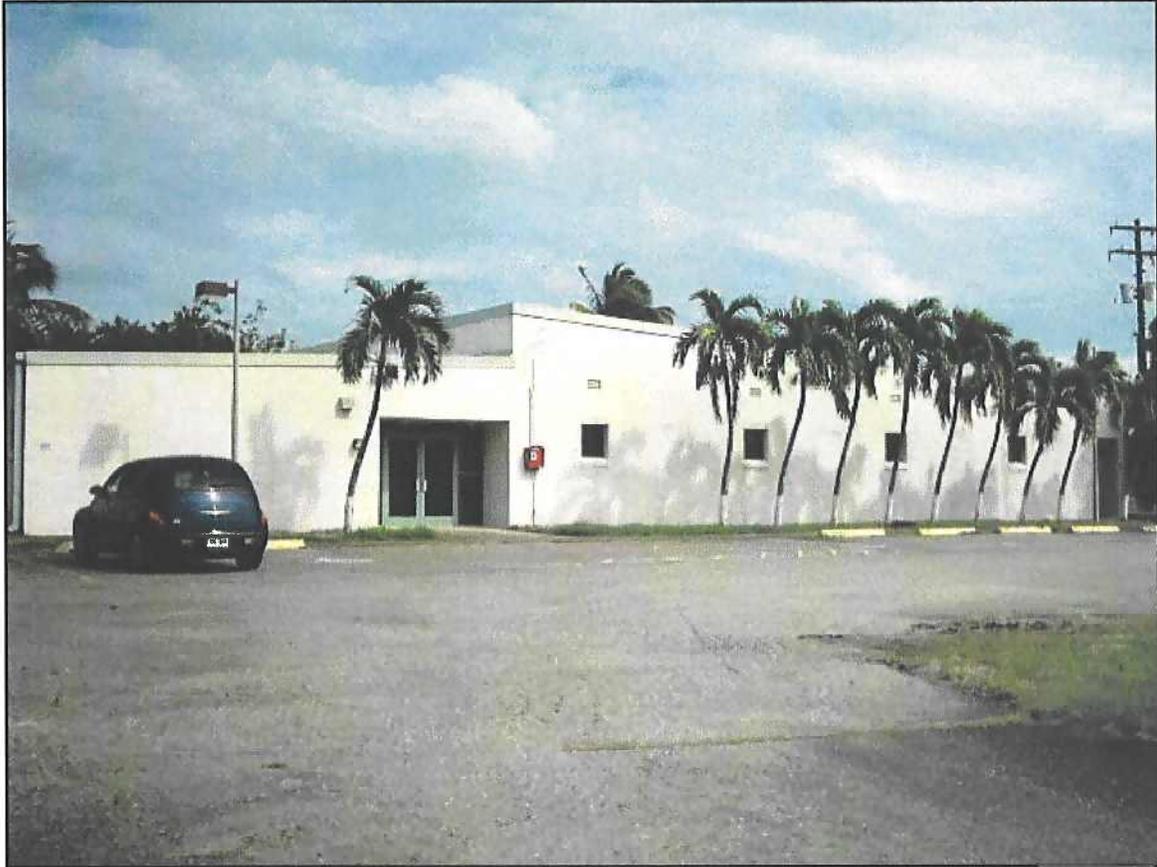
Building 1811 is identified as “Community Center” and is approximately 5,029 square feet in size. Thirteen suspect homogeneous materials were identified and sampled. Two materials, two types of floor adhesive (Materials #002 and #010), were found to be ACM. No friable, damaged, and accessible ACM was identified.

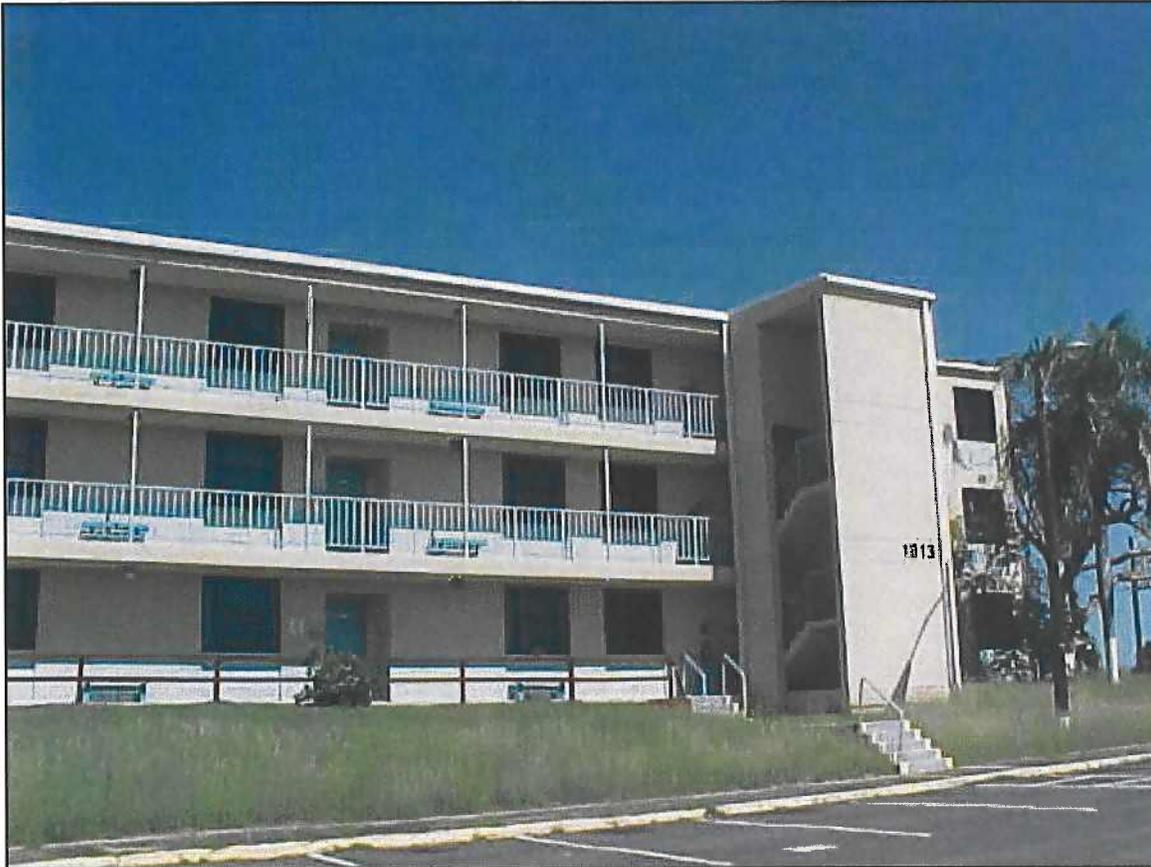
Building 1813 is identified as “BEQ” and is approximately 15,807 square feet in size. Nine suspect homogeneous materials were identified and sampled. One material, cove base adhesive (Material #003), was found to be an ACM. No friable, damaged, and accessible ACM was identified.
