Final
Asbestos Inspection Report
for

Naval Activity Puerto Rico
Ceiba, Puerto Rico

Volume 4 of 7

Buildings 1706 through 1994

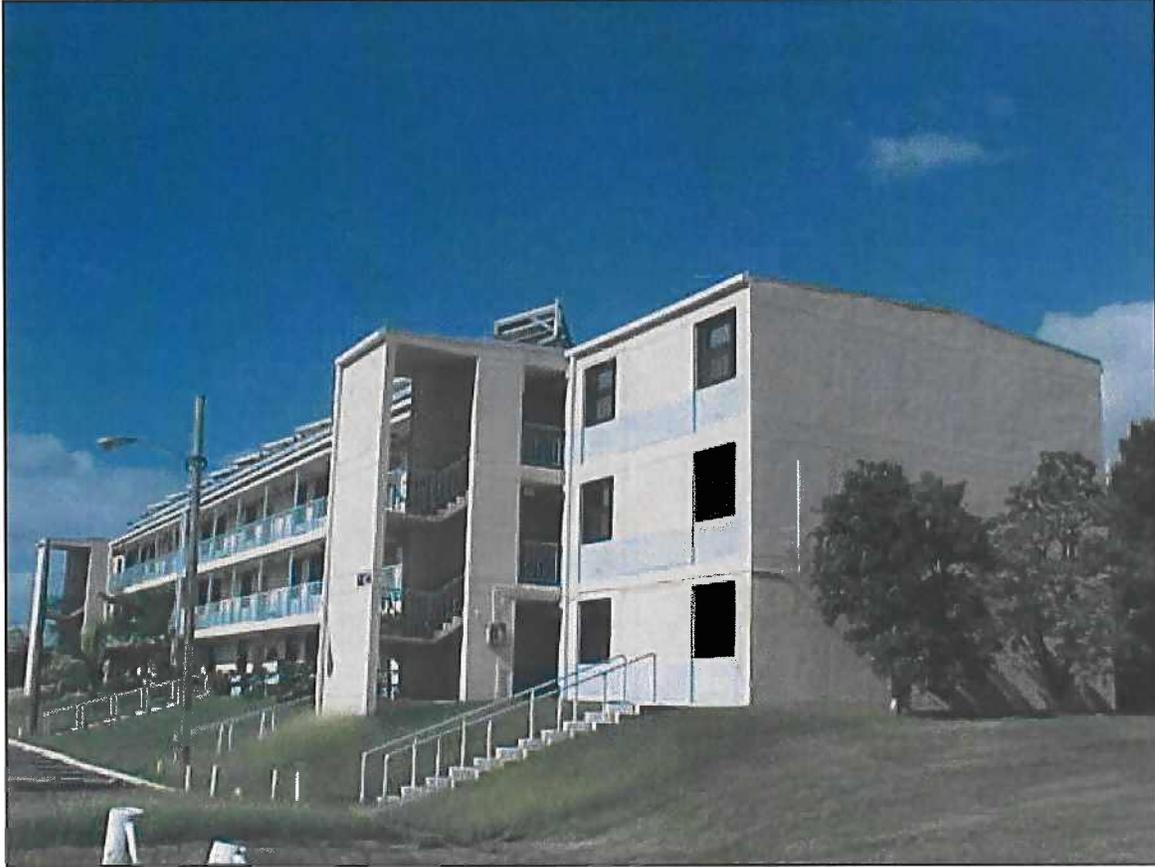
Building 1814 is identified as “BEQ” and is approximately 29,258 square feet in size. Fourteen suspect homogeneous materials were identified and sampled. One material, floor adhesive (Material #011), was found to be an ACM. No friable, damaged, and accessible ACM was identified.

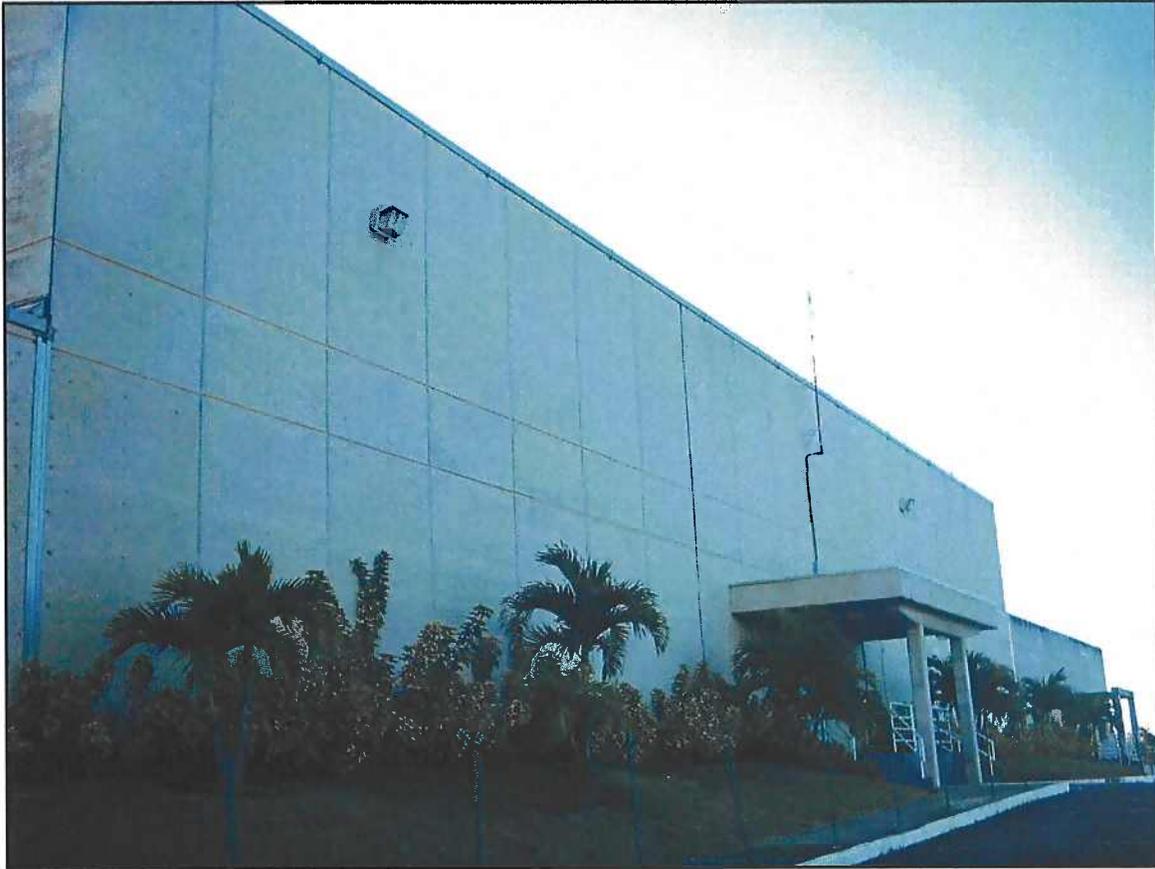
Building 1817 is identified as “Comm. Operations Building” and is approximately 35,783 square feet in size. Twenty two suspect homogeneous materials were identified and sampled. Six materials, two types of vinyl floor tile (Materials #001 and #005) and four types of floor adhesive (Materials #002, #006, #008, #012), were found to be ACM. No friable, damaged, and accessible ACM was identified.

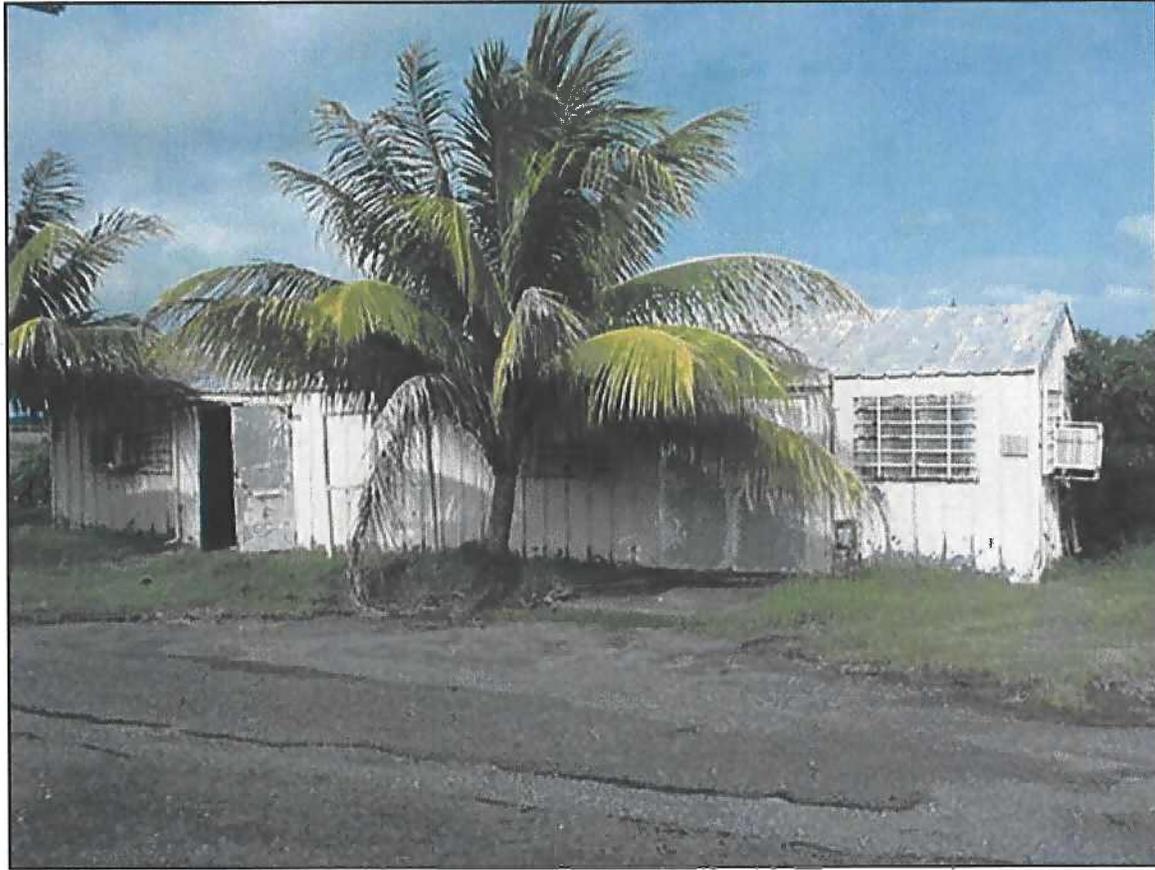
Building 1819 is identified as “Electronic Maint Shop” and is approximately 960 square feet in size. Three suspect homogeneous materials were identified and sampled. Two materials, vinyl floor tile (Material #001) and the associated floor adhesive (Material #002), were found to be ACM. No friable, damaged, and accessible ACM was identified.

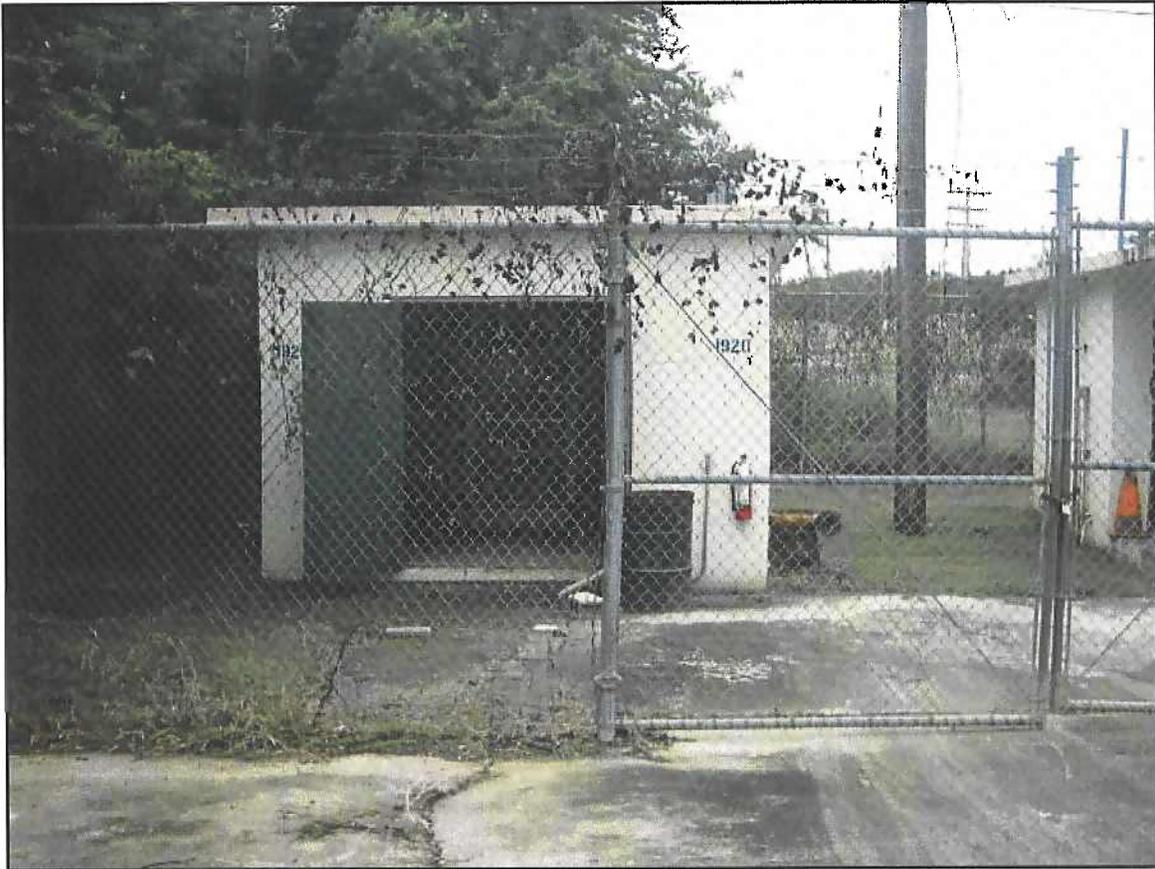
Building 1920 is identified as “Standby Gen by Bldg #1471” and is approximately 224 square feet in size. One suspect homogeneous material was identified and sampled. This material is not an ACM. No friable, damaged, and accessible ACM was identified.

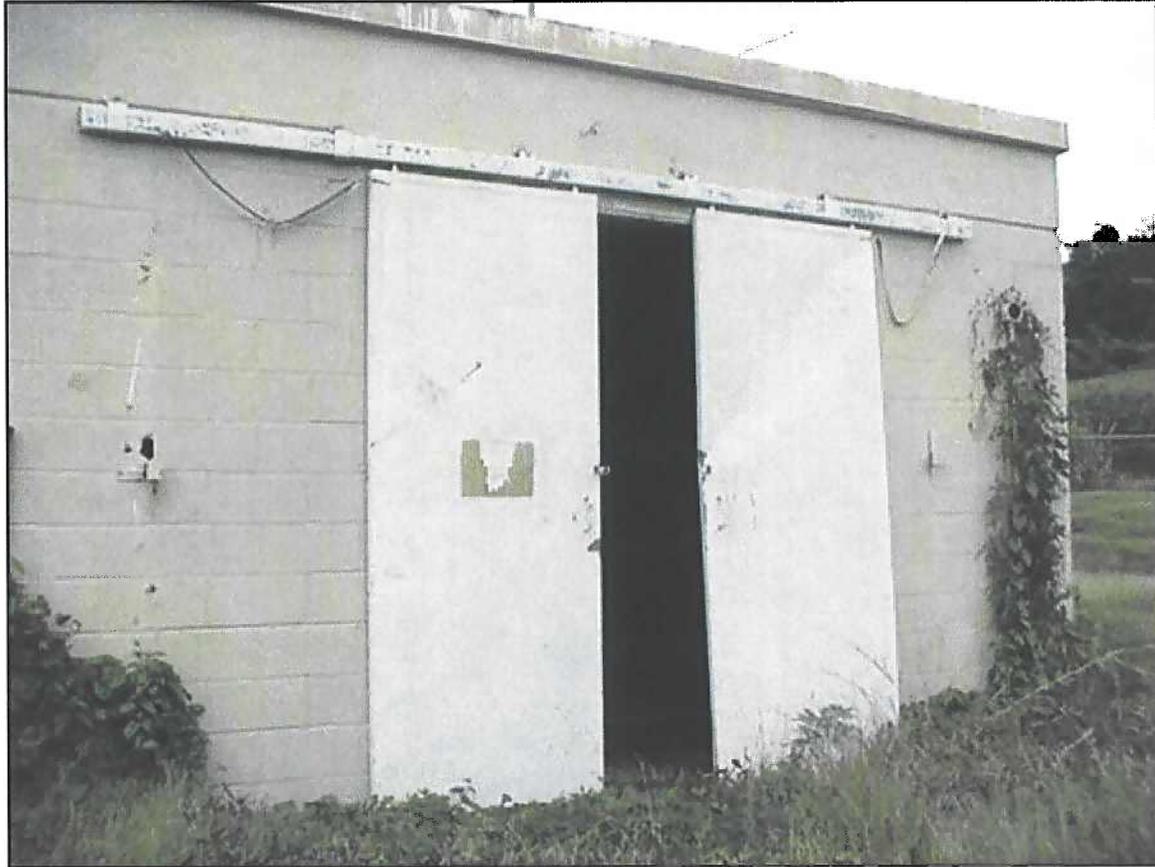
Building 1927 is identified as “Bomb Buildup Area” and is approximately 315 square feet in size. One suspect homogeneous material was identified and sampled. The material is not an ACM. No friable, damaged, and accessible ACM was identified.

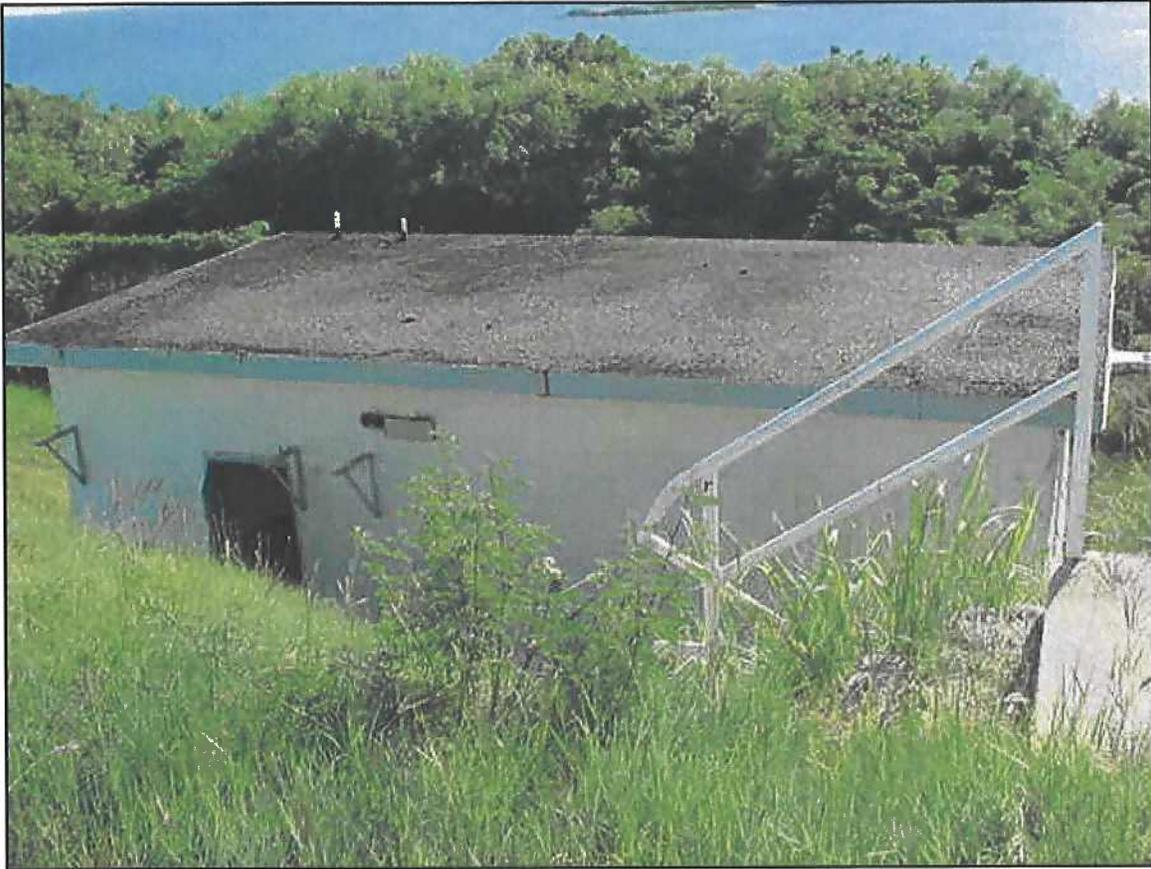
Building 1931 is identified as “Telemetry Building” and is approximately 512 square feet in size. Ten suspect homogeneous materials were identified and sampled. Three materials, vinyl floor tile (Material #003) and two types of cove base adhesive (Materials #007 and #008), were found to be ACM. No friable, damaged, and accessible ACM was identified.

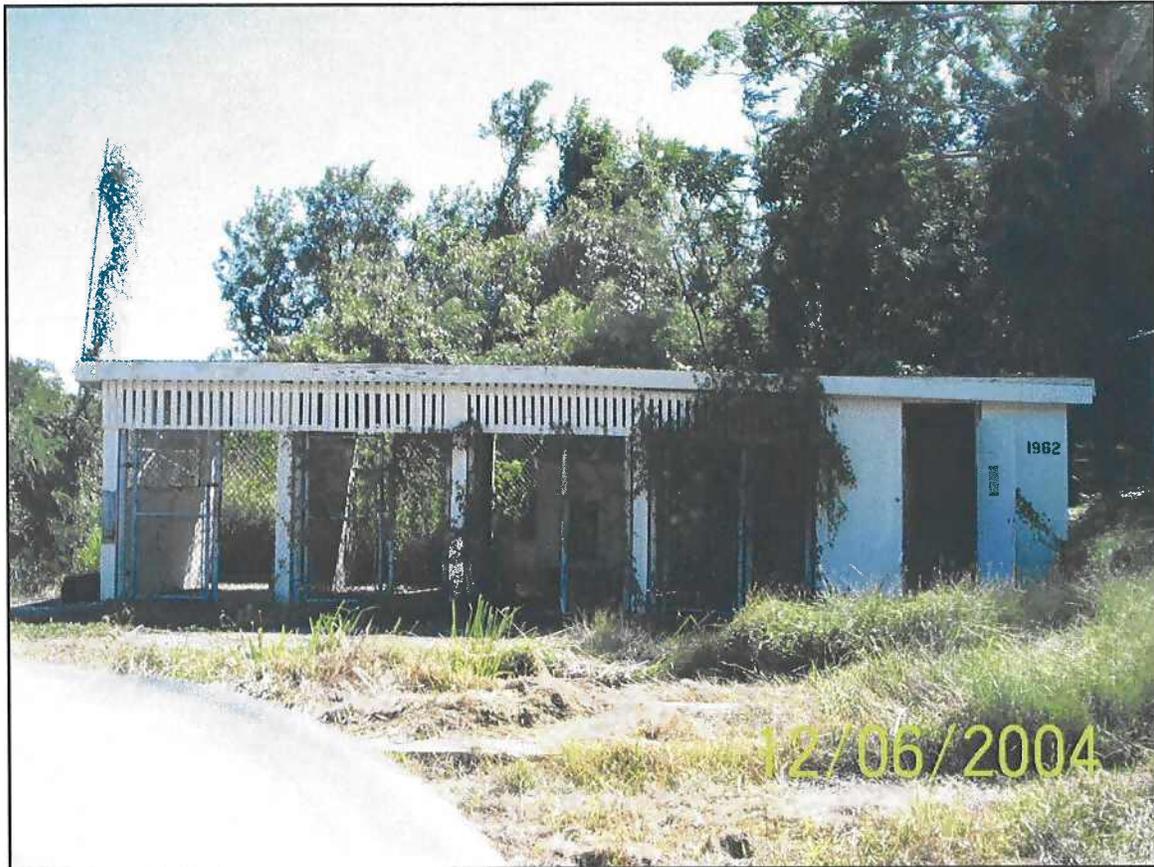
Building 1962 is identified as “Sec. Stge Behind B504” and is approximately 432 square feet in size. Three suspect homogeneous materials were identified and sampled. Two materials, 1’x1’ green vinyl floor tile and its associated mastic (Material #002) and 1’x1’ tan vinyl floor tile and its associated mastic (Material #003), were found to be ACM. No friable, damaged, and accessible ACM was identified.

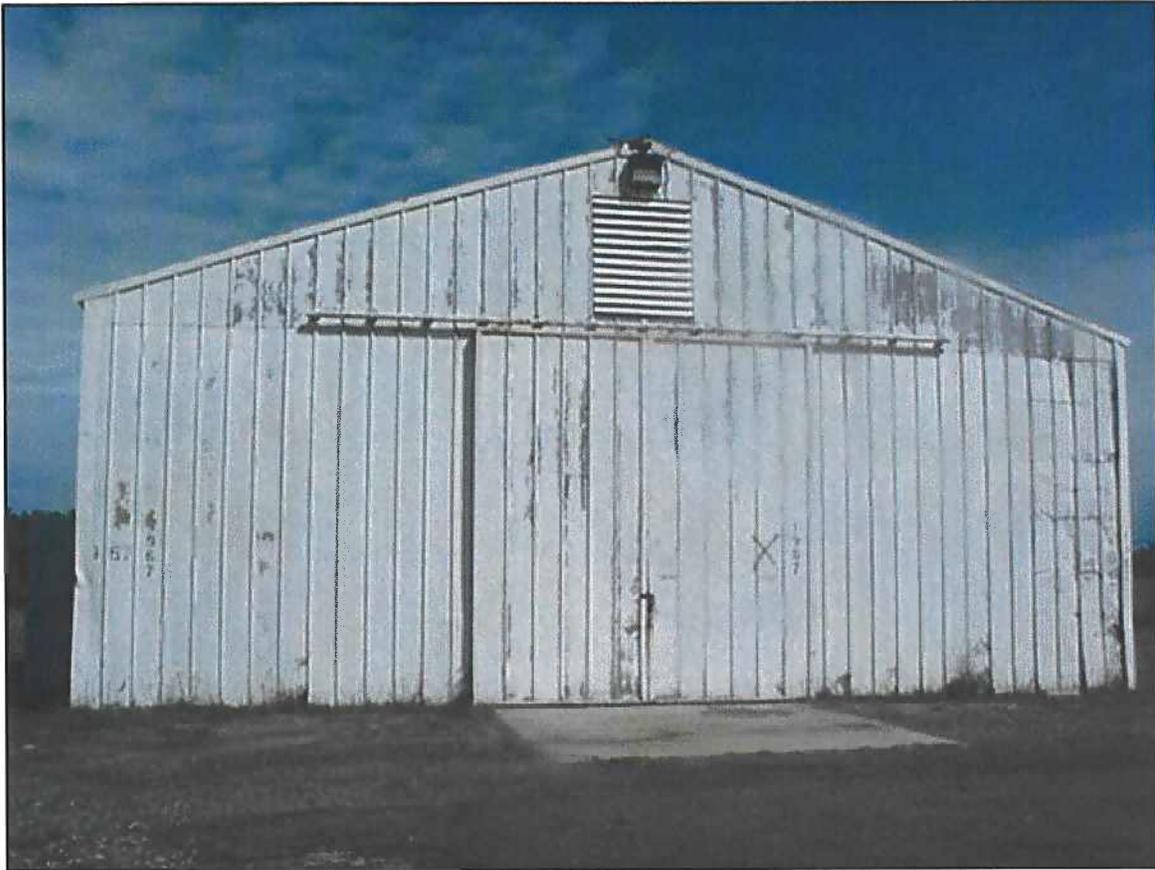
Building 1967 is identified as “Prod Equip Maint Shop” and is approximately 4,000 square feet in size. Three suspect homogeneous materials were identified and sampled. Two materials, vinyl floor tile (Material #001) and wall and ceiling board (Material #003), were found to be ACM. No friable, damaged, and accessible ACM was identified.

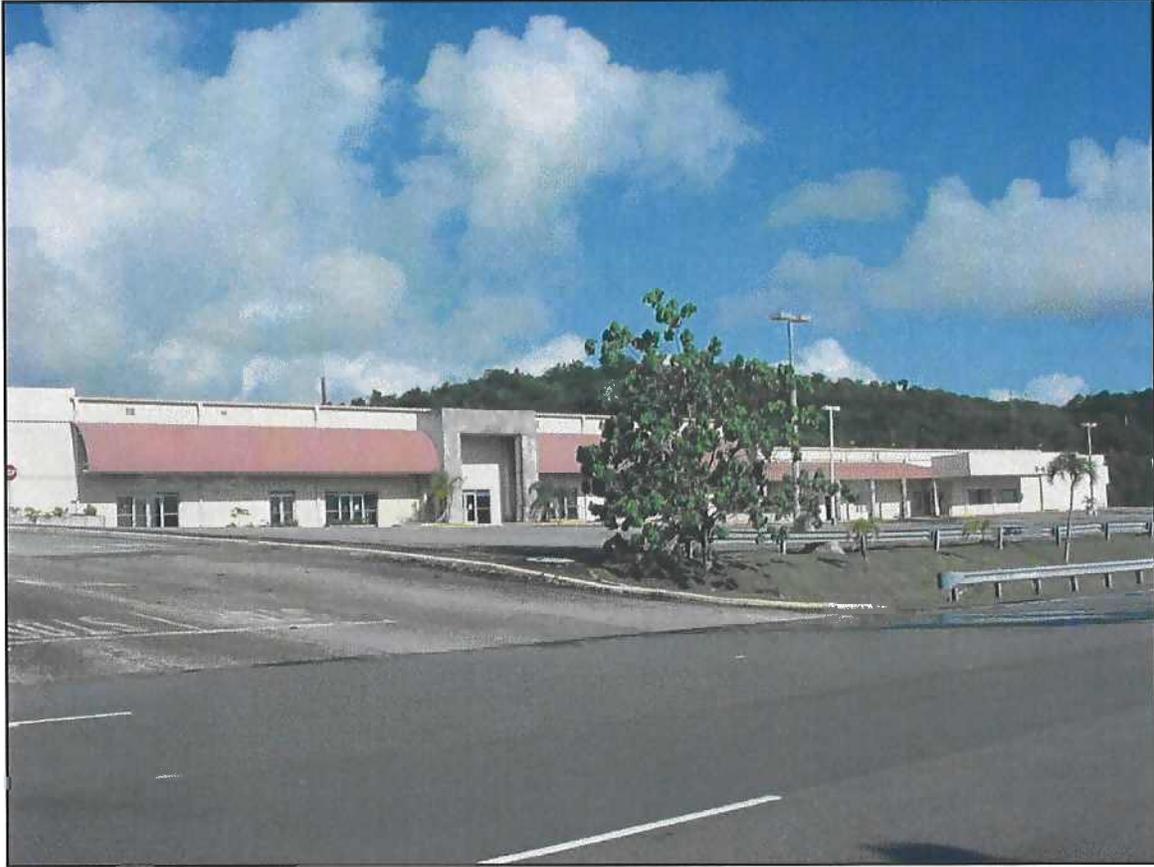
Building 1970 is identified as “Navy Exchange Complex” and is approximately 43,688 square feet in size. Fourteen suspect homogeneous materials were identified and sampled. Two materials, floor adhesive (Material #013) and black roofing material (Material #014), were found to be ACM. No friable, damaged, and accessible ACM was identified.

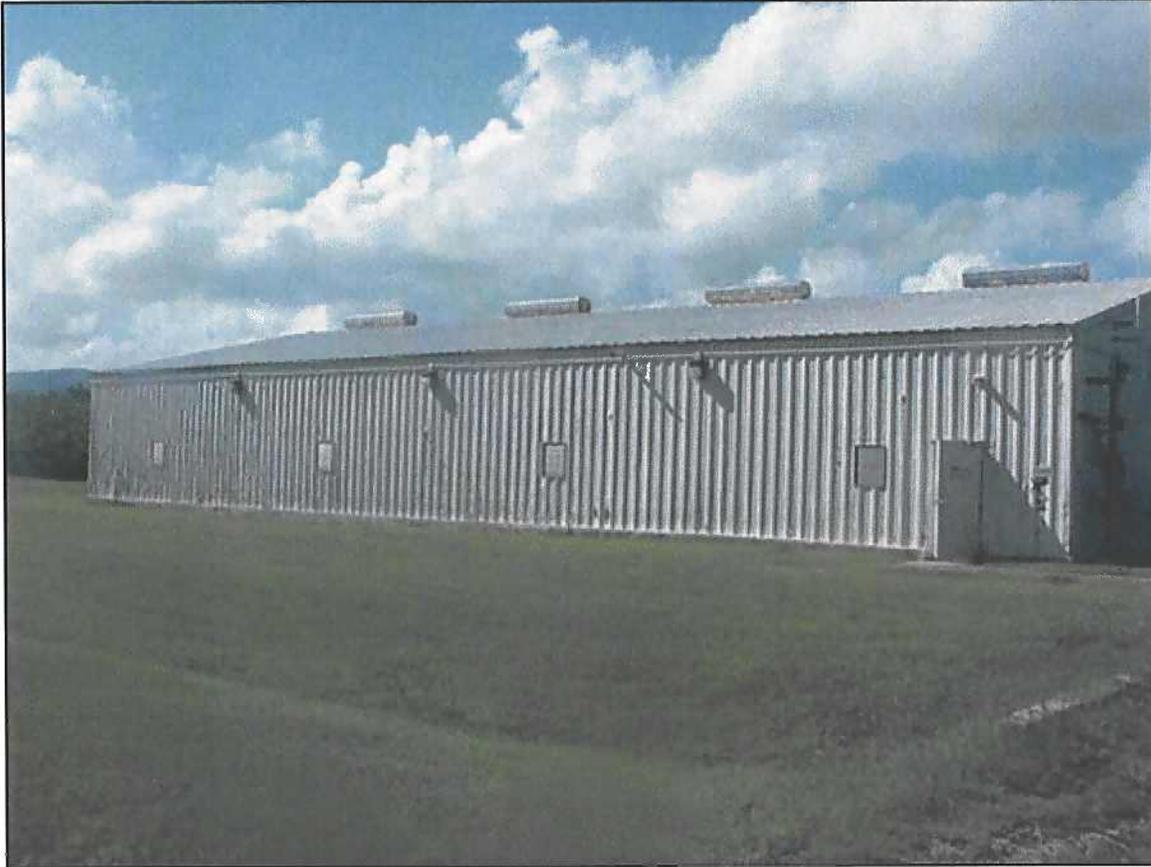
Building 1980 is identified as “Operational Storage” and is approximately 6,000 square feet in size. Five suspect homogeneous materials were identified and sampled. One material, vinyl floor tile (Material #003), was found to be an ACM. No friable, damaged, and accessible ACM was identified.

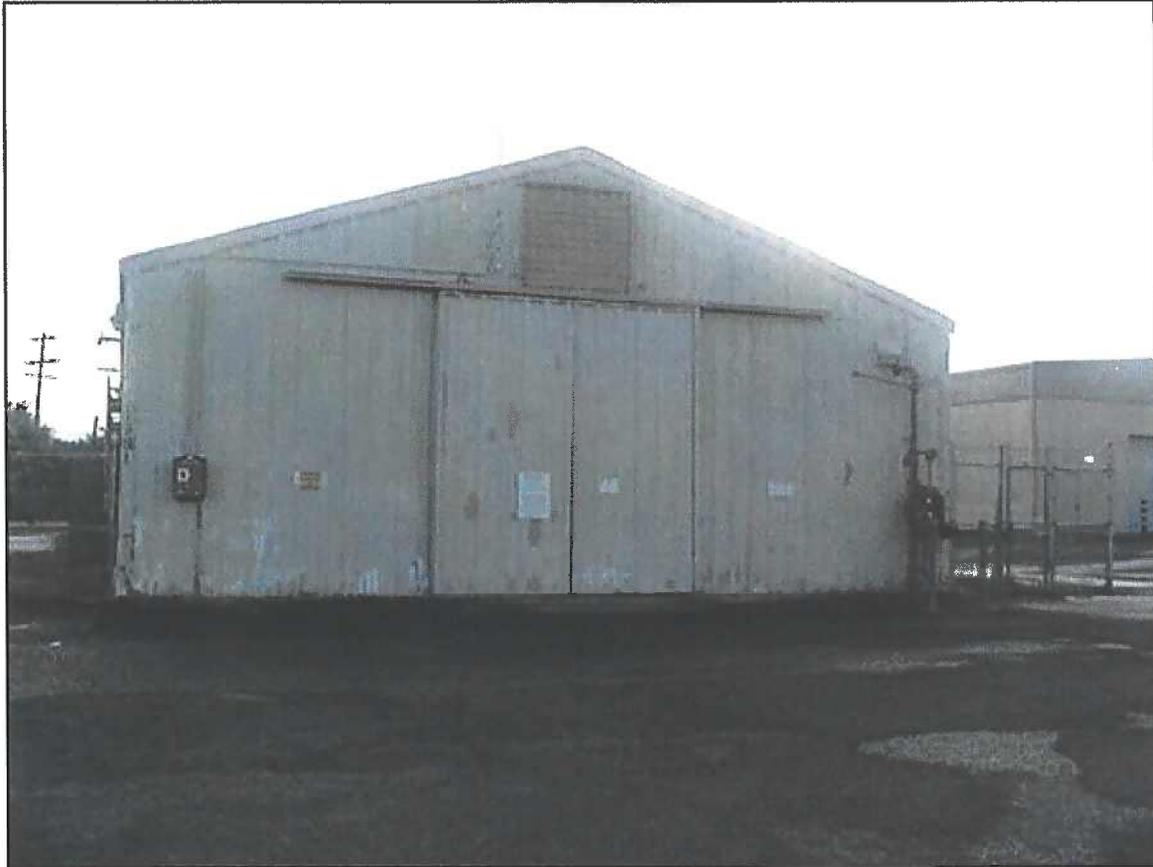
Building 1981 is identified as “Electric Maint Shop (AFWTF)” and is approximately 4,000 square feet in size. Five suspect homogeneous materials were identified and sampled. One material, vinyl floor tile (Material #004), was found to be an ACM. No friable, damaged, and accessible ACM was identified.

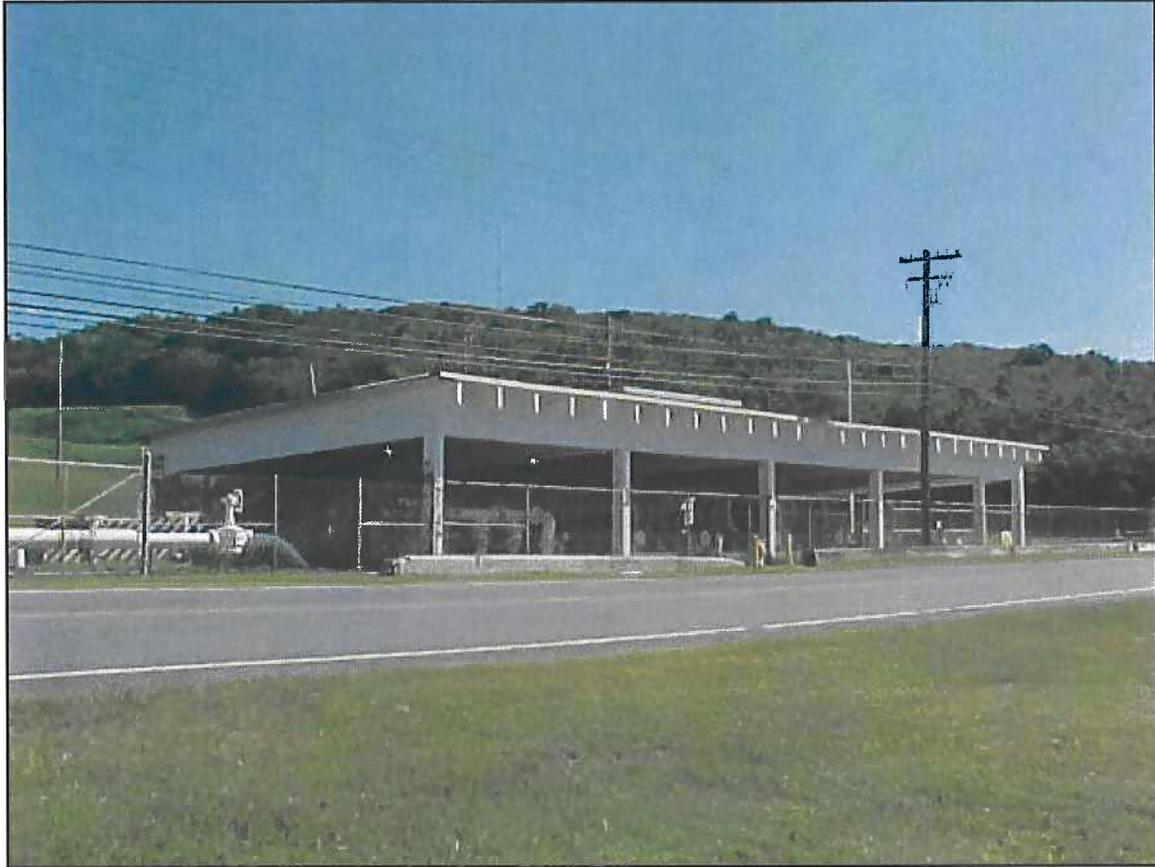
Building 1982 is identified as “POL (9) Pump Hse 850KW SBG” and is approximately 5,494 square feet in size. Three suspect homogeneous materials were identified and sampled. Two materials, asphaltic roofing material (Material #001) and sheet gasket (Material #002), were found to be ACM. No friable, damaged, and accessible ACM was identified.
