Final Report
Aerial Photograph Assessment
MCAS El Toro
Contract No. N68711-91-D-4658
Delivery Order 0002
SAIC Project No. 01-0892-02-0817

Aerial Photographic Interpretation
 MCAS El Toro
 Santa Ana, California

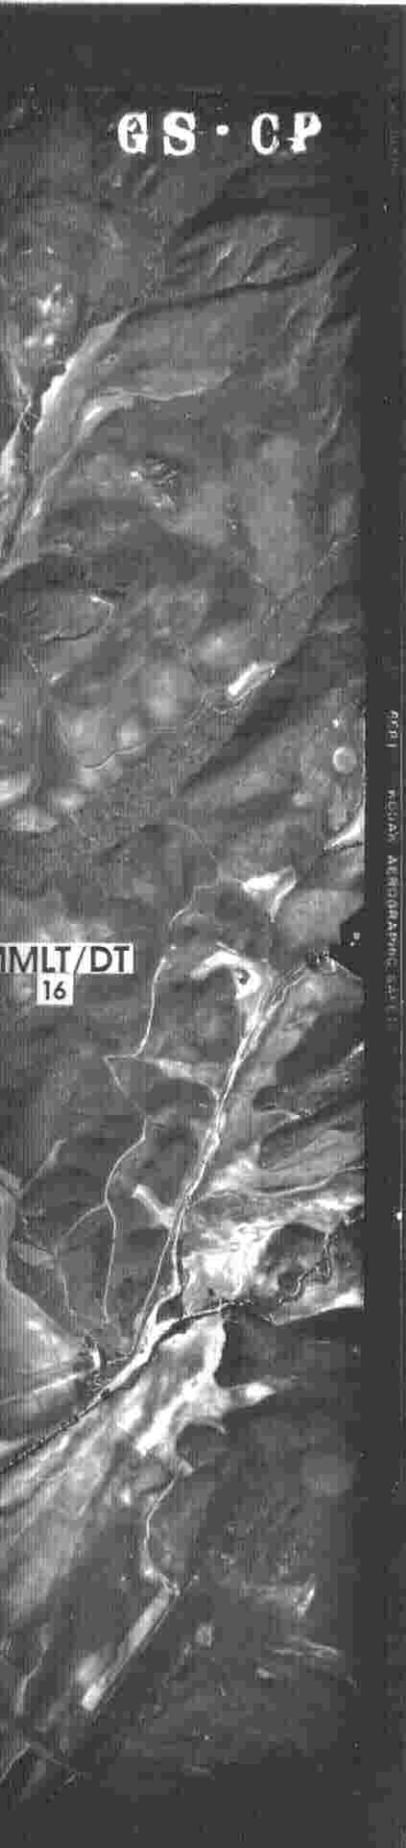
1946

- c 1. An excavation (EX) about 400 feet wide by 500 feet long is noted beneath the present threshold area of Runway 16L. The purpose of the excavation is unknown, but may be an early, undocumented disposal area. The site history, or the site itself, should be investigated to determine if potential contaminants were disposed of in the excavation.

- c 2. A fill area (FA) is located immediately west of the excavation (EX) discussed in the previous comment. The area appears to contain spoil material from the excavation. No additional investigation of the fill material is recommended at this time.

- c 3. A circular graded (GR) area about 300 feet in diameter is located near the present Auto Hobby Shop (Building 625). Along the western border of the area is a dark-toned mound (MMDT) of unknown composition, but may be soil and vegetation debris from the grading. No additional investigation is recommended at this time.

- c 4. Farm buildings (B) and a possible excavation (EX) are located on Irvine Boulevard, north of the activity. The buildings may contain fuel, solvents, pesticides, fertilizers, and other potential contaminants; the excavation may have been used to dispose of these materials. No additional investigation is recommended at this time, unless contamination is detected near, or downgradient of the site, in areas of interest to the IR program.

- c 5. A vertical tank (VT) is noted at N 6th Street and D Street. This is probably Building 222 (Elevated Water Tank). No additional investigation is recommended at this time.

- c 7. There are stains (ST) adjacent to the aircraft parking apron at N 6th Place and K Street, and at N 4th Place and K Street. Additional investigation of these sites is recommended.

- c 8. A drainage channel (EX) with probable liquid (LQ) extends from the aircraft parking apron near the approach end of Runway 21 and into a drainage ditch near the approach end of Runway 16R. The channel probably controls runoff from the apron area, and may convey contaminated water. Additional investigation is recommended.

- c 9. Farm buildings (B) are noted adjacent to Trabuco Road, near Gate No.1. The buildings may contain fuel, solvents, pesticides, fertilizers, and other potential contaminants; the excavation may have been used to dispose of these materials. No additional investigation is recommended at this time, unless contamination is detected near, or downgradient of the site, in areas of interest to the IR program.

- c 10. A large quarry (EXT) with apparent support buildings (B) and stains (ST) are located northwesterly of the present residential area of the activity. The buildings may be the site of fuel, oil and solvent use and storage. No additional investigation is recommended at this time, unless contamination is detected near, or downgradient of the site, in areas of interest to the IR program.

- c 11. Farm buildings (B) are located adjacent to Irvine Boulevard, southwest of the quarry. The buildings may contain fuel, solvents, pesticides, fertilizers, and other potential contaminants; the excavation may have been used to dispose of these materials. No additional investigation is recommended at this time, unless contamination is detected near, or downgradient of the site, in areas of interest to the IR program.

- c 12. There are stains (ST) adjacent to the aircraft parking apron in the vicinity of the present site of Building 605, near N 8th Street and M Street. Additional investigation of the site is recommended.

- c 13. There are soil stains (ST) in the area southwest of Building 292, near N 8th Street, between N Street and M Street. The stains appear to result from flowing liquids. Additional investigation is recommended.

- c 14. An open storage (OS) area on the northerly side of Building 136, between N 9th Street and North Marine Way, and between N Street and O Street, may contain drums (D). Additional investigation of the site is recommended.

- b 16. Light-and dark-toned mounded material (MMLT and MMDT) occur on the easterly side of the trench (TR) noted in the previous comment. The materials are unidentified, but may be construction debris. The areas appears to extend beyond the limits of the present IR program field investigation. Expansion of the investigation area is advised.

- a 17. Vertical tank (VT) is Tank 293, Water Reservoir. No additional investigation is recommended.

b 19. There is a large area of stained (ST) soil in the vicinity of the Original Landfill (DG). The Site 3 investigation appears to encompass the area; no additional investigation is recommended at this time.

c 20. There are three areas of apparent extraction (EXT) at the mouth of Agua Chinon Wash. These areas may have been used for waste disposal. Additional investigation is recommended if contamination is detected near, or downgradient of the site, in areas of interest to the IR program.

c 21. An open storage (OS) area on the northwest side of Building 120, near N 8th Street and O Street, contains possible drums (D). Additional investigation is recommended.

c 22. Probable soil stains (ST) occur in the southwestern portion of Tank Farm No. 4, near N 8th Street and O Street. Additional investigation is recommended.

a 23. There are stains(ST): adjacent to the aircraft parking apron about 200 feet northeast of Building 12; at S 1st Street and K Street; and between Buildings 10 and 11, on S 4th Place.

c 24. Seven (7) possible vertical tanks (VT) are noted on the north side of Trabuco Road, west of Gate No. 1. These may be silos, however, the existence and use of the suspected tanks should be verified, and if necessary, the area investigated.

c 26, a 27, and c 28. These sites are located on the northwesterly sides of Buildings 25, 27, 29, and 31 between S 5th and S 8th Streets and G Street and West Marine Avenue. The area contains open storage (OS) areas with possible drums (D), light- and dark-toned mounded material (MMLT and MMDT), unidentified materials, and unidentified objects (UO) that may be mounds or drums. Additional investigation of these areas is recommended.

a 29. There appears to be stained (ST) soil on the southwest side of Building 241, near S 5th Street and West Marine Way. Additional investigation is recommended.

- c 30. An open storage (OS) area with possible drums (D) is located on the southwest side of Building 246, near S 8th Street and West Marine Way. Additional investigation is recommended.

- b 31. There is stained (ST) soil on the southeast side of Building 246, near S 8th Street and West Marine Way. Additional investigation is recommended.

- c 32. A probable vertical tank (VT) is located about 400 feet southwest of Building 31, near S 8th Street and West Marine Way. There also appears to be soil staining (ST) or wet soil (WS) at the base of the tank. Verification of the tank and possible contents is recommended.

- c 33. There is a probable vertical tank (VT) on the southwest side of Building 249, near S 8th Street and D Street. Verification of the tank and its possible contents is recommended.

- c 34. A probable vertical tank (VT), possibly Tank 155, is located near S 11th Street and L Street. Verification of the tank and its contents is recommended.

- c 35. An unidentified object (UO), possibly a vertical tank (VT) or mound (M) is noted on the north side of Perimeter Road, about 800 feet northwest of Bee Canyon Wash. Additional investigation is recommended.

- c 36. There appears to be a vertical tank (VT) near the railroad tracks at the Bee Canyon Wash crossing. Verification of the tank and its contents is recommended.

- a 37. There is liquid (LQ) flowing southwesterly from the southwest side of Building 132, near S 14th Street, between M and N Streets. Additional investigation is recommended.

- c 38. There appears to be a vertical tank (VT) adjacent to the railroad tracks about 250 feet southwest of Building 317. Verification of the tank and its contents is recommended.

- c 39. Two impoundments (IM) can be observed on the southwest side of Building 306, near S 11th Street and L Street. Investigation of the impoundments' uses is recommended.

- a 40. There are two vertical tanks (VT) on the northeast side of Building 306, near S 11th Street and L Street. Investigation of the tanks' contents is recommended.

- b 41. There is an open storage (OS) area, possibly with drums (D), on the westerly side of Building 320, near S 15th Street and O Street. Additional investigation is recommended.

- b 42. There are soil stains (ST) beneath the present aircraft parking apron about 500 feet southeast of Tank 174. Additional investigation may be advisable.

- b 43. Open storage (OS) areas with possible drums (D) are noted about 700 and 1000 feet southeast of Tank 174, beneath the present aircraft parking apron. Additional investigation may be advised.

- c 44. There are soil stains (ST) in an open storage (OS) area now occupied by Buildings 386 and 1389, about 350 feet northeast of Building 368 (Public Works). Additional investigation is advisable.

- b 45. There is wet soil (WS) or stains (ST) in the open storage (OS) area about 500 feet northwest of Building 322 (Mess Hall). Additional investigation is advisable.

- c 46. There is wet soil (WS) or stains (ST) in the area now occupied by the southwest corner of Building 1389, and in the open storage (OS) area about 200 feet northwest of Building 1389. Additional investigation is be advisable.

- c 47. There is an open storage (OS) area with possible drums (D) near the approximate location of Building 359, near South Marine Way and P Street. Additional investigation is recommended.

- b 48. There appear to be stains (ST) caused by liquids (LQ) flowing easterly from the aircraft parking apron about 200 feet east of Building 296 (hangar). Additional investigation is recommended.

- b 49. There may be drums (D) in an open storage (OS) area about 200 feet east of Building 296 (hangar). Additional investigation is recommended.
- c 50. There is an open storage (OS) area at the present location of Building 360, near South Marine Way, between Q and R Streets. Additional investigation may be advisable.

- c 51. Dark-toned mounded material (MMDT) can be seen adjacent to the drainage ditch between Perimeter Road and the southeast corner of the aircraft parking apron. The mounds appear to be soil related to maintenance of the ditch. No additional investigation is recommended at this time.

c 53. Liquid (LQ) can be seen flowing from a former hangar (?) near the northeast end of the aircraft parking apron on the northerly side of the present ACER site (Site 19). The liquid (LQ) discharges into a drainage ditch from a small building behind the former hangar. The flow appears to be significant and additional investigation is recommended.

c 54. There are farm buildings (B) near Perimeter Road and Borrego Canyon Wash, near Gate No. 3 on Trabuco Road. The buildings may contain fuel, solvents, pesticides, fertilizers, and other potential contaminants. Additional investigation is recommended if contamination is detected near the site, or downgradient of the site, in areas of interest to the IR program.

c 55. There is light-toned mounded material (MMLT) adjacent to the drainage ditch between North Marine Way and the approach end of Runway 25R. The material appears to be soil associated with construction or maintenance of the ditch. The ditch drains the Original Landfill (Site 3) area, and is intersected by one of the trenches. Investigation of the mounded soil and ditch is recommended.

c 56. Soil stains (ST) can be observed: on the southeast side of Building 125, near S Place and N 9th Street; at the edge of the aircraft parking apron about 200 feet northwest of Tank Farm No. 6; and near the present location of Buildings 697 and 642, near N 8th Street and S Street. Additional investigation is recommended.

c 59. There is a probable impoundment (IM) or storage tank of some sort southeast of the building indicated in the previous comment. The object appears to be a square-shaped, bermed area with impounded liquid or a square-shaped object on top of the mound. Additional investigation is recommended.
