# Bechtel

## Interoffice Memorandum

Subject Historical Aerial Photograph Review of Landfill Sites, MCAS El Toro Date May 12, 1997

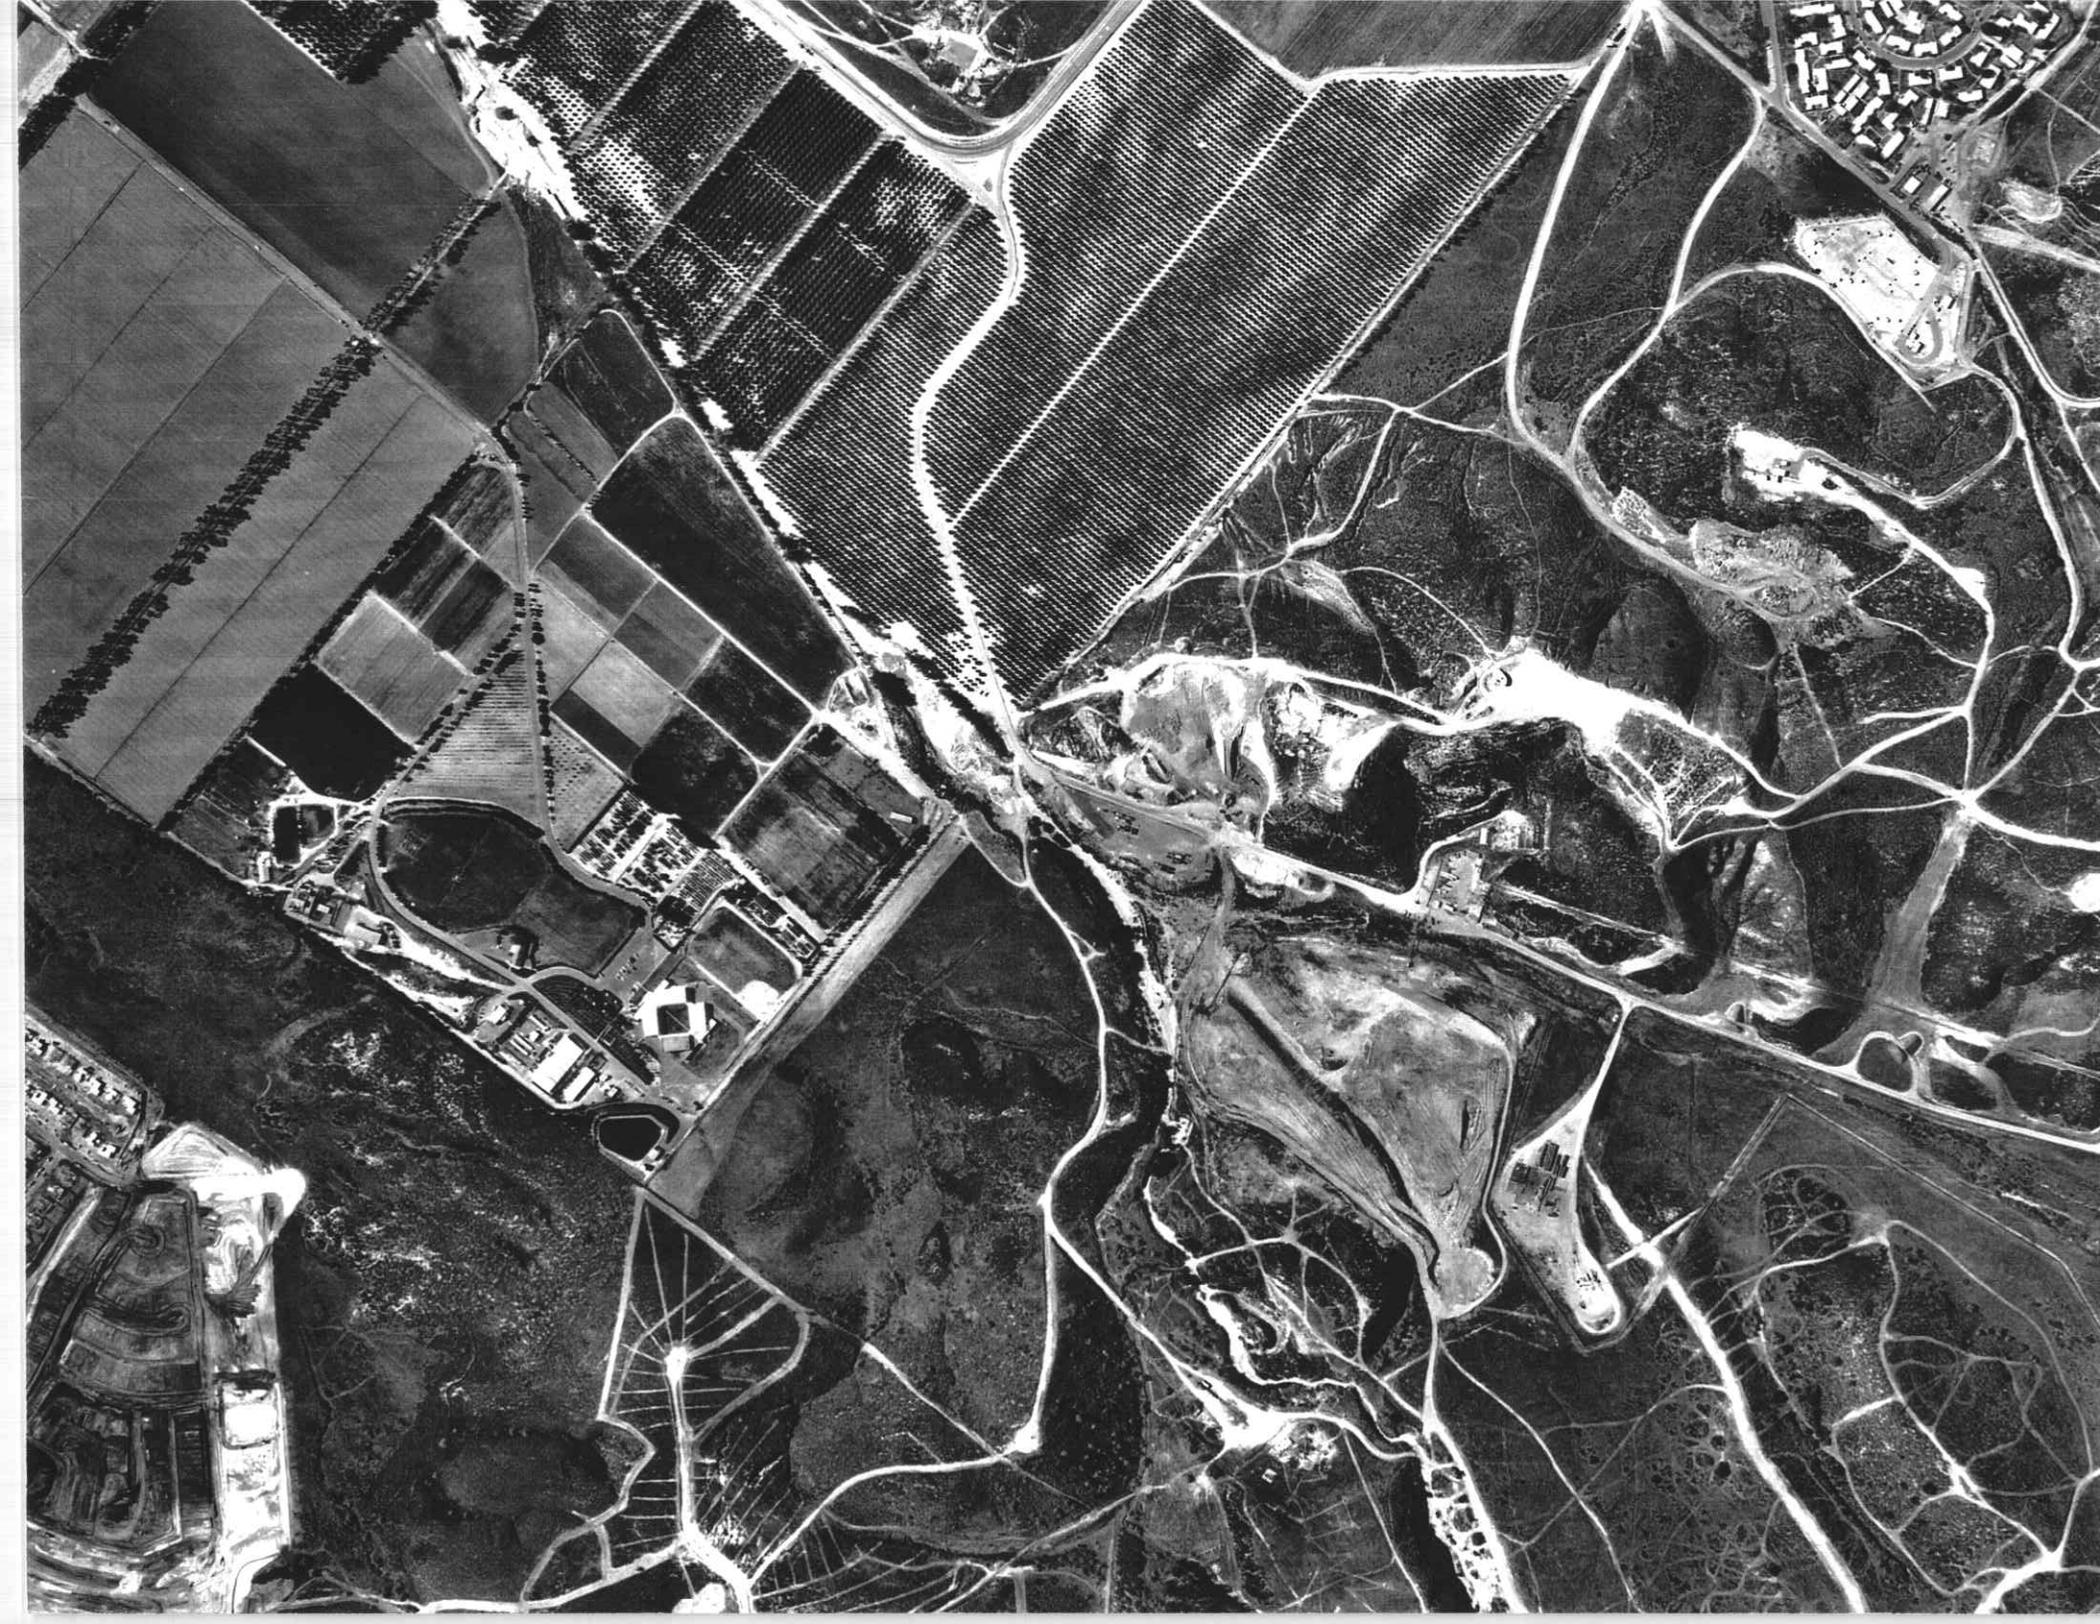
**NEGATIVE NO.:** 181-11-18

Site 2 - Area A is completely disturbed (landfill operations). Area B has occasional small areas of disturbance. Borrow pit above the Area A and B is present. Area C1 has top of bank cleared with some bank disturbances. Area C2 has the top cleared with bank disturbances with apparent equipment storage occurring in the area. Area D1 has a few piles present on the fill area.

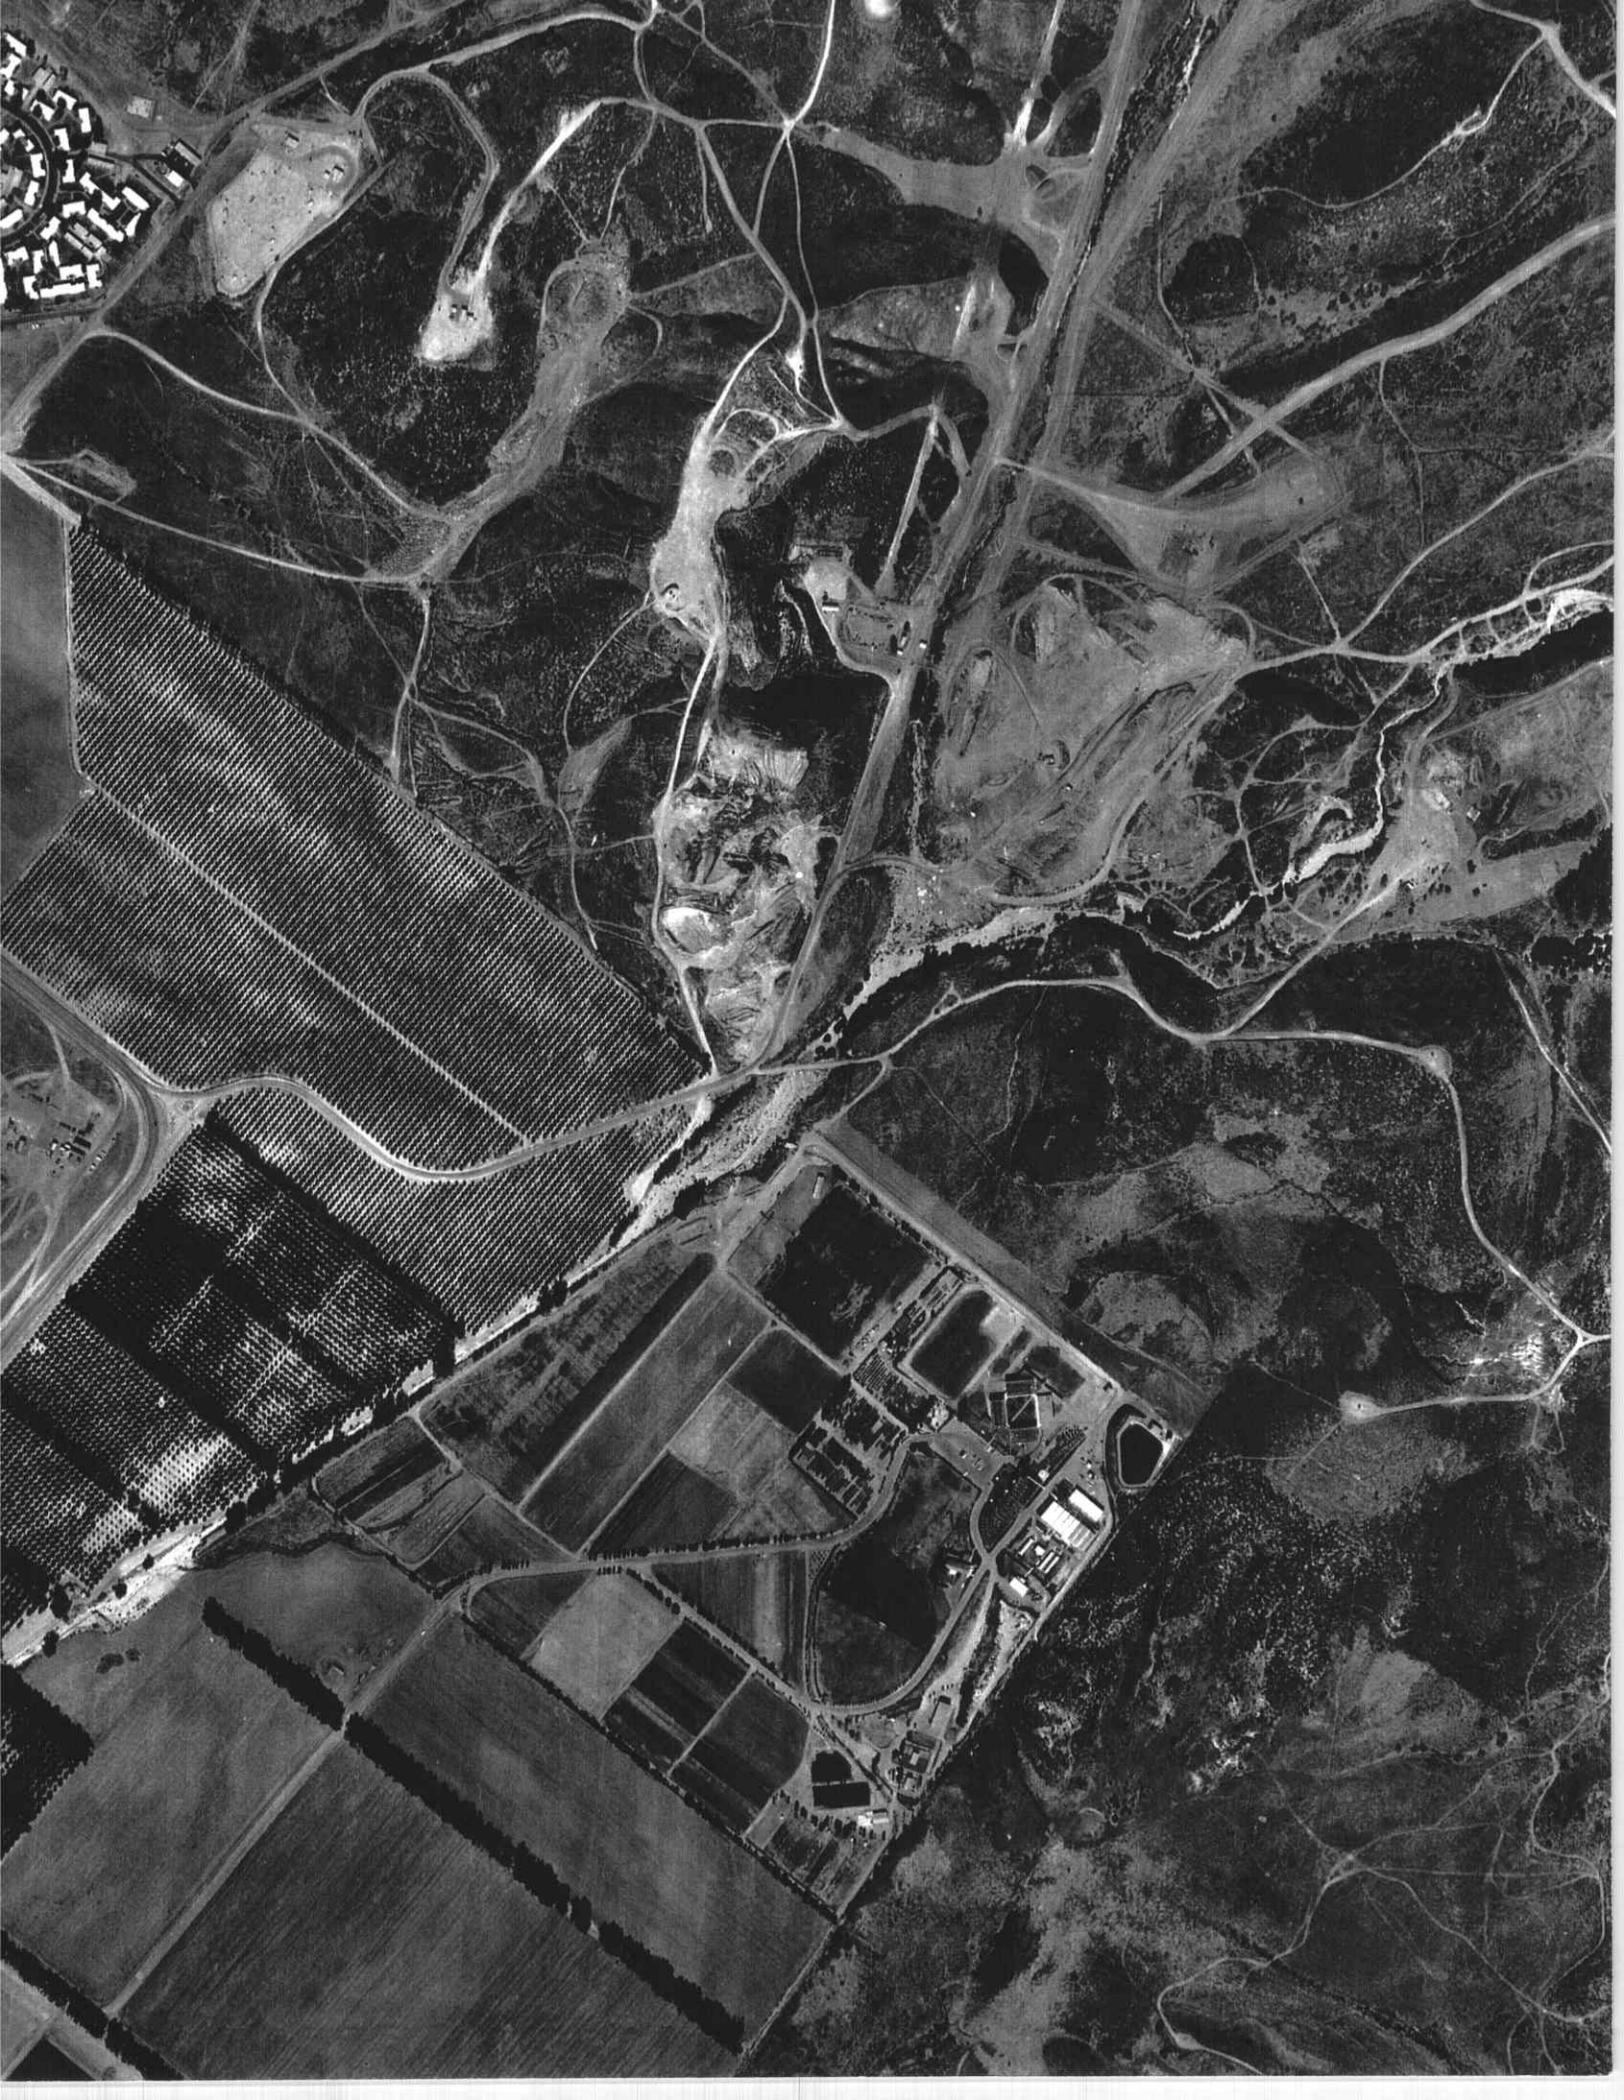
**NEGATIVE NO.:** 132-10-11

Site 2 - Area A has an apparent deep trench on west side and disturbance throughout area (landfill operations). Area B has disturbance throughout area. Area C1 has some clearing (mowing) occurring on top of streambank. Area C2 minimal disturbance (mowing) in southern half of area. Area D1 appears to be filled but no piles are visible. Area D2 has no disturbances.

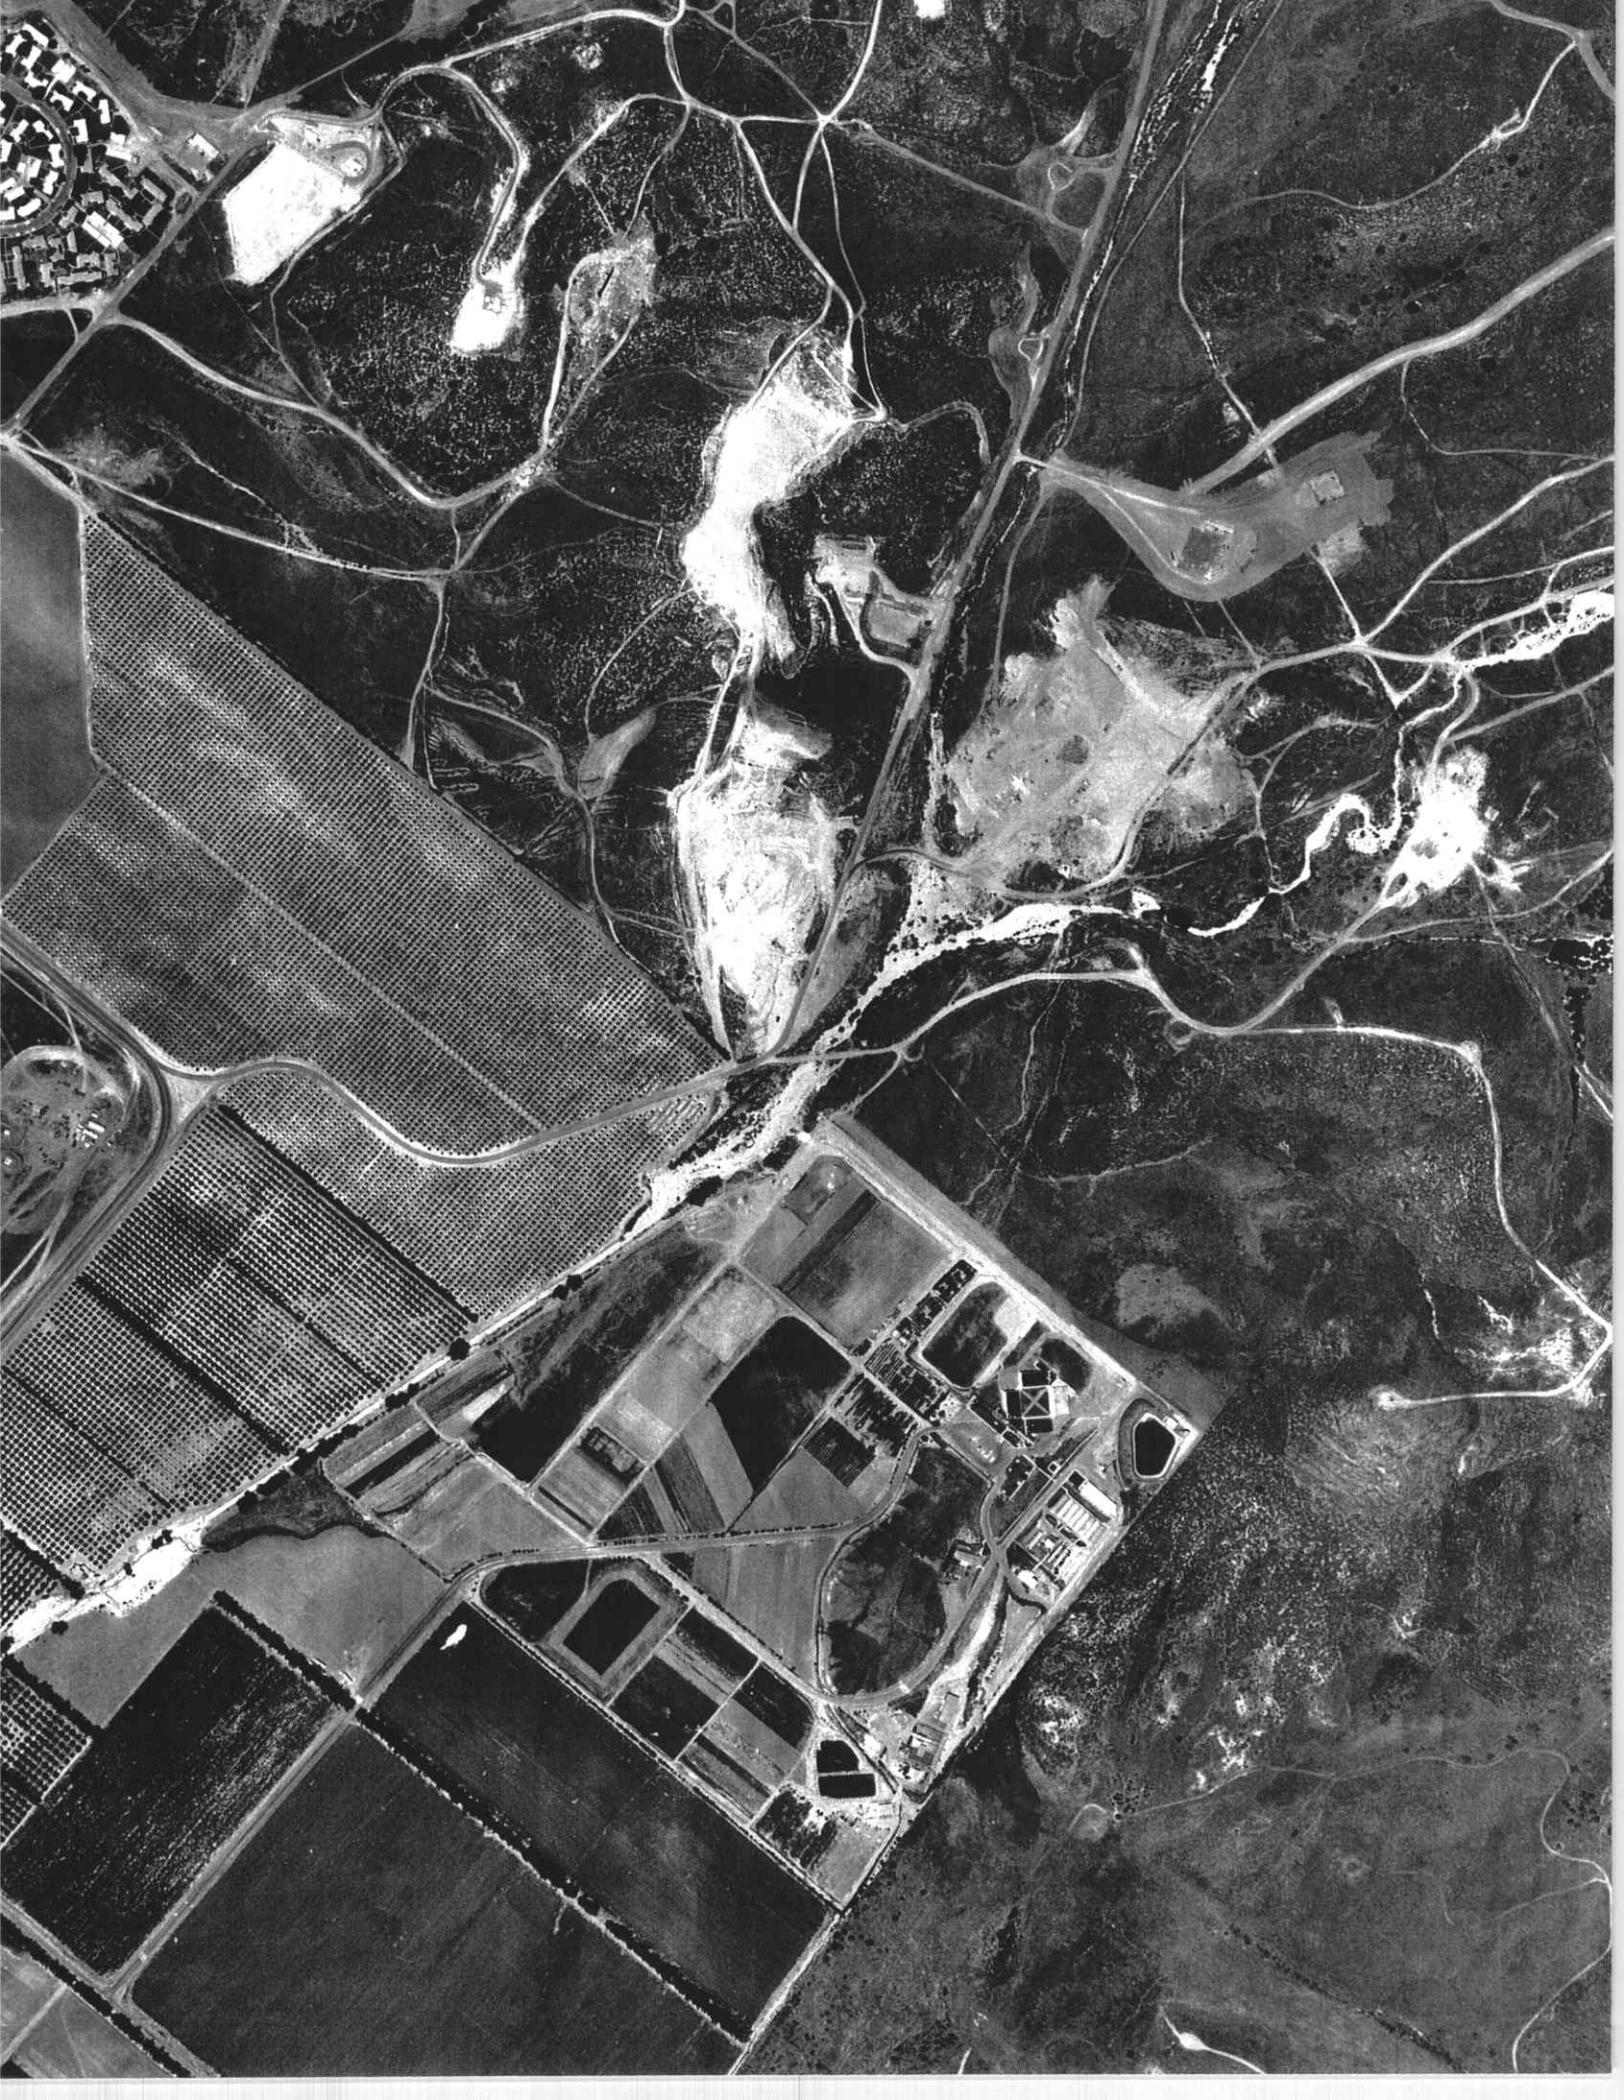
**NEGATIVE NO.: 94-19**

Site 2 - Area A is disturbed in the southern half (landfill operations). Area B is disturbed in the northern half (landfill operations). Area C1 has no apparent disturbances. Area C2 is disturbed I the southern half. Area D1 has disturbance along the perimeter to the Orange County facility.

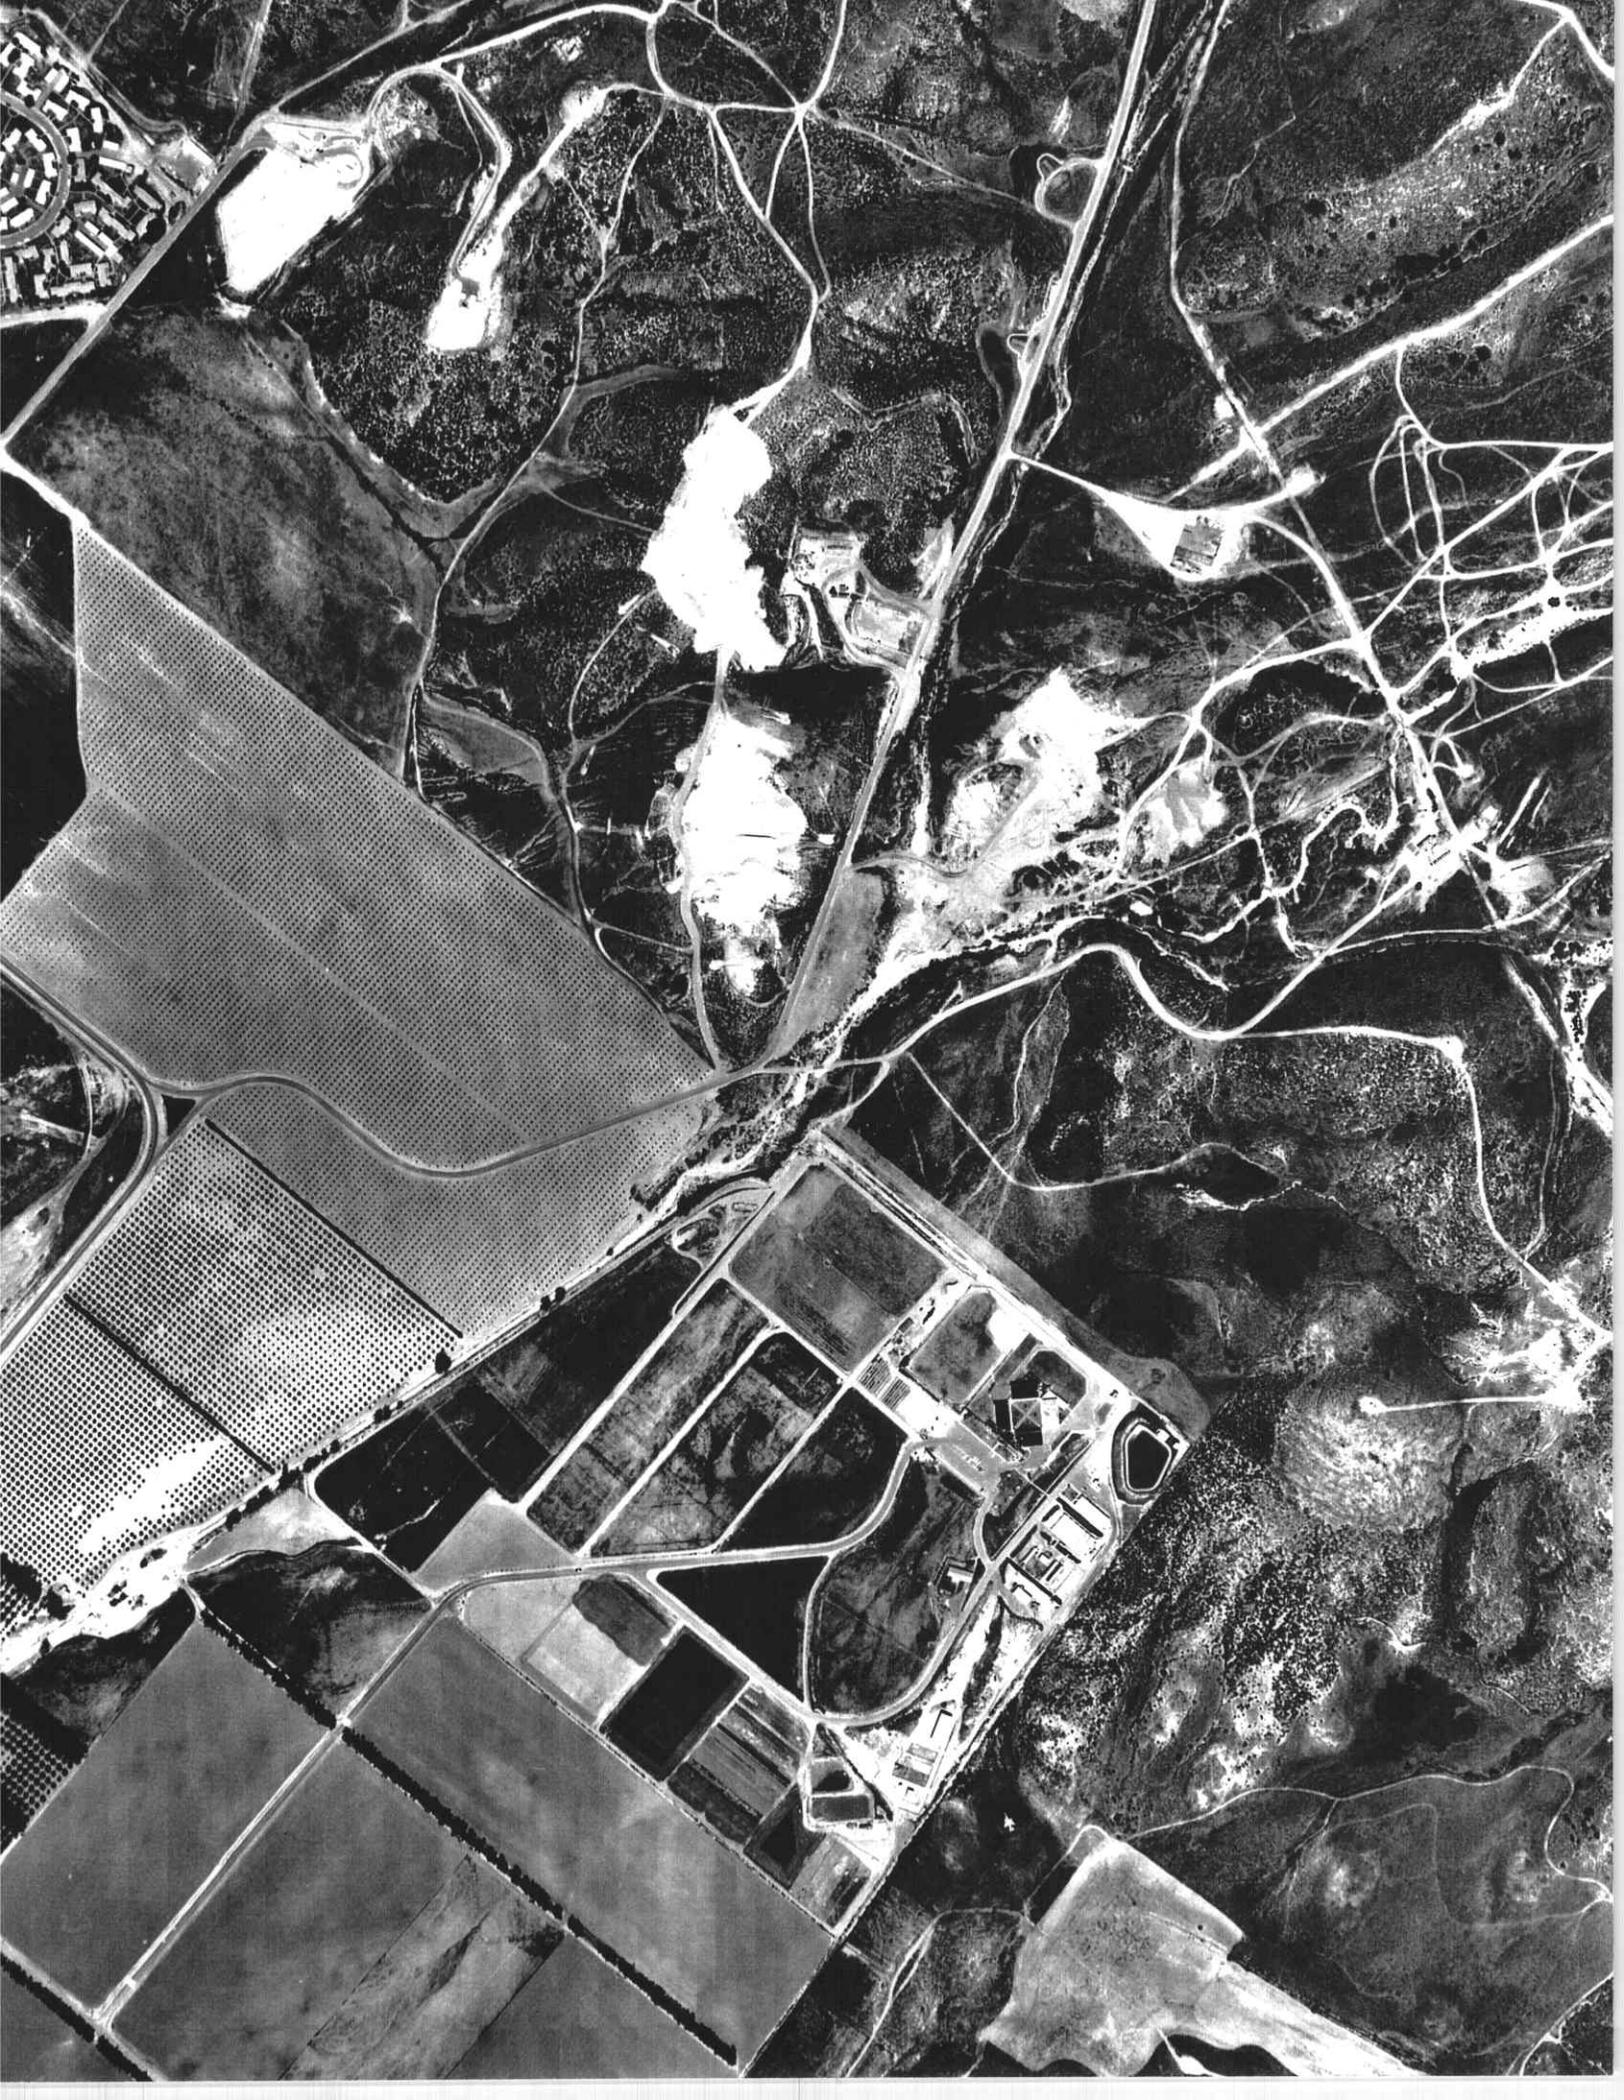
**NEGATIVE NO.: DC-105**

Site 2- Area A has south half disturbed (early landfill operation). Area B has west half disturbed (early landfill operation). Area C1 has no disturbance. Area C2 top of are appears to be cleared. Area D1 has no disturbance of streambank, piles apparent on perimeter of the area. Area D2 small areas of surface disturbance next to archery range road.

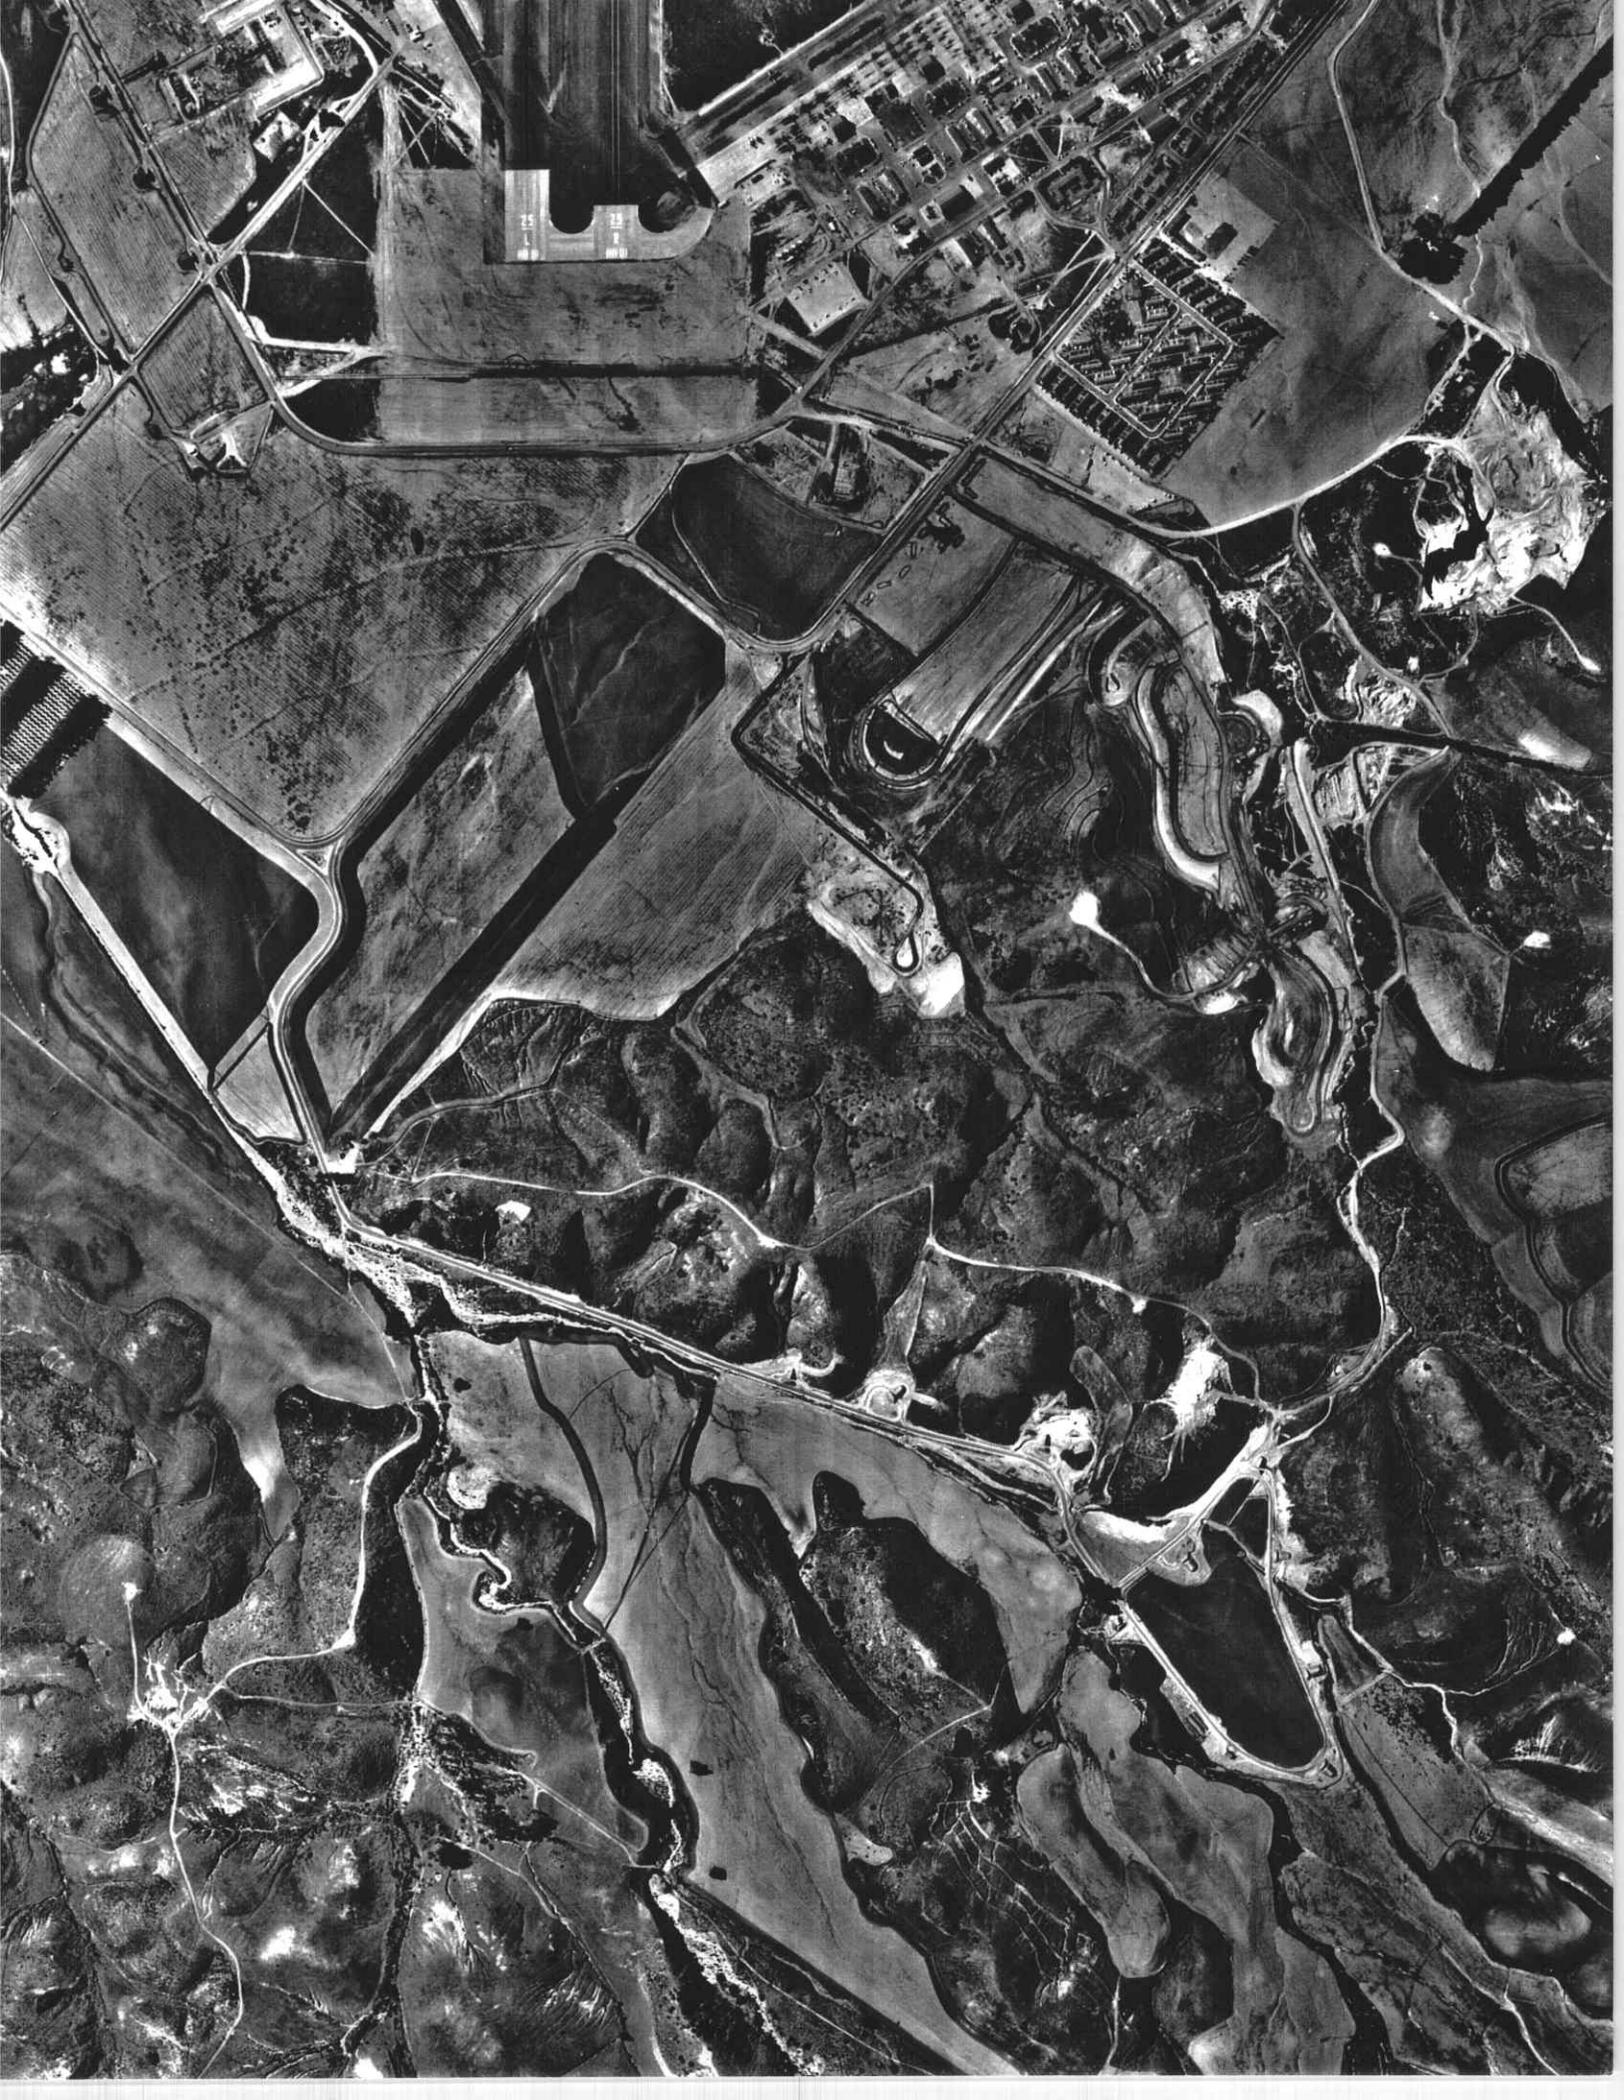
**NEGATIVE NO.:** 3K-36

Site 2 - Areas A and B appear as open fields with short (grass vegetation). Area C1 and C2 are not disturbed and appear adjacent to the washes. Area D1 is located at the end of an open field and Area D2 is an open field.

Site 5 - no activities present; possible native habitat.

Site 3 - possible piles in the west half; large disturbance in east half.

Site 17 - no wastes or activities present.
