Summary Report

Former Temporary Accumulation Area (TAA) 779
Solid Waste Management Unit (SWMU) 227
Former Marine Corps Air Station, El Toro, California

25 March 2002

Prepared by:
Southwest Division, Naval Facilities Engineering Command
BRAC Programs Office
San Diego, CA 92101-2404

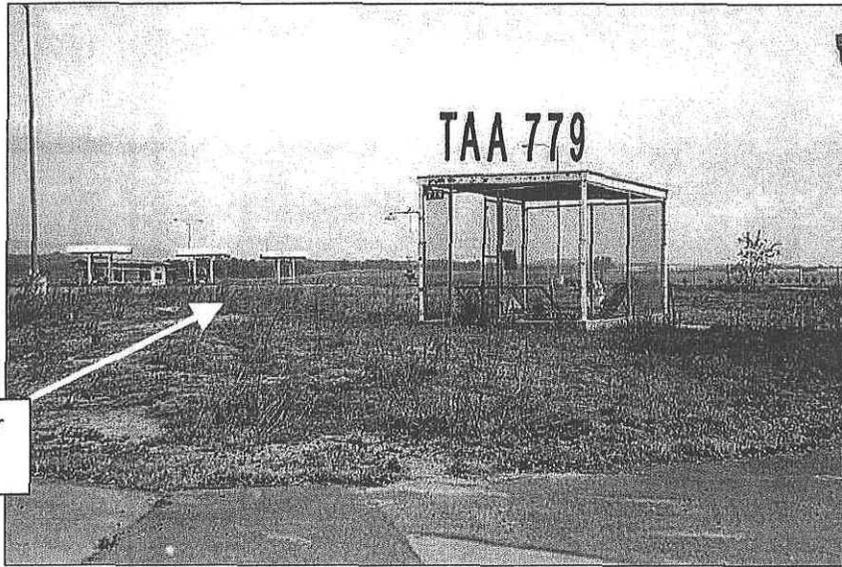
- The Navy inspected TAA 779 in March 2002. No stains were observed on the concrete surfaces of the floor or on the curb of the TAA. No significant cracks were observed in the concrete surfaces of the floor or on the curb. No stains were observed on the unpaved areas surrounding the TAA.

Photograph 1. Former Temporary Accumulation Area (TAA) 779
Solid Waste Management Unit (SWMU) 227
(structure is approximately 12 feet wide by 17 feet long)
Marine Corps Air Station, El Toro
Date of Photograph: 15 March 2002

Based upon the absence of visual evidence of a significant release at or near former TAA 779, the results of the screening risk calculations, and the excellent condition of the concrete floor and curb, it is recommended that no further action status be designated for TAA 779 in the next BRAC Business Plan Update

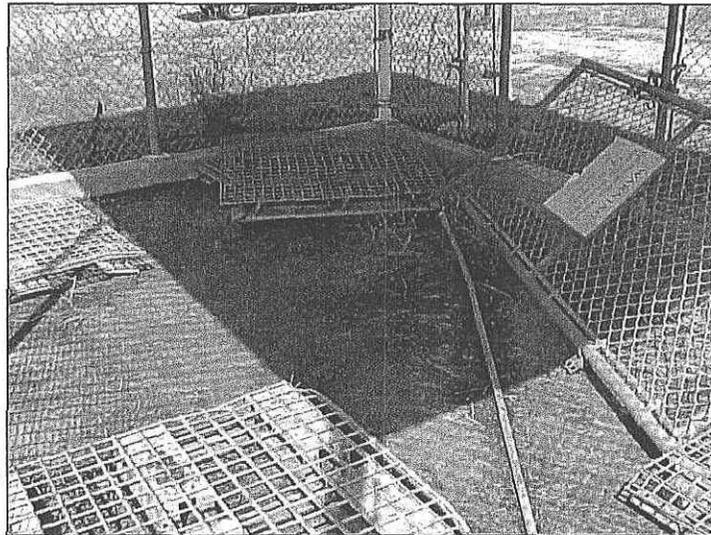
Photograph 2. Former Temporary Accumulation Area (TAA) 779
Marine Corps Air Station, El Toro
Date of Photograph: 1 March 2002

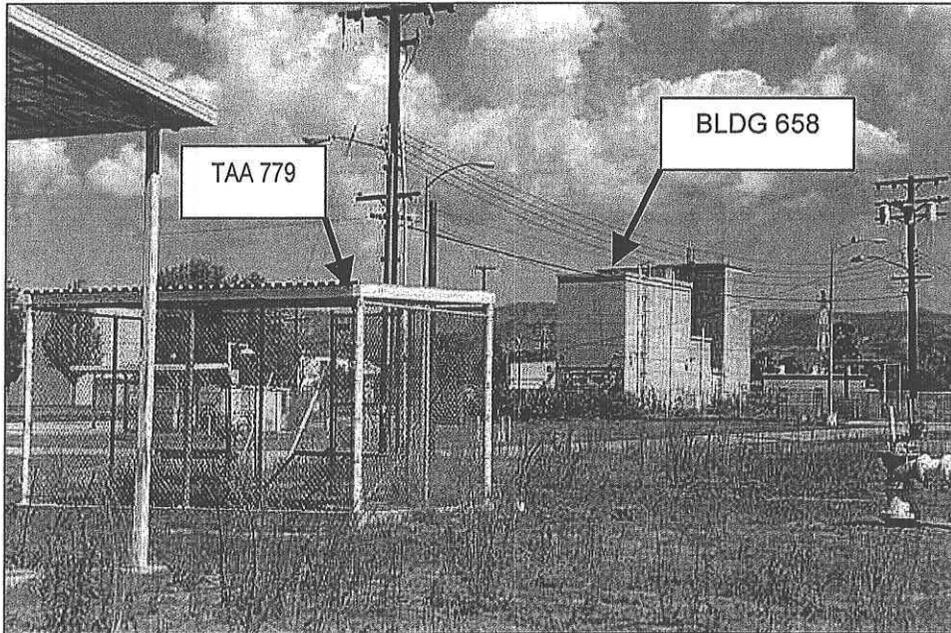
Photograph 5. Former Temporary Accumulation Area (TAA) 779
Looking approximately northeast
Marine Corps Air Station, El Toro
Date of Photograph: March 2002

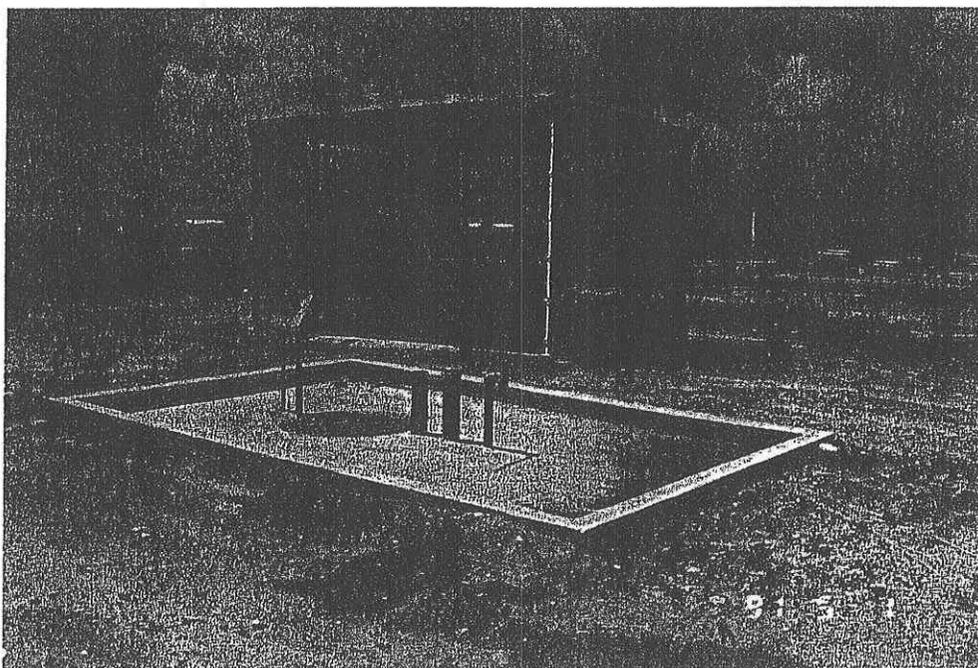
The HWSA is intended to be inactive. At the time of the visit, however, several cases of Kodak 55 Developer were placed inside the storage area by a departing squadron without authorization. Some of the photodeveloper had leaked within the HWSA; it was contained completely by the berm.

Photodeveloper had leaked inside the storage area

Although there was no evidence of a release outside of the storage area, the past and present HWSAs at MCAS El Toro are recommended for a sampling visit.
