Subj: Aerial Photograph Anomalies APHO 93 (SAIC 121) and APHO 97 (SAIC 135)  
Former Marine Corps Air Station, El Toro

Aerial Photograph Anomalies APHO 93 (SAIC 121) and APHO 97 (SAIC 135)  
Former Marine Corps Air Station, El Toro

28 January 2004

*Prepared by:*  
Naval Facilities Engineering Command  
Southwest Division  
BRAC Operations  
San Diego, California

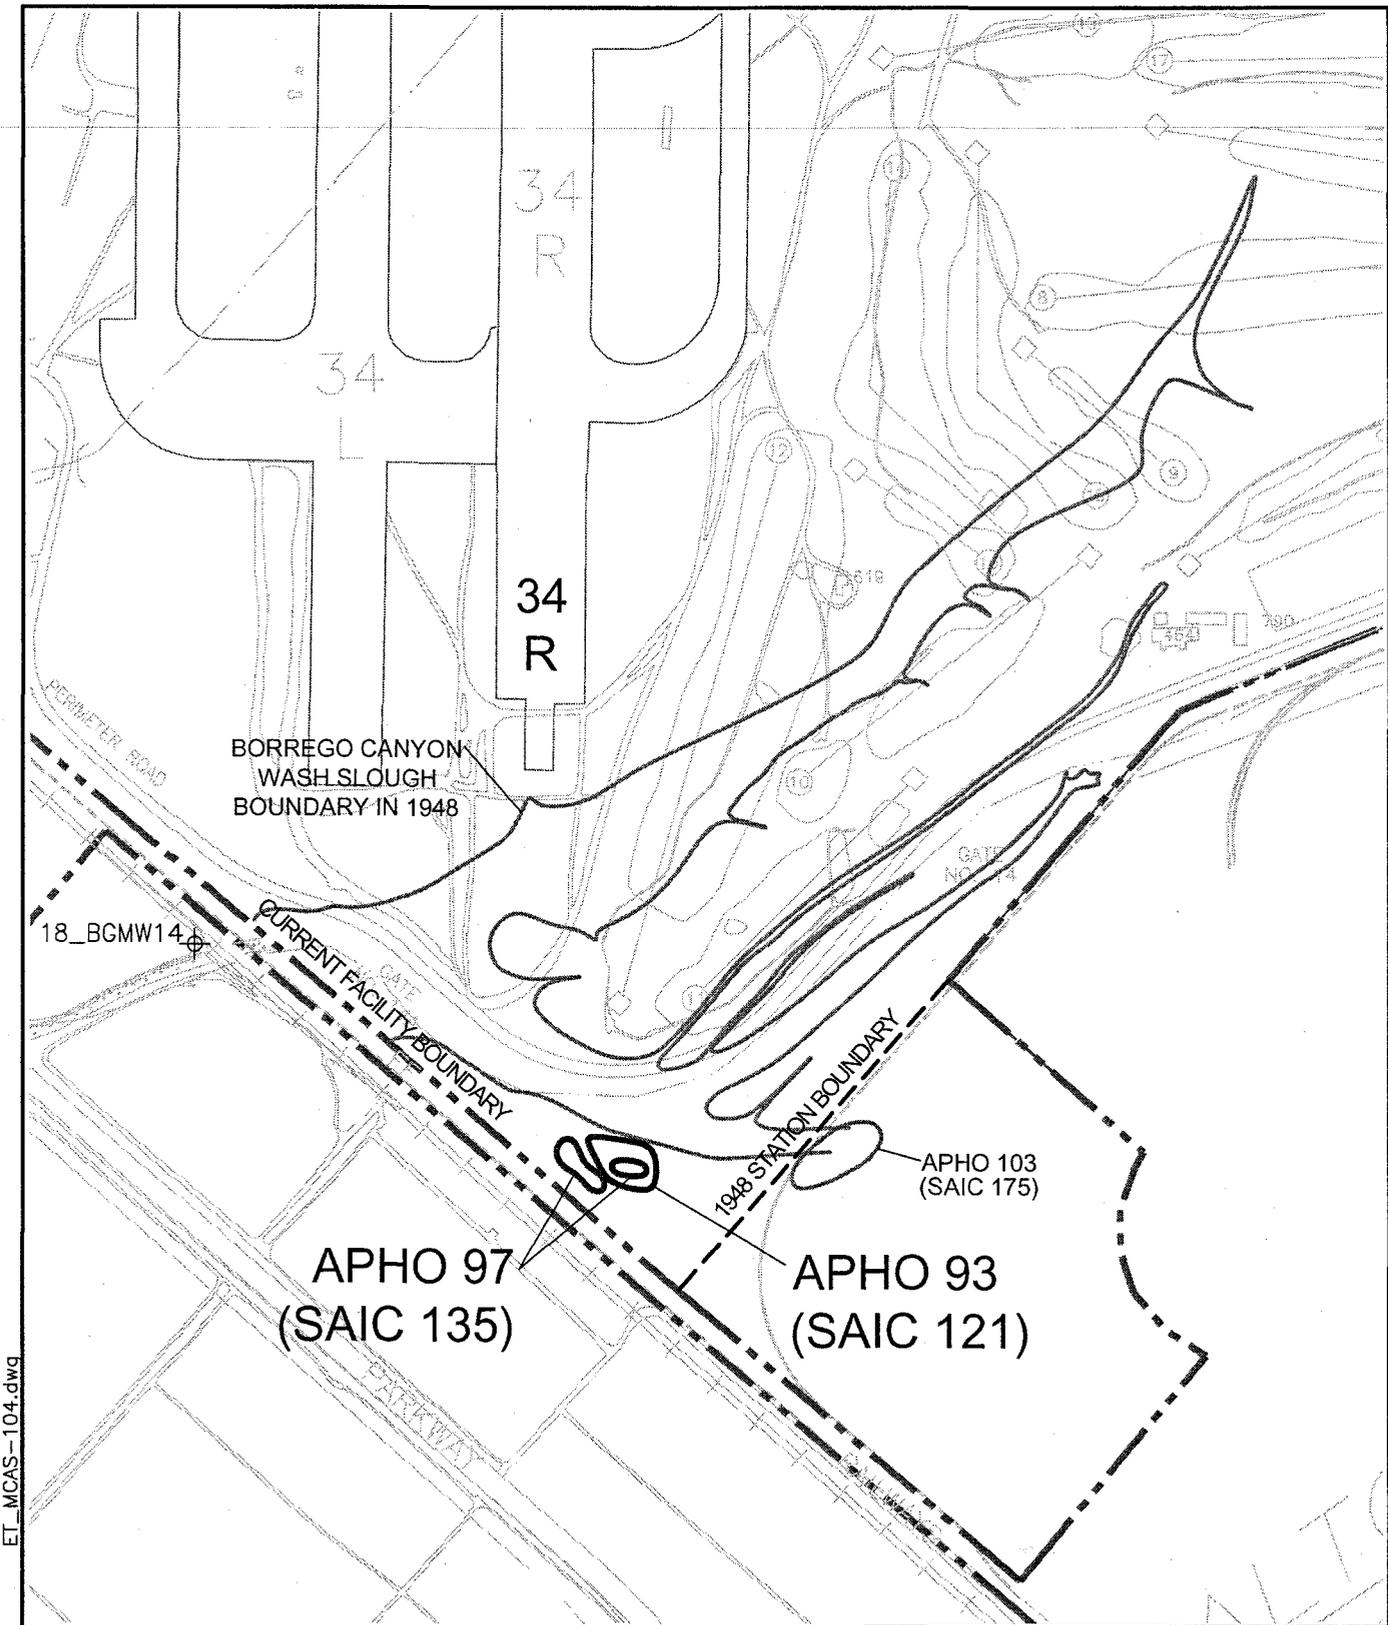
APHO 97  
(SAIC 135)

The historical maps show a former slough on Borrego Canyon Wash located near or at the edge of APHO 93/APHO 97. It is possible that one of the branches of the slough caused the appearance of an excavation, or trench, or area of disturbed ground on the 1961 and 1964 aerial photographs. Due to channel improvements and maintenance activities on Borrego Canyon Wash, the slough areas were filled in with soil over the years. The area designated as a slough

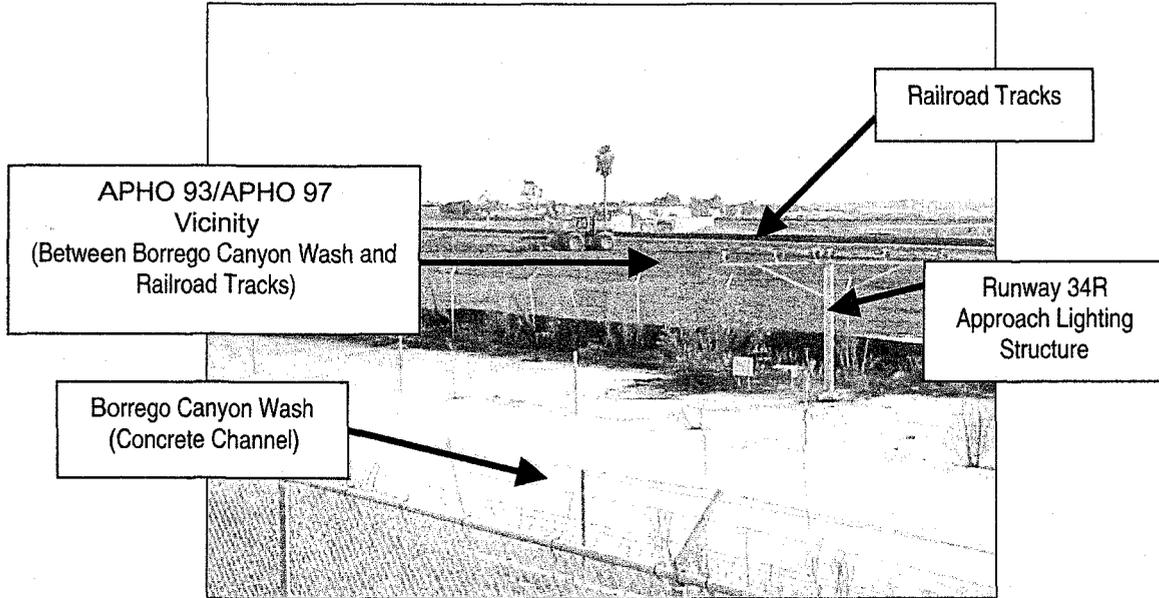
**Photograph 1. APHO 93/APHO 97 Vicinity**  
Borrego Canyon Wash, Between Railroad Tracks and Perimeter Road  
Former Marine Corps Air Station, El Toro  
Date of Photograph: 20 January 2004

Visual inspections were conducted of the APHO 93/APHO 97 vicinity in November 2003, December 2003, and January 2004. The ground surface is relatively flat and no large trees or shrubs were observed. The APHO 93/APHO 97 vicinity was in use for agricultural activities at the time of the visual inspections in January 2004. A tractor was preparing the ground surface at APHO 93/APHO 97 during the January 2004 site visits. No evidence of current or historical industrial or waste disposal activities was observed during the visual inspections. No evidence of excavations, trenches, or areas of disturbed ground was observed during the visual inspections. The approach lighting structures for Runway 34R were observed near the location of APHO 93/APHO 97. Photographs from the inspections are included in the Appendix.

No further action is recommended for APHO 93 (SAIC 121)/APHO 97 (SAIC 135) with Environmental Condition of Property (ECP) category 3.

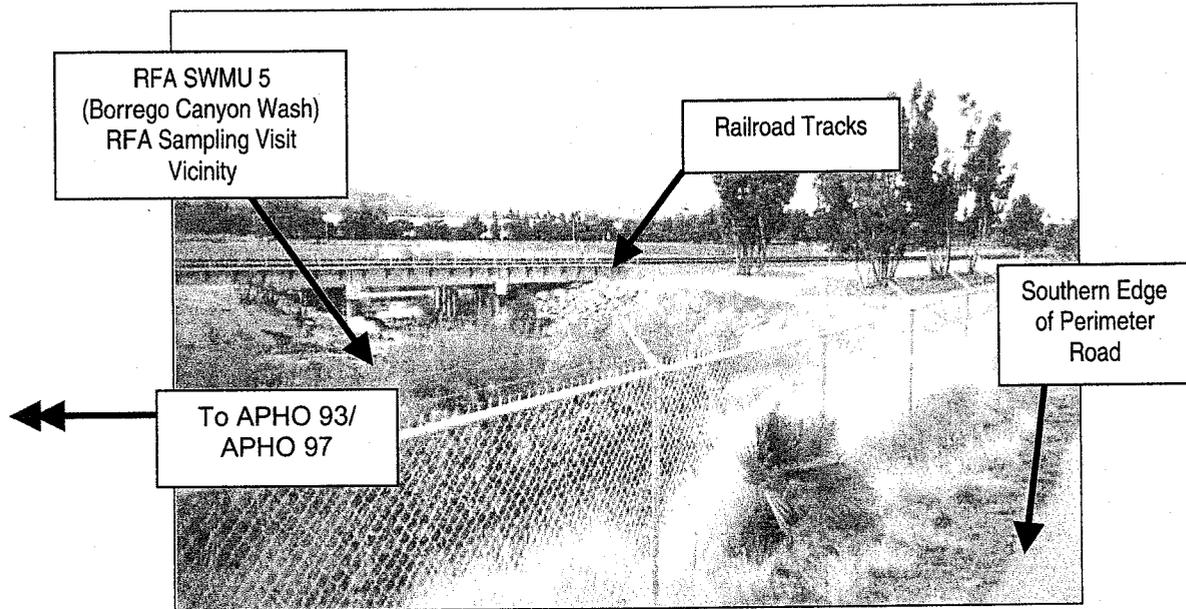
**Photograph 3. Vicinity of SWMU 5 (Borrego Canyon Wash)  
RFA Sampling Visit Area**

Field sampling activities were conducted along Borrego Canyon Wash near APHO 93/APHO 97 during the RFA sampling visit for SWMU 5, and no further action was recommended. Additionally, sampling was conducted at agricultural use parcel AG-7, that includes APHO 93/APHO 97, during the Environmental Baseline Survey (EBS) and the results indicated that residual chemical concentrations were less than the USEPA Region 9 PRGs for residential soil. The EBS recommended no further action for parcel AG-7.

Approximately West of APHO 93/APHO 97.
