UNITED STATES ENVIRONMENTAL PROTECTION AGENCY
REGION IX
75 Hawthorne Street
San Francisco, CA 94105

November 16, 1999

The U.S. Environmental Protection Agency has conducted an inspection of the Site 1 Landfill Cap at Moffett Federal Airfield. This inspection was performed by TRC, a subcontractor to TechLaw Inc., under an EPA contract. EPA performed this inspection to assess whether the remedial action is consistent with the Remedial Design. Detailed comments are attached.

INSPECTION OF THE SITE 1 LANDFILL CAP AT MOFFETT FEDERAL AIR FIELD MOUNTAIN VIEW, CALIFORNIA

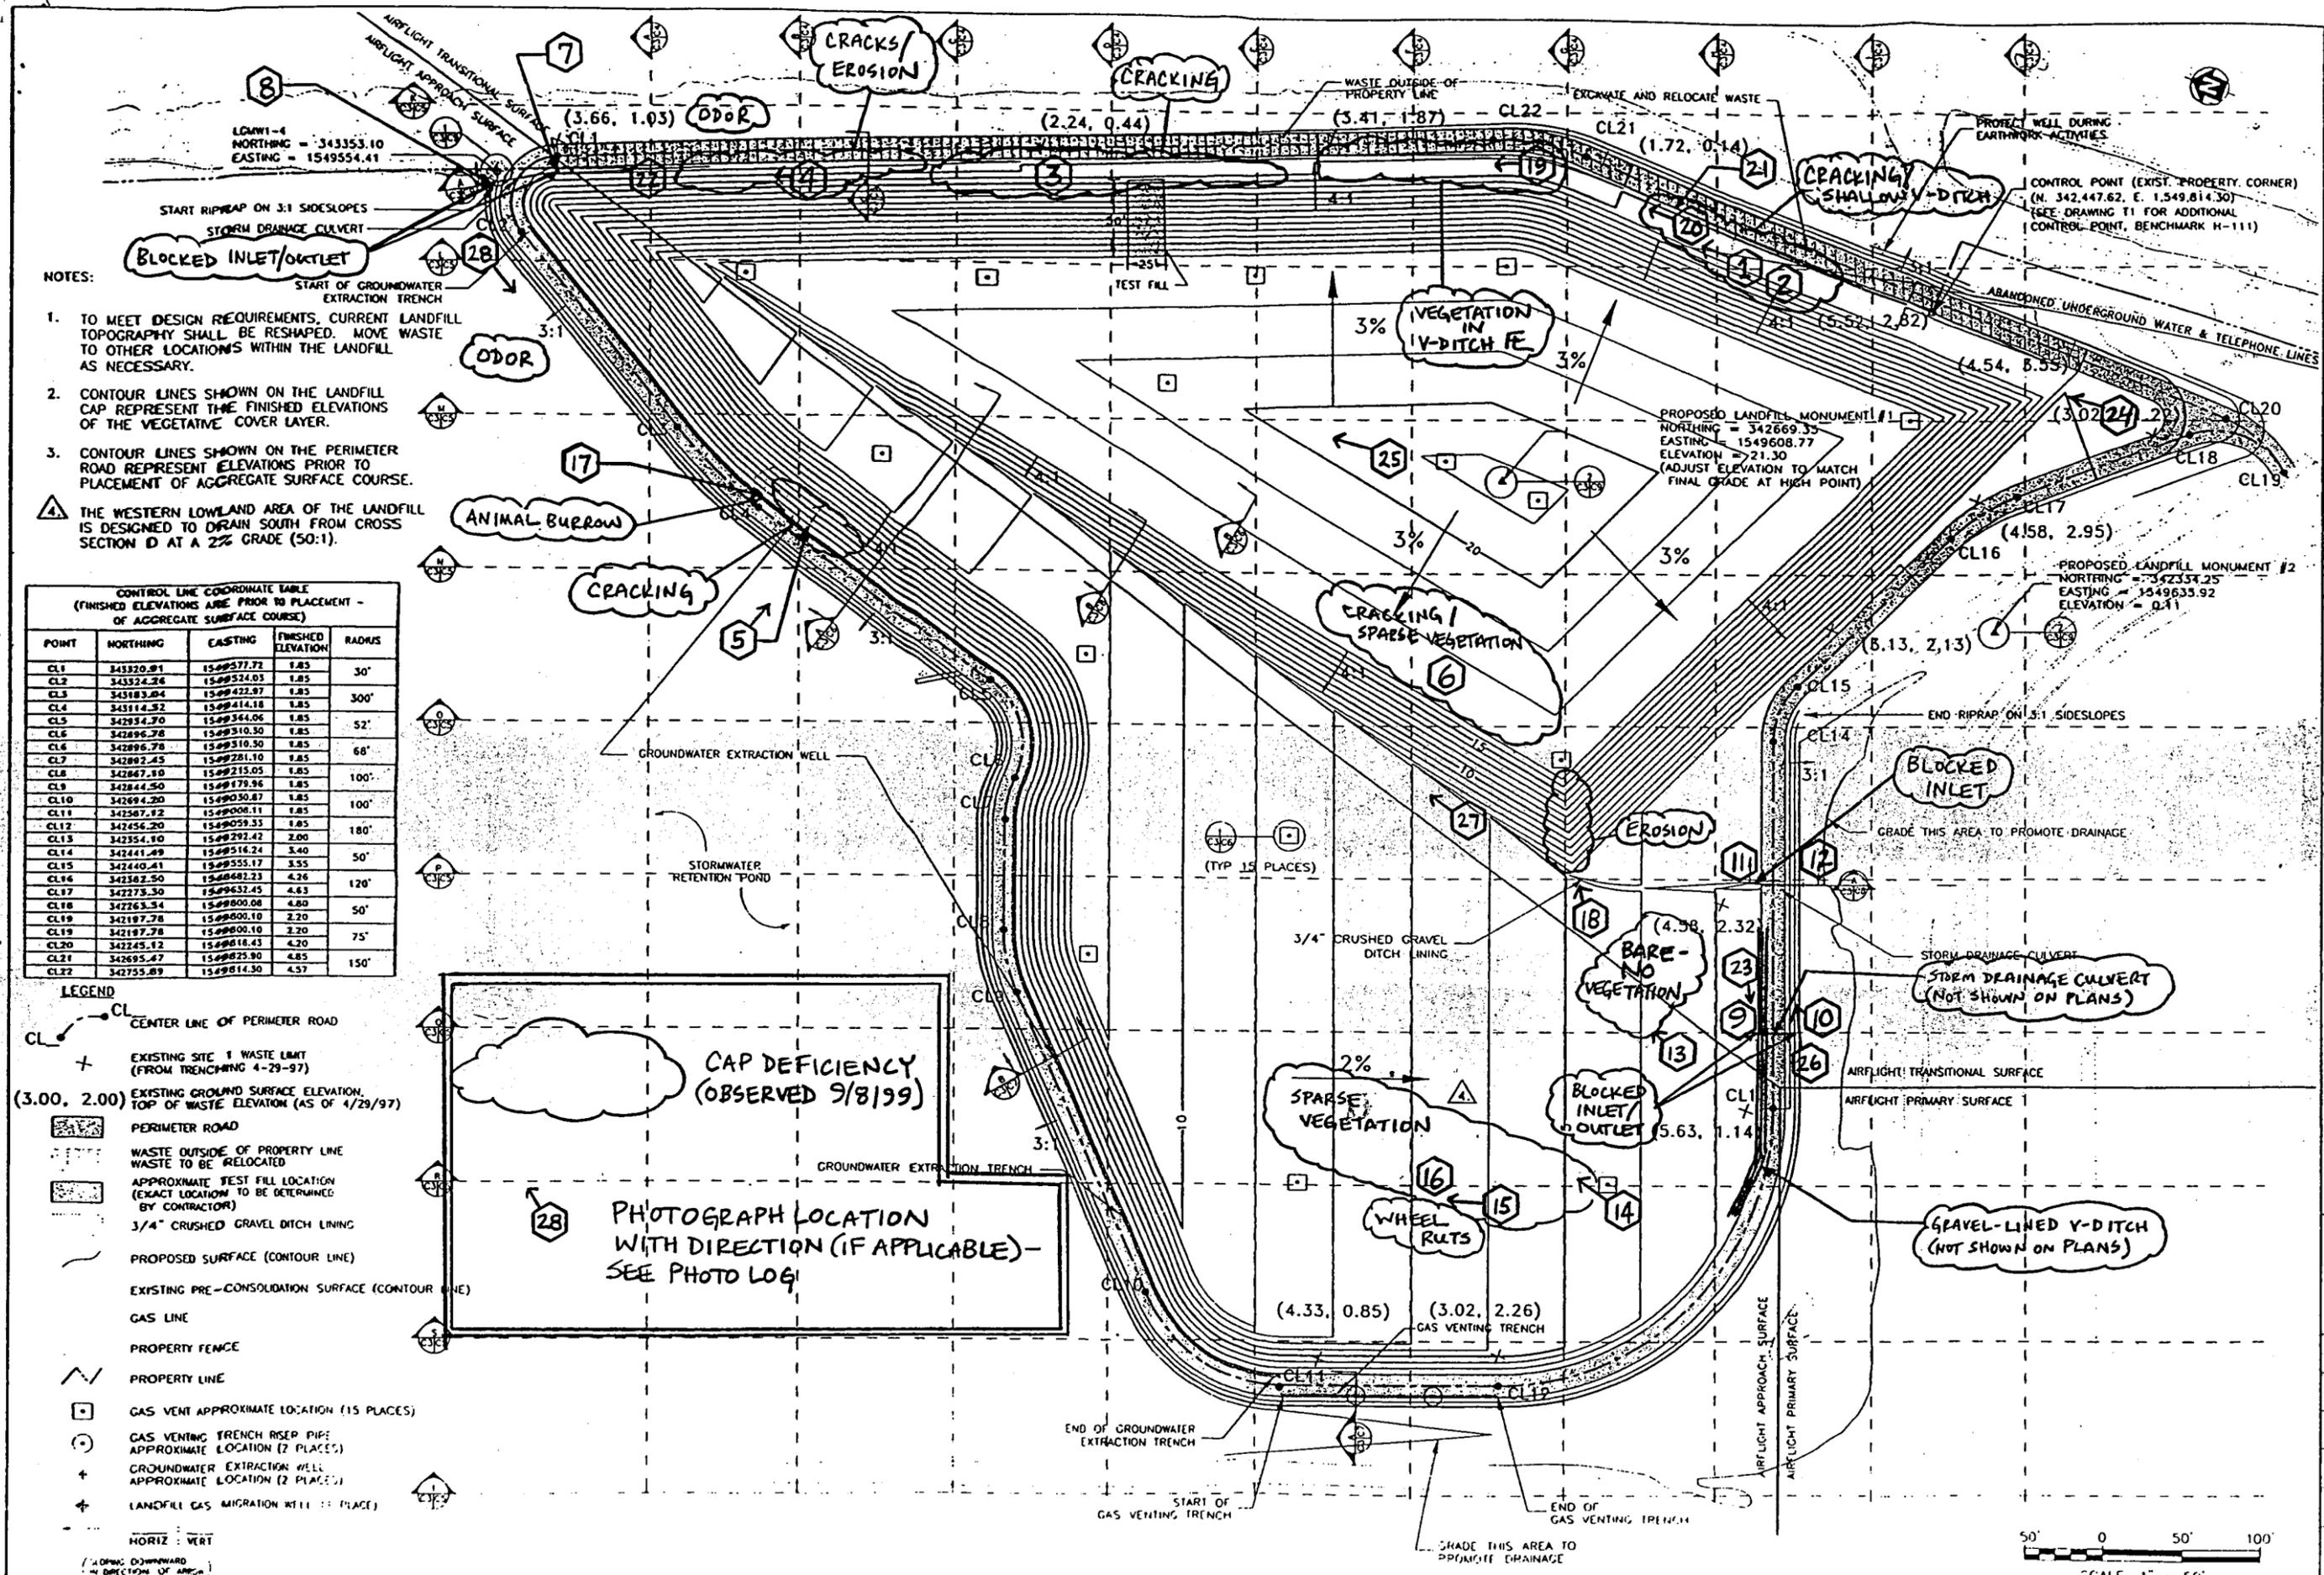
ATTACHMENT 1
DEFICIENCY LOCATION MAP

28 CAP DEFICIENCY (OBSERVED 9/8/99)

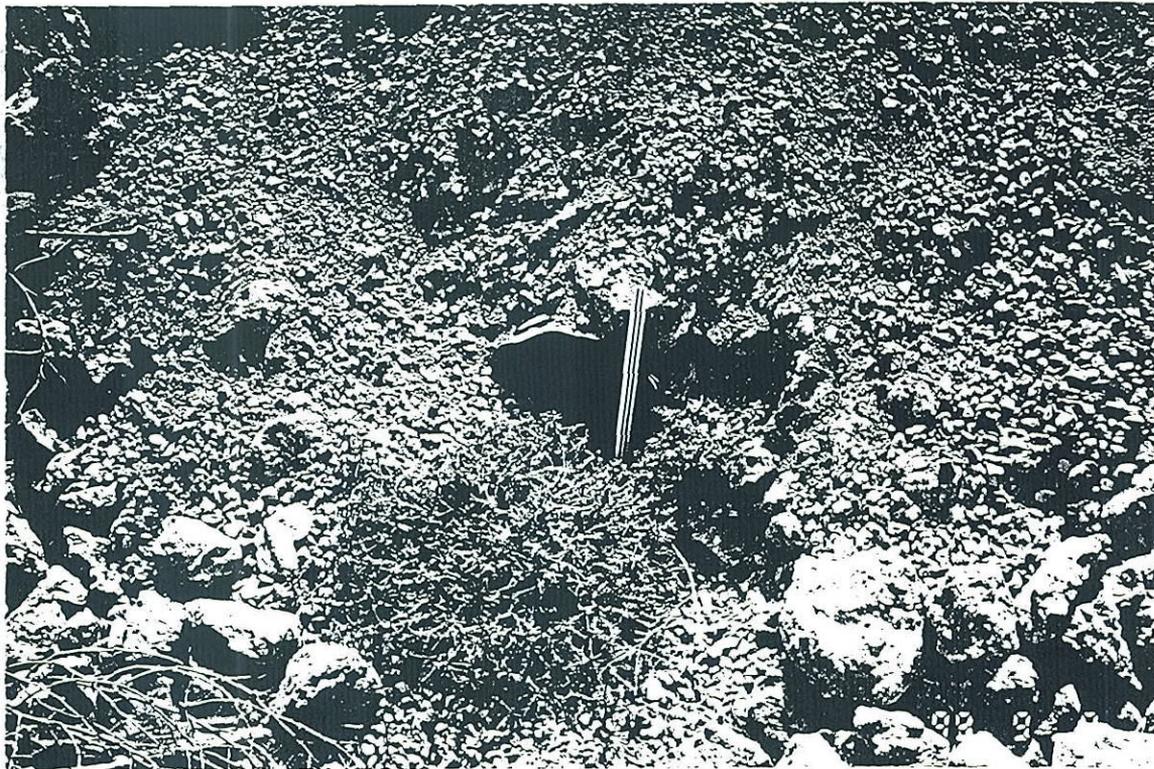
The inlets and outlets of the culverts which carry surface water across the perimeter road to the storm water retention pond were observed to be blocked with soil and vegetation (Photos 7-11), with the exception of the outlet of the southeastern culvert which is

Photo 8 - N culvert outlet blocked by soil and vegetation.

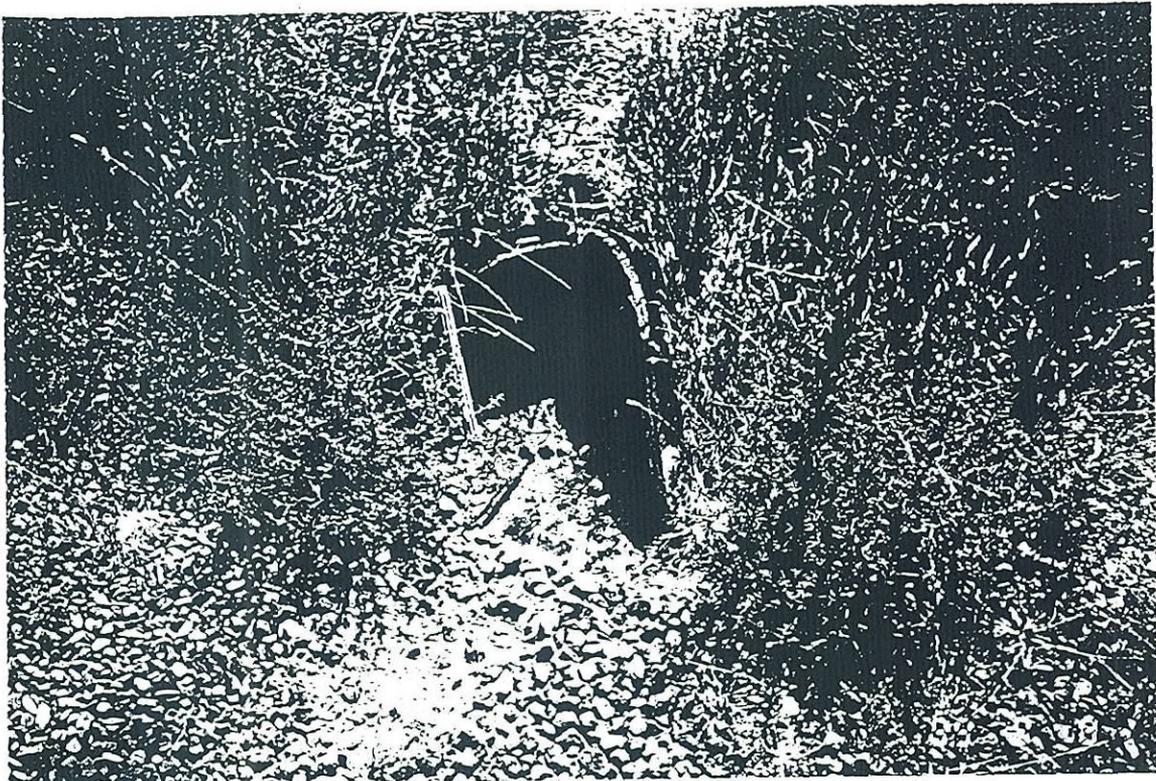
11	1220	--	SE culvert inlet blocked by soil and vegetation; flared inlet broken at top.

Photo 11 - SE culvert inlet blocked by soil and vegetation.

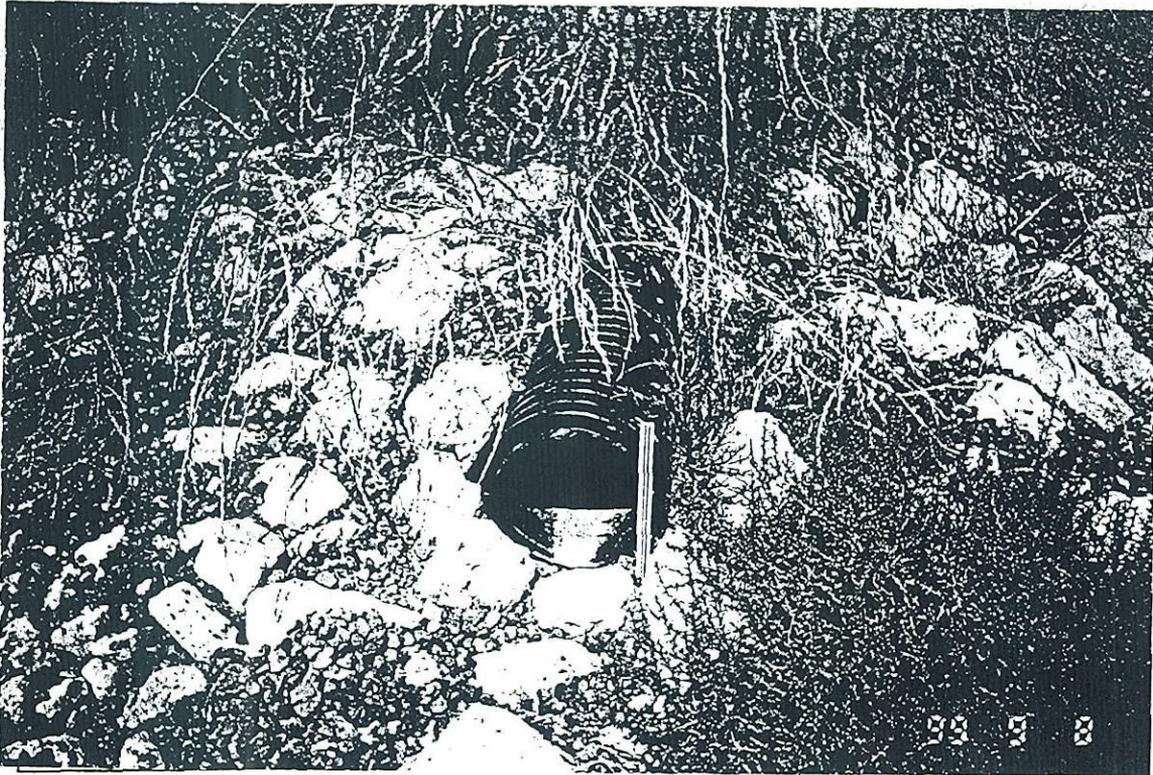
Photo 12 - SE culvert outlet (clear).

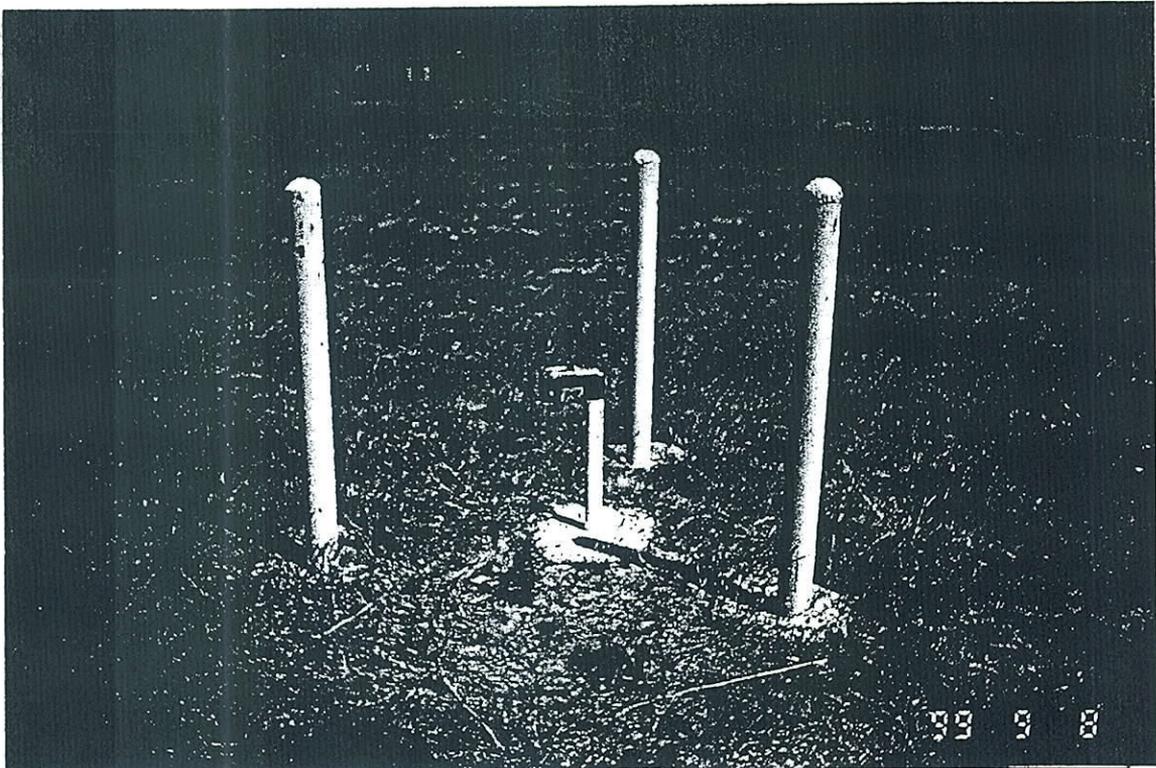
Photo 14 - Sparse vegetation on lower deck/gas vent (good condition).

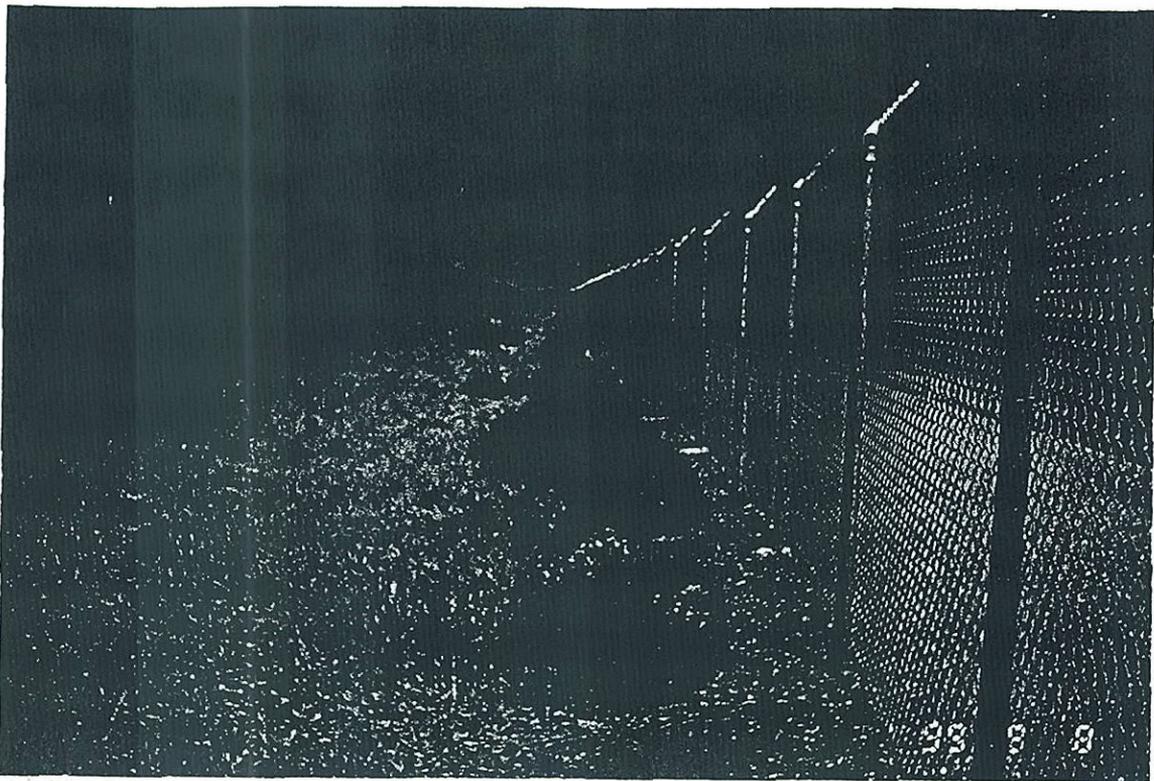
Moderate to heavy vegetation exists in the v-ditch on the northeast side of the landfill (Photo 19). This vegetation will block the surface water runoff from the landfill and, subsequently, increase the likelihood of landfill erosion.

Photo 19 - Vegetation in v-ditch on NE side.

To ensure proper surface water drainage, all v-ditches should be cleared of any vegetation which could affect flow performance prior to the rainy season.

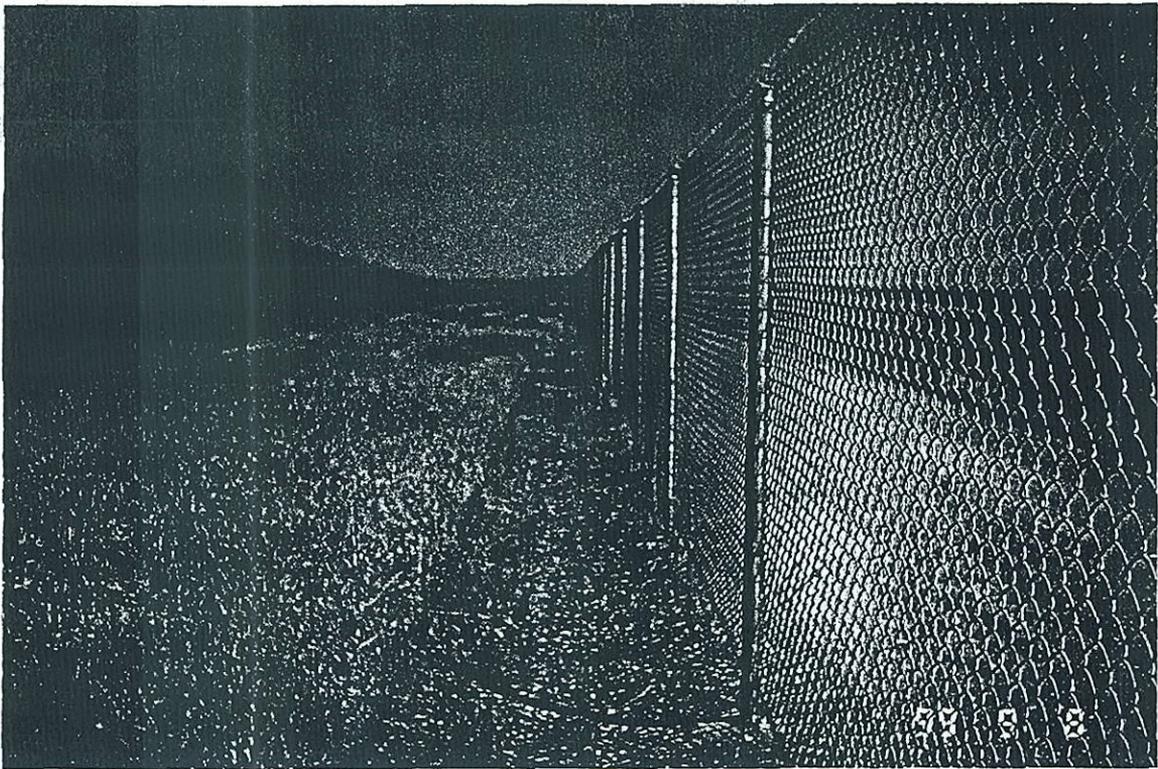
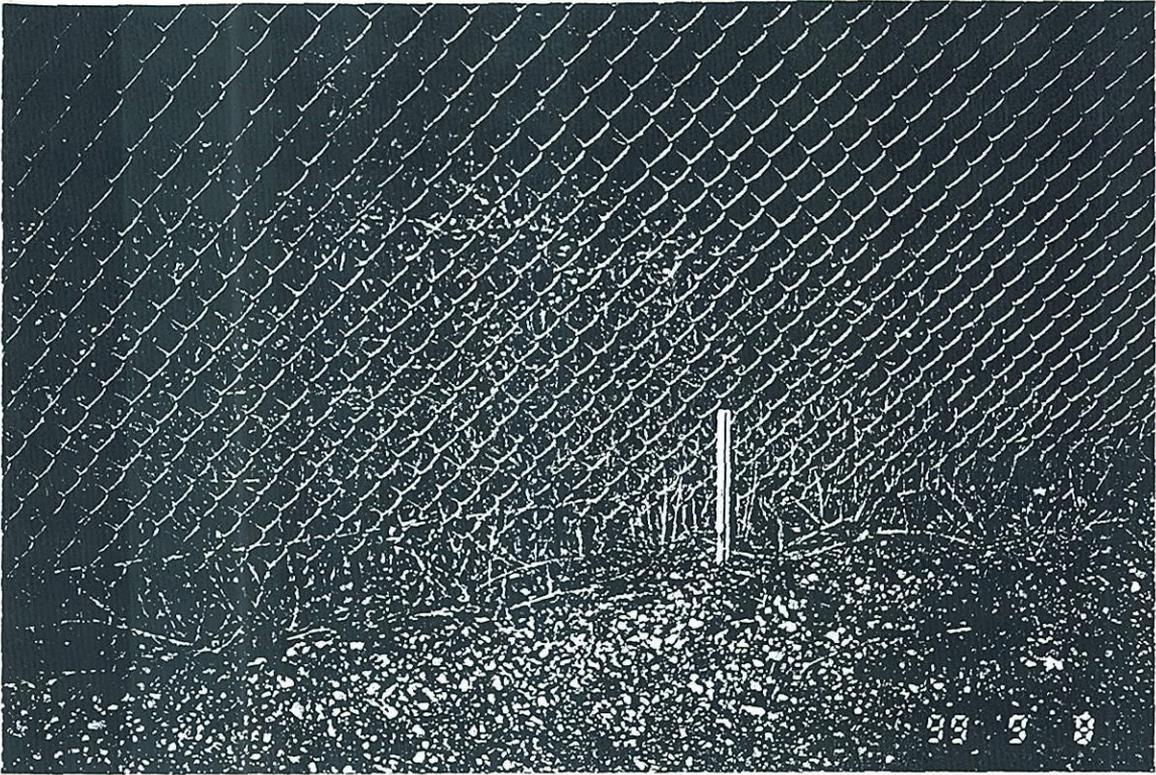
The v-ditch along the southeast side of the landfill appears to be approximately 6 inches deep, which is less than the depth (1-foot) shown on the Design Drawings (Photo 20 and 21).

Photo 20 - Wider/shallower (approximately 6" depth) v-ditch on SE side.

Photo 21 - Side view of Photo 20.

Since the shallow depth of the v-ditch could adversely affect the ability of the ditch to perform as designed and remove surface water from the landfill, the depth of the ditch should be increased to 1 foot.

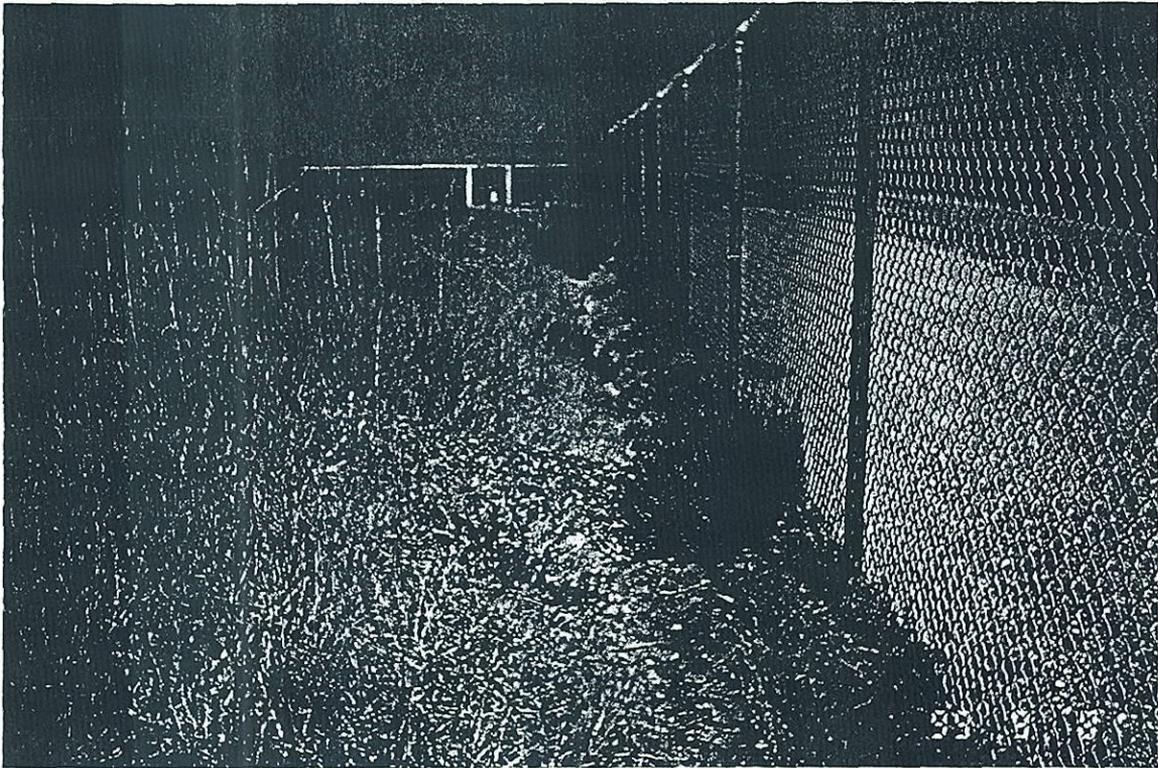
Gravel silt traps (Photo 22) and an additional gravel-lined v-ditch and culvert (Photo 23) were observed at the landfill although these components are not shown on the Design Drawings. Since the as-built drawings were not available for review, it is unclear whether these additional components are shown in the as-built drawings.

Photo 22 - Gravel silt trap in v-ditch on NE side (not shown on plans).

For consistency and completeness, these additional components should be shown on the as-built drawings.

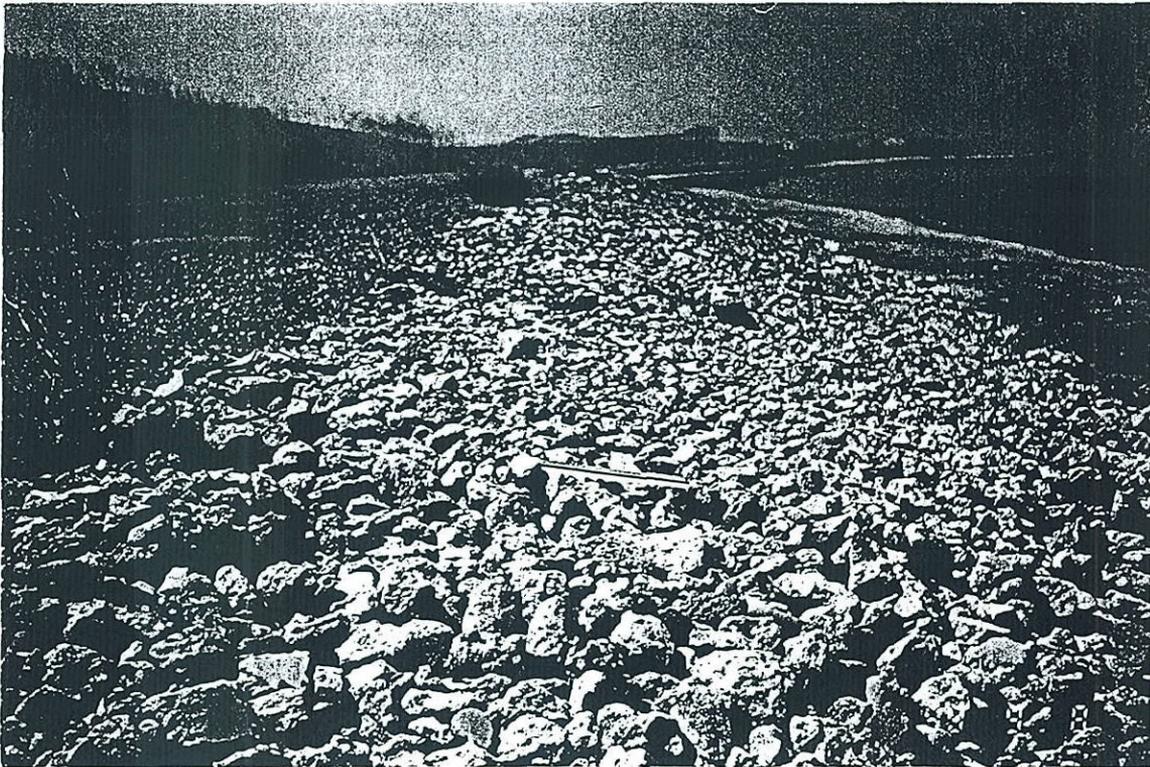
Photo 28 - Riprap slope to stormwater retention pond (good condition); riprap may be undersize ($d_{50} < 6''$).
