UNITED STATES ENVIRONMENTAL PROTECTION AGENCY
REGION IX
75 Hawthorne Street
San Francisco, CA 94105

November 16, 1999

INSPECTION OF EAST-SIDE AQUIFER TREATMENT SYSTEM AT MOFFETT FEDERAL AIR FIELD, MOUNTAIN VIEW, CALIFORNIA

INSPECTION RESULTS OF THE
EAST-SIDE AQUIFER TREATMENT SYSTEM

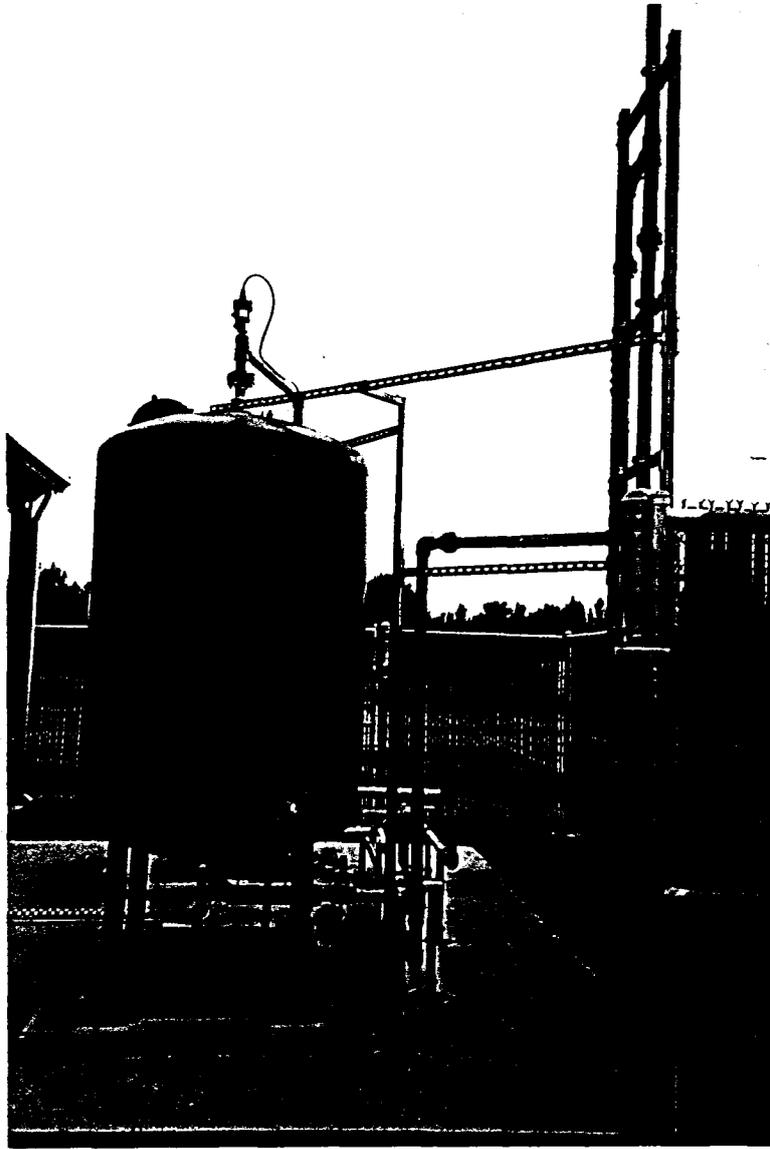
Based on the inspection, it appears that the flow rate may be exceeding the system design at some times. Once the flow rate is increased past 40 gpm., the piping at the discharge point starts leaking treated water through a raised pipe prior to discharge. Inspection of the design drawings indicates that the effluent of the LGAC is discharged to the storm drain through a 2-inch PVC pipe which is elevated 1'-8" above the LGAC canister influent line, bent through one three way "T" and one 90-degree elbow and discharged. The top side of the "T" is a 2-foot pipe that is open to the atmosphere (Photos 1 and 2). As the flow rate is increased to above 40 gpm., some of the effluent is discharged through the open pipe. Please explain this phenomenon and how it can be addressed.

Photo 1. 9/8/99, 11:00 a.m. (northwest)
LGAC systems and effluent discharge piping

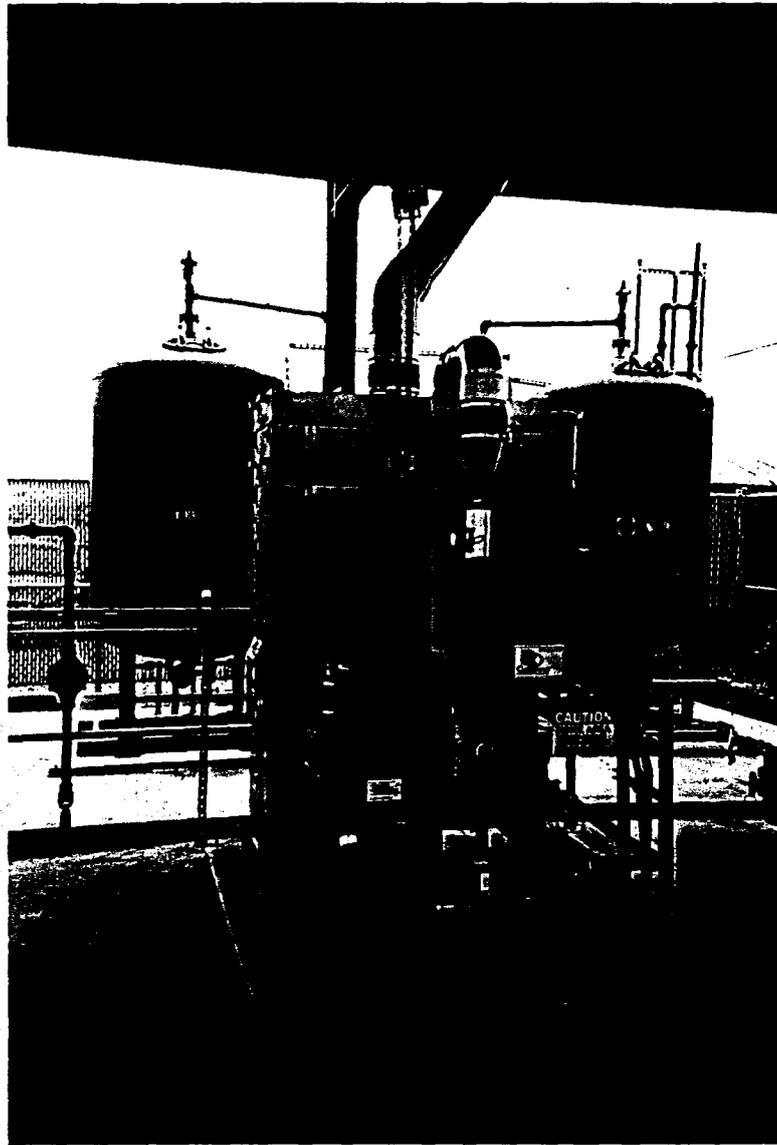
Photo 2. 9/899, 11:00 a.m. (northeast)
Air stripper with the LGAC system in the background

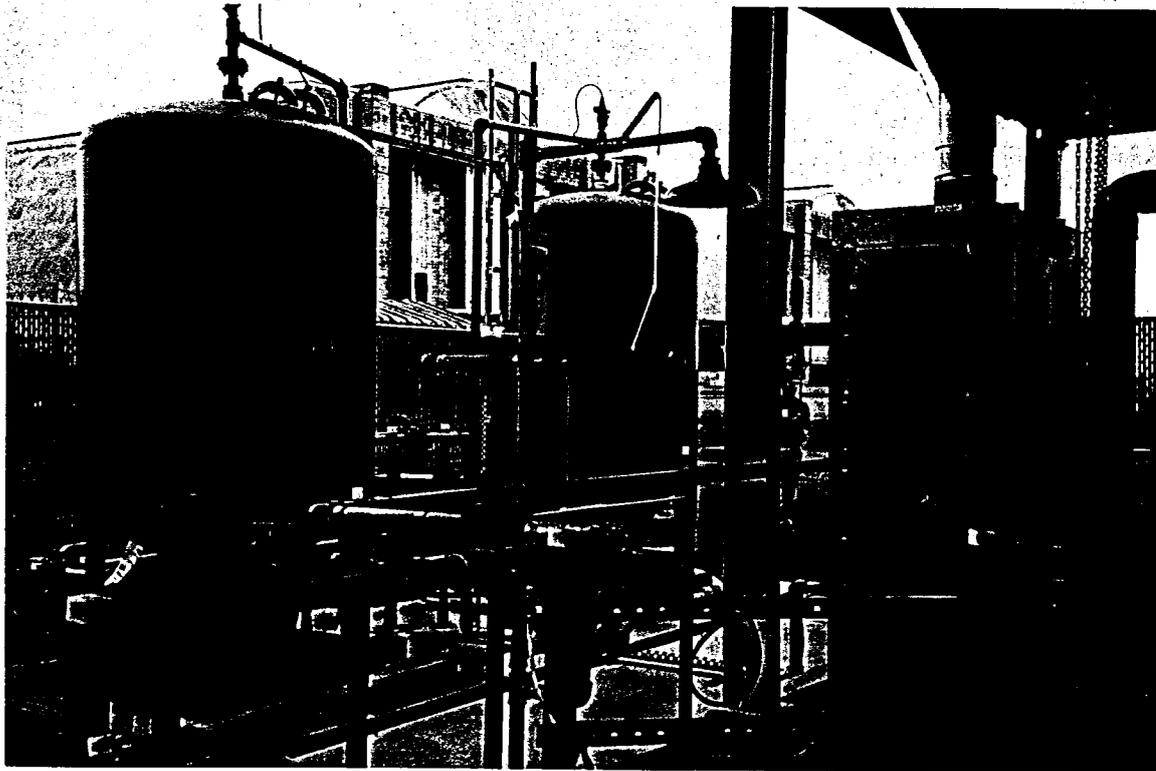
Photo 4. 9/8/99, 11:00 a.m. (east)
Air stripper and vent on the RHS and LGAC system to the LHS
