Naval Facilities Engineering Command

Abstract of an Accident

99-10

ACCIDENT TYPE: Fall
INJURY: Broken Arm/Laceration
TYPE OF WORK: Reinforcing Steel

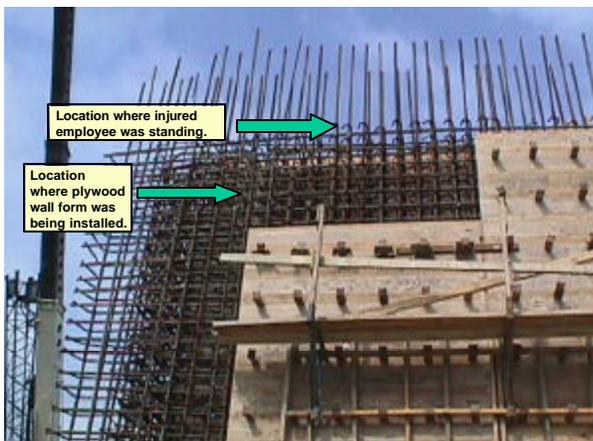
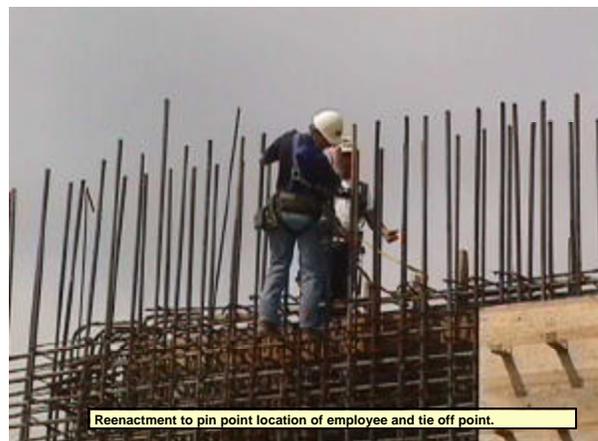
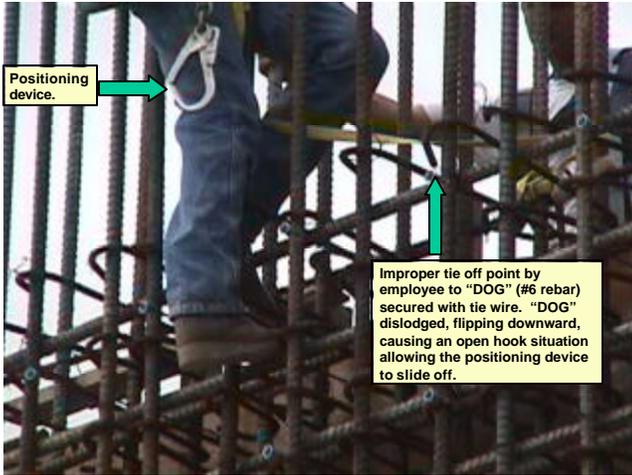
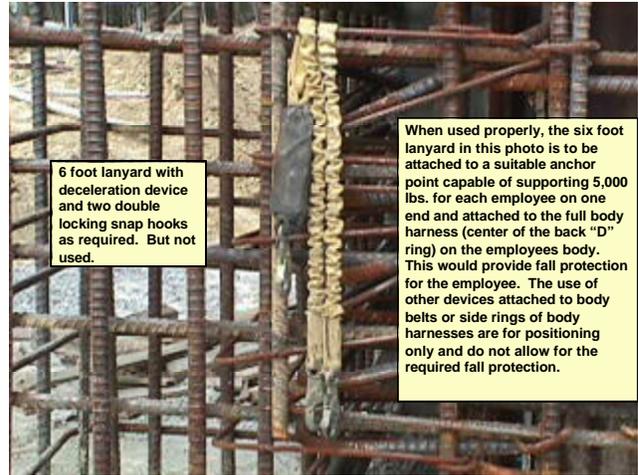
Three steelworkers were in the process of installing an exterior 4'x8' sheet of plywood form for a concrete wall replacement 20' above grade. Two workers held the plywood sheet in place while the injured employee inserted the wall ties from a position above the plywood sheet. The worker fell as a result of inadequate fall protection equipment.

- Adequate fall protection equipment was not being worn. The worker was using a positioning device as his means of fall protection and attached it at an inadequate anchor point.

- Although standards allow reinforcing steelworkers to use body belts with positioning devices while tying reinforcing steel, it must be used in conjunction with a full body harness attached with a lanyard designed to limit the employee's fall distance to no more than six feet affixed to a suitable anchor point.
- Fall Protection is required for workers whenever they are exposed to falls of six feet or more. In addition, it is required that body belts and harnesses have two lanyards when necessary to insure that a person is tied-off with at least one lanyard at all times. Workers should have been utilizing two lanyards in addition to the positioning device to allow for safe employee movement from one location to another.
- A positioning device is not acceptable as a means of fall protection, additional harnesses and lanyards are needed.
