## Naval Facilities Engineering Command

# Abstract of an Accident

99-12

**Accident Type:** Fall from height  
**Injury:** Fatality  
**Type of Work:** Iron welding  
**Equipment:** Personal fall arrest equipment not in use

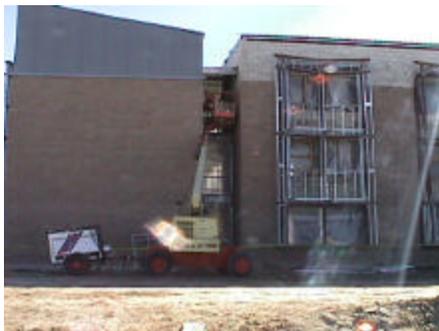
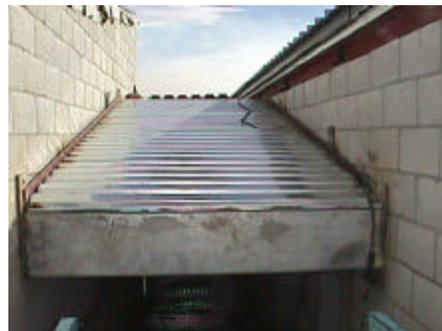
An ironworker fell from a slightly sloped roof, to his death, during the process of spot welding corrugated roof substrate panels. Management personnel had observed the two workers on the roof without fall protection and instructed them to tie-off. One of the ironworkers left the roof to obtain fall arrest harnesses from the contractor's trailer leaving the victim alone for a brief period. While the coworker was retrieving the fall arrest harnesses the victim fell from the roof. There were no eyewitnesses to the incident.

The worker was not wearing personal fall arrest equipment. No guardrail or other protective system had been installed to provide fall protection in lieu of personal fall arrest systems for workers on the roof.

- 1) Workers involved had not been provided adequate fall hazard risk assessment training or appropriate precautionary measures.
- 2) Management personnel provided insufficient control to initiate appropriate action in a timely manner.

Specific work plans must be in place for work involving fall hazards. In absence of perimeter guardrail system or other installed fall protection systems, a plan for anchorage and oversight inspection milestones could decrease likelihood of workers in at-risk situations. Strict conformance with USACE EM 385-1-1 Section 21, OSHA 29 CFR 1926 Subpart M and project safety requirements are essential.

Individuals designated as competent persons and involved in fall protection and arrest systems should have documented training in accordance with USACE EM 385-1-1 and 29 CFR 1926.
