## Naval Facilities Engineering Command

# Abstract of an Accident

99-08

**ACCIDENT TYPE:** Fall  
**INJURY:** Fatality  
**TYPE OF WORK:** Painting 1000 ft high Towers  
**EQUIPMENT:** Two Point Scaffold

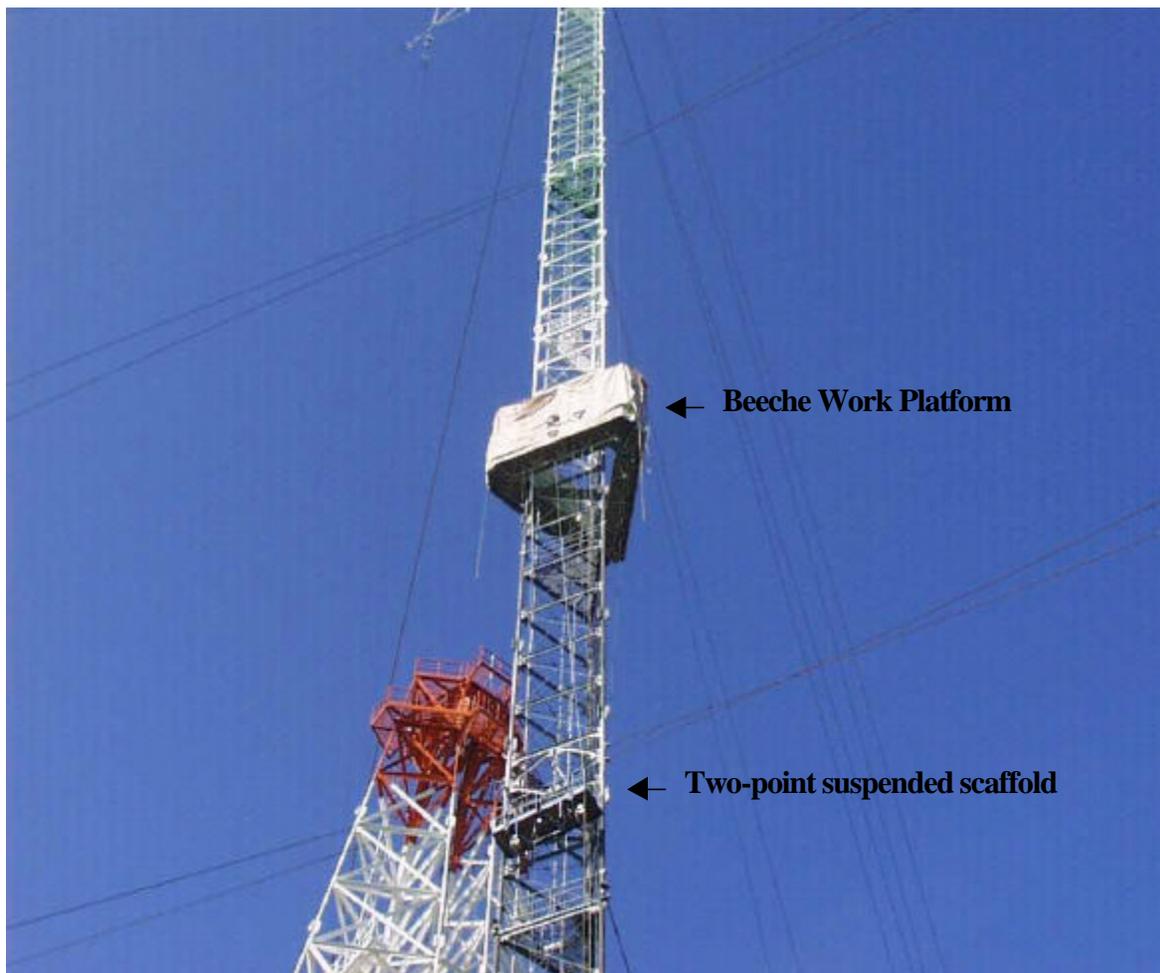
The mishap site consisted of 1000-foot radio transmission towers that were being scraped and painted. Two point suspension scaffolds were used to travel up the tower to gain access to a larger suspended Beeche Inc. work platform, which is a series of three scaffolds joined together to form a working platform which surrounds the tower being painted. A rope used to temporarily hold the two-point suspended scaffold used to gain access to the Beeche system snapped causing two workers to fall with the scaffold. The rope became overloaded when a misunderstanding of the control mechanism caused the worker to pick up an approximately 3000-lb. concrete counterweight being used to correct wind sway. One worker remained in the scaffold when the scaffold main support lines became taught approximately 67 feet below where it was temporarily tied off but the second worker fell out of the scaffold an additional 180 feet to his death.

- Fall protection equipment not worn.
- Scaffold controller was not working properly. Up meant down and down meant up.

- Equipment procedure change initiated by the crews, which was being practiced for several weeks, tied the traveling scaffold to the tower approximately 70 feet below the Beeche working platform. This required a crewmember to lower the traveling scaffold to take up the slack in the main support cable cables created by the larger Beeche scaffold being lowered as the work progressed downward. In lowering the access scaffold an error was made and the scaffold was trying to raise itself. The cable securing the scaffold to the tower snapped and the scaffold fell ejecting the victim from the scaffold to his death.

- Employees took off their fall protection equipment when working on the larger Beeche work platform and did not put it back on when they entered the two-point suspension scaffold used for access.

- Main support cables for the two-point suspended scaffold used to access the larger suspended Beeche scaffold above were anchored at the bottom in an attempt to prevent wind sway. This anchor introduced a potential for overloading of the scaffold system which occurred.

- The two point suspended access scaffold was temporarily tied off with rope allowing a slack condition to occur in the access scaffold cables. The employees entered the scaffold when only the rope supported it. This was a misuse of the system in utilizing the rope not designed for supporting personnel.

- Fall protection equipment must be worn at all times when in suspension scaffolds. Refer to OSHA publication Directive CPL 2 – 1.29 for communication tower access.

- Do not make changes to equipment procedures until approval from supervisors and the equipment manufacture has been obtained.
- All equipment shall be maintained in good working order in accordance with manufacturer recommendations.
- Ensure that all damaged or unsafe equipment is removed from service and tagged "Not For Use" or "Unsafe ".
