Window/Viewport Inspections for Navy Hyperbaric Chambers in Protected Service Environments

Ref: NAVSEA/NAVFAC-00C3-PI-006

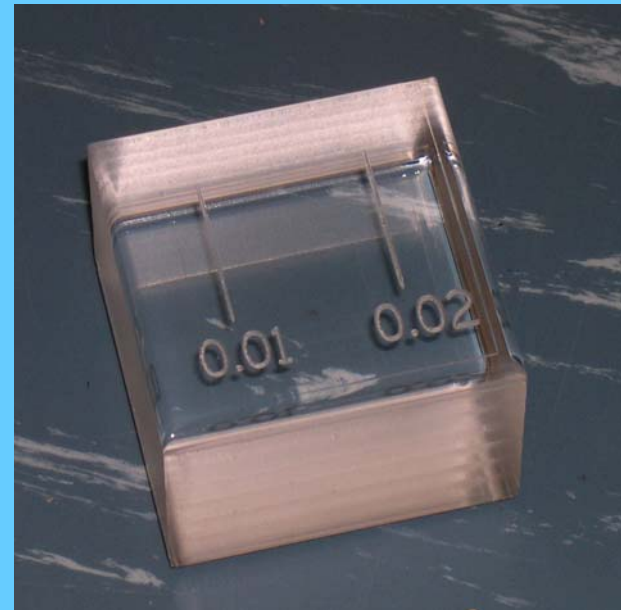
Scratch Comparator for Identifying Scratch Depth

- Comparator to be used by
dragging fingernail over scratch
making a tactile comparison to
scratches in windows
- 0.01 or less is the Pass criteria

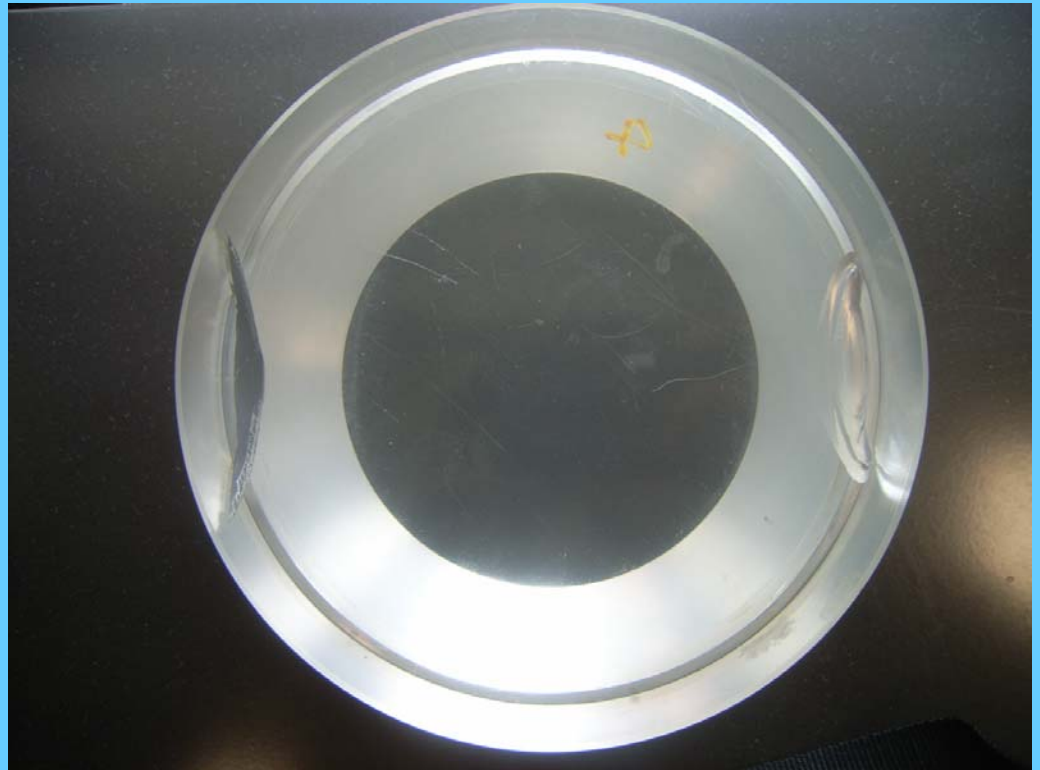
Why Inspect Windows

- Window from ex-Navy Medical Research Institute Wet Pot (Saturation facility)
- Cracks noticed in a Wet Pot window during a manned 1000 FSW Sat Dive

Note: Acrylic shards are not visible on x-rays – avoid them

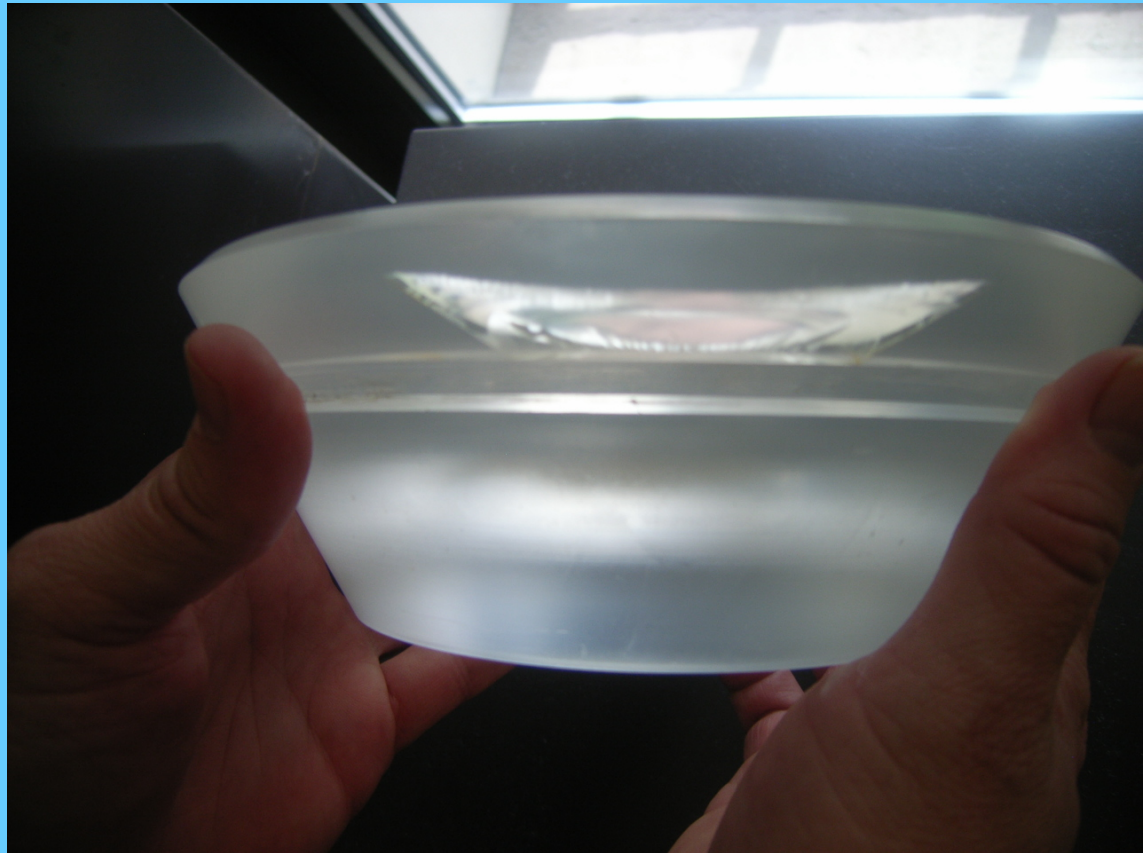
- Saturation complex split and emergent repairs made during the dive
- Note: O-ring grooves in acrylic windows are no longer used

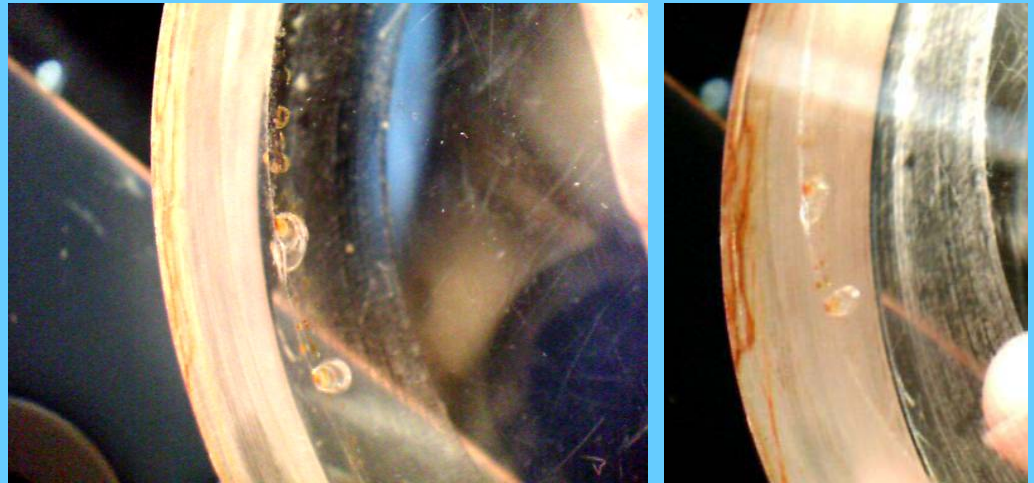
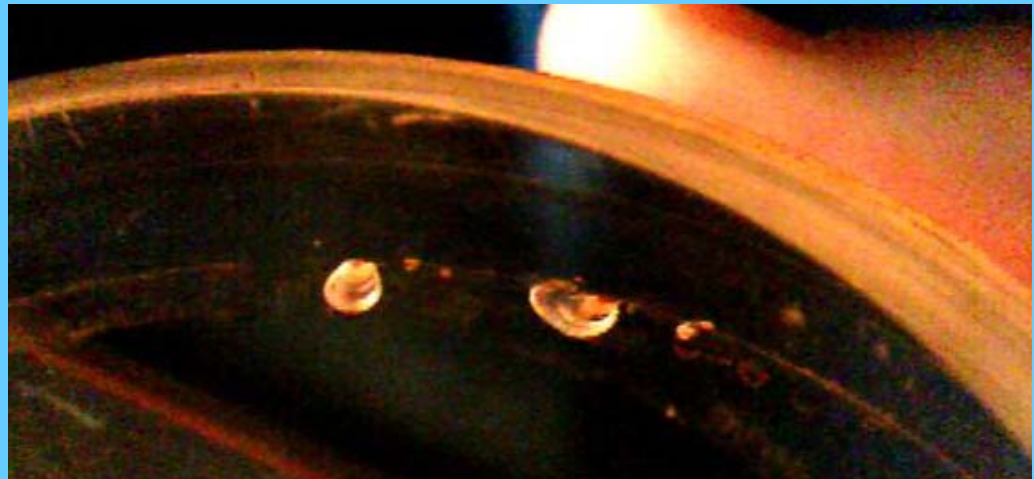
Concoidal Fractures

- These Fractures are inside the window or along an edge
- Appear similar to arrow head (flint) flaking

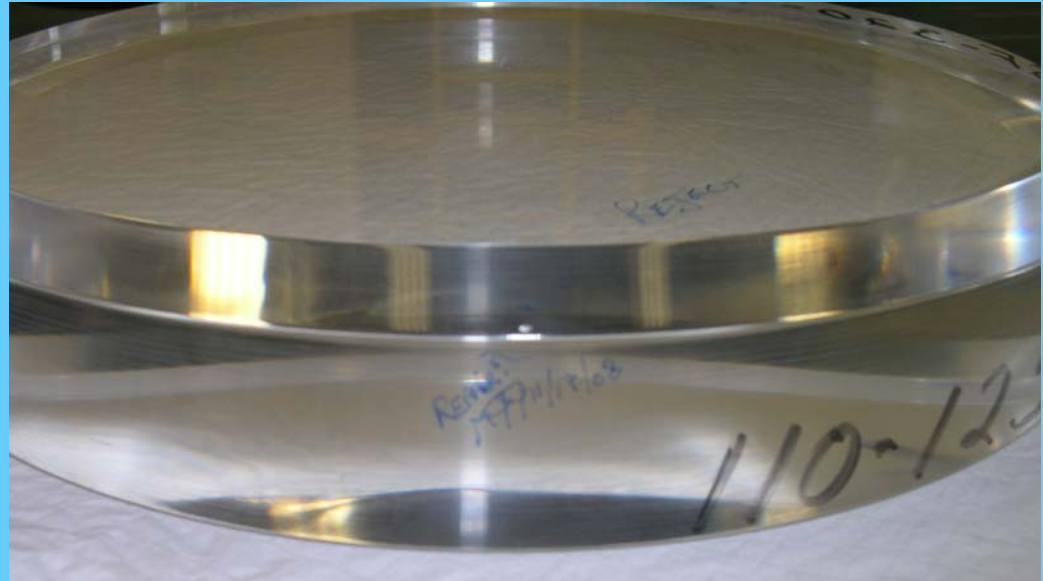
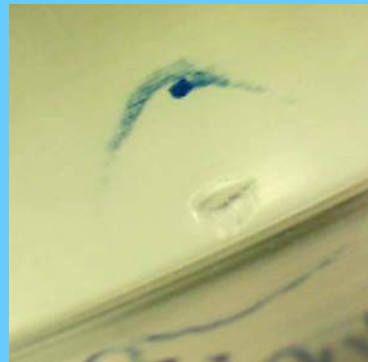
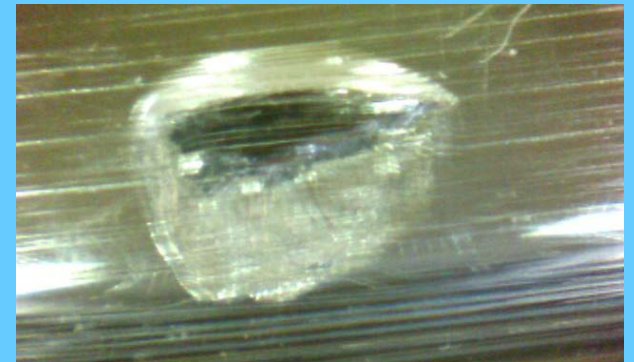
Concoidal Fracture/Chip

- Typically occurs from a mechanical impact or point loading to the edge/side of the window

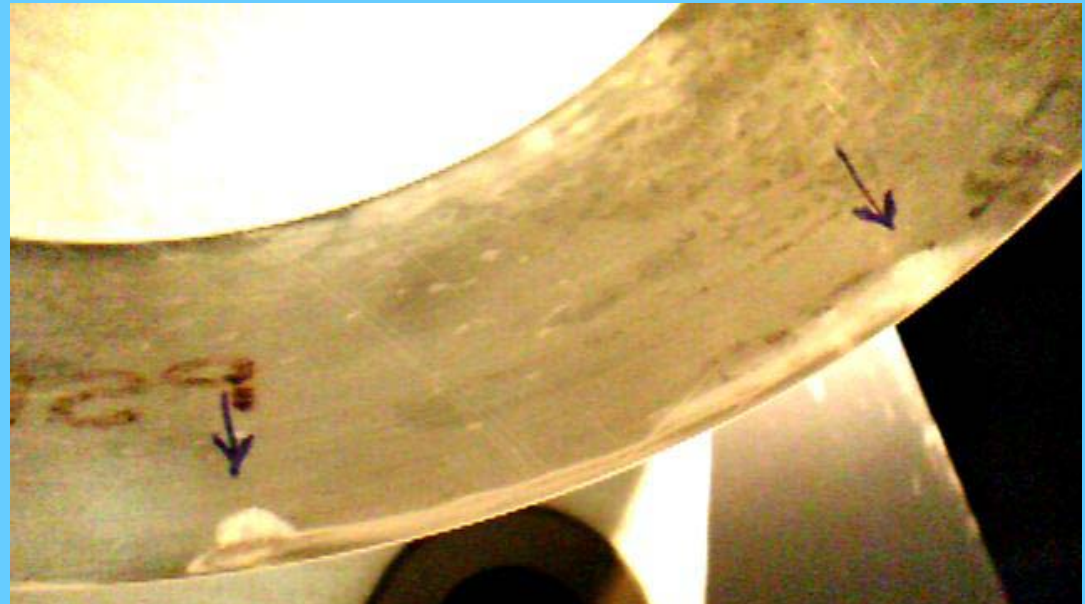
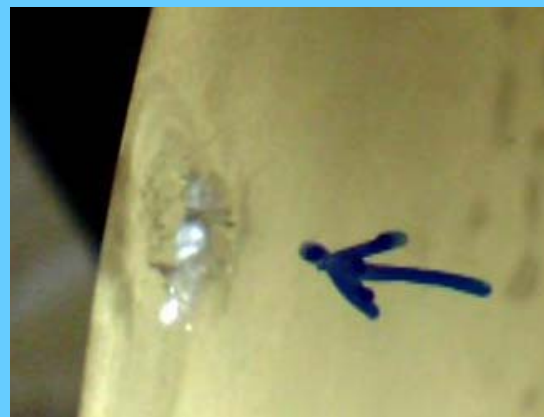
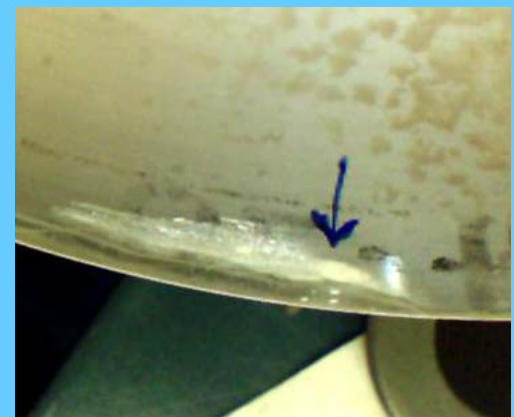
In-Plane Fractures

- Sub-surface fractures
- Probable cause is point loading

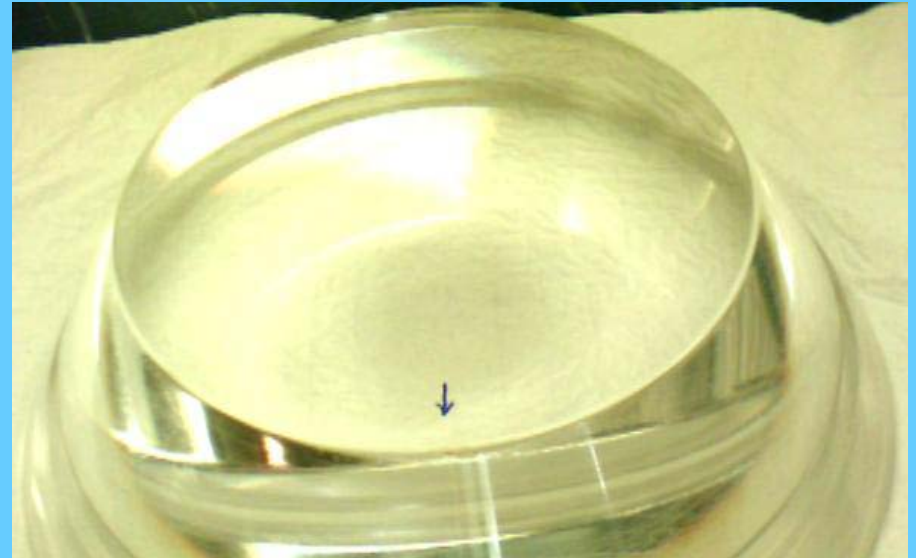
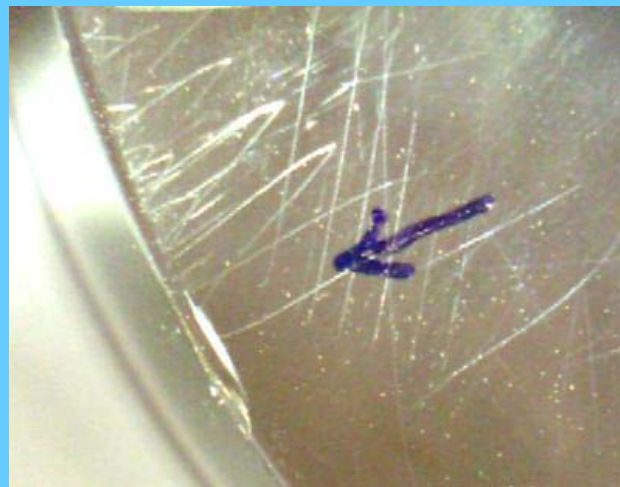
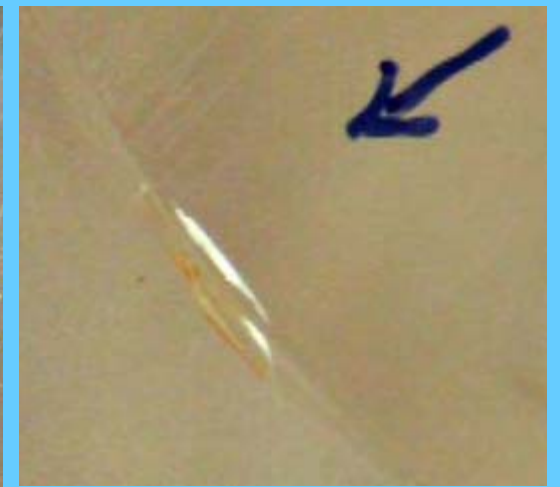
In-Plane Fractures

- In plane fractures on edge of window. Note that scratches are within specifications.

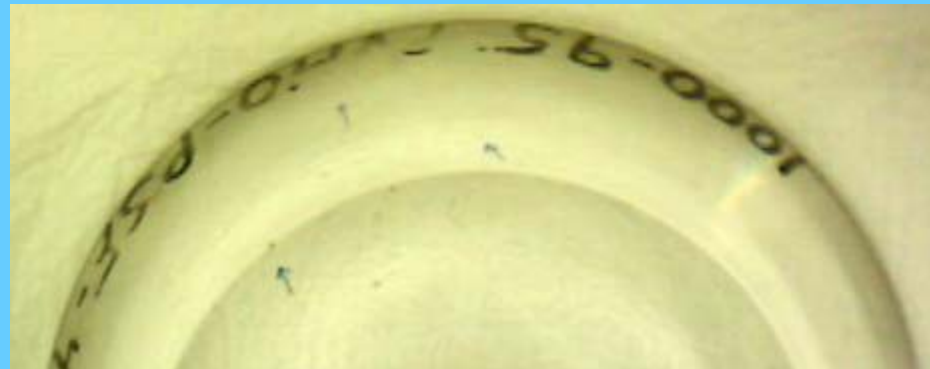
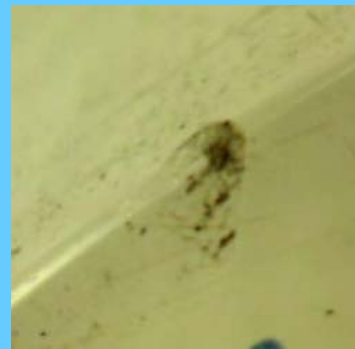
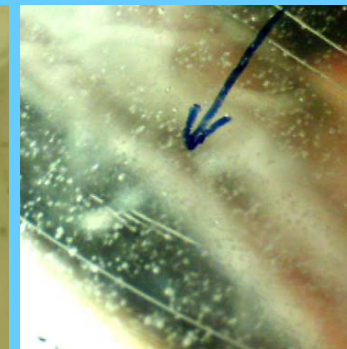
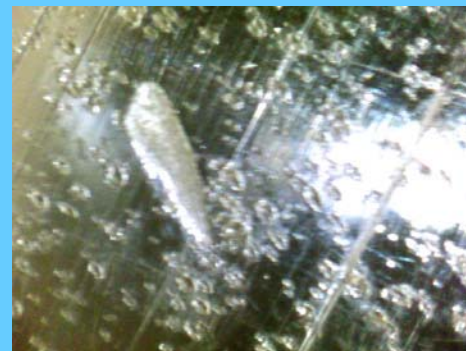
Discoloration, Scratches, and Heavy Pitting

- Pitting may be caused from transfer of mating surface roughness to window under load

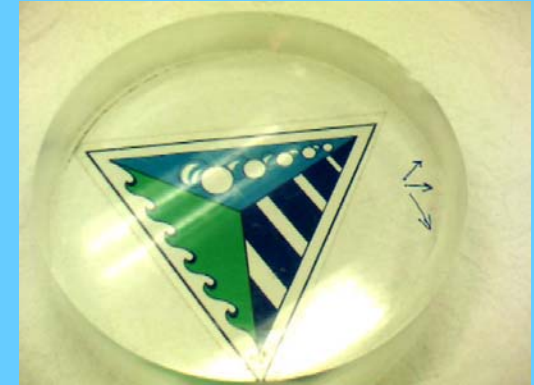
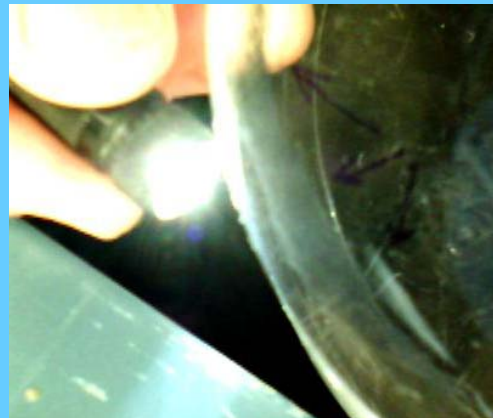
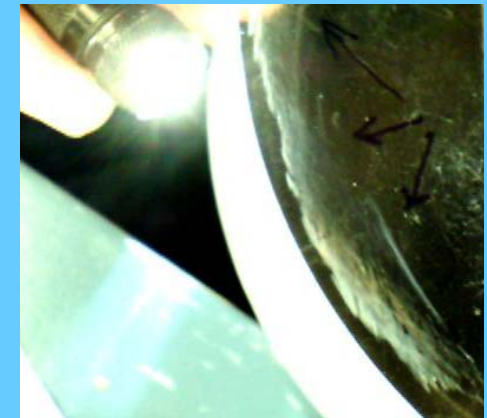
- Crazing is micro cracking that can occur on the window's surface or sub-surface

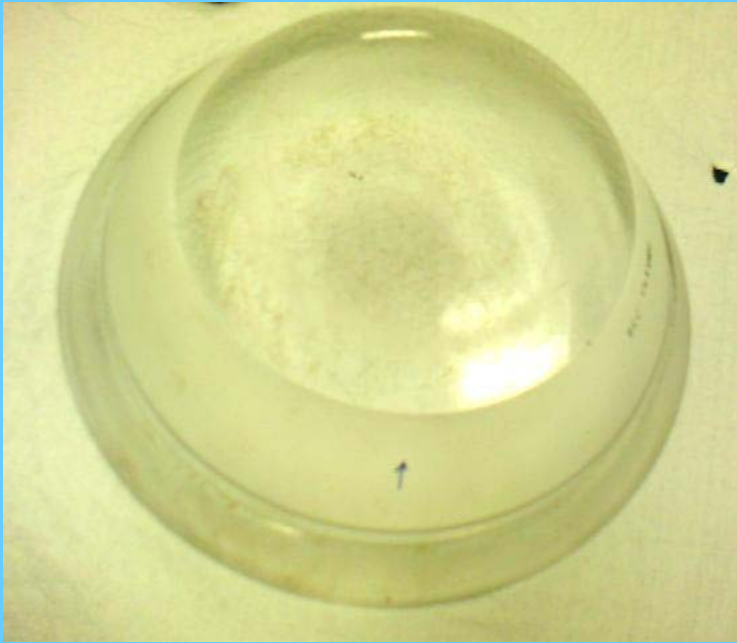
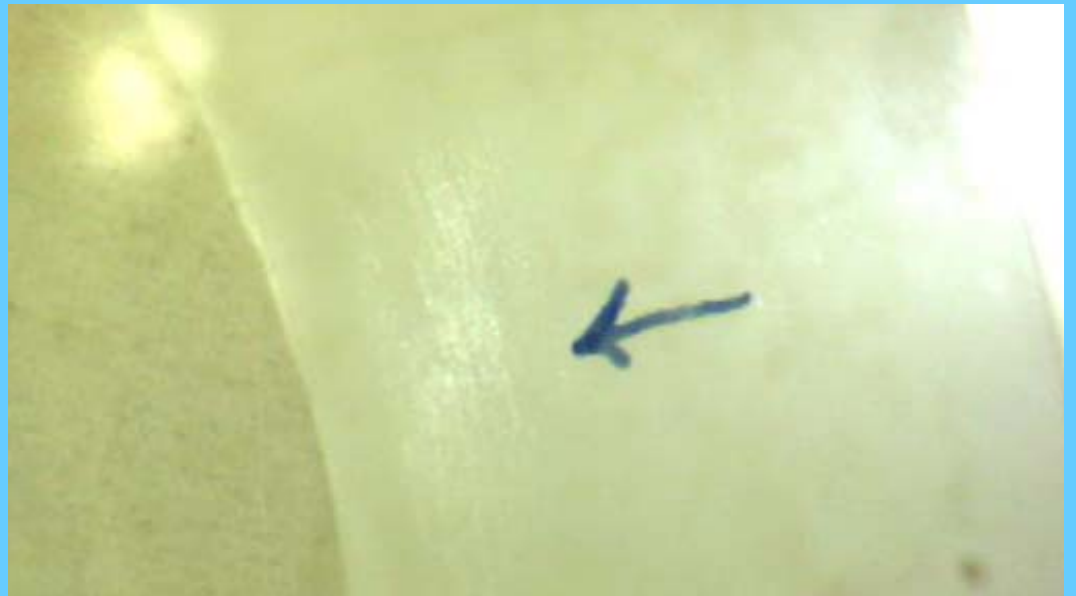
Crazing

- Unbalanced stresses, either applied or residual tensile stress
- Temp differential across the thickness of the acrylic window
- Weathering
- Sorption (uptake) and desorption of moisture generating surface stress
- Contact with organic solvents (unapproved cleaners and chemicals)

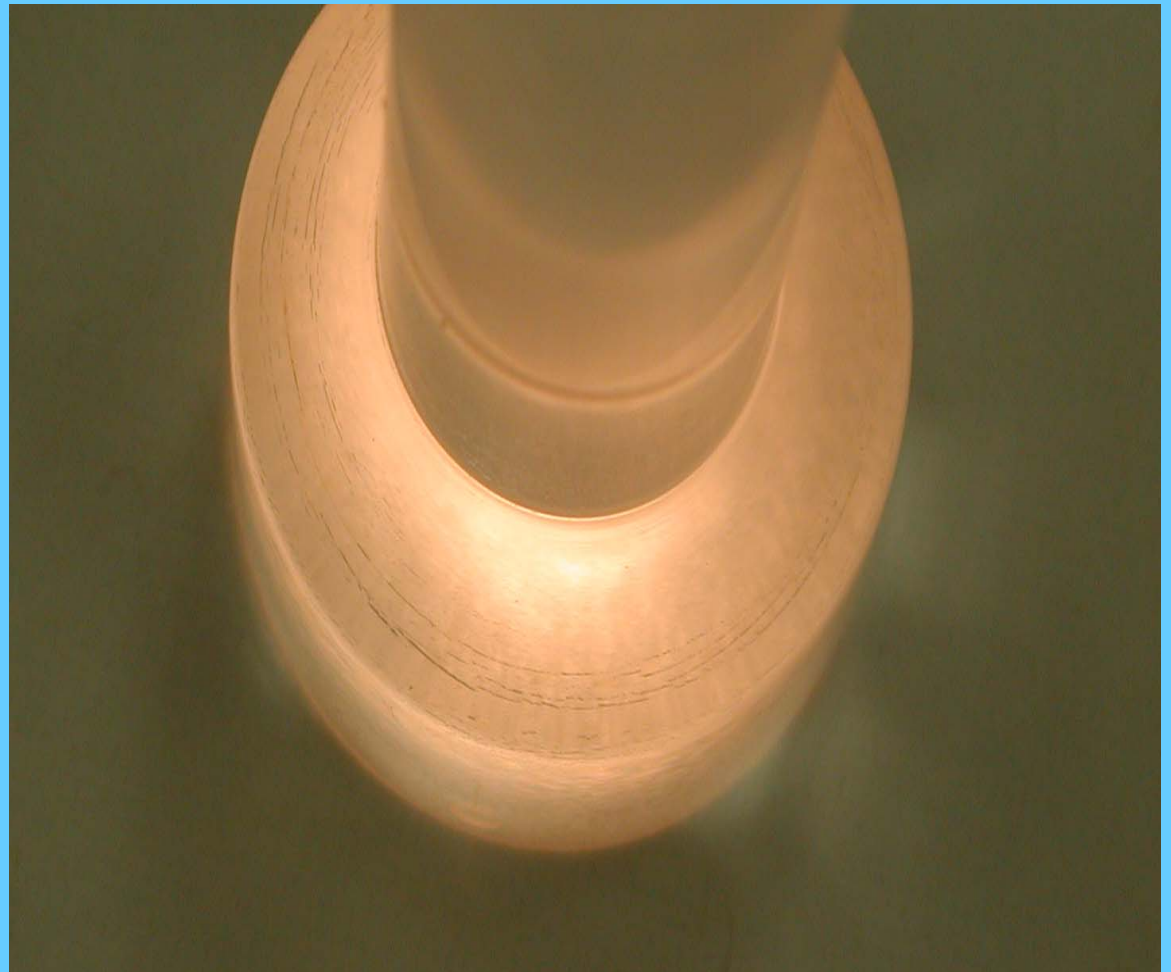
Crazing on Light Pipe

- Circular crazing caused at O-ring contact point.
- Probable cause localized stress with chemical reaction

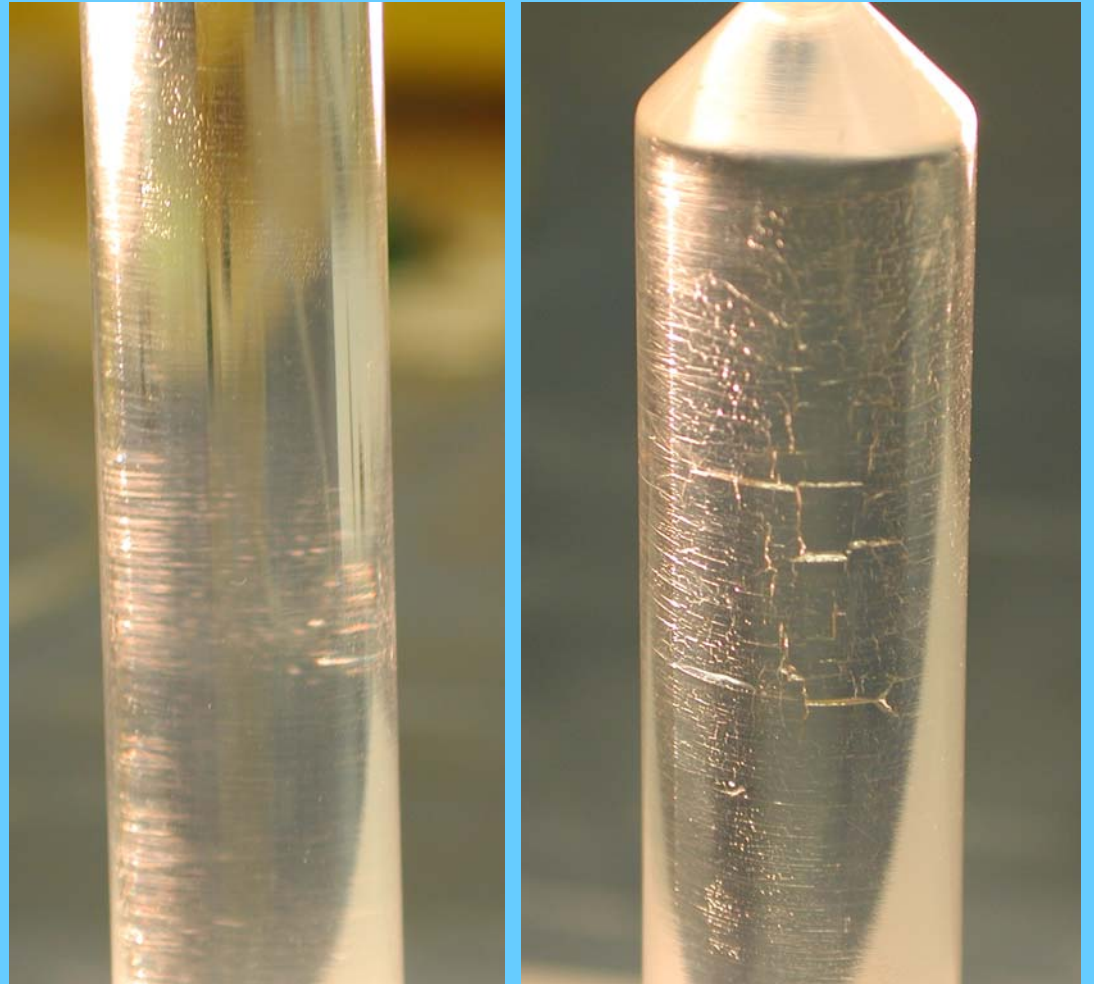
Crazing on Light Pipe Shaft

- Probable cause
chemical reaction
(cleaners)

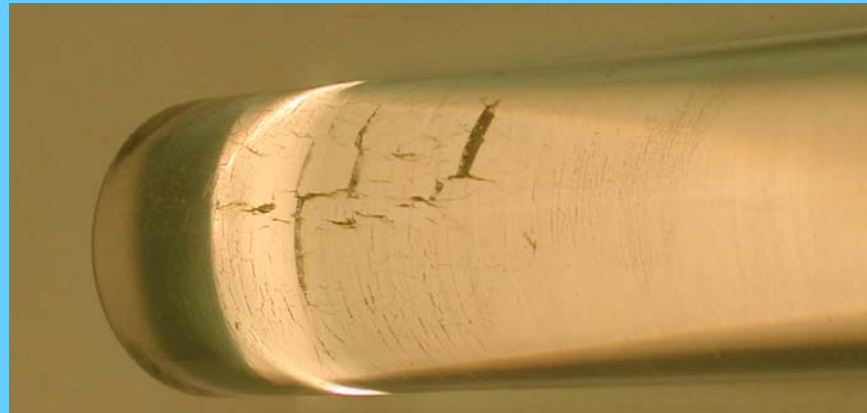
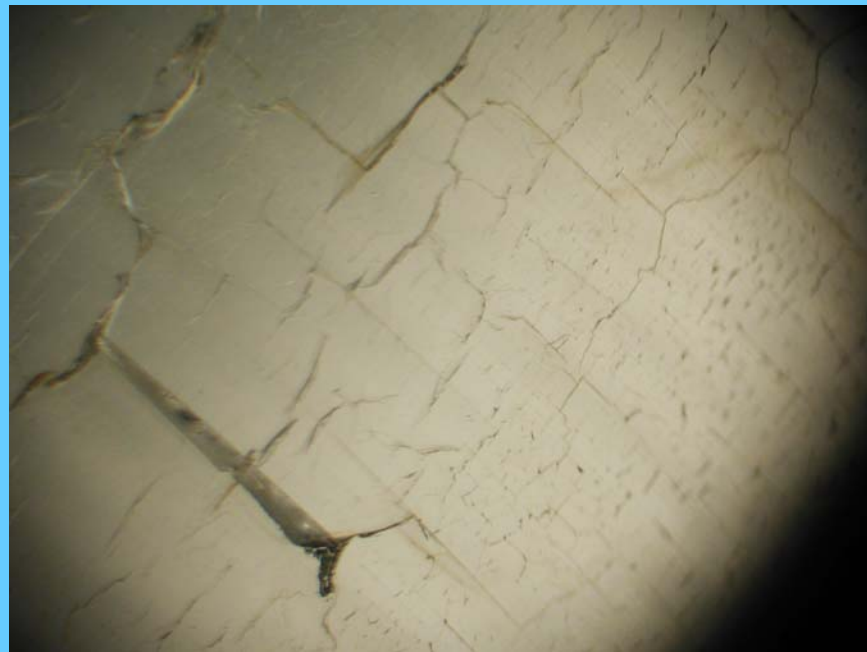
Crazing on Light Pipe

- Some crazing can be fairly deep

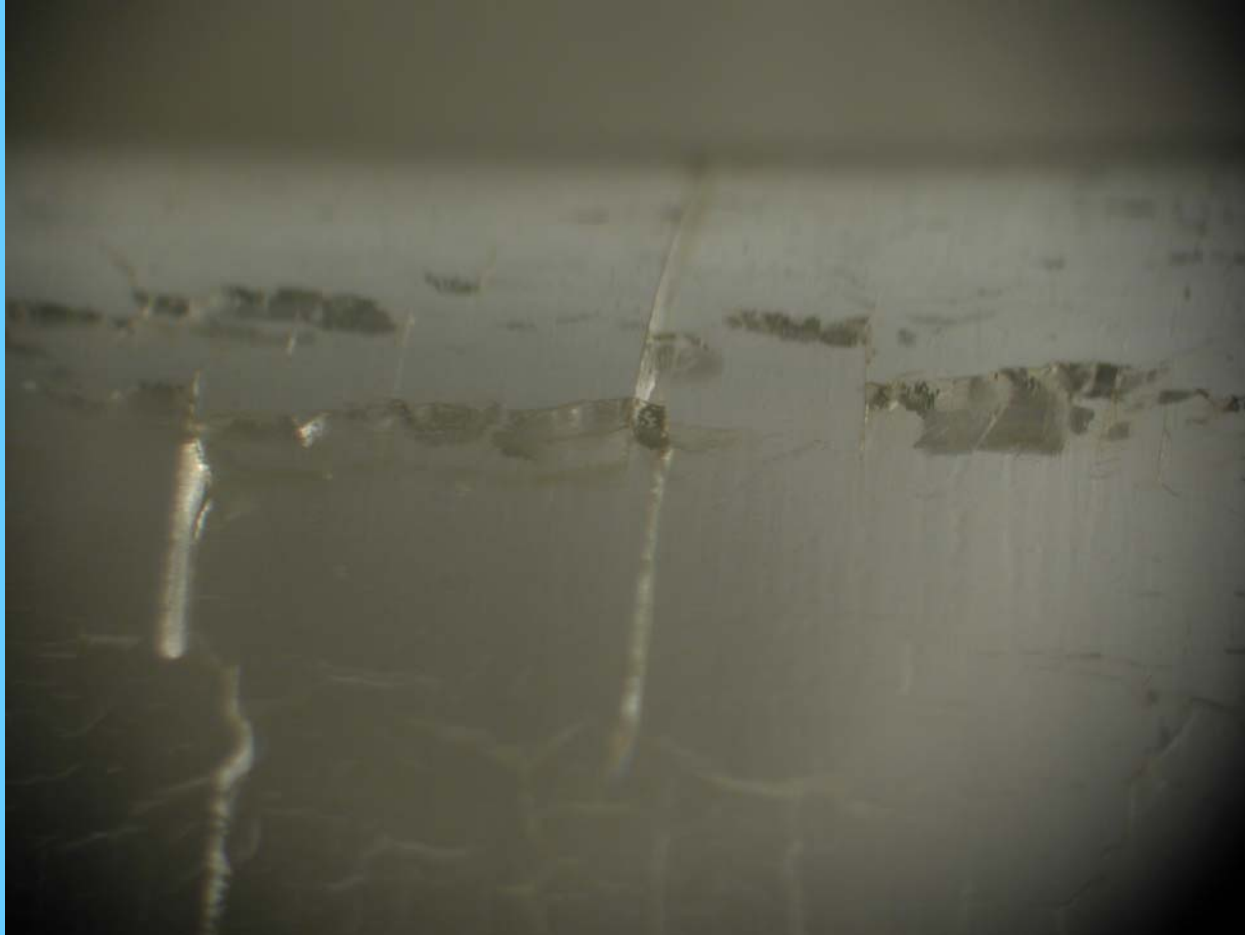
Close-up of Deep Craze

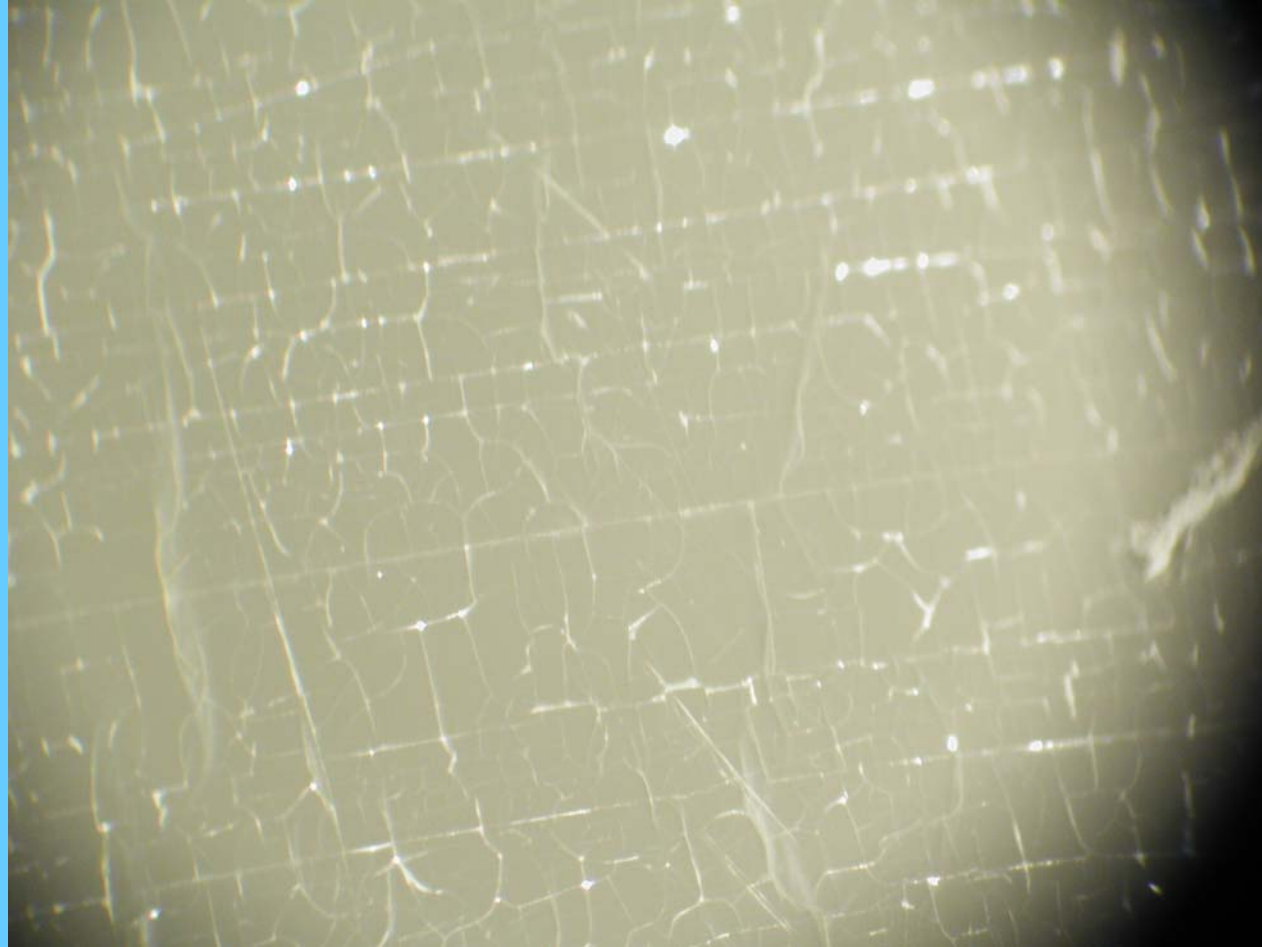
Surface Crazeing
