Vieques Restoration Advisory Board Meeting Vieques Environmental Restoration Program Update

Expanded Site Inspection (ESI)

UXO 15

**Former Vieques Naval Training Range
Vieques, Puerto Rico**

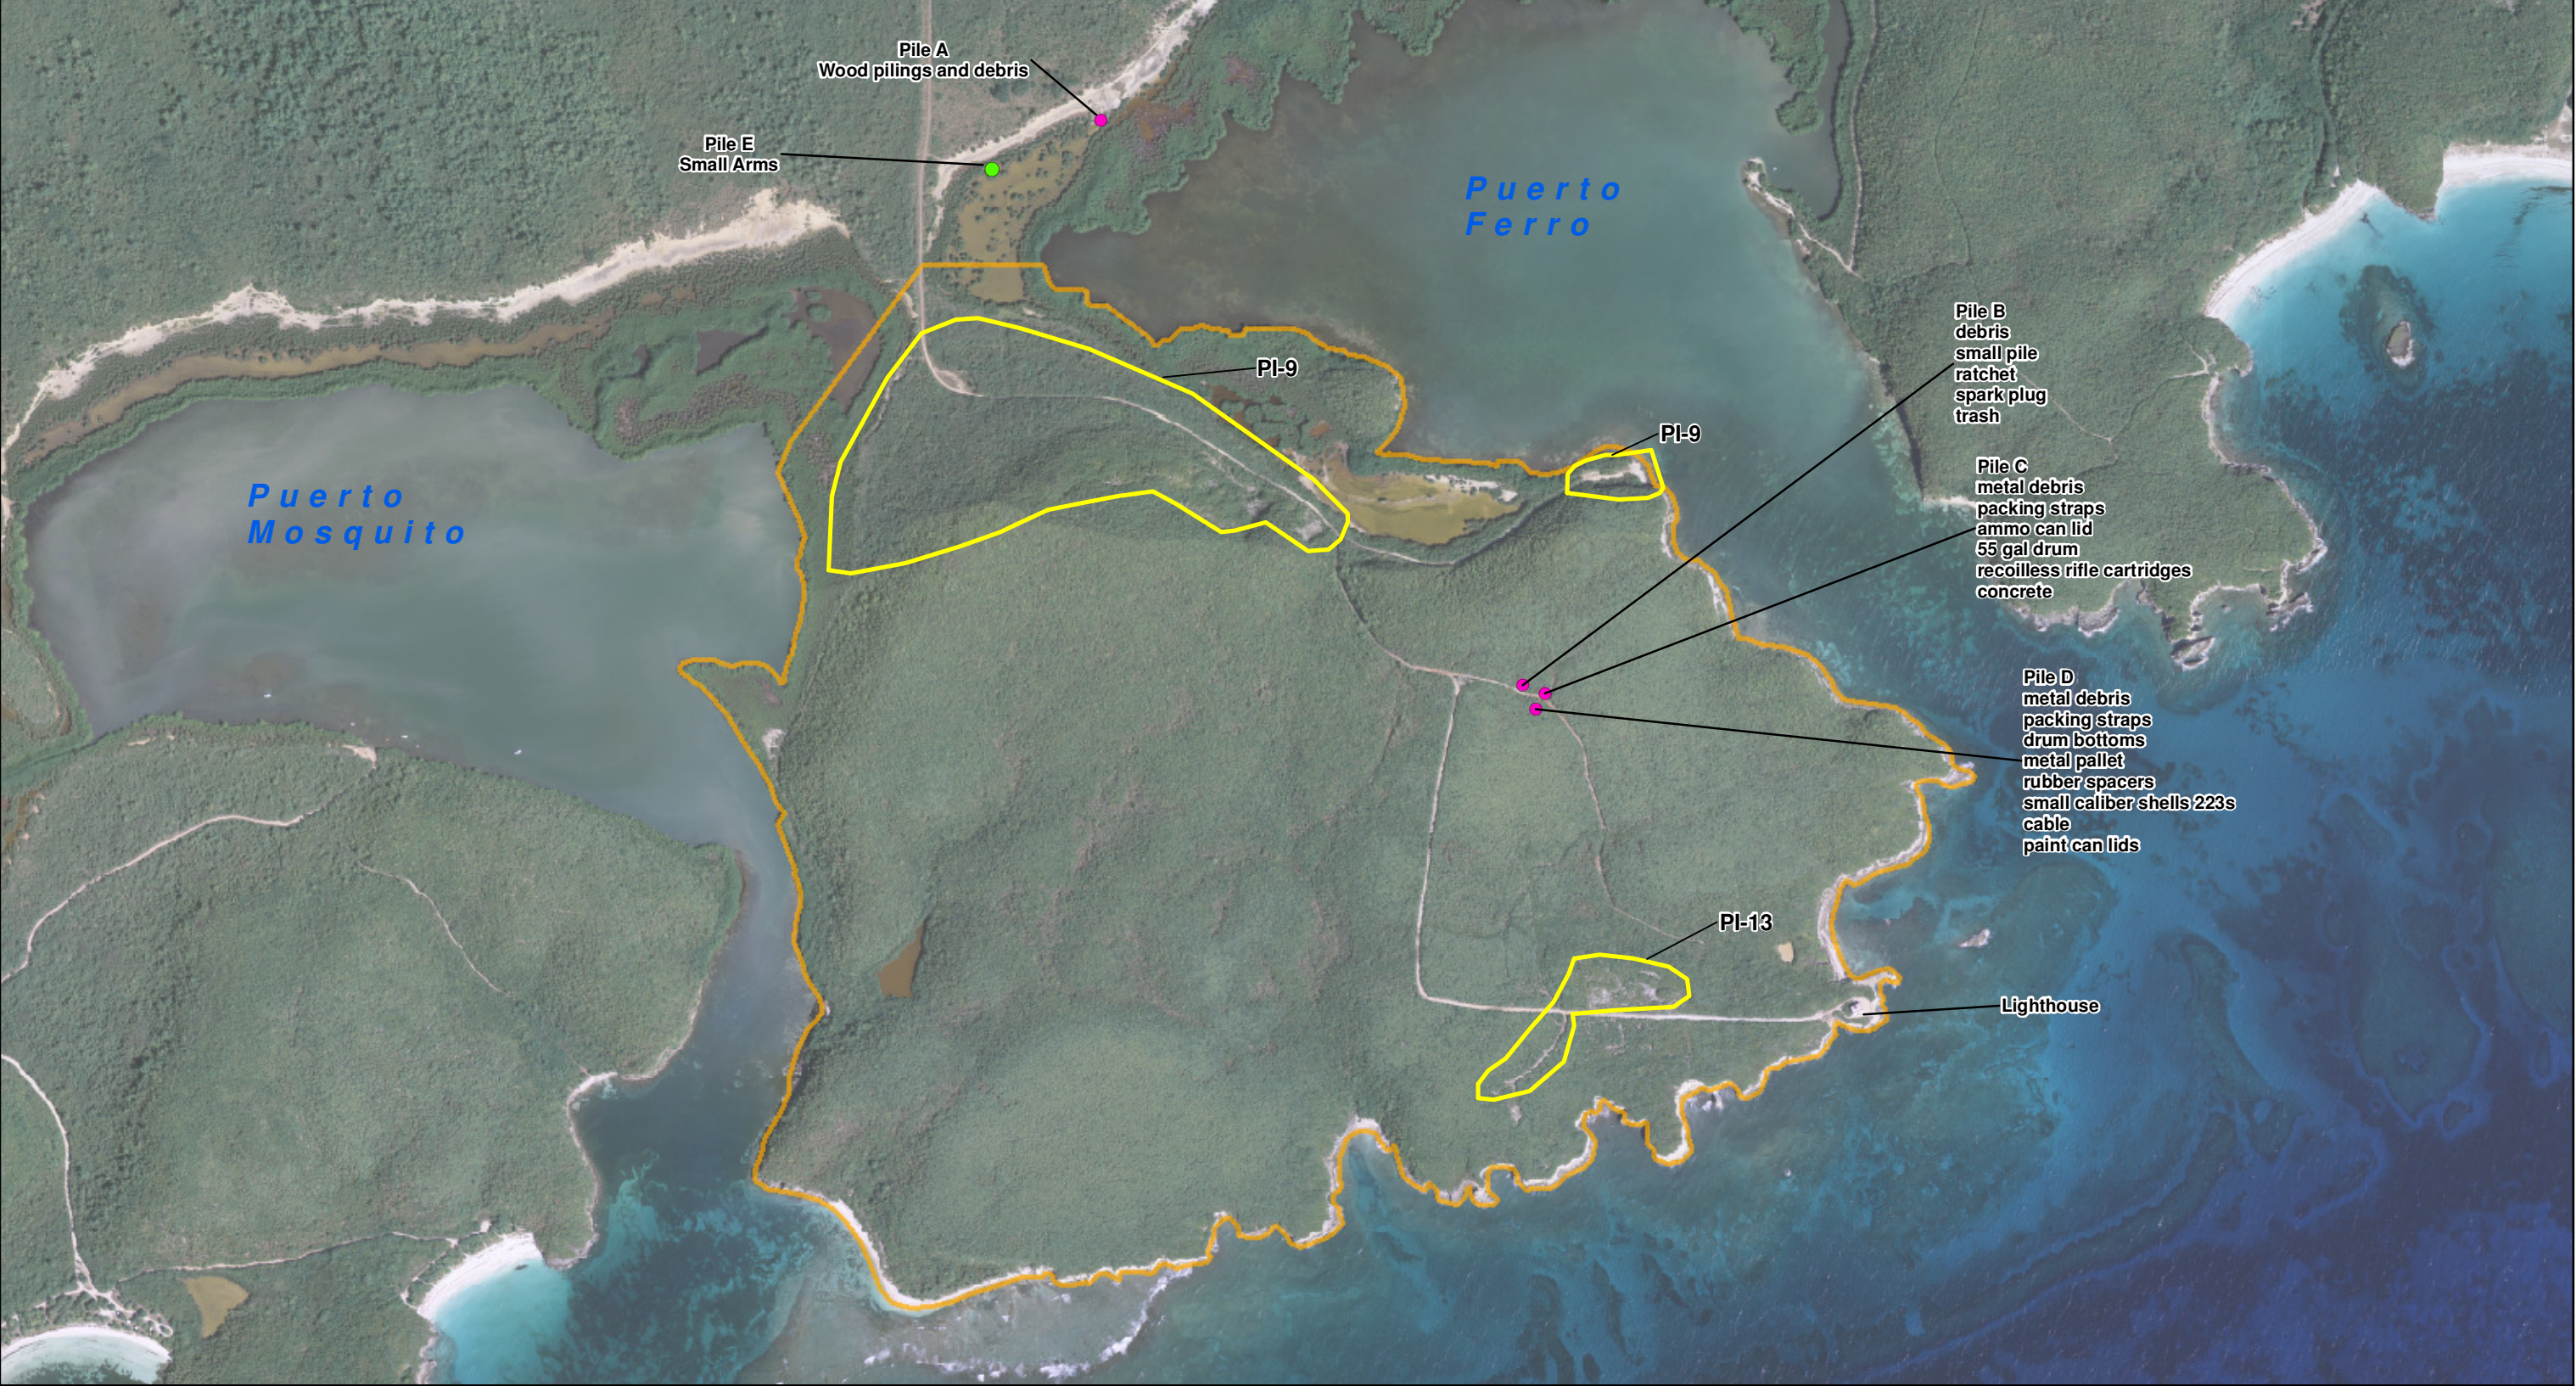
Figure 4
Debris Piles
UXO 15 - Expanded Site Inspection Sampling and Analysis Plan
Vieques, Puerto Rico

- **No unexploded ordnance found on UXO 15**
 - 5 debris piles consisting mainly of metallic debris, munitions debris, wood, concrete, miscellaneous trash
 - Several other isolated areas of non-munitions-related scrap metal and munitions debris
 - Several munitions debris (empty casings) just offshore that have been incorporated into the reef
 - One small arms item (50-caliber projectile)
- **Aerial magnetometer survey identified two magnetic anomaly areas within PI 9 and PI 13**
- **Site visits have found no evidence of a firing point at PI 13**

- **Remove the debris piles and isolated munitions debris (potential sources of contamination)**
- **Collect soil samples beneath the debris piles to determine if contaminant releases have occurred**
- **Perform digital geophysical mapping (DGM) in the magnetic anomaly areas to determine if there are subsurface objects present**
- **Excavate subsurface objects to determine if there are munitions or explosives of concern (MEC) present**
- **Remove any man-made objects and collect additional soil samples if MEC is identified**

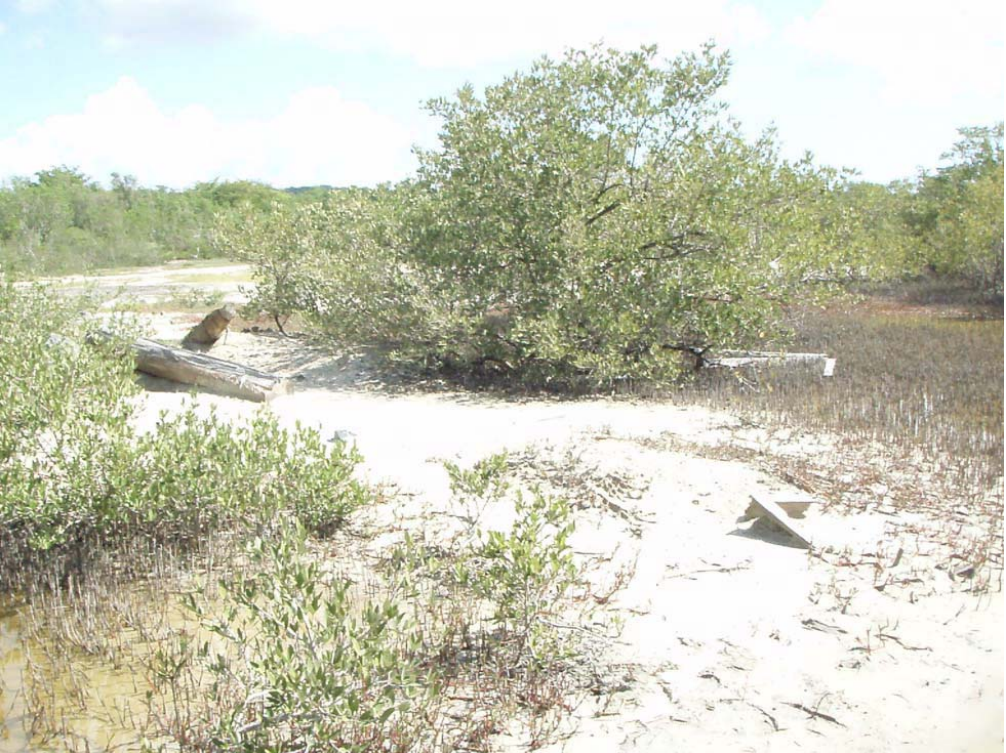
Figure 6 "Pile A" Wood pilings and debris

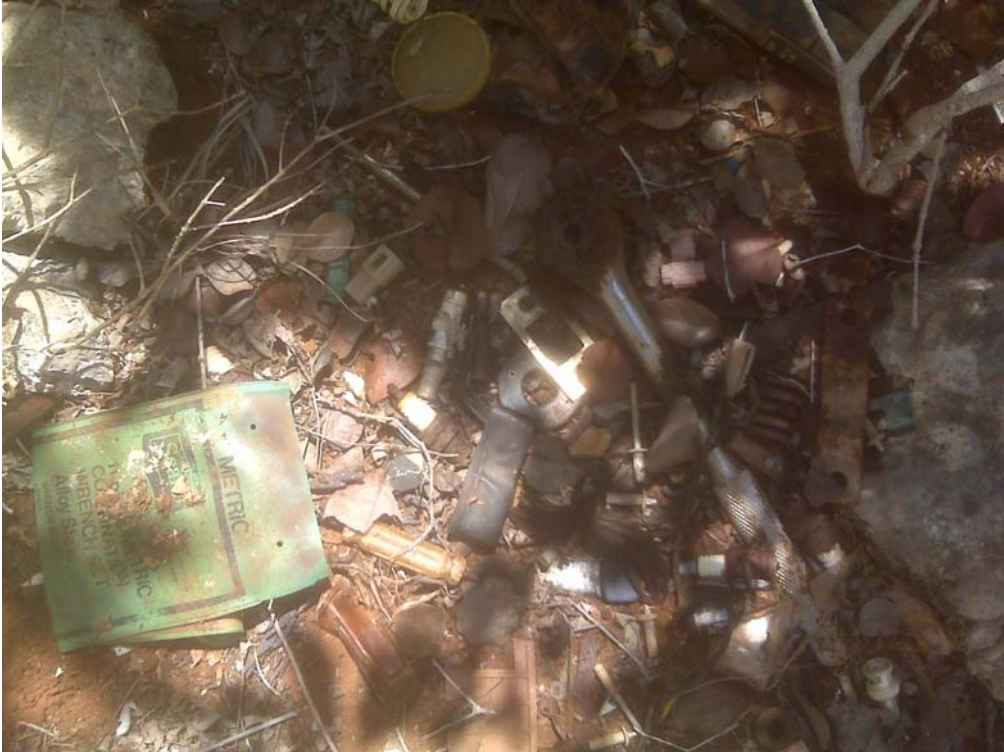
Figure 7 "Pile B" Trash

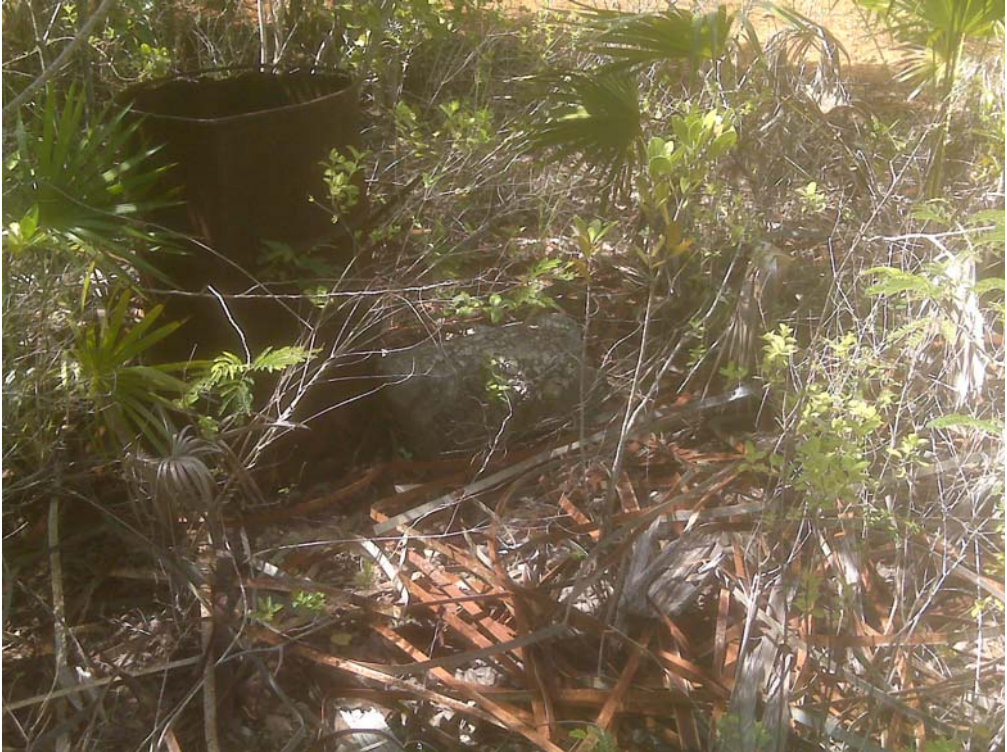
Figure 8 "Pile C" Empty 55 gallon drum and metal straps

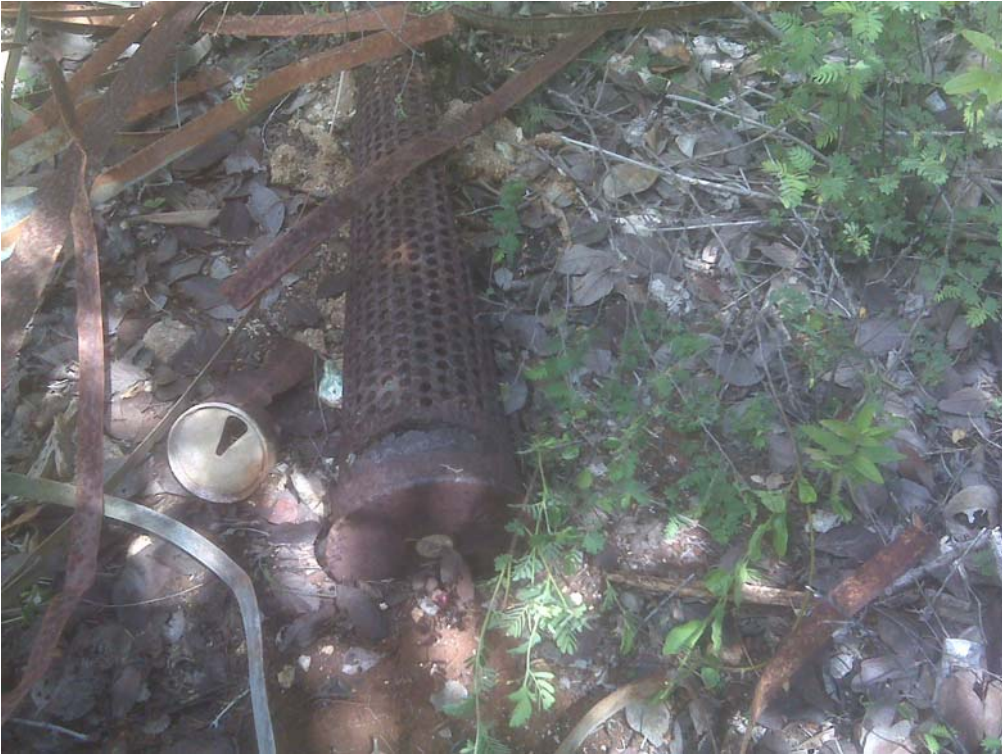
Figure 9 "Pile C" Recoilless rifle cartridge and metal straps

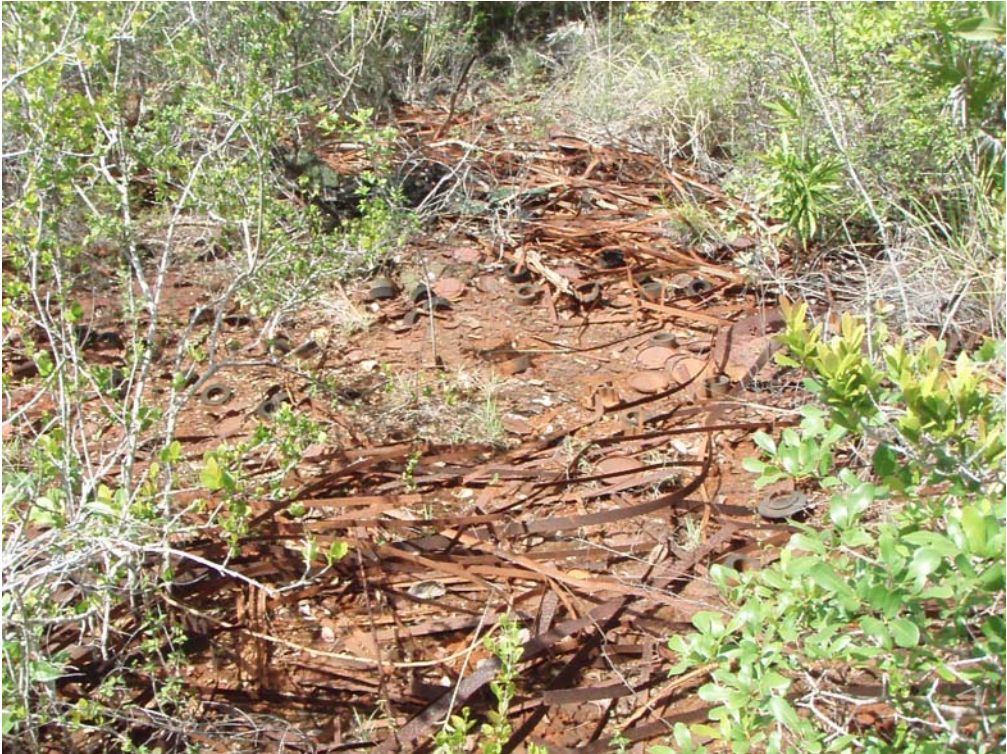
Figure 10 "Pile D" Metal straps

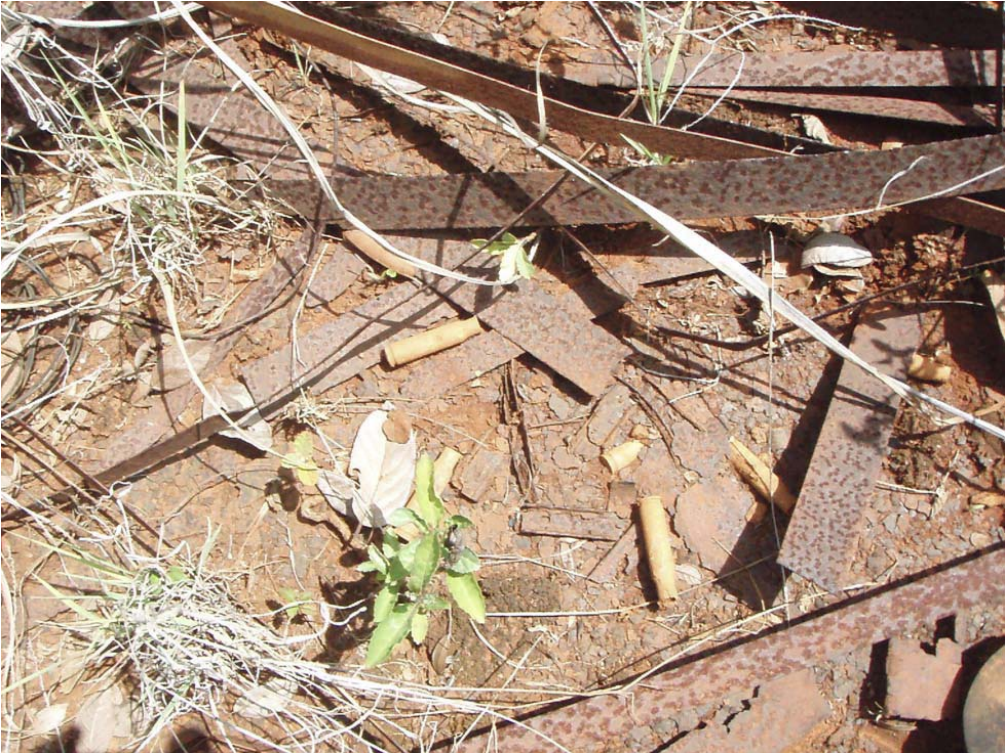
Figure 11 "Pile D" Small caliber empty shells with metal straps
