# Memorandum

To: Brian Murray, NAVFAC MIDLANT  
From: David Brayack, Tetra Tech  
Date: January 28, 2021  
Re: Annual LUC Inspection and Operation Summary Report: Sites 1, 2, 3, and 4 – NWIRP Bethpage  
Revision 1  
Contract/CTO Number: N6247016D9008/WE13

## 1.0 Introduction

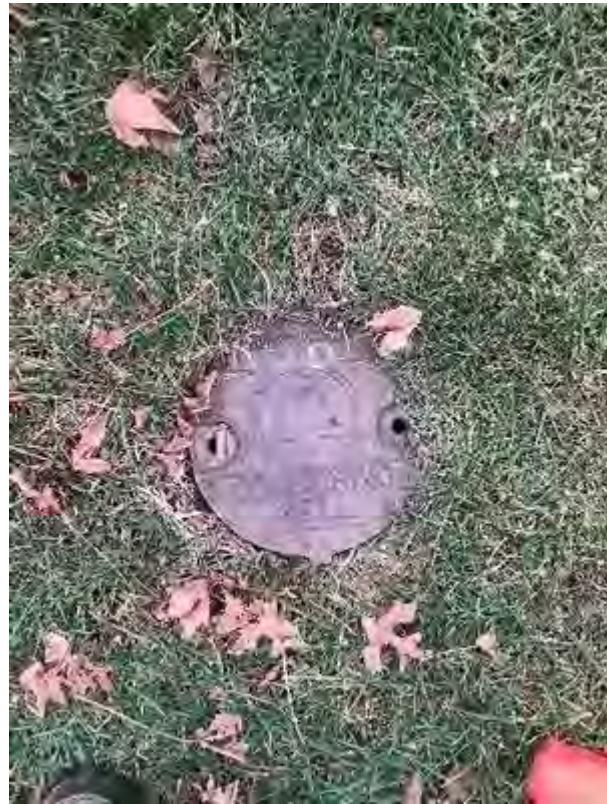
| <b>Notes (Explain if answered No to any of the above)</b><br>Missing two bolts | |

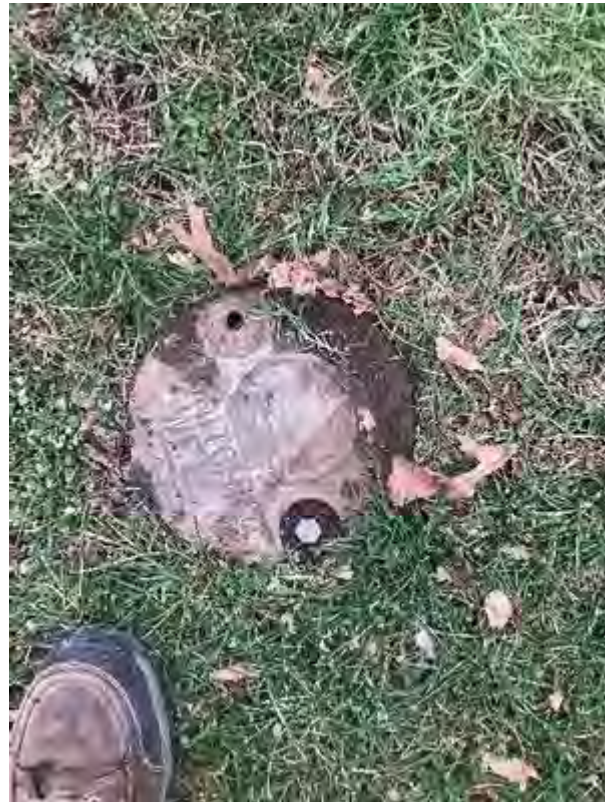
| <b>Notes (Explain if answered No to any of the above)</b><br>Missing one bolt | |

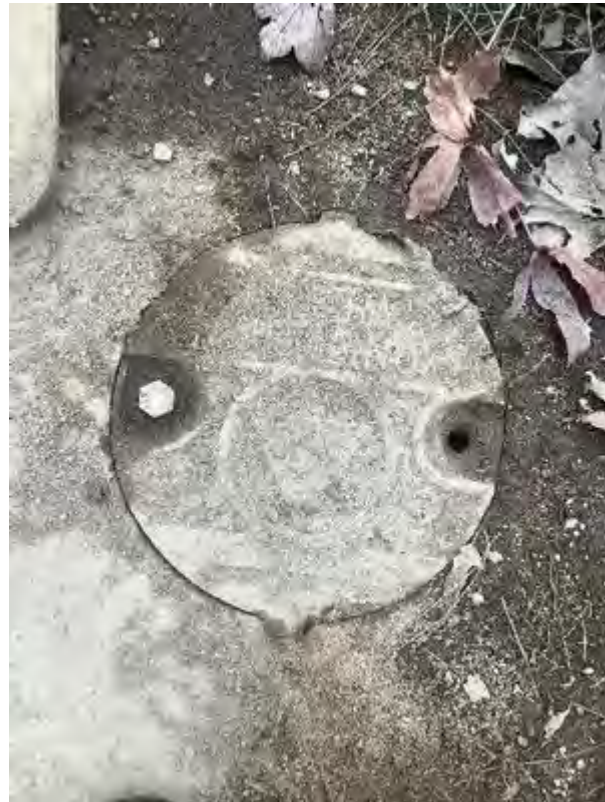
| <b>Notes (Explain if answered No to any of the above)</b><br>Missing one bolt | |

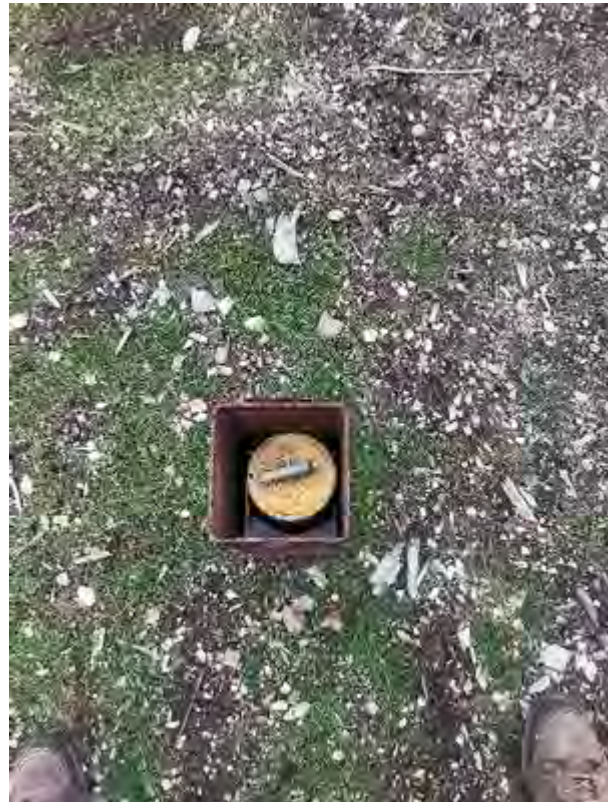
| <b>Notes (Explain if answered No to any of the above)</b><br>Stick up casing missing top | |

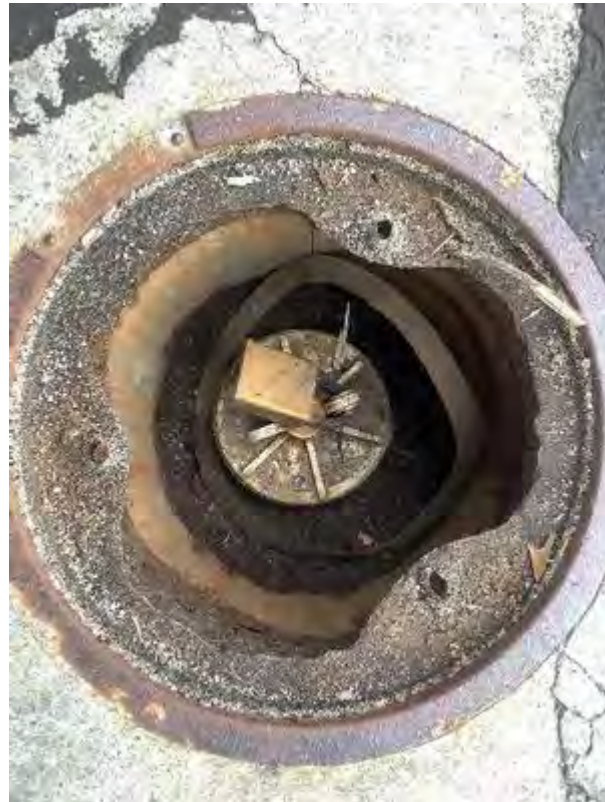
| <b>Notes (Explain if answered No to any of the above)</b><br>Missing one bolt | |

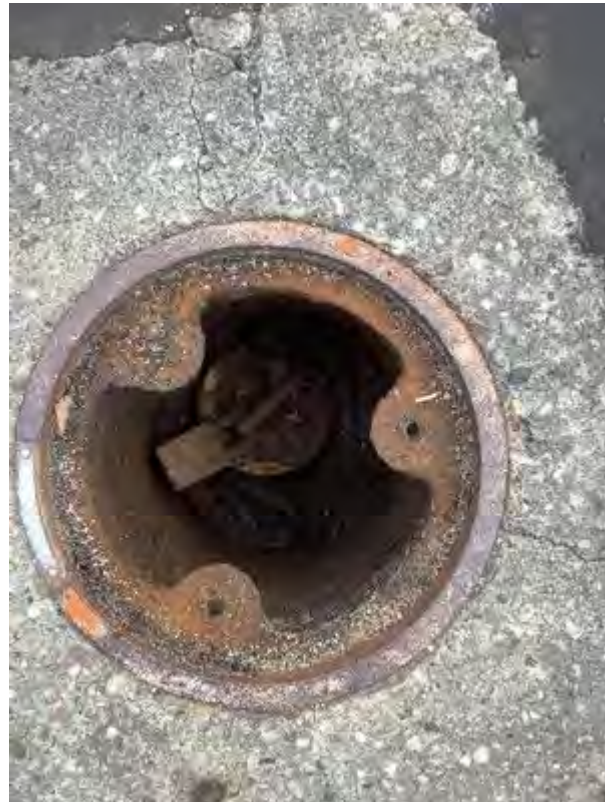
| <b>Notes (Explain if answered No to any of the above)</b><br>Missing one bolt | |

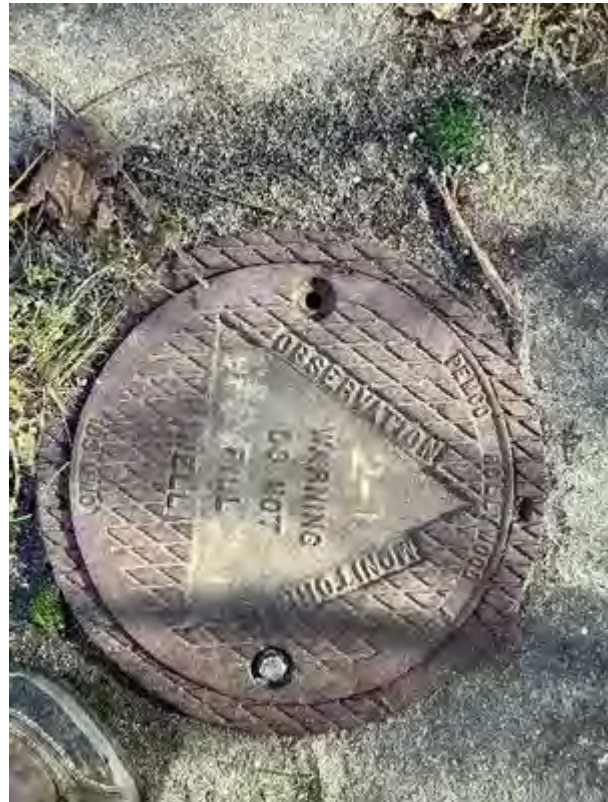
| <b>Notes (Explain if answered No to any of the above)</b><br>Missing one bolt | |

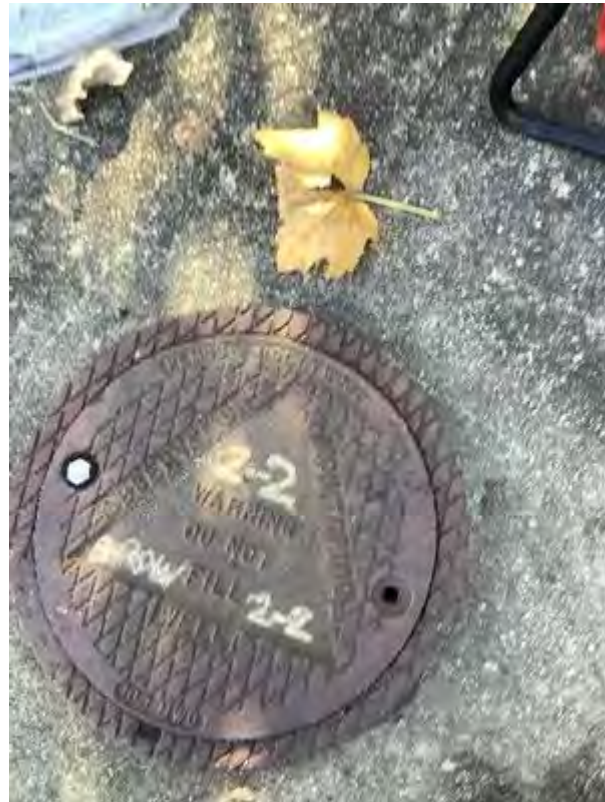
| <b>Notes (Explain if answered No to any of the above)</b><br>Missing one bolt | |

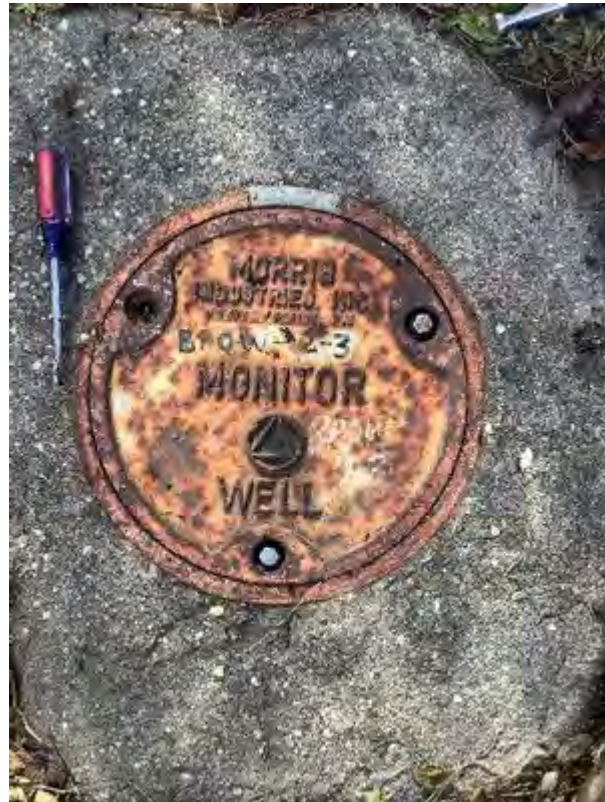
| <b>Notes (Explain if answered No to any of the above)</b><br>Missing one bolt | |

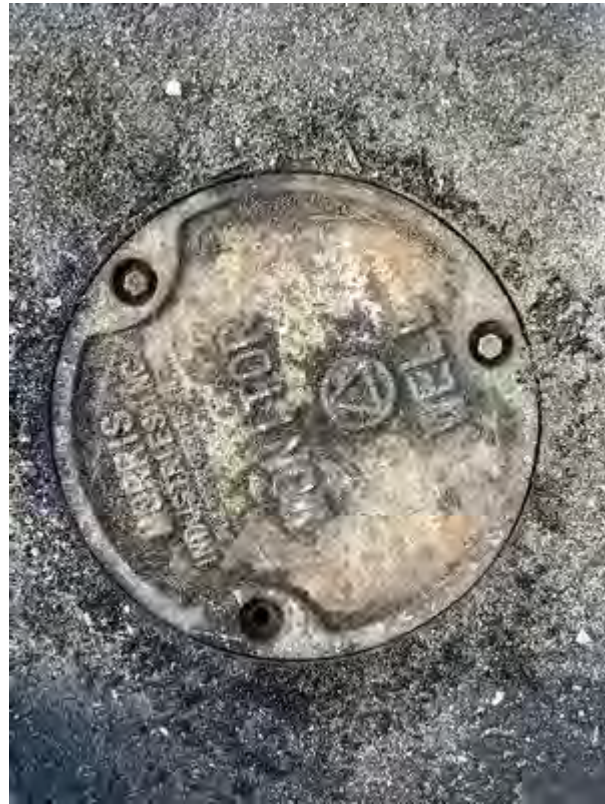
| <b>Notes (Explain if answered No to any of the above)</b><br>Missing one bolt | |

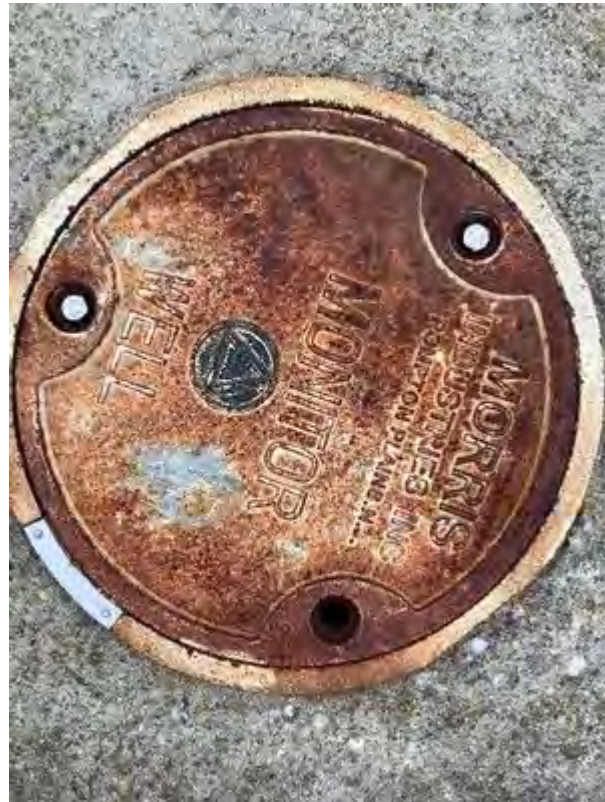
| <b>Notes (Explain if answered No to any of the above)</b><br>Missing one bolt | |

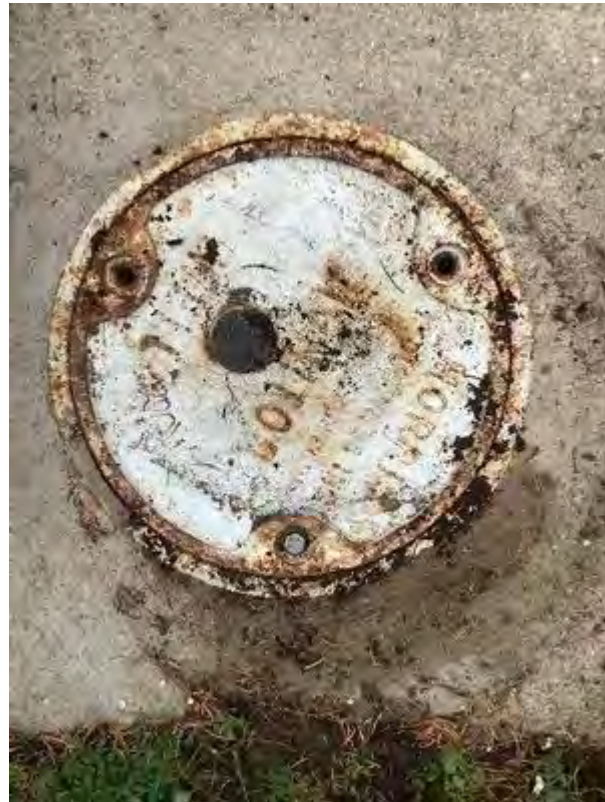
| <b>Notes (Explain if answered No to any of the above)</b><br>Missing two bolts | |

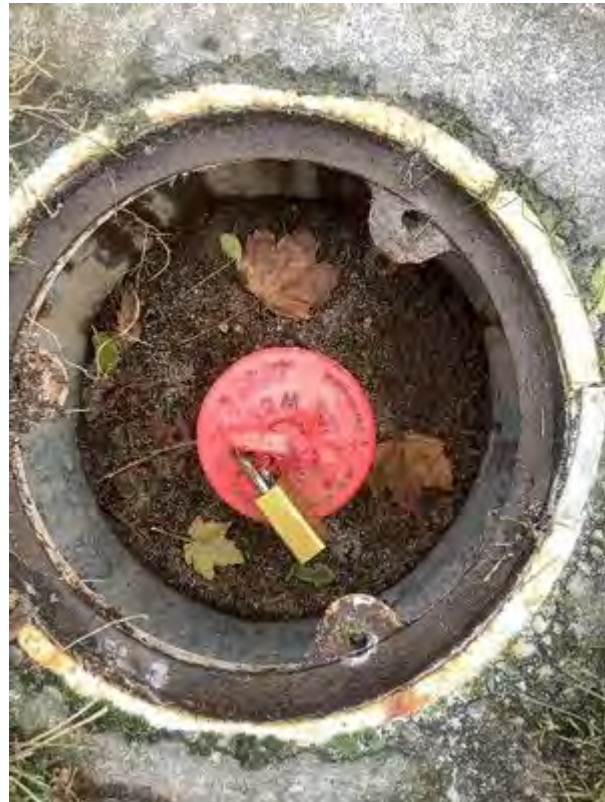
| <b>Notes (Explain if answered No to any of the above)</b><br>One bolt missing | |

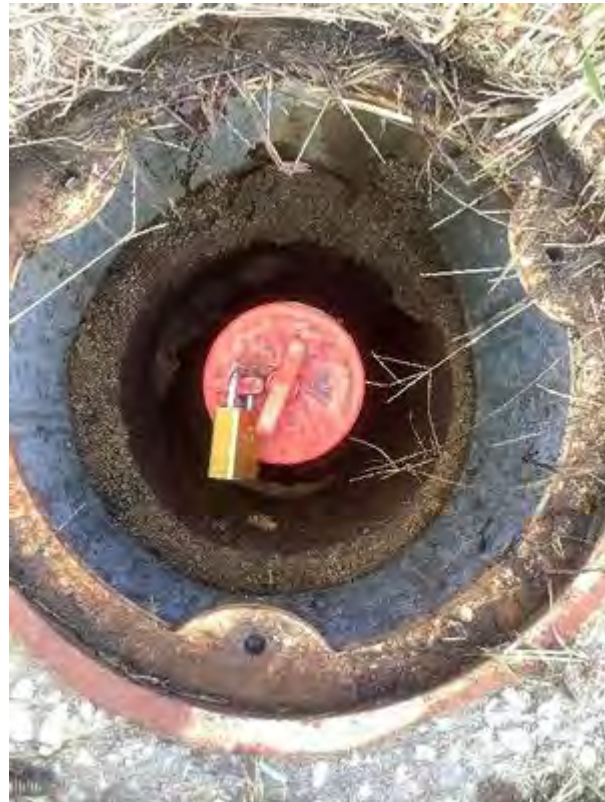
| <b>Notes (Explain if answered No to any of the above)</b><br>Missing one bolt and needs backfill | |

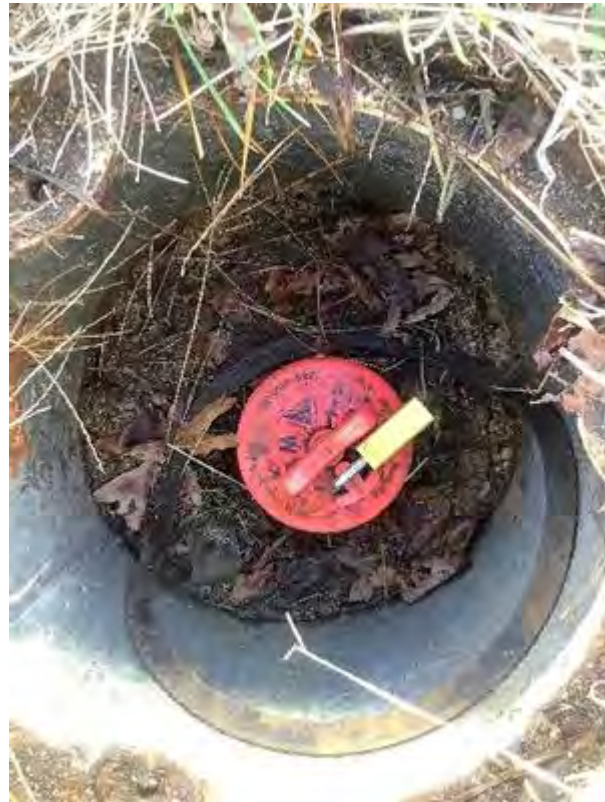
| <b>Notes (Explain if answered No to any of the above)</b><br>Missing one bolt | |

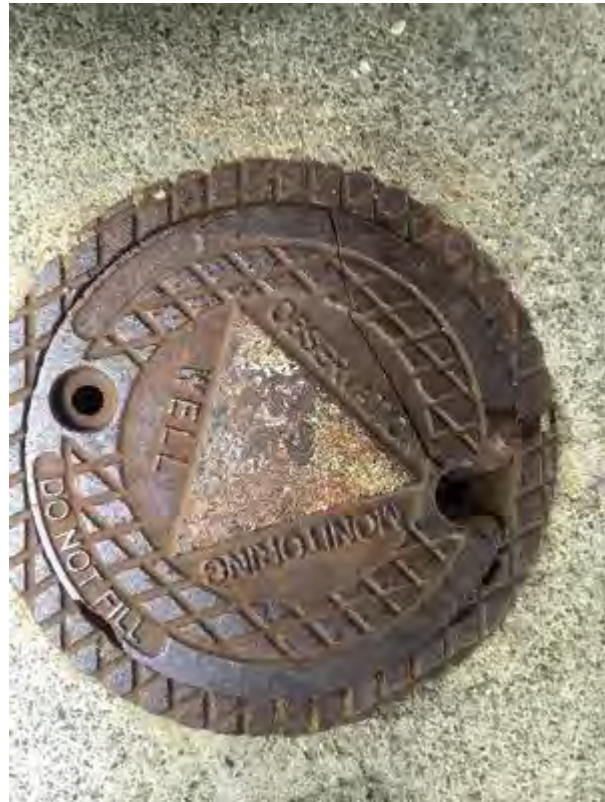
| <b>Notes (Explain if answered No to any of the above)</b><br>Missing two bolts. Manhole cover cracked. | |

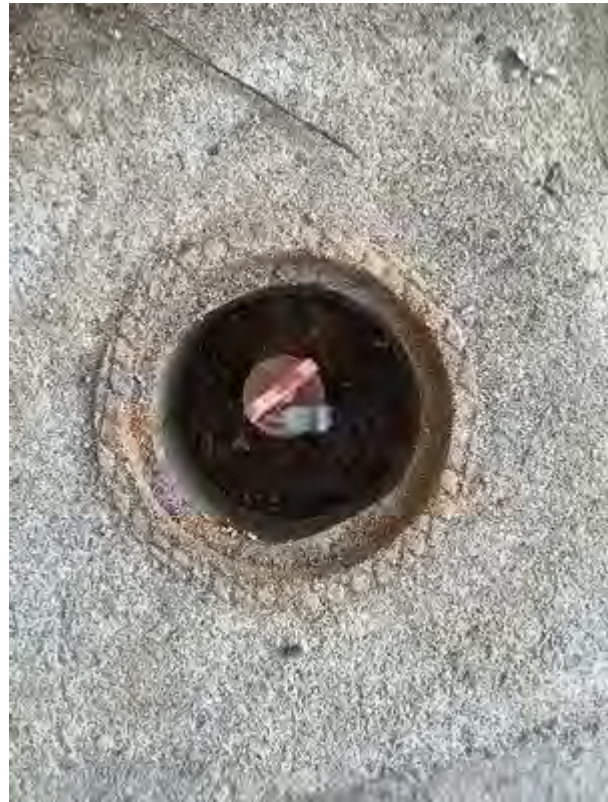
| <b>Notes (Explain if answered No to any of the above)</b><br>Missing two bolts | |

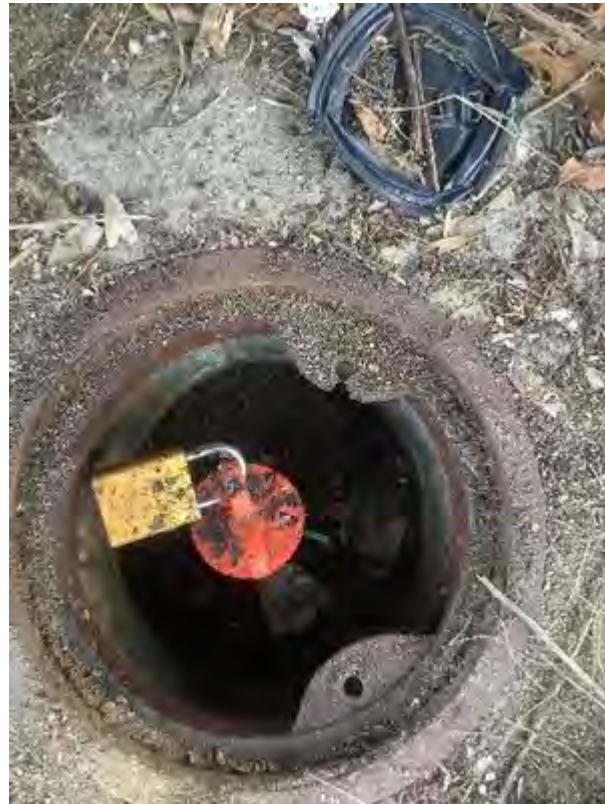
| <b>Notes (Explain if answered No to any of the above)</b><br>Missing one bolt, two bolts stripped | |

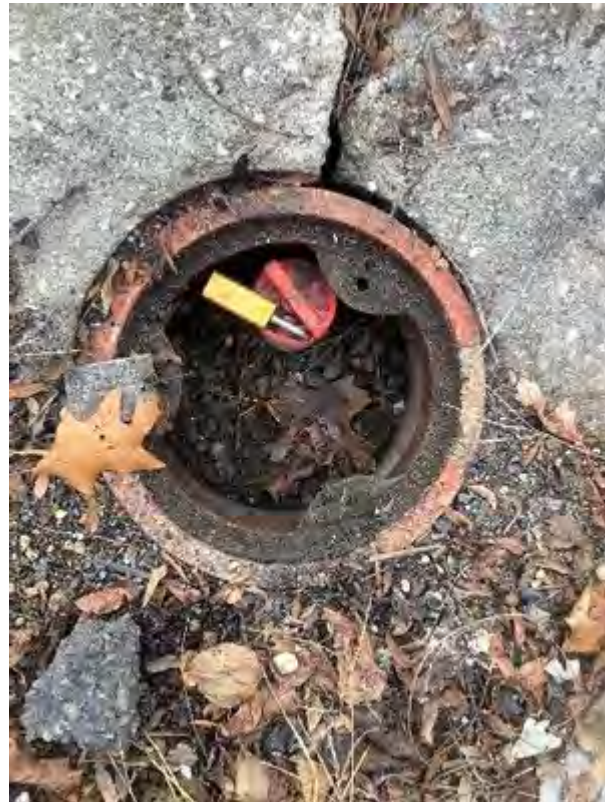
| <b>Notes (Explain if answered No to any of the above)</b><br>Well pad cracked | |

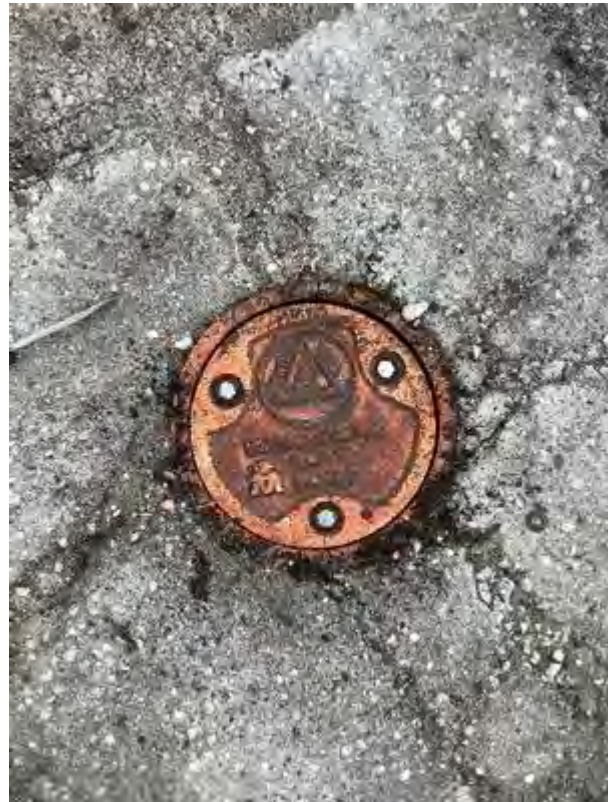
| <b>Notes (Explain if answered No to any of the above)</b><br>Missing one bolt | |

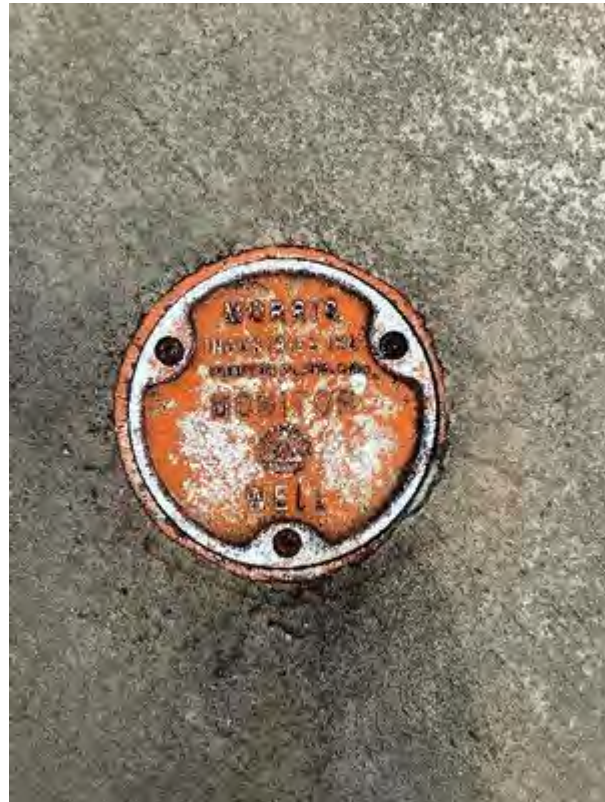
| <b>Notes (Explain if answered No to any of the above)</b><br>Missing three bolts | |

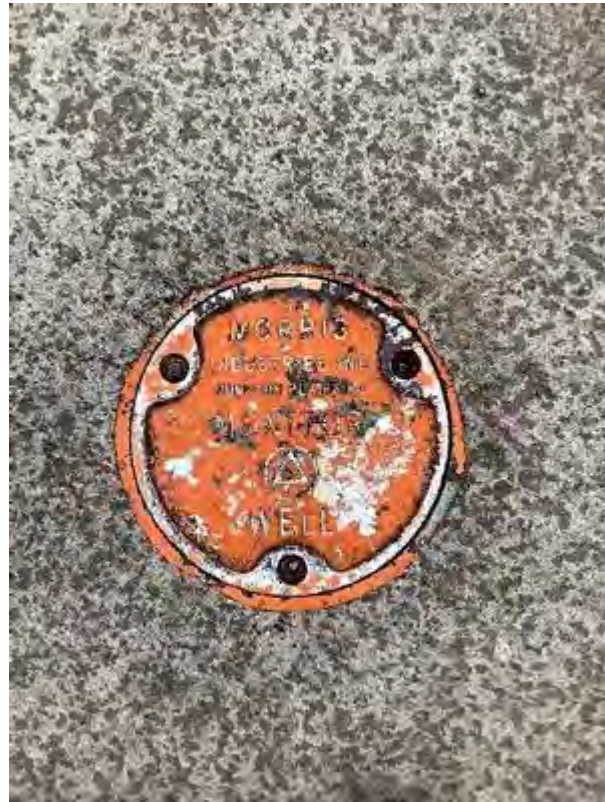
| <b>Notes (Explain if answered No to any of the above)</b><br>Missing two bolts | |

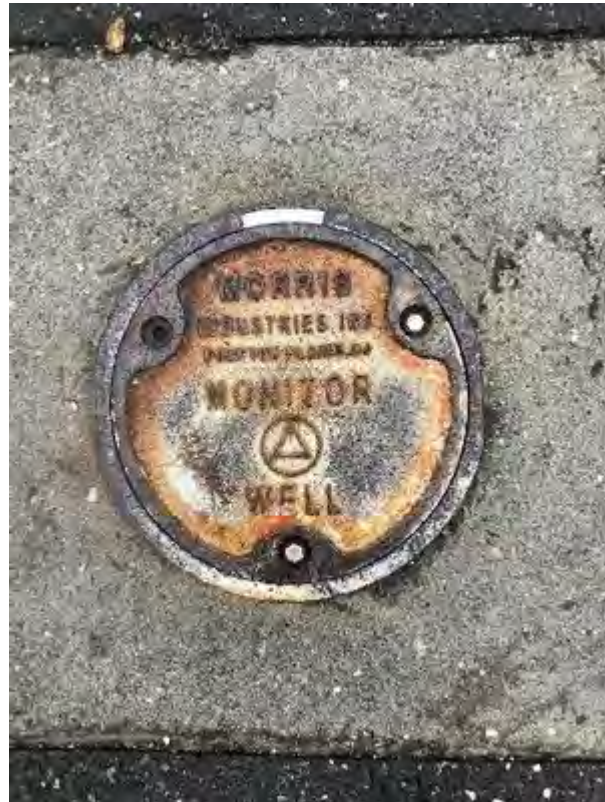
| <b>Notes (Explain if answered No to any of the above)</b><br>Missing one bolt | |

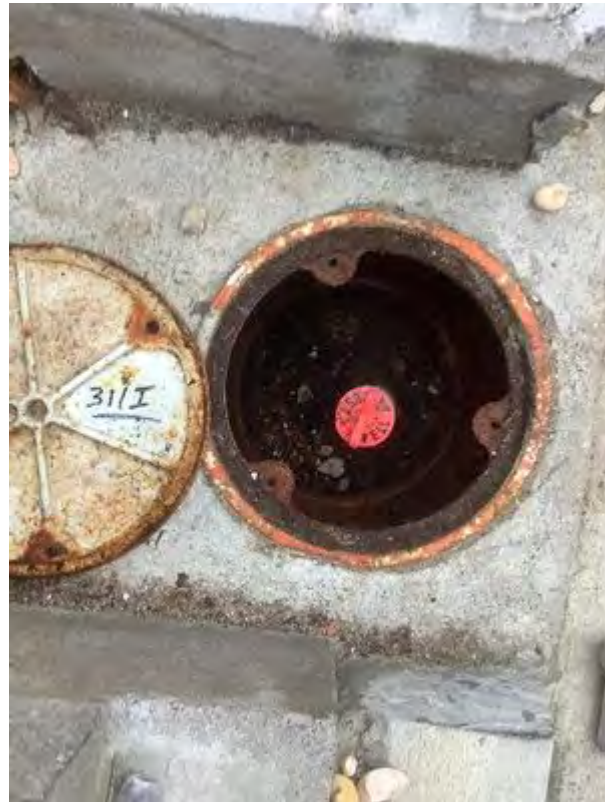
| <b>Notes (Explain if answered No to any of the above)</b><br>Missing one bolt | |

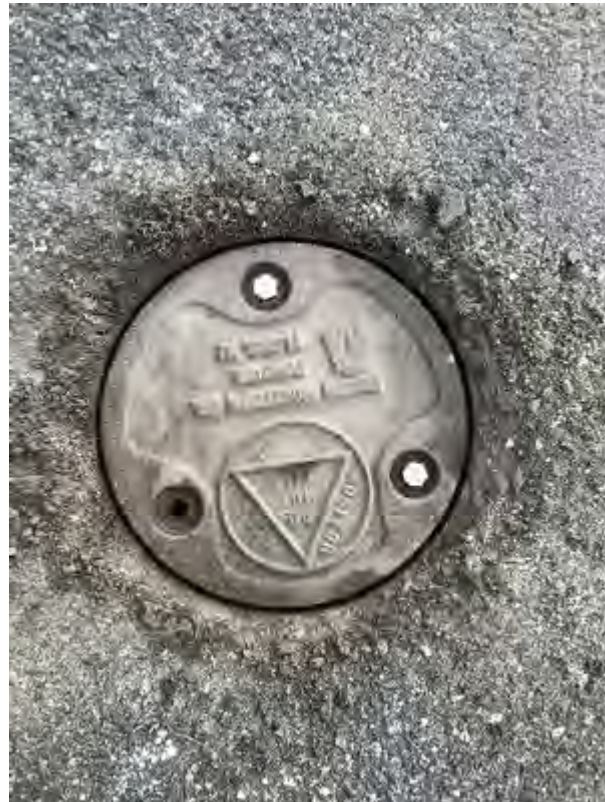
| <b>Notes (Explain if answered No to any of the above)</b><br>Missing one bolt | |

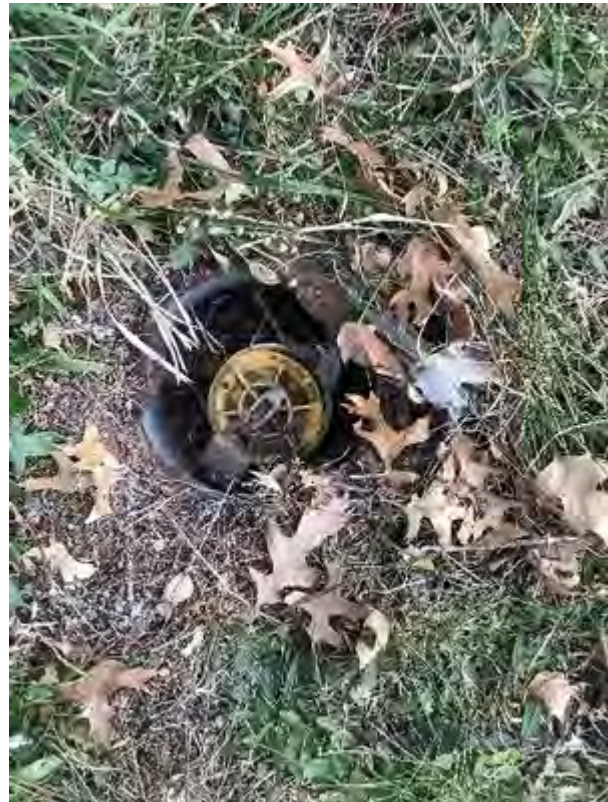
| <b>Notes (Explain if answered No to any of the above)</b><br>Missing two bolts | |

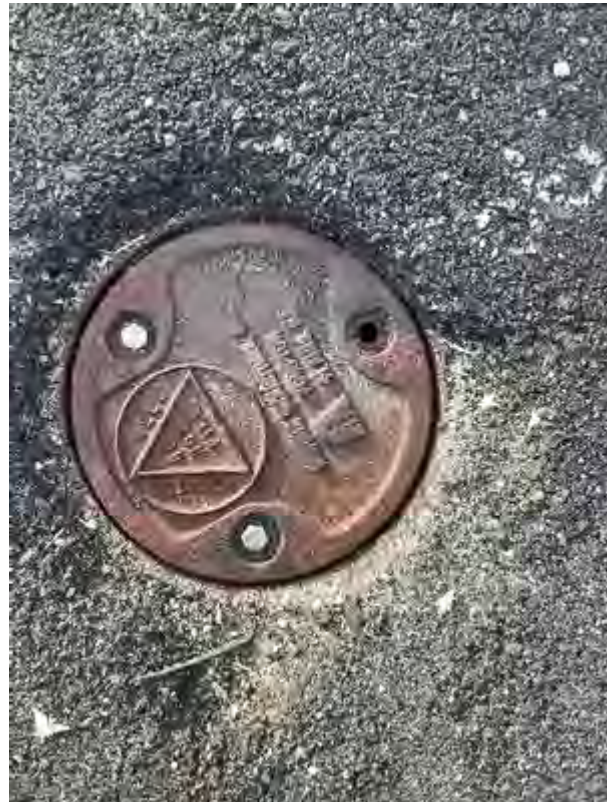
| <b>Notes (Explain if answered No to any of the above)</b><br>Missing one bolt | |

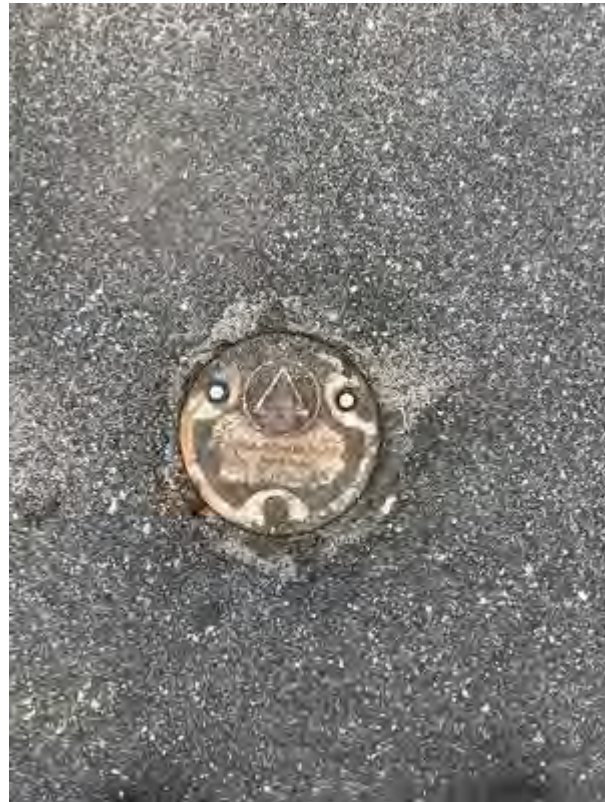
| <b>Notes (Explain if answered No to any of the above)</b><br>Missing two bolts | |

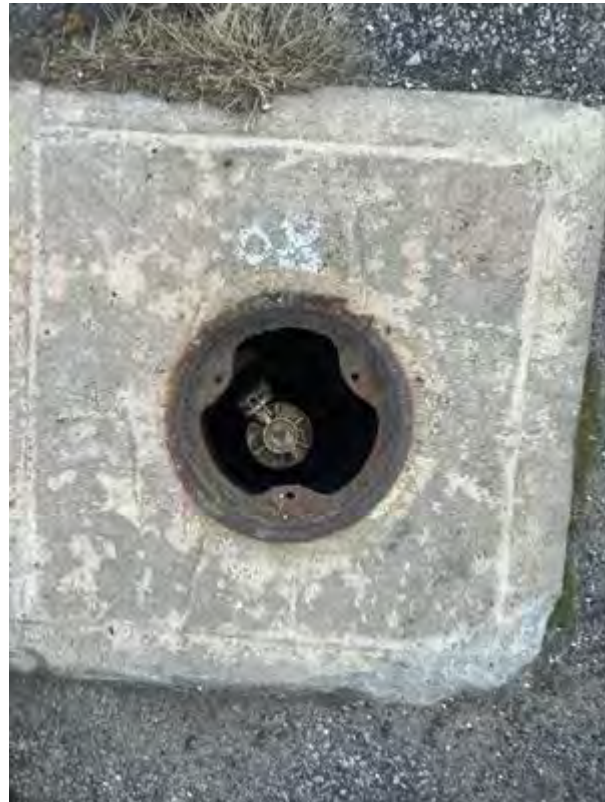
| <b>Notes (Explain if answered No to any of the above)</b><br>Missing three bolts | |

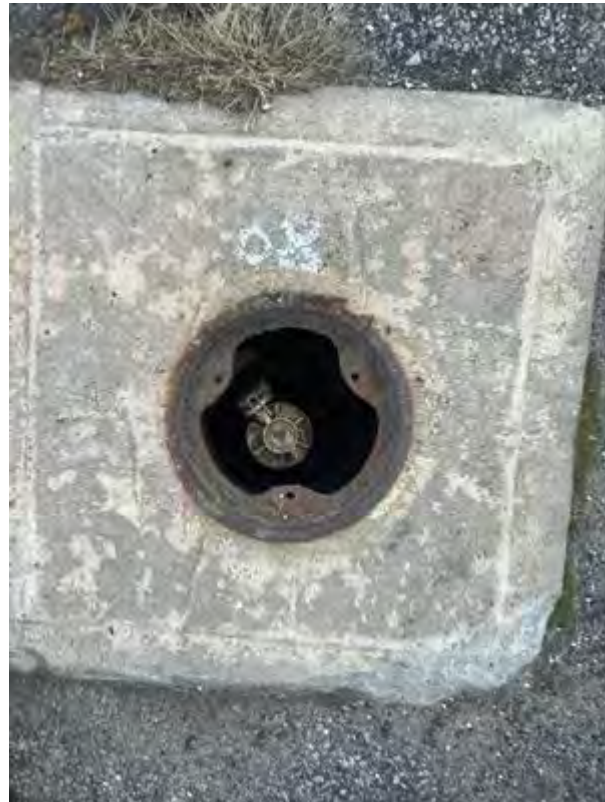
| <b>Notes (Explain if answered No to any of the above)</b><br>Missing three bolts | |

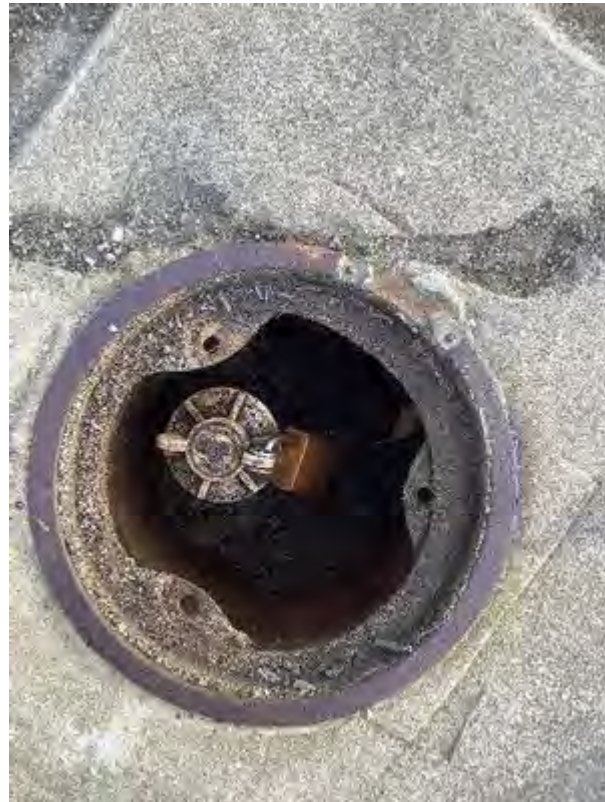
| <b>Notes (Explain if answered No to any of the above)</b><br>Missing two bolts | |

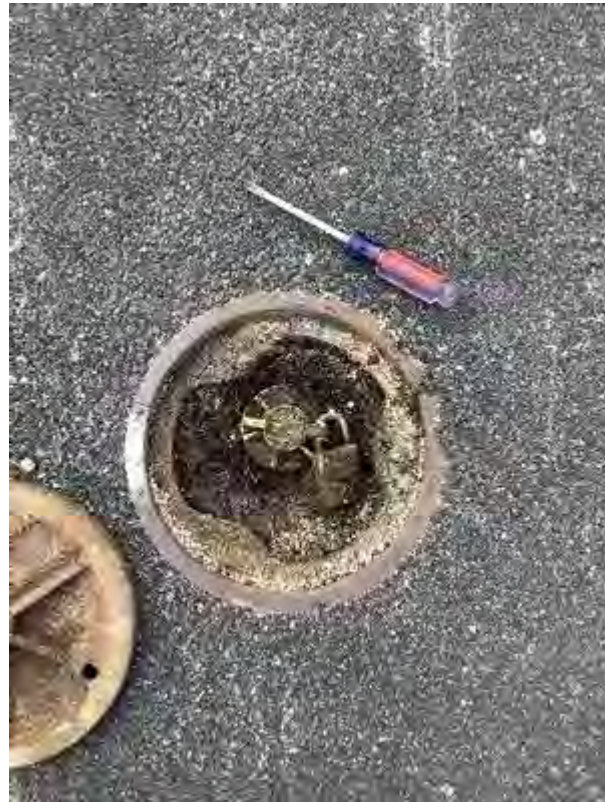
| <b>Notes (Explain if answered No to any of the above)</b><br>Missing two bolts | |

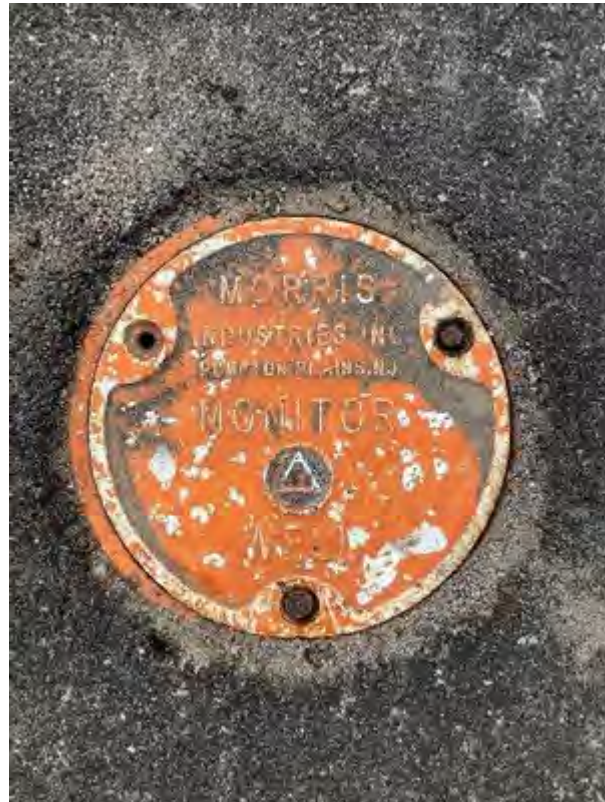
| <b>Notes (Explain if answered No to any of the above)</b><br>Missing one bolt | |

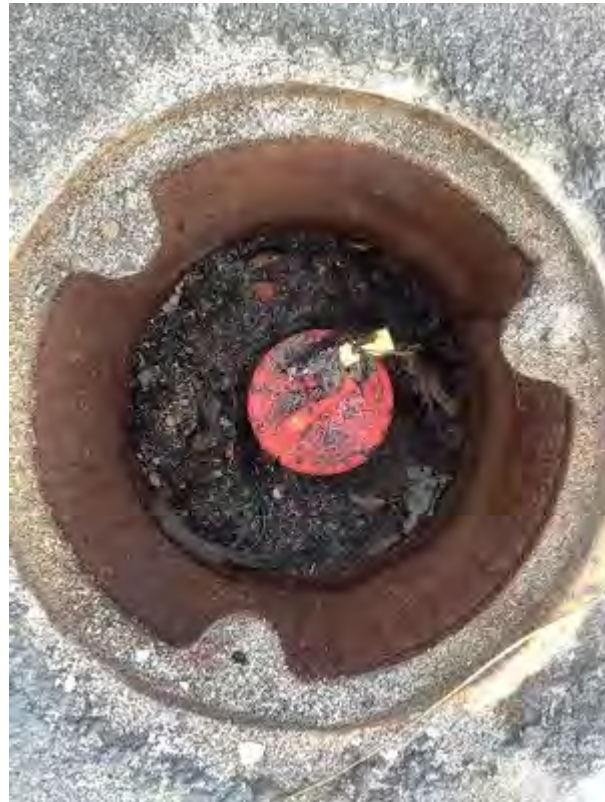
| <b>Notes (Explain if answered No to any of the above)</b><br>Missing two bolts | |

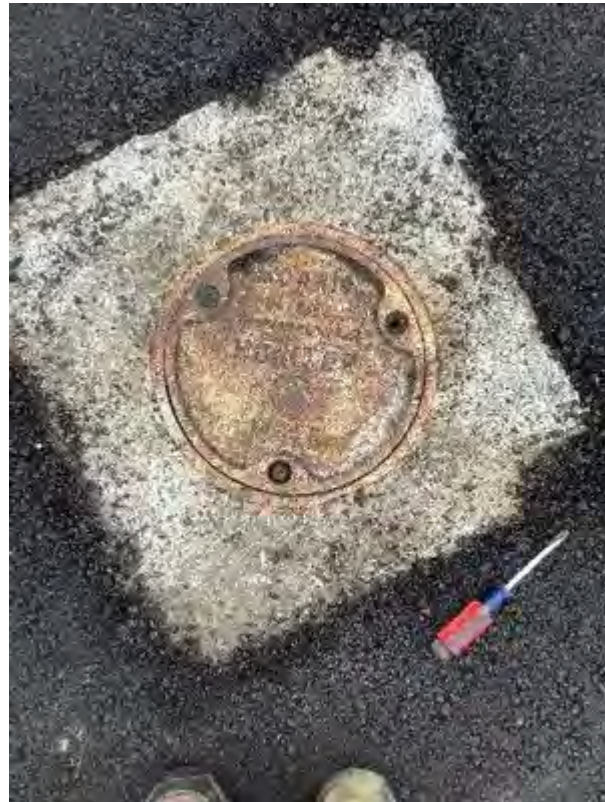
| <b>Notes (Explain if answered No to any of the above)</b><br>Missing two bolts | |

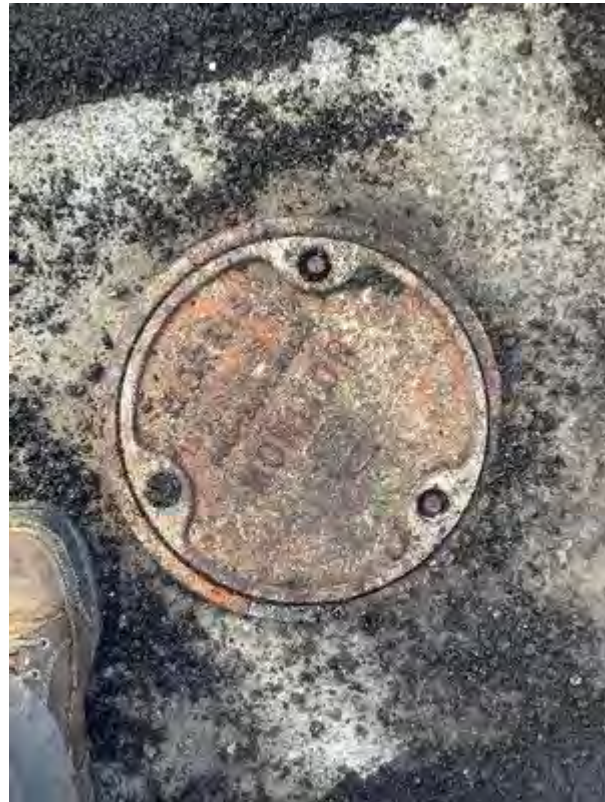
| <b>Notes (Explain if answered No to any of the above)</b><br>Missing one bolt | |

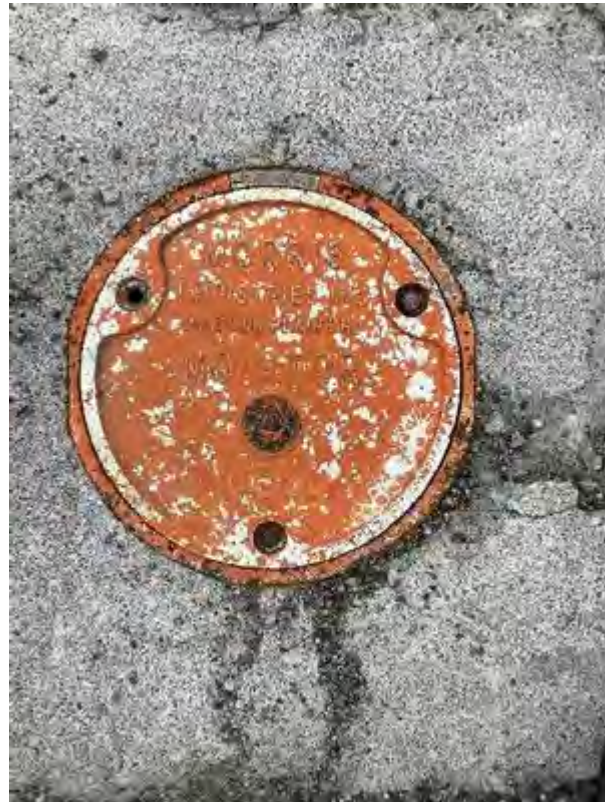
| <b>Notes (Explain if answered No to any of the above)</b><br>Missing one bolt | |

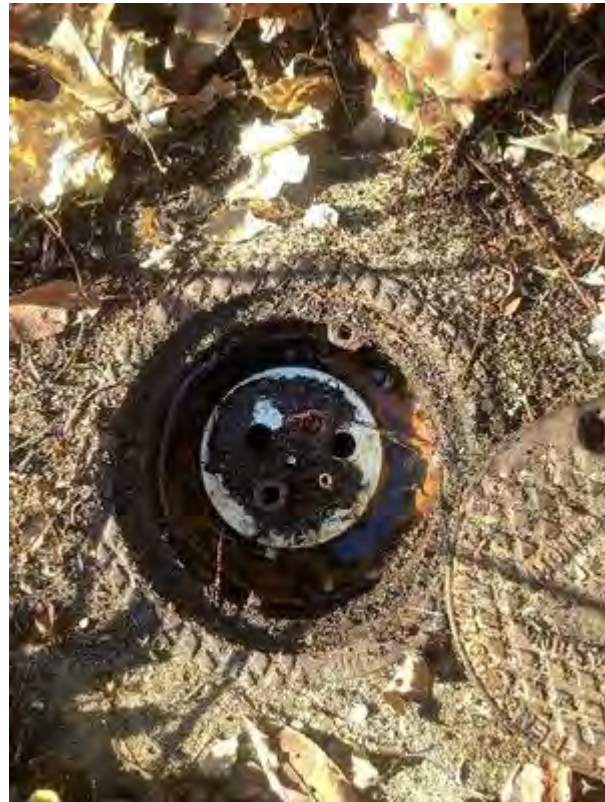
| <b>Notes (Explain if answered No to any of the above)</b><br>Two bolts missing | |

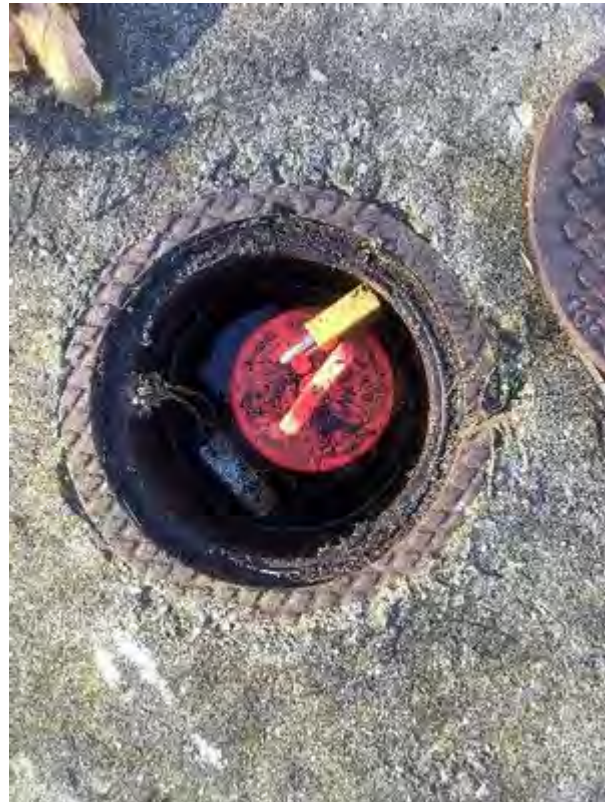
| <b>Notes (Explain if answered No to any of the above)</b><br>Missing two bolts. Standing water inside protective casing | |

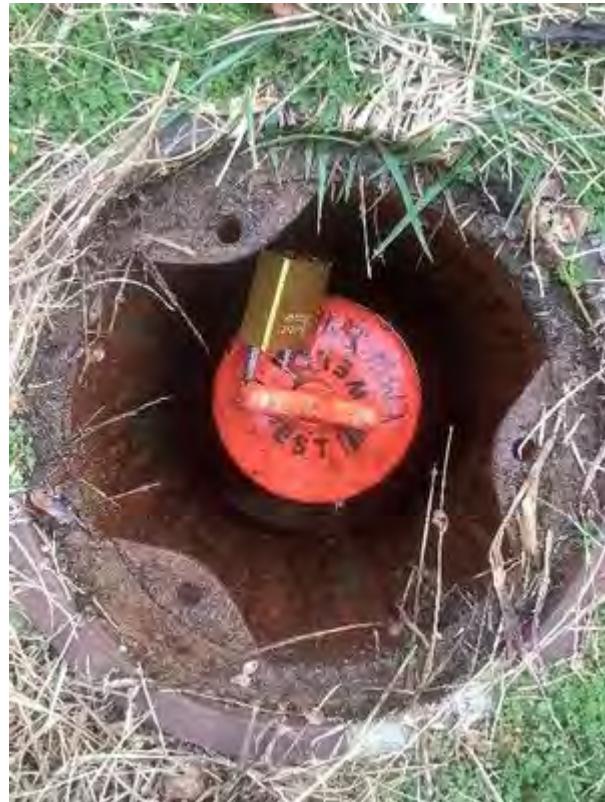
| <b>Notes (Explain if answered No to any of the above)</b><br>Missing one bolt | |

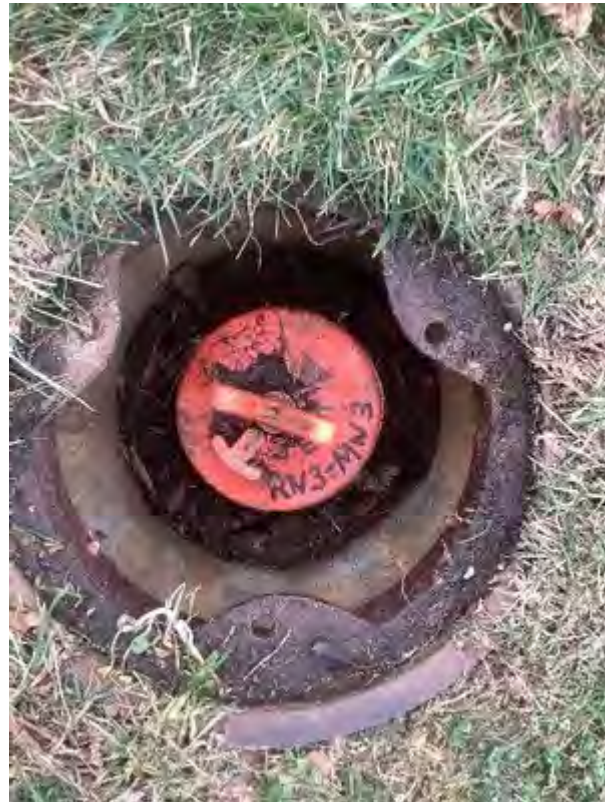
| <b>Notes (Explain if answered No to any of the above)</b><br>Missing two bolts | |

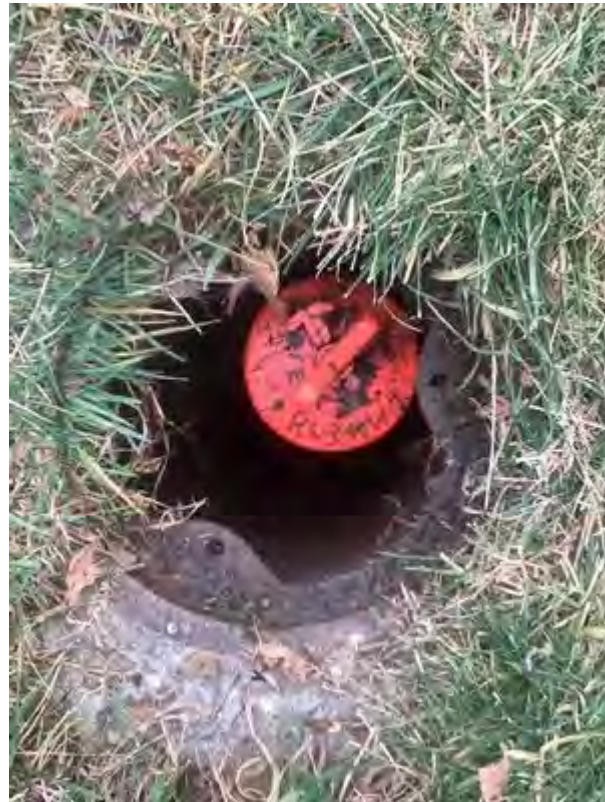
| <b>Notes (Explain if answered No to any of the above)</b><br>Missing two bolts | |

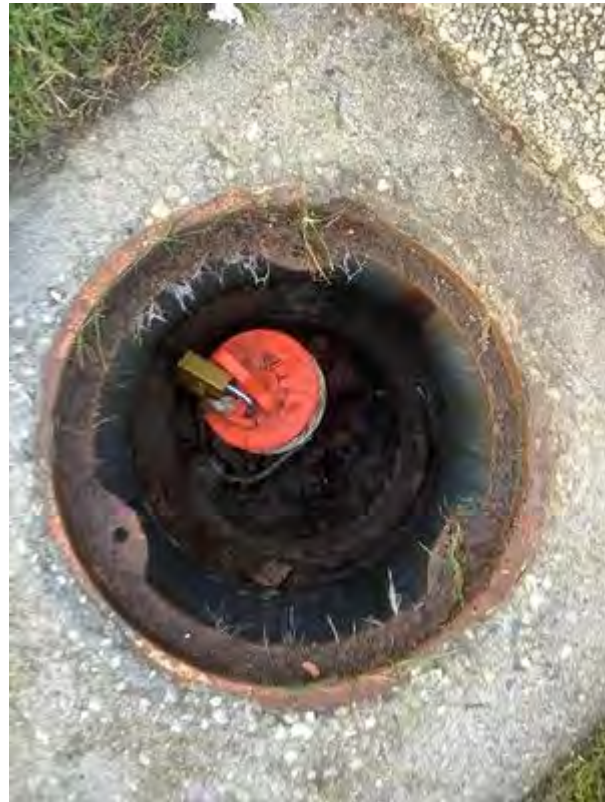
| <b>Notes (Explain if answered No to any of the above)</b><br>Missing one bolt | |

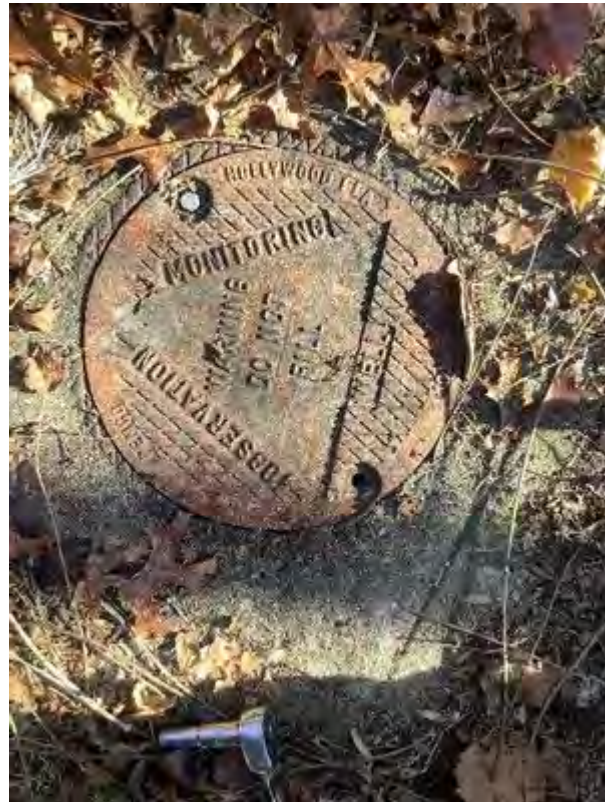
| <b>Notes (Explain if answered No to any of the above)</b><br>Missing one bolt | |

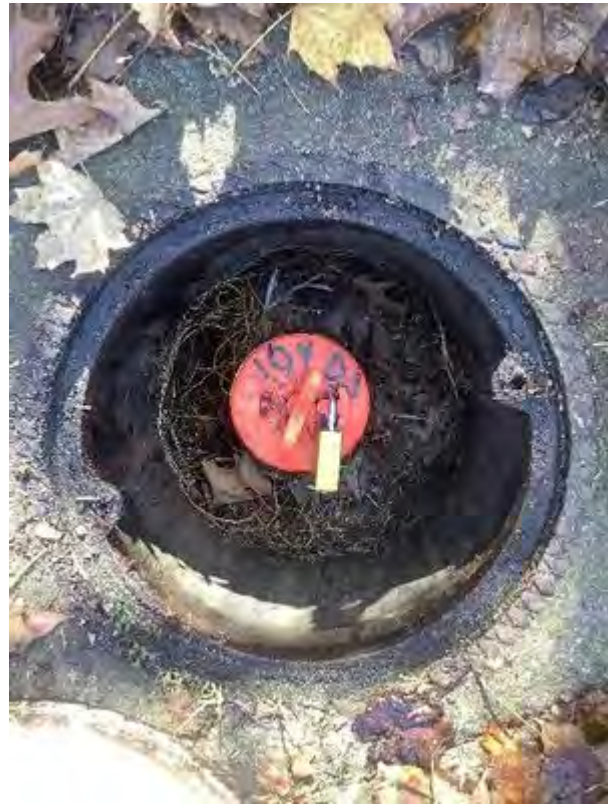
| <b>Notes (Explain if answered No to any of the above)</b><br>Missing one bolt | |
