# Memorandum

To: Brian Murray, NAVFAC MIDLANT  
From: David Brayack, Tetra Tech  
Date: January 28, 2021  
Re: Annual LUC Inspection and Operation Summary Report: Sites 1, 2, 3, and 4 – NWIRP Bethpage  
Revision 1  
Contract/CTO Number: N6247016D9008/WE13

## 1.0 Introduction

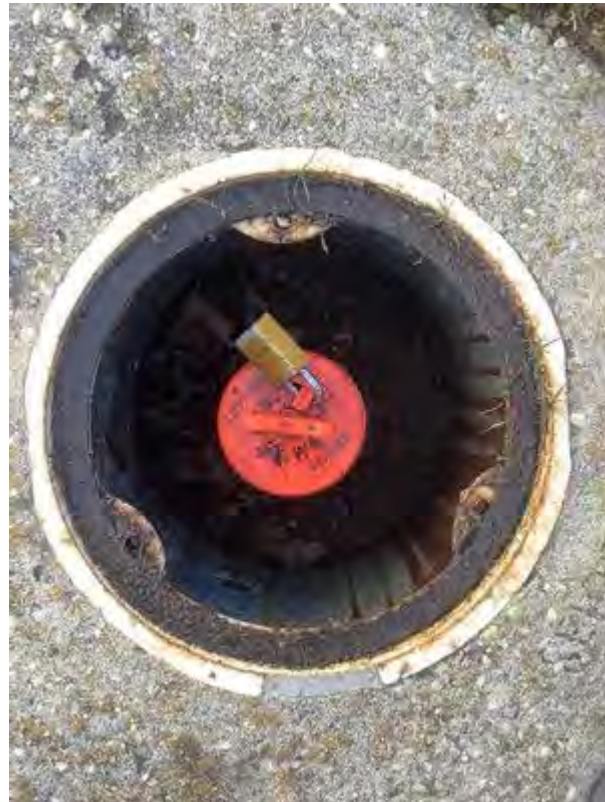
| <b>Notes (Explain if answered No to any of the above)</b><br>Missing one bolt | |

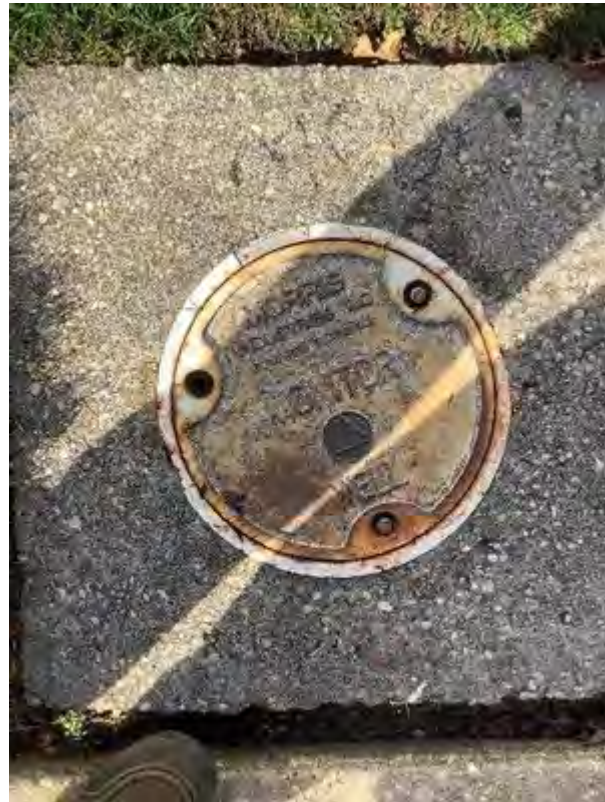
| <b>Notes (Explain if answered No to any of the above)</b><br>Missing one bolt | |

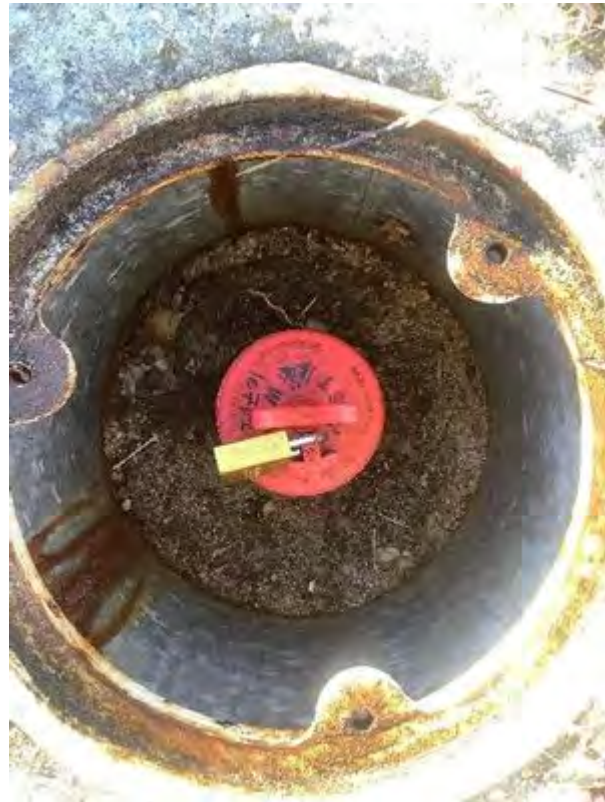
| <b>Notes (Explain if answered No to any of the above)</b><br>Missing one bolt | |

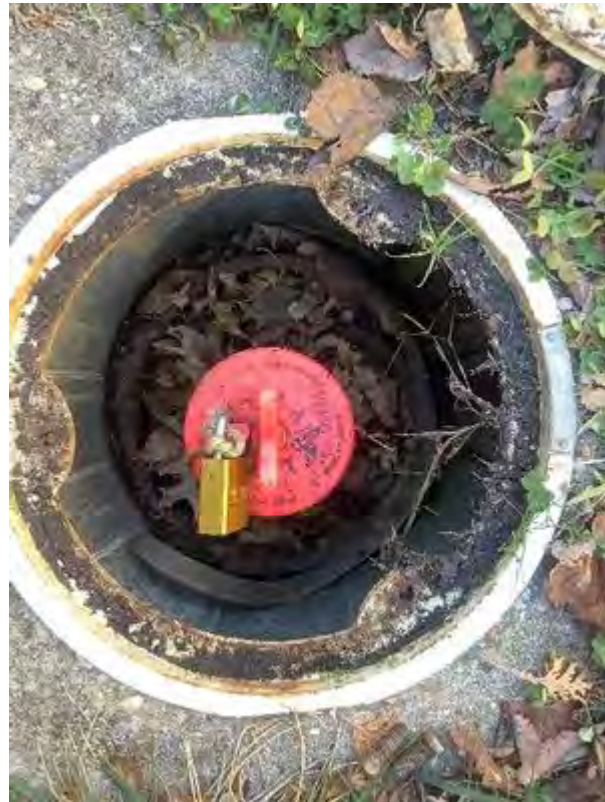
| <b>Notes (Explain if answered No to any of the above)</b><br>One bolt missing | |
