Memorandum

To: Scot Sokolowski, NAVFAC MIDLANT
From: David Brayack, Tetra Tech
Date: December 30, 2021
Re: Annual LUC Inspection and Operation Summary Report: Sites 1, 2, 3, and 4 – NWIRP Bethpage
Revision 1
Contract/CTO Number: N6247016D9008/WE13

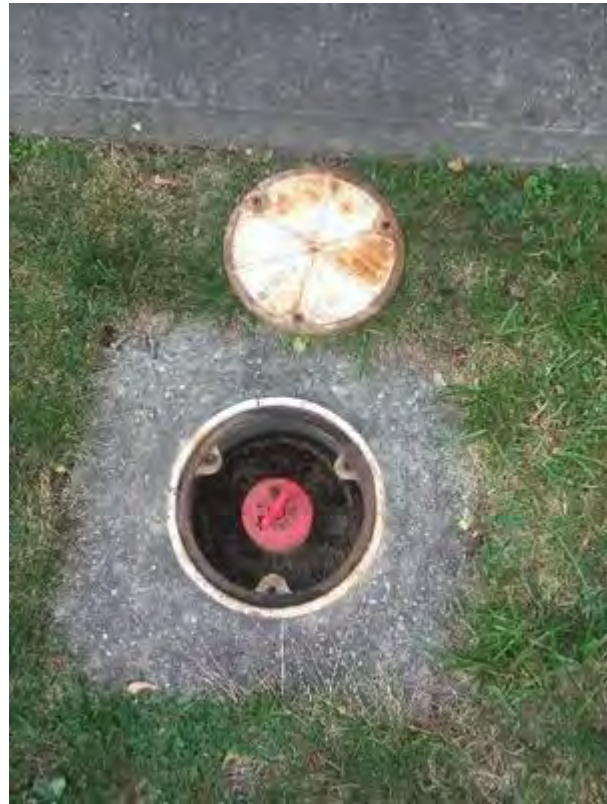
Client: Navy CLEAN	Facility: NWIRP Bethpage
Project Number: 112G08005-WE13	Location: Bethpage, New York
Date: September 20, 2021 14:21	Personnel: Noah Sprouse
Well ID: RE126D3	Well Location: 208568.11 1125643.6
Well Status: Other	Screen Interval: 640-660
WELL INVENTORY CONDITION	
Concrete pad in acceptable condition i.e. no cracks?	NO
Manhole cover present and in working condition?	YES
All bolts on manhole present and not stripped?	NO
Well plug present, locked and in good working condition?	YES
OVERALL CONDITION:	FAIR
Notes (Explain if answered No to any of the above) Concrete pad has cracks, all bolts stripped.

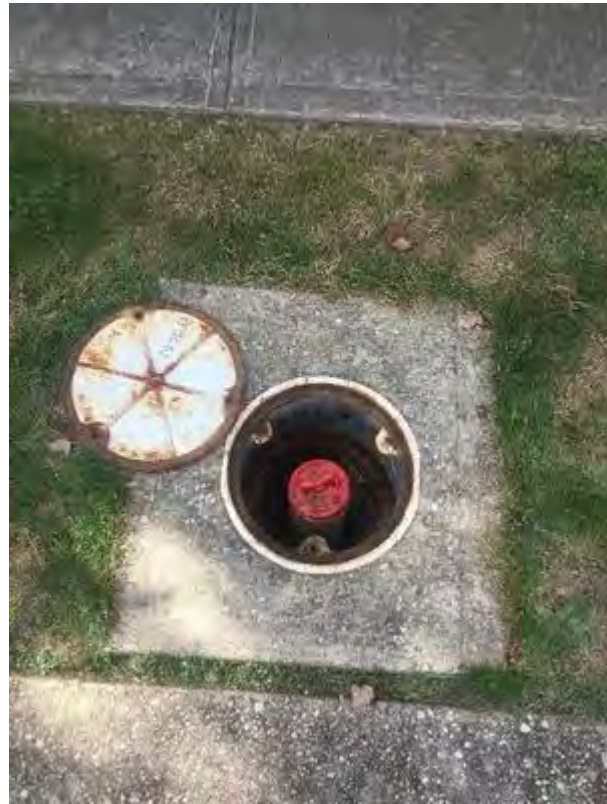
Client: Navy CLEAN	Facility: NWIRP Bethpage
Project Number: 112G08005-WE13	Location: Bethpage, New York
Date: September 20, 2021 08:24	Personnel: Noah Sprouse
Well ID: RE103D1	Well Location: 206694.59 1125111.764
Well Status: Other	Screen Interval: 625-640
WELL INVENTORY CONDITION	
Concrete pad in acceptable condition i.e. no cracks?	YES
Manhole cover present and in working condition?	YES
All bolts on manhole present and not stripped?	NO
Well plug present, locked and in good working condition?	YES
OVERALL CONDITION:	FAIR
Notes (Explain if answered No to any of the above) All bolts stripped, missing rubber gasket, needs fill

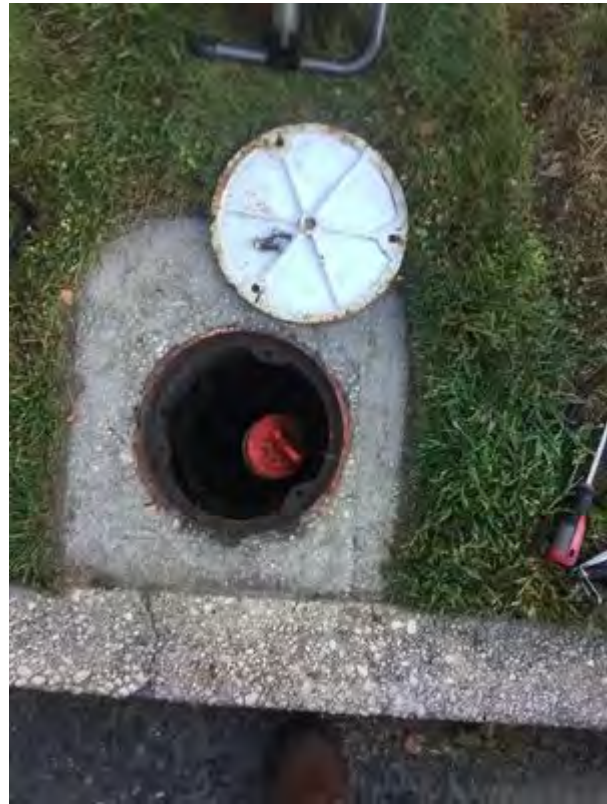
Client: Navy CLEAN	Facility: NWIRP Bethpage
Project Number: 112G08005-WE13	Location: Bethpage, New York
Date: September 19, 2021 15:07	Personnel: Noah Sprouse
Well ID: BP-TT-MW201D1	Well Location: 214055.8 1123155.3
Well Status: Other	Screen Interval: 480-500
WELL INVENTORY CONDITION	
Concrete pad in acceptable condition i.e. no cracks?	YES
Manhole cover present and in working condition?	YES
All bolts on manhole present and not stripped?	NO
Well plug present, locked and in good working condition?	YES
OVERALL CONDITION:	FAIR
Notes (Explain if answered No to any of the above) All three bolts snapped. Use this one (has both pictures).

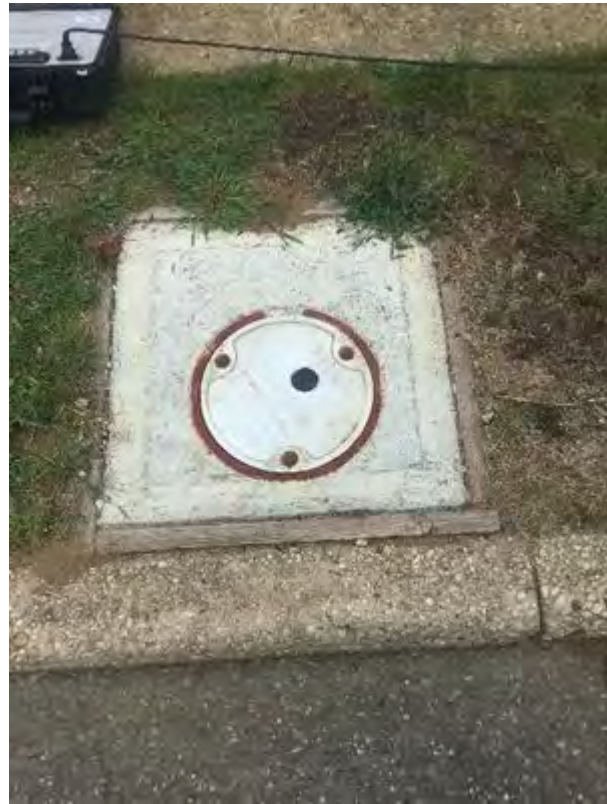
Client: Navy CLEAN	Facility: NWIRP Bethpage
Project Number: 112G08005-WE13	Location: Bethpage, New York
Date: September 15, 2021 11:57	Personnel: Wyatt Bostick
Well ID: RE131D2	Well Location: 204359.42 1123099.42
Well Status: Other	Screen Interval: 565-590
WELL INVENTORY CONDITION	
Concrete pad in acceptable condition i.e. no cracks?	NO
Manhole cover present and in working condition?	YES
All bolts on manhole present and not stripped?	YES
Well plug present, locked and in good working condition?	YES
OVERALL CONDITION:	GOOD
Notes (Explain if answered No to any of the above) Minor cracking

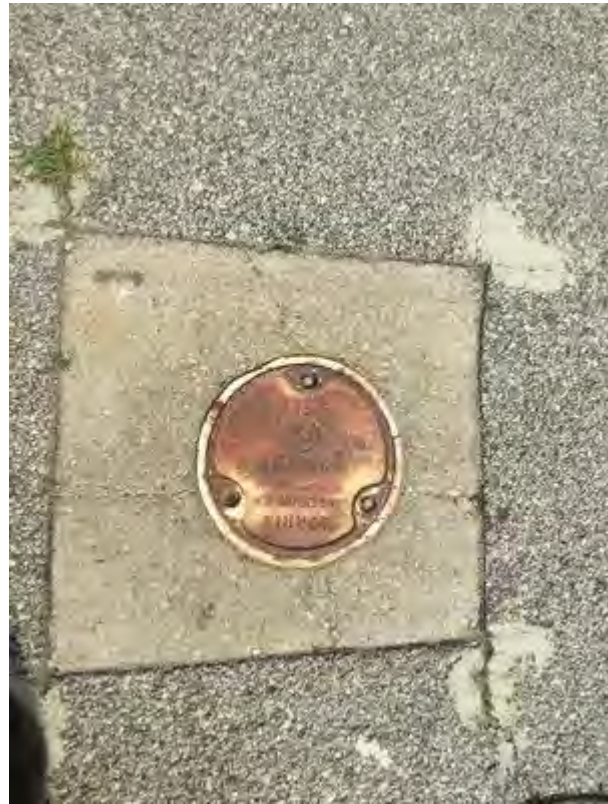
Client: Navy CLEAN	Facility: NWIRP Bethpage
Project Number: 112G08005-WE13	Location: Bethpage, New York
Date: September 15, 2021 11:17	Personnel: Wyatt Bostick
Well ID: RE134D1	Well Location: 206193.848977 1123302.32141
Well Status: Other	Screen Interval: 325-345
WELL INVENTORY CONDITION	
Concrete pad in acceptable condition i.e. no cracks?	YES
Manhole cover present and in working condition?	YES
All bolts on manhole present and not stripped?	NO
Well plug present, locked and in good working condition?	YES
OVERALL CONDITION:	FAIR
Notes (Explain if answered No to any of the above) Snapped bolt

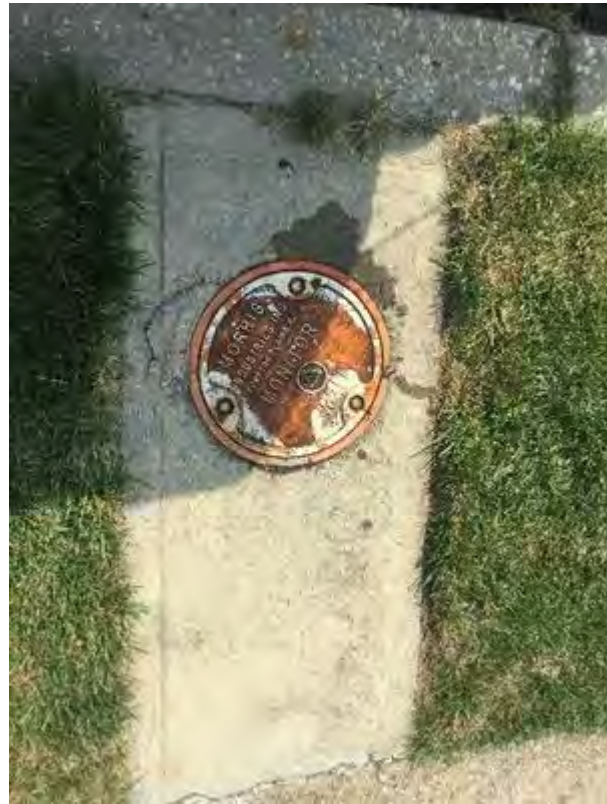
Client: Navy CLEAN	Facility: NWIRP Bethpage
Project Number: 112G08005-WE13	Location: Bethpage, New York
Date: September 15, 2021 11:07	Personnel: Wyatt Bostick
Well ID: RE134D4	Well Location: 206154.828879 1123280.64358
Well Status: Other	Screen Interval: 665-685
WELL INVENTORY CONDITION	
Concrete pad in acceptable condition i.e. no cracks?	YES
Manhole cover present and in working condition?	YES
All bolts on manhole present and not stripped?	NO
Well plug present, locked and in good working condition?	YES
OVERALL CONDITION:	GOOD
Notes (Explain if answered No to any of the above) Snapped bolt

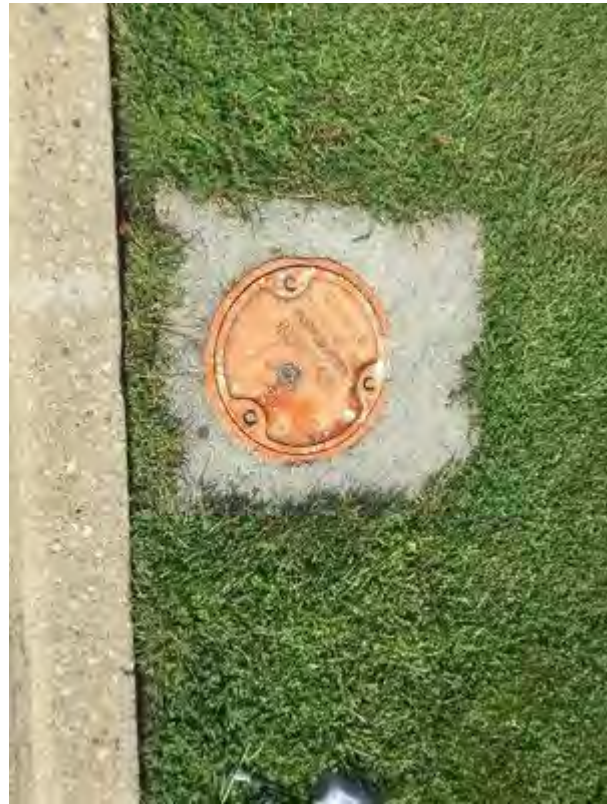
Client: Navy CLEAN	Facility: NWIRP Bethpage
Project Number: 112G08005-WE13	Location: Bethpage, New York
Date: September 21, 2021 11:55	Personnel: Noah Sprouse
Well ID: TT101D1	Well Location: 203545.086 1125484.11
Well Status: Other	Screen Interval: 570-590
WELL INVENTORY CONDITION	
Concrete pad in acceptable condition i.e. no cracks?	YES
Manhole cover present and in working condition?	YES
All bolts on manhole present and not stripped?	YES
Well plug present, locked and in good working condition?	YES
OVERALL CONDITION:	FAIR
Notes (Explain if answered No to any of the above) Missing one bolt

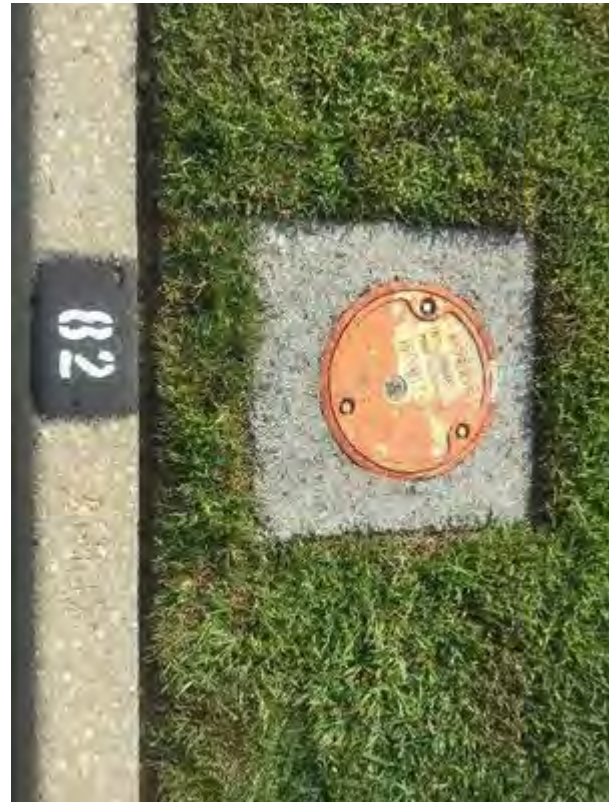
Client: Navy CLEAN	Facility: NWIRP Bethpage
Project Number: 112G08005-WE13	Location: Bethpage, New York
Date: September 15, 2021 10:16	Personnel: Wyatt Bostick
Well ID: RE131D3	Well Location: 204350.99 1123115.19
Well Status: Other	Screen Interval: 660-680
WELL INVENTORY CONDITION	
Concrete pad in acceptable condition i.e. no cracks?	NO
Manhole cover present and in working condition?	YES
All bolts on manhole present and not stripped?	YES
Well plug present, locked and in good working condition?	YES
OVERALL CONDITION:	FAIR
Notes (Explain if answered No to any of the above) Minor cracking of well pad

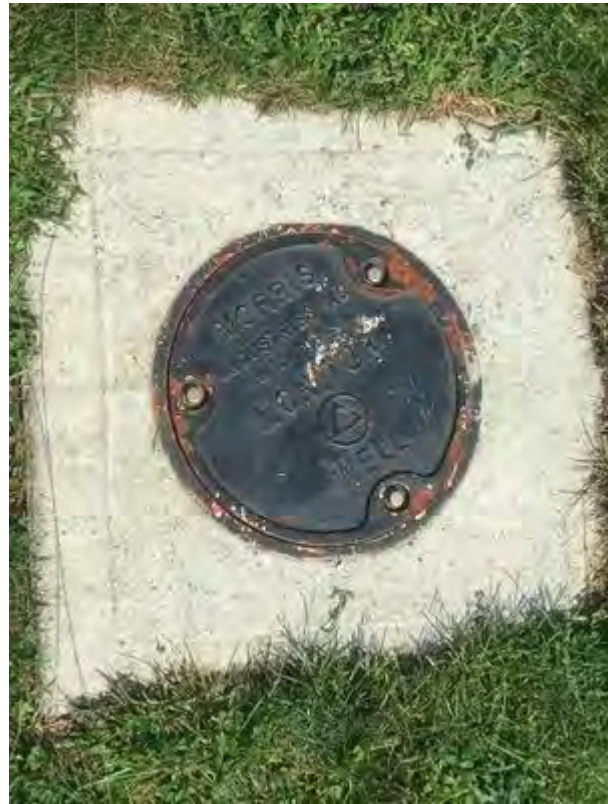
Client: Navy CLEAN	Facility: NWIRP Bethpage
Project Number: 112G08005-WE13	Location: Bethpage, New York
Date: September 14, 2021 12:02	Personnel: Wyatt Bostick
Well ID: RE132D1	Well Location: 203063.35272 1125662.70266
Well Status: Other	Screen Interval: 220-240
WELL INVENTORY CONDITION	
Concrete pad in acceptable condition i.e. no cracks?	YES
Manhole cover present and in working condition?	YES
All bolts on manhole present and not stripped?	YES
Well plug present, locked and in good working condition?	YES
OVERALL CONDITION:	GOOD
Notes (Explain if answered No to any of the above) No datalogger

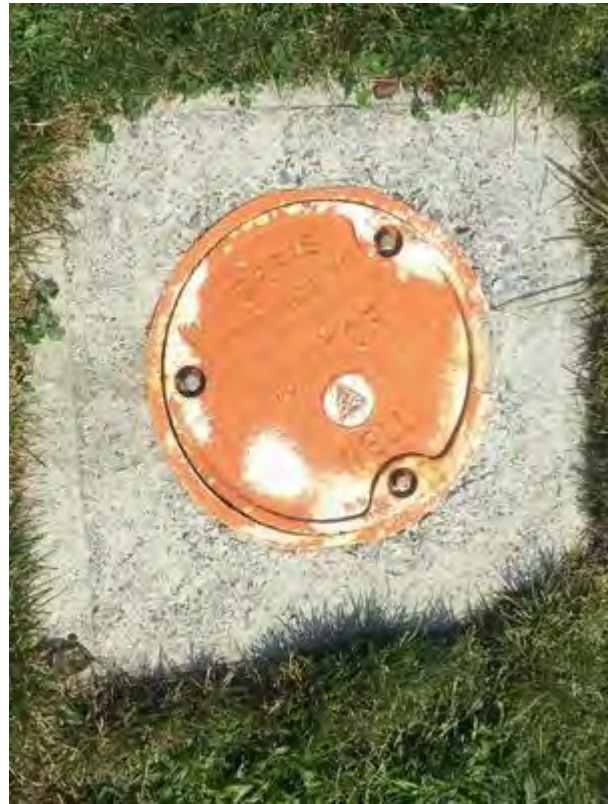
Client: Navy CLEAN	Facility: NWIRP Bethpage
Project Number: 112G08005-WE13	Location: Bethpage, New York
Date: September 13, 2021 16:51	Personnel: Noah Sprouse
Well ID: BPS1-TT-MW307S	Well Location: 213350.824 1124901.871
Well Status: Other	Screen Interval: 40.5-50.5
WELL INVENTORY CONDITION	
Concrete pad in acceptable condition i.e. no cracks?	NO
Manhole cover present and in working condition?	NO
All bolts on manhole present and not stripped?	NO
Well plug present, locked and in good working condition?	YES
OVERALL CONDITION:	FAIR
Notes (Explain if answered No to any of the above) No manhole cover, poor well pad, no bolts

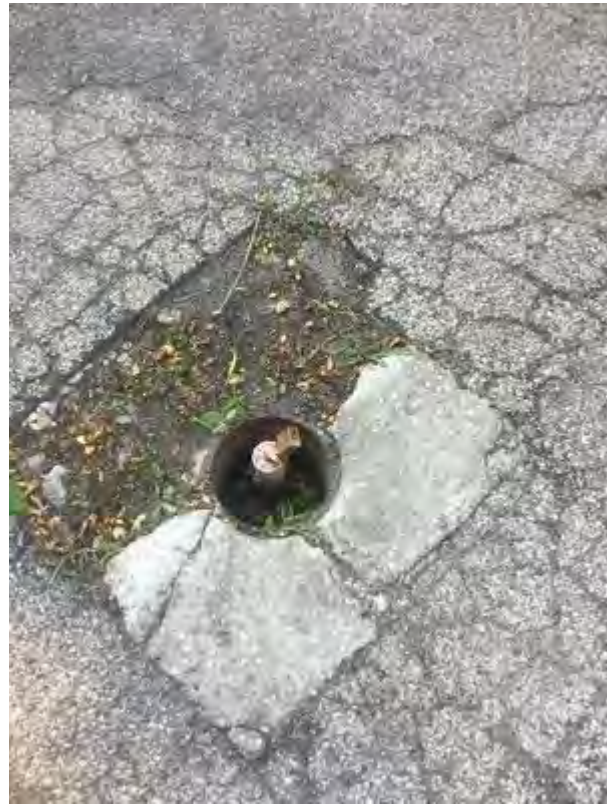
Client: Navy CLEAN	Facility: NWIRP Bethpage
Project Number: 112G08005-WE13	Location: Bethpage, New York
Date: September 13, 2021 16:47	Personnel: Noah Sprouse
Well ID: BPS1-TT-MW307I	Well Location: 213353.775 1124914.838
Well Status: Other	Screen Interval: 188-198
WELL INVENTORY CONDITION	
Concrete pad in acceptable condition i.e. no cracks?	NO
Manhole cover present and in working condition?	YES
All bolts on manhole present and not stripped?	YES
Well plug present, locked and in good working condition?	YES
OVERALL CONDITION:	FAIR
Notes (Explain if answered No to any of the above) Poor well pad (sunk and cracked)

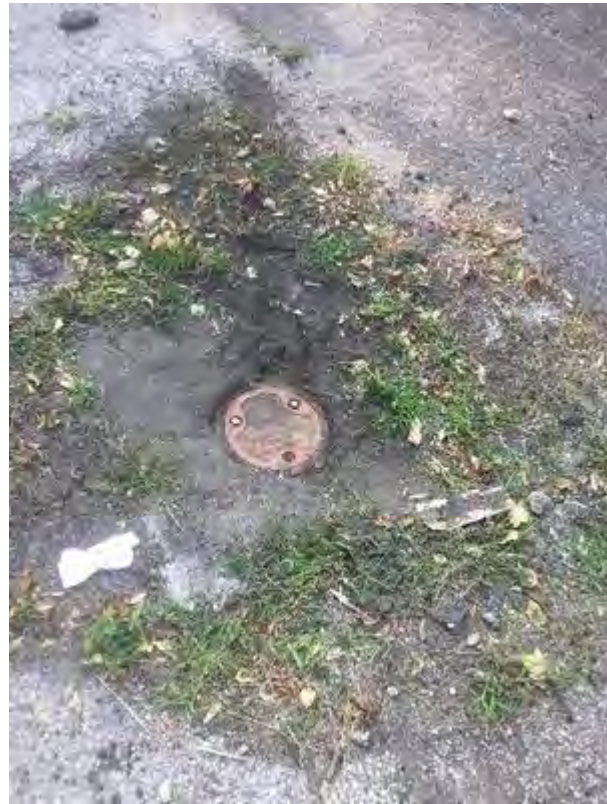
Client: Navy CLEAN	Facility: NWIRP Bethpage
Project Number: 112G08005-WE13	Location: Bethpage, New York
Date: September 13, 2021 16:44	Personnel: Noah Sprouse
Well ID: BPS1-TT-MW307D	Well Location: 213357.307 1124926.918
Well Status: Other	Screen Interval: 276-286
WELL INVENTORY CONDITION	
Concrete pad in acceptable condition i.e. no cracks?	NO
Manhole cover present and in working condition?	YES
All bolts on manhole present and not stripped?	YES
Well plug present, locked and in good working condition?	YES
OVERALL CONDITION:	FAIR
Notes (Explain if answered No to any of the above) Poor well pad (sunk and cracked)

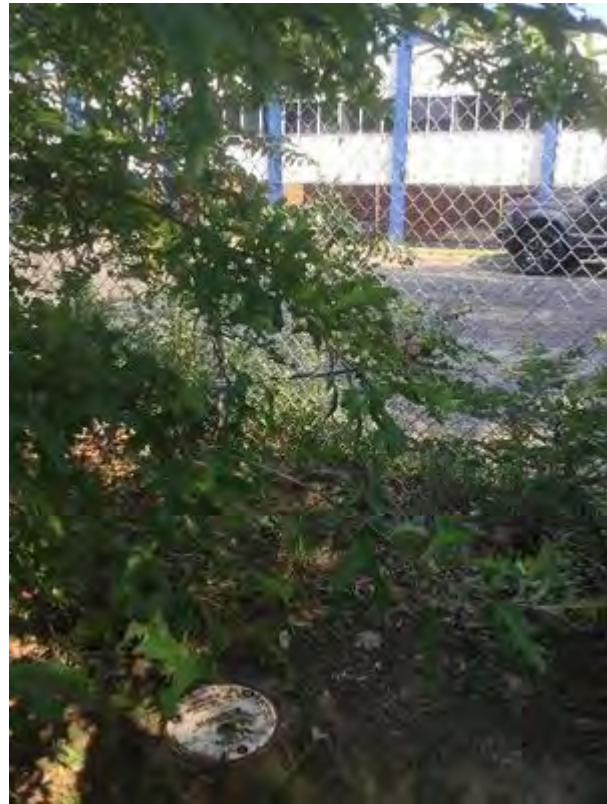
Client: Navy CLEAN	Facility: NWIRP Bethpage
Project Number: 112G08005-WE13	Location: Bethpage, New York
Date: September 13, 2021 14:42	Personnel: Noah Sprouse
Well ID: GM38-RW1-MW2	Well Location: 206077.6 1129746.4
Well Status: Other	Screen Interval: 395-435
WELL INVENTORY CONDITION	
Concrete pad in acceptable condition i.e. no cracks?	NO
Manhole cover present and in working condition?	YES
All bolts on manhole present and not stripped?	NO
Well plug present, locked and in good working condition?	YES
OVERALL CONDITION:	FAIR
Notes (Explain if answered No to any of the above) No bolts (missing two), inadequate well pad

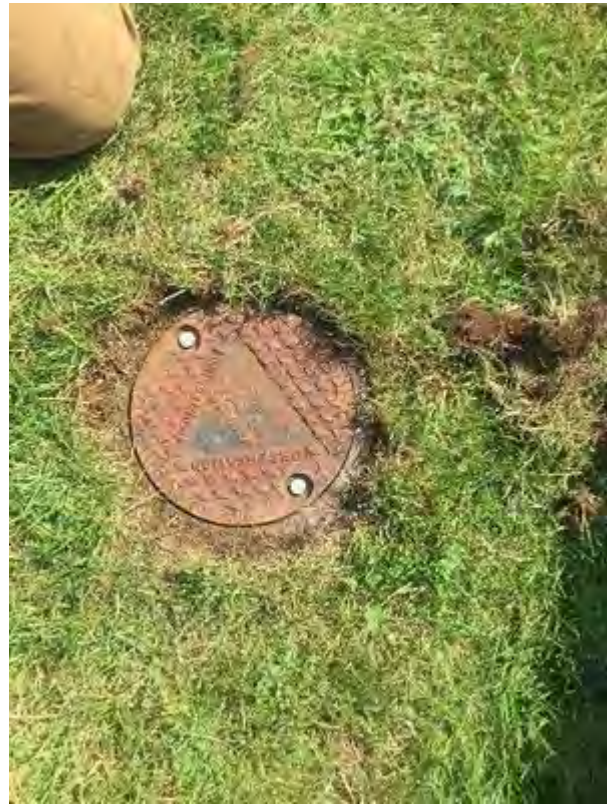
Client: Navy CLEAN	Facility: NWIRP Bethpage
Project Number: 112G08005-WE13	Location: Bethpage, New York
Date: September 13, 2021 13:38	Personnel: Noah Sprouse
Well ID: GM38-RW2-MW1	Well Location: 206433 1129248.1
Well Status: Other	Screen Interval: 470-510
WELL INVENTORY CONDITION	
Concrete pad in acceptable condition i.e. no cracks?	NO
Manhole cover present and in working condition?	NO
All bolts on manhole present and not stripped?	NO
Well plug present, locked and in good working condition?	NO
OVERALL CONDITION:	POOR
Notes (Explain if answered No to any of the above) Missing two bolts, missing tubing, undercut well pad, broken well cover

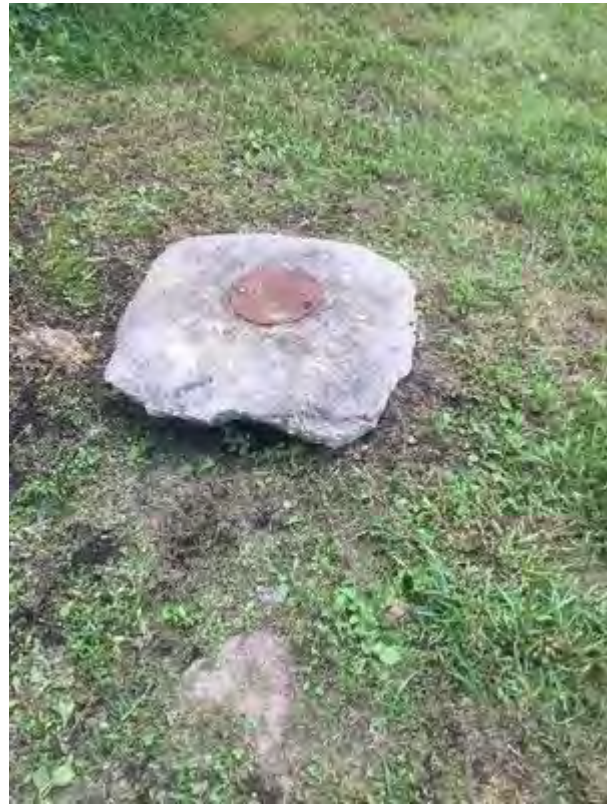
Client: Navy CLEAN	Facility: NWIRP Bethpage
Project Number: 112G08005-WE13	Location: Bethpage, New York
Date: September 13, 2021 13:28	Personnel: Noah Sprouse
Well ID: GM38-RW3-MW3	Well Location: 206763.9 1128986.6
Well Status: Other	Screen Interval: 320-340
WELL INVENTORY CONDITION	
Concrete pad in acceptable condition i.e. no cracks?	YES
Manhole cover present and in working condition?	YES
All bolts on manhole present and not stripped?	NO
Well plug present, locked and in good working condition?	YES
OVERALL CONDITION:	FAIR
Notes (Explain if answered No to any of the above) Missing two bolts

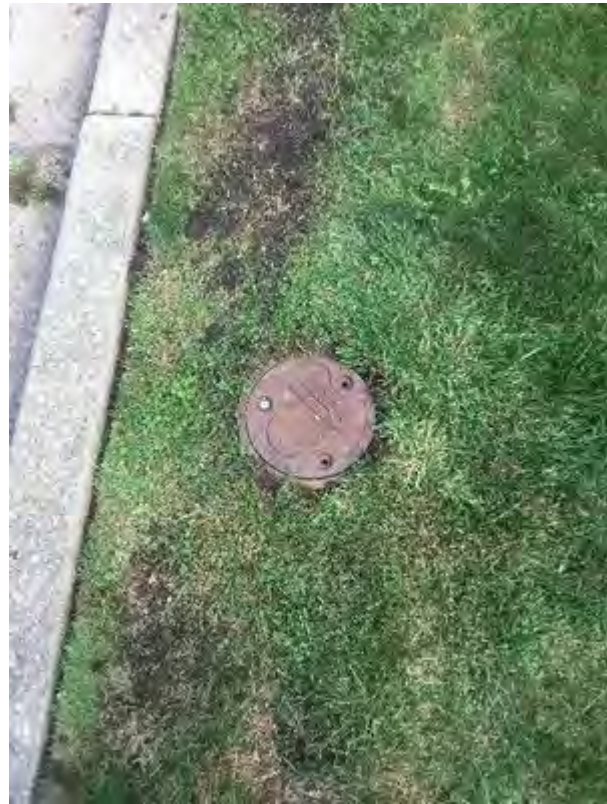
Client: Navy CLEAN	Facility: NWIRP Bethpage
Project Number: 112G08005-WE13	Location: Bethpage, New York
Date: September 13, 2021 13:25	Personnel: Noah Sprouse
Well ID: GM38-RW3-MW4	Well Location: 206759.7 1128970.5
Well Status: Other	Screen Interval: 475-495
WELL INVENTORY CONDITION	
Concrete pad in acceptable condition i.e. no cracks?	YES
Manhole cover present and in working condition?	YES
All bolts on manhole present and not stripped?	NO
Well plug present, locked and in good working condition?	YES
OVERALL CONDITION:	FAIR
Notes (Explain if answered No to any of the above) Missing two bolts, bad fill/stabilizer

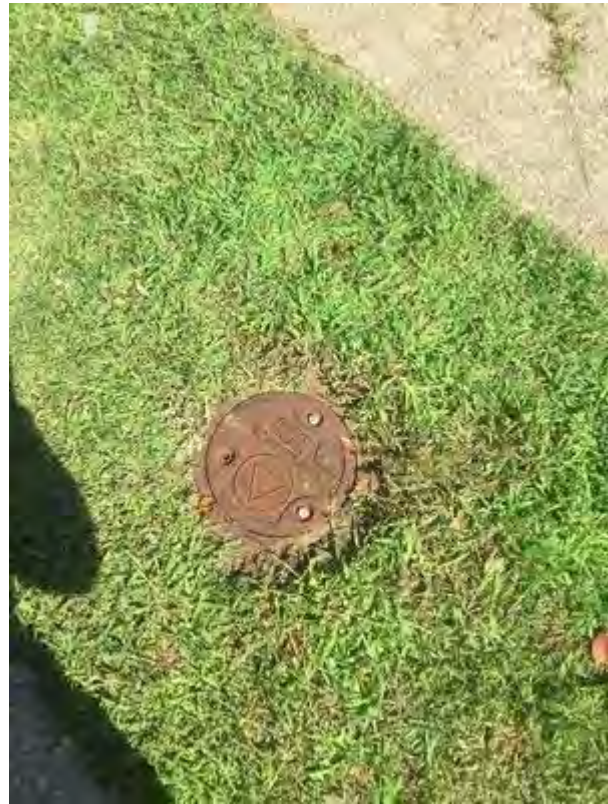
Client: Navy CLE	Facility: NWIRP Bethpage
Project Number: 112G08005-WE13	Location: Bethpage, New York
Date: September 21, 2021 12:05	Personnel: Noah Sprouse
Well ID: TT101D	Well Location: 203545.488 1125462.038
Well Status: Other	Screen Interval: 325-345
WELL INVENTORY CONDITION	
Concrete pad in acceptable condition i.e. no cracks?	YES
Manhole cover present and in working condition?	YES
All bolts on manhole present and not stripped?	YES
Well plug present, locked and in good working condition?	YES
OVERALL CONDITION:	FAIR
Notes (Explain if answered No to any of the above) Needs fill/ missing rubber gasket.

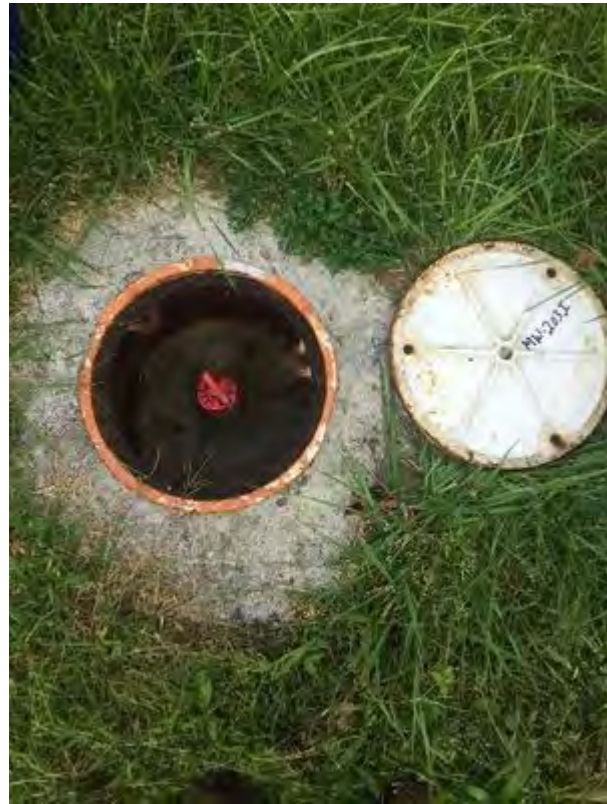
Client: Navy CLEAN	Facility: NWIRP Bethpage
Project Number: 112G08005-WE13	Location: Bethpage, New York
Date: September 23, 2021 08:27	Personnel: Wyatt Bostick
Well ID: BPGMMW39DA	Well Location: 209882 1124170
Well Status: Other	Screen Interval: 262-282
WELL INVENTORY CONDITION	
Concrete pad in acceptable condition i.e. no cracks?	NO
Manhole cover present and in working condition?	NO
All bolts on manhole present and not stripped?	NO
Well plug present, locked and in good working condition?	YES
OVERALL CONDITION:	FAIR
Notes (Explain if answered No to any of the above) Below grade, bolts stripped, and manhole chipped

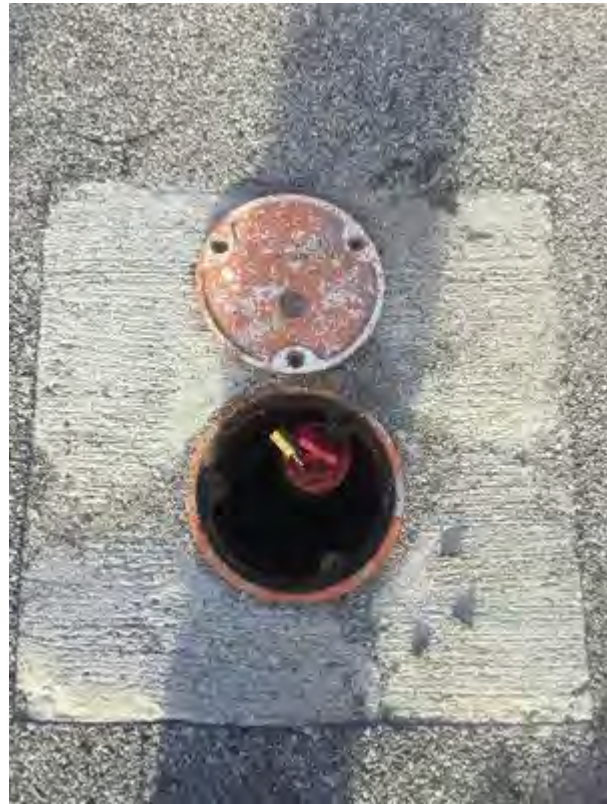
Client: Navy CLEAN	Facility: NWIRP Bethpage
Project Number: 112G08005-WE13	Location: Bethpage, New York
Date: September 23, 2021 08:06	Personnel: Vince Shickora
Well ID: BPHNMW27S	Well Location: 214,421.96 1,124,934.89
Well Status: Other	Screen Interval: 44-54
WELL INVENTORY CONDITION	
Concrete pad in acceptable condition i.e. no cracks?	NO
Manhole cover present and in working condition?	NO
All bolts on manhole present and not stripped?	NO
Well plug present, locked and in good working condition?	NO
OVERALL CONDITION:	POOR
Notes (Explain if answered No to any of the above) Cannot close security casing lid due to height of pvc well casing. No concrete pad observed. No locks on well. Well installed as stickup.

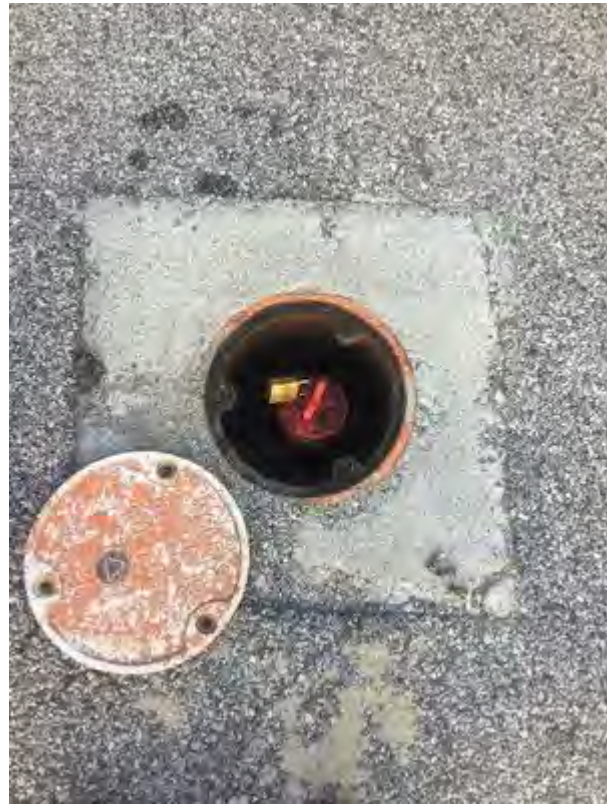
Client: Navy CLEAN	Facility: NWIRP Bethpage
Project Number: 112G08005-WE13	Location: Bethpage, New York
Date: September 23, 2021 08:02	Personnel: Noah Sprouse
Well ID: BP-TT-MW203D2	Well Location: 215507.2 1123778
Well Status: Other	Screen Interval: 435-450
WELL INVENTORY CONDITION	
Concrete pad in acceptable condition i.e. no cracks?	NO
Manhole cover present and in working condition?	YES
All bolts on manhole present and not stripped?	YES
Well plug present, locked and in good working condition?	YES
OVERALL CONDITION:	FAIR
Notes (Explain if answered No to any of the above) Cracked well pad.

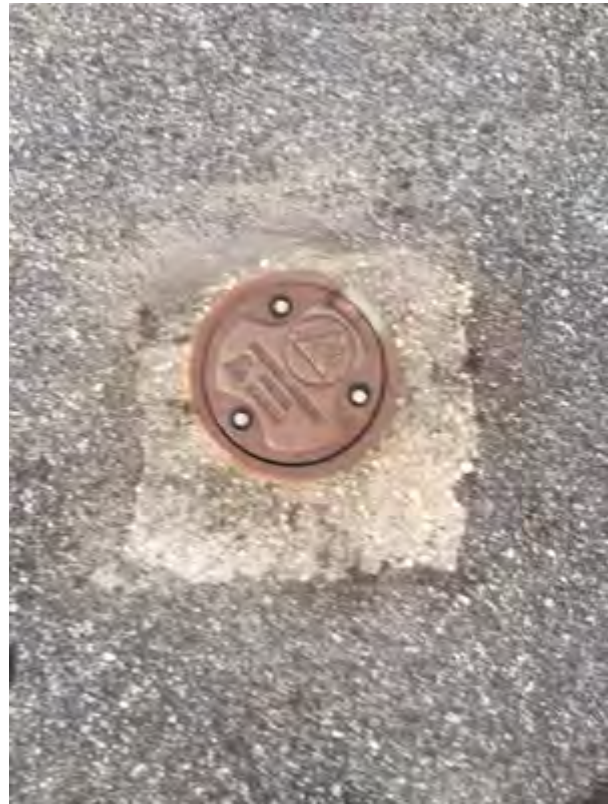
Client: Navy CLEAN	Facility: NWIRP Bethpage
Project Number: 112G08005-WE13	Location: Bethpage, New York
Date: September 22, 2021 17:36	Personnel: Noah Sprouse
Well ID: BPTTAOC22MW04	Well Location: 214026.062685 1123644.93391
Well Status: Other	Screen Interval: 46-66
WELL INVENTORY CONDITION	
Concrete pad in acceptable condition i.e. no cracks?	YES
Manhole cover present and in working condition?	YES
All bolts on manhole present and not stripped?	NO
Well plug present, locked and in good working condition?	YES
OVERALL CONDITION:	FAIR
Notes (Explain if answered No to any of the above) Missing two bolts, missing rubber gasket.

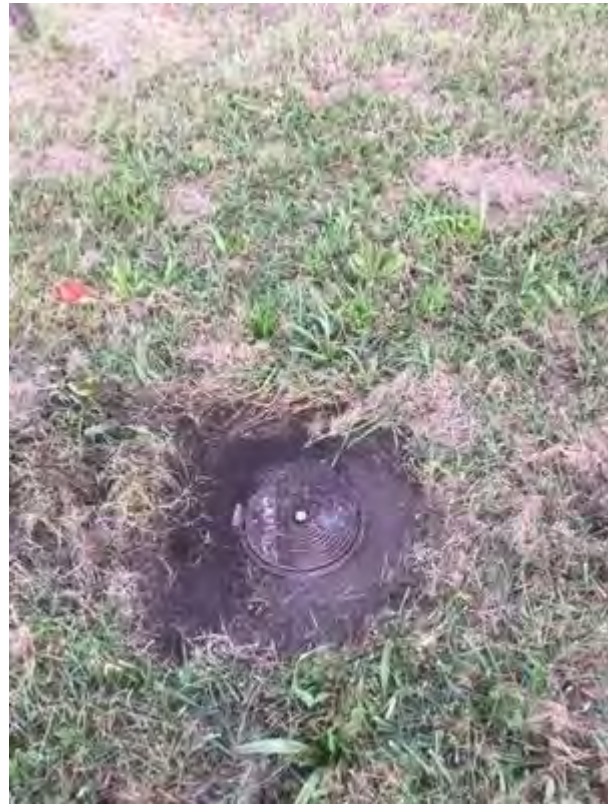
Client: Navy CLEAN	Facility: NWIRP Bethpage
Project Number: 112G08005-WE13	Location: Bethpage, New York
Date: September 22, 2021 16:17	Personnel: Wyatt Bostick
Well ID: BPHNMW40I	Well Location: 212473 1125986
Well Status: Other	Screen Interval: 108-118
WELL INVENTORY CONDITION	
Concrete pad in acceptable condition i.e. no cracks?	YES
Manhole cover present and in working condition?	YES
All bolts on manhole present and not stripped?	NO
Well plug present, locked and in good working condition?	YES
OVERALL CONDITION:	FAIR
Notes (Explain if answered No to any of the above) Bolts stripped

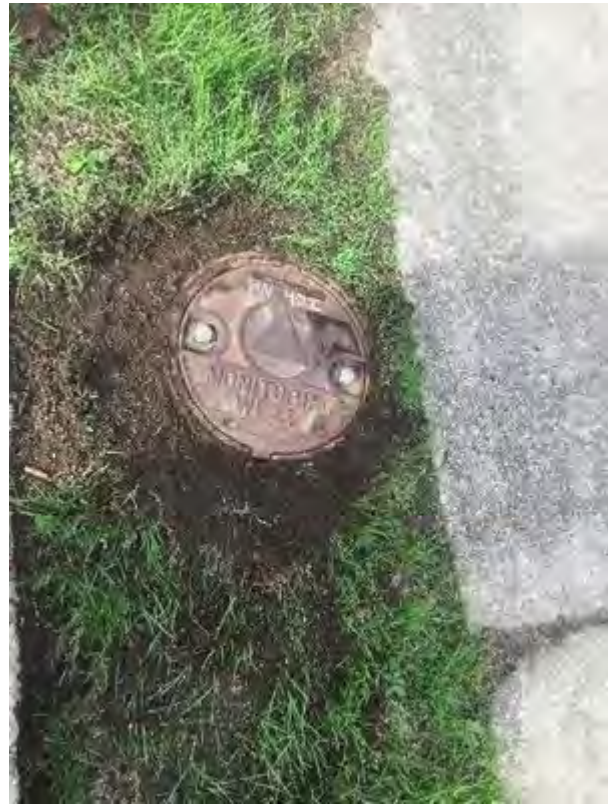
Client: Navy CLEAN	Facility: NWIRP Bethpage
Project Number: 112G08005-WE13	Location: Bethpage, New York
Date: September 22, 2021 15:48	Personnel: Noah Sprouse
Well ID: BPHNMW29I	Well Location: 213928.573 1124685.862
Well Status: Other	Screen Interval: 120-130
WELL INVENTORY CONDITION	
Concrete pad in acceptable condition i.e. no cracks?	NO
Manhole cover present and in working condition?	YES
All bolts on manhole present and not stripped?	NO
Well plug present, locked and in good working condition?	YES
OVERALL CONDITION:	FAIR
Notes (Explain if answered No to any of the above) One missing bolt, one broken bolt, one stripped bolt, broken rubber gasket.

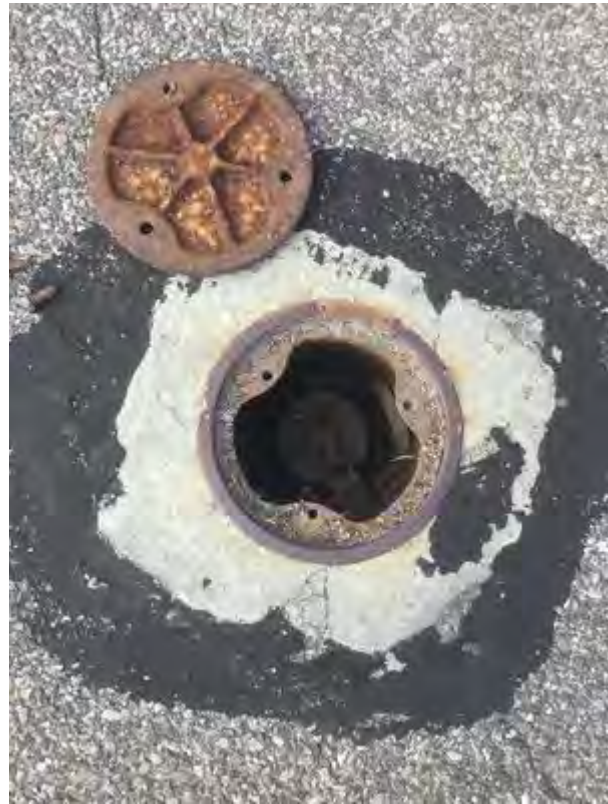
Client: Navy CLEAN	Facility: NWIRP Bethpage
Project Number: 112G08005-WE13	Location: Bethpage, New York
Date: September 22, 2021 15:33	Personnel: Noah Sprouse
Well ID: BPS1-TT-MW303I2	Well Location: 213779.054 1124562.054
Well Status: Other	Screen Interval: 146-156
WELL INVENTORY CONDITION	
Concrete pad in acceptable condition i.e. no cracks?	YES
Manhole cover present and in working condition?	YES
All bolts on manhole present and not stripped?	NO
Well plug present, locked and in good working condition?	YES
OVERALL CONDITION:	FAIR
Notes (Explain if answered No to any of the above) Missing two bolts.

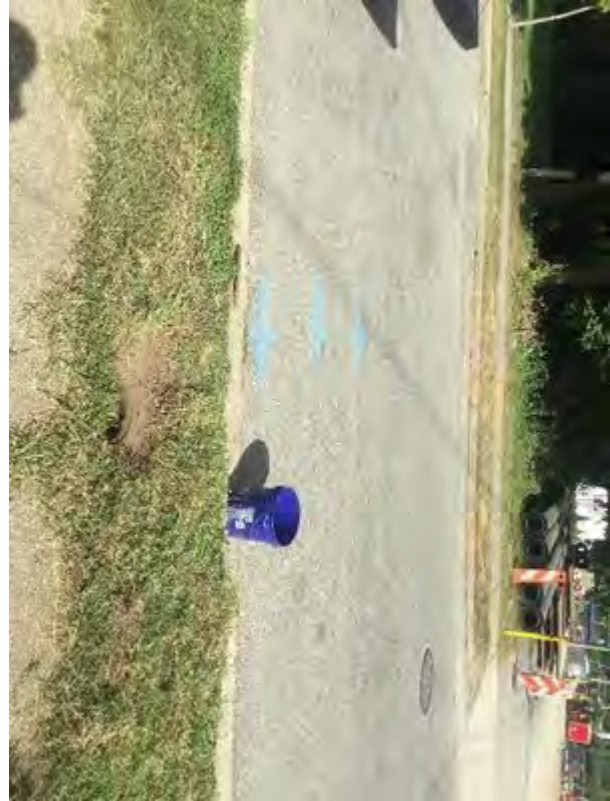
Client: Navy CLEAN	Facility: NWIRP Bethpage
Project Number: 112G08005-WE13	Location: Bethpage, New York
Date: September 22, 2021 14:57	Personnel: Wyatt Bostick
Well ID: GM38D2	Well Location: 206338 1128953
Well Status: Other	Screen Interval: 475-495
WELL INVENTORY CONDITION	
Concrete pad in acceptable condition i.e. no cracks?	NO
Manhole cover present and in working condition?	YES
All bolts on manhole present and not stripped?	NO
Well plug present, locked and in good working condition?	YES
OVERALL CONDITION:	POOR
Notes (Explain if answered No to any of the above) Burried under sod and possible collapsing pad

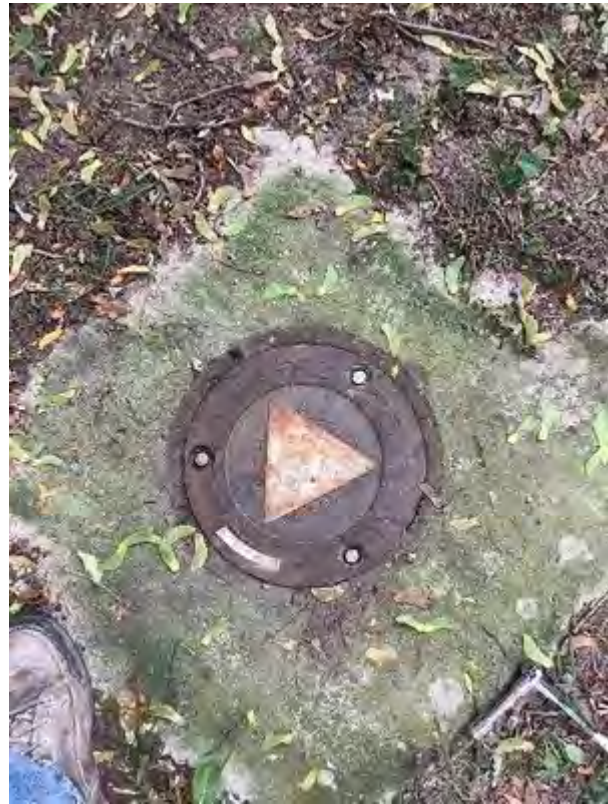
Client: Navy CLEAN	Facility: NWIRP Bethpage
Project Number: 112G08005-WE13	Location: Bethpage, New York
Date: September 22, 2021 14:11	Personnel: Noah Sprouse
Well ID: BPS1-TT-MW305D	Well Location: 213405.975 1123949.183
Well Status: Other	Screen Interval: 286-296
WELL INVENTORY CONDITION	
Concrete pad in acceptable condition i.e. no cracks?	NO
Manhole cover present and in working condition?	YES
All bolts on manhole present and not stripped?	NO
Well plug present, locked and in good working condition?	YES
OVERALL CONDITION:	POOR
Notes (Explain if answered No to any of the above) Cracked well pad, missing one bolt, two bolts stripped, missing rubber gasket.
